Brick By Brick Inspections, Inc.

Home Inspection Report

123

Inspected on Sat, Feb 11 2017 at 8:35 AM

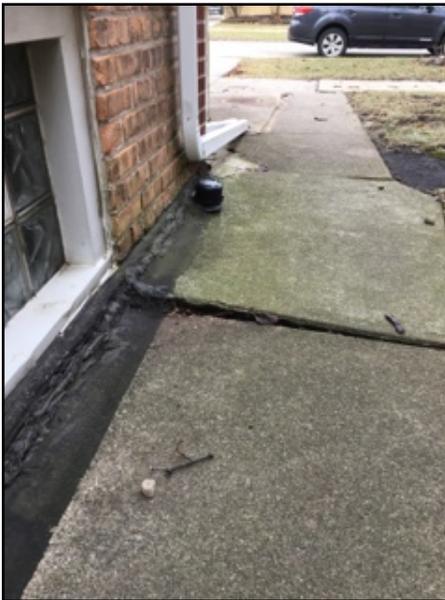
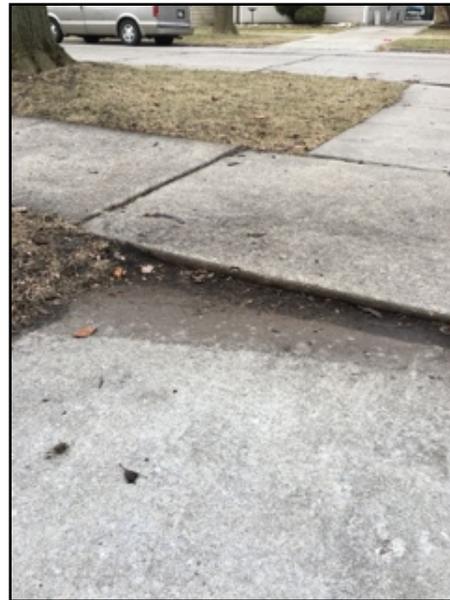
Comment 2:
Some sections of the side entrance walkway and entryway have raised edges which could be a tripping hazard.

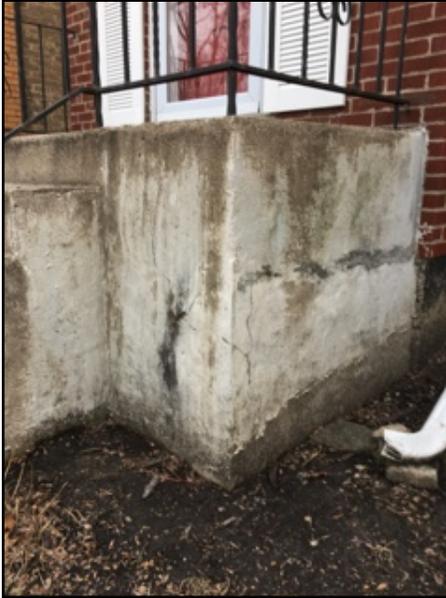
Figure 3-1

Front entry way stairs with light cracking. Not a concern at this time but should be monitored.

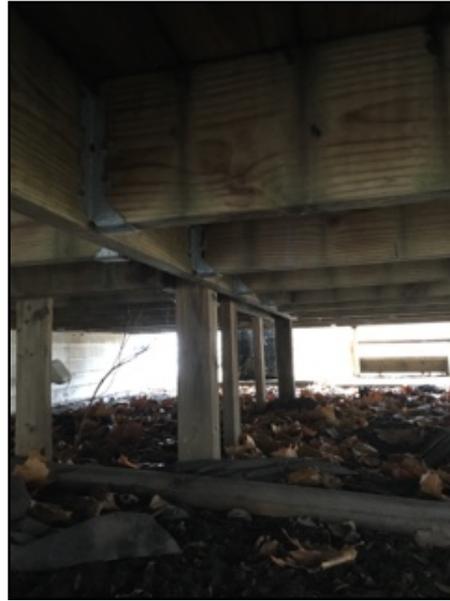
Figure 4-2

Joint hangers pulling away from support beams.

Some bracing needs further evaluation by a professional contractor.

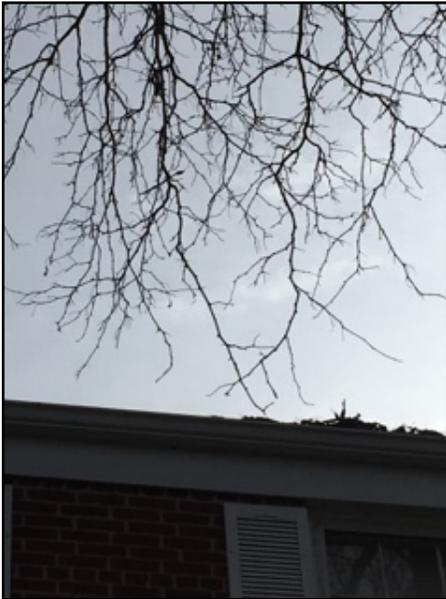
Figure 5-1

Tree in front should be trimmed back so that it does not damage the roof. Large amounts of leaves and seeds present in gutters, should be cleaned annually.

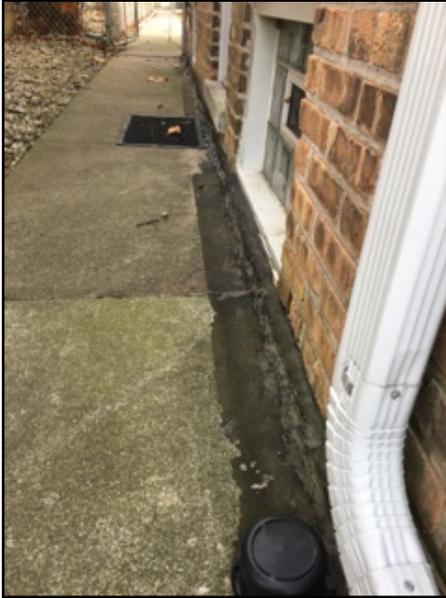
Figure 6-1

It appears as if roofing sealant was used along the northern edge of foundation to prevent water intrusion. This is not a recommended solution.

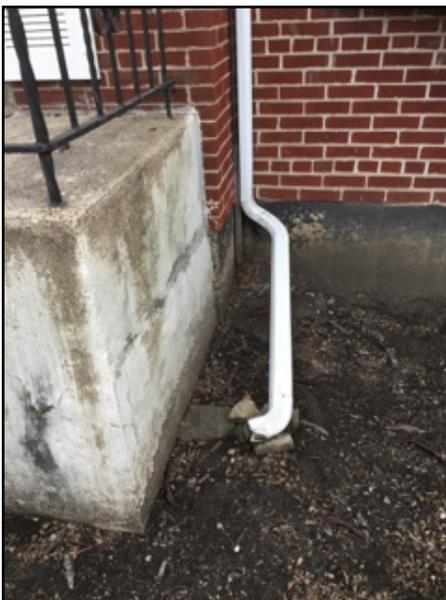
Figure 7-1

Gutters should direct water away from the house, recommended removing the end and extending this gutter away from the foundation or stairs.

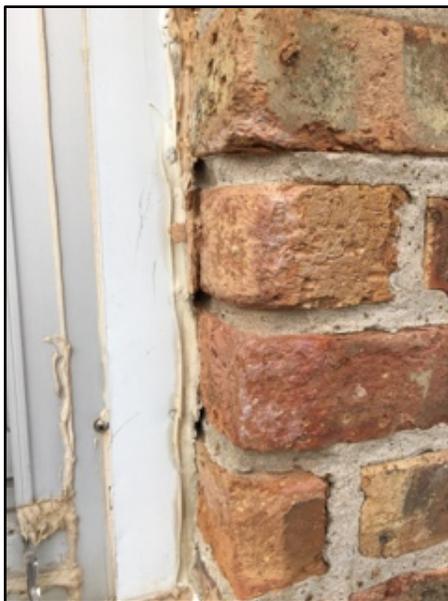
Figure 8-1

Sealing around rear 2nd floor window has failed. Recommend caulking open areas.

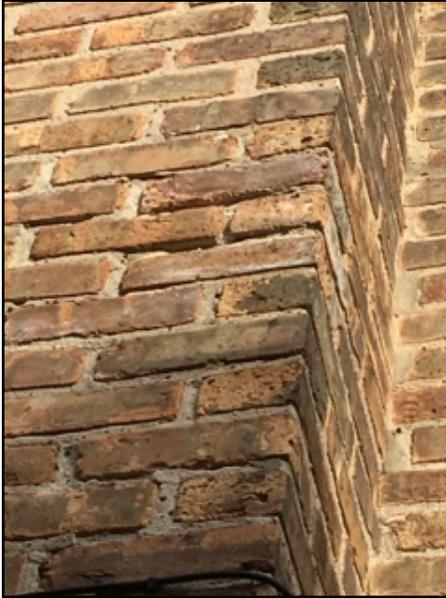
Figure 9-1

Some minor, small sections with loose or missing mortar between the bricks. These should be monitored and evaluated by a professional if the condition worsens.

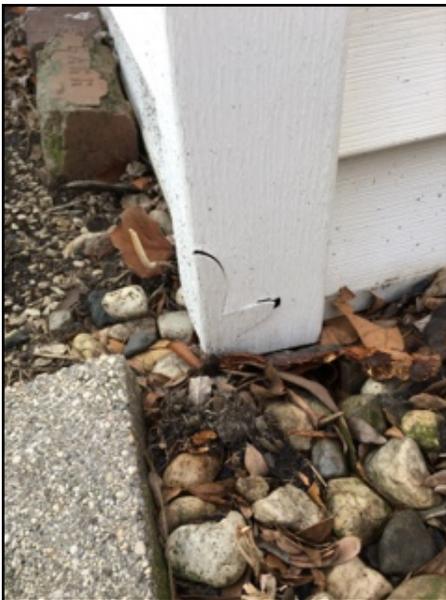
Figure 10-1

Crack in vinyl corner NE corner.

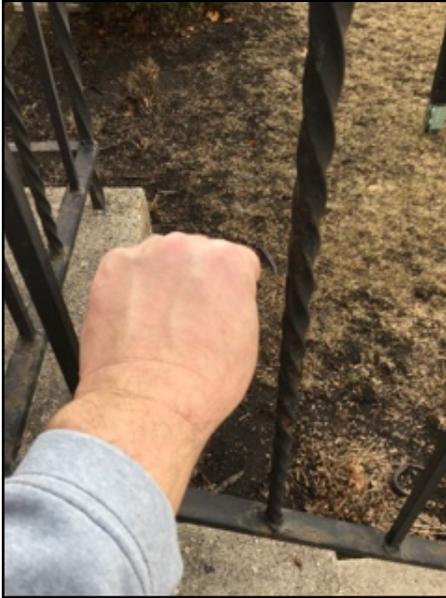
Figure 11-1

- Comment 11:
Distance between ballistas is more than 4 inches which is a safety hazard.

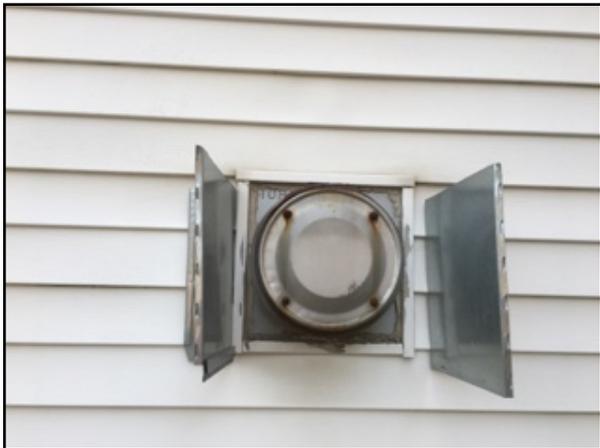
Figure 12-1

-
- Comment 12:
Exhaust vent for the heater in the rear addition/family room appears to be missing parts or requires repair.

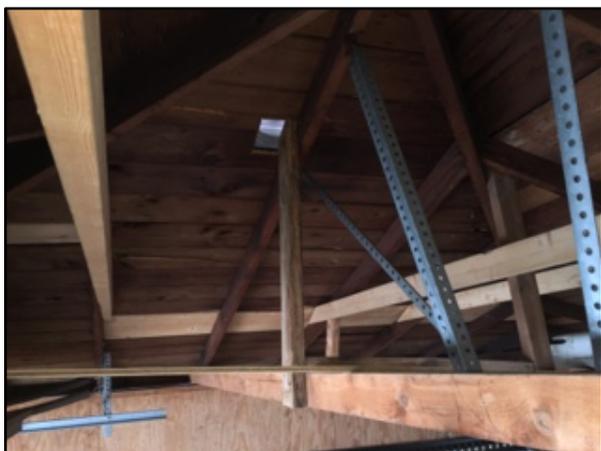
Figure 13-1

Roof appears to have been recently repaired and replaced. Some of the decking material appears to be undersized leaving gaps

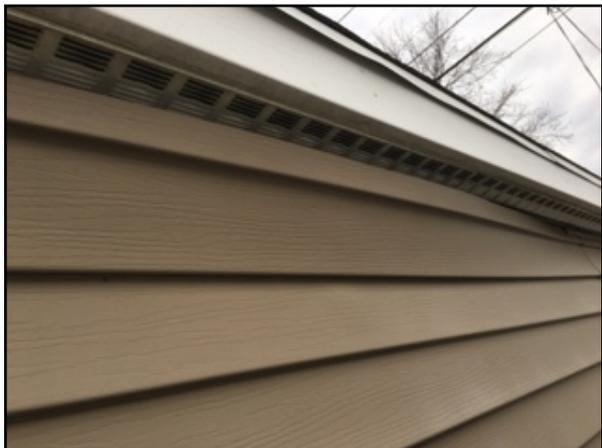
Figure 14-1

**Comment 14:**
Siding on garage is not properly attached. Recommend having a vinyl siding professional evaluate and repair.

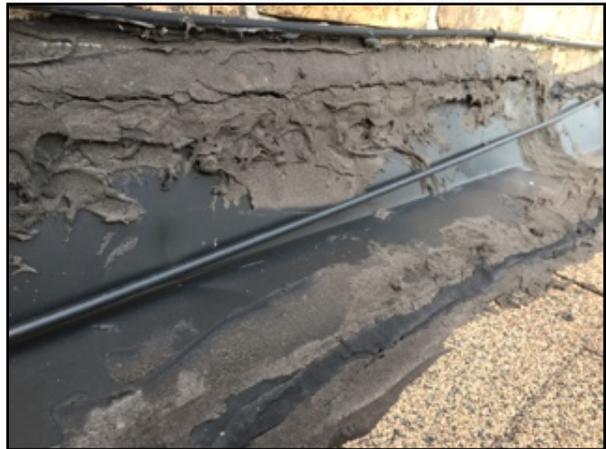
Figure 15-2

Lower level of roof not properly flashed around vent pipe or along transition from brick to the roof. This should be evaluated by a roofing professional.

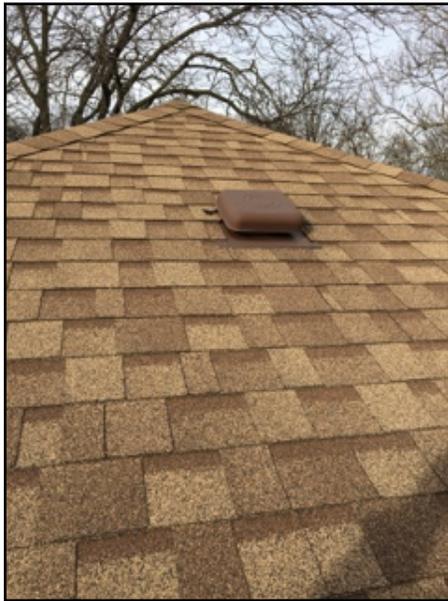
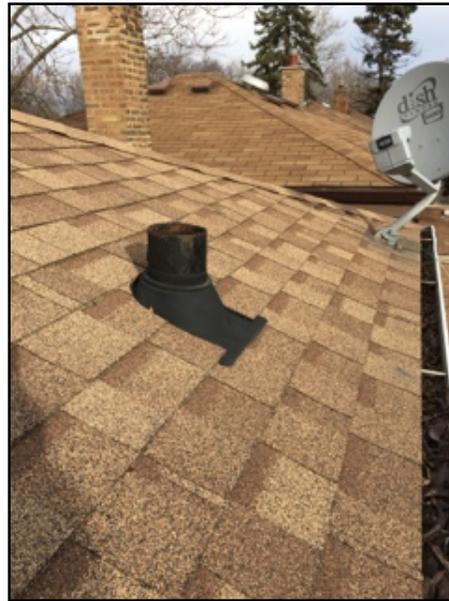
Upper level of roof has proper flashings around vents and appears to be in good working order.

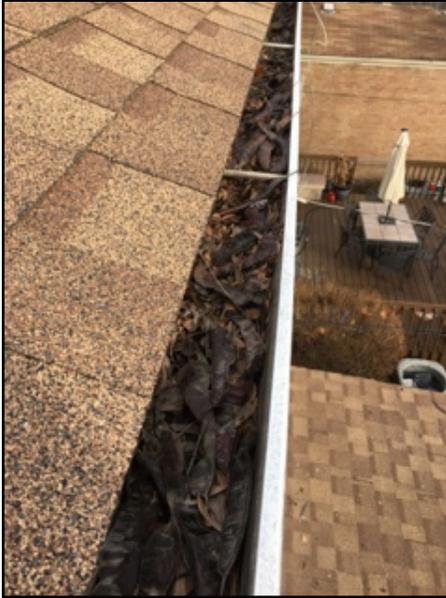
Figure 17-1

Gutters are clogged with leaves and debris. Recommend having them cleaned immediately.

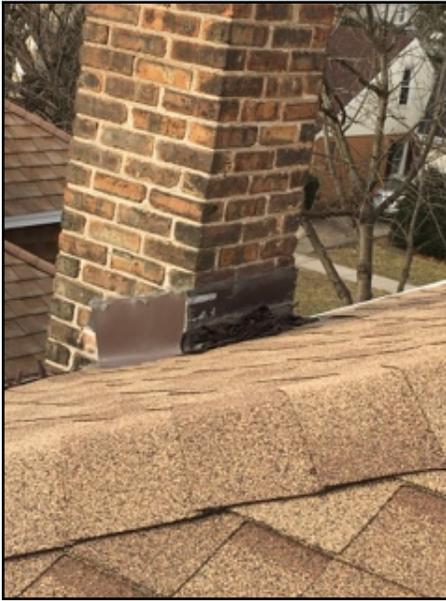
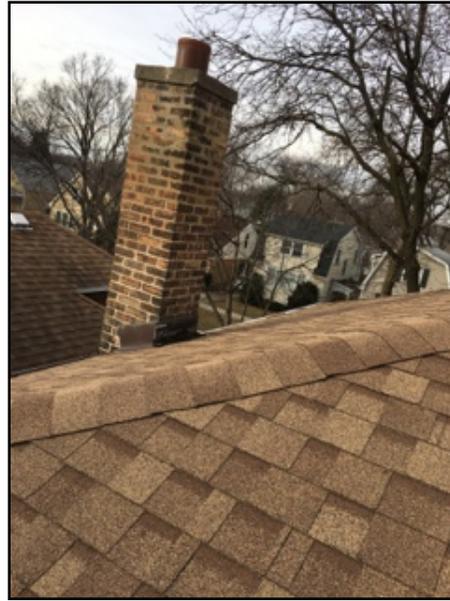
Chimney does not have a "cricket" installed. Flashing around chimney may be inadequate and allow moisture to penetrate around the chimney. Recommend having a roofing professional further evaluate and repair as needed.

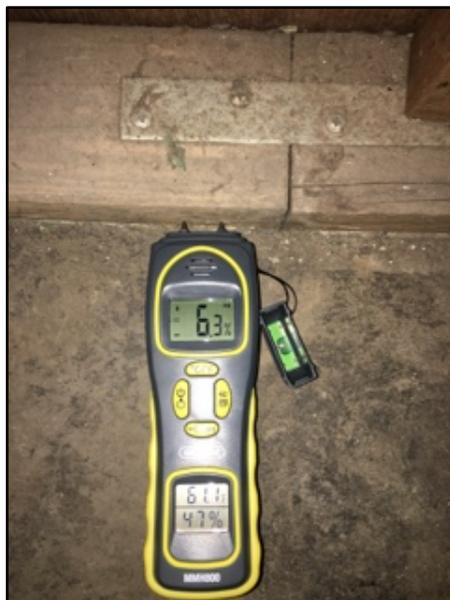
Figure 20-1

Comment 20:
Moisture readings in basement.

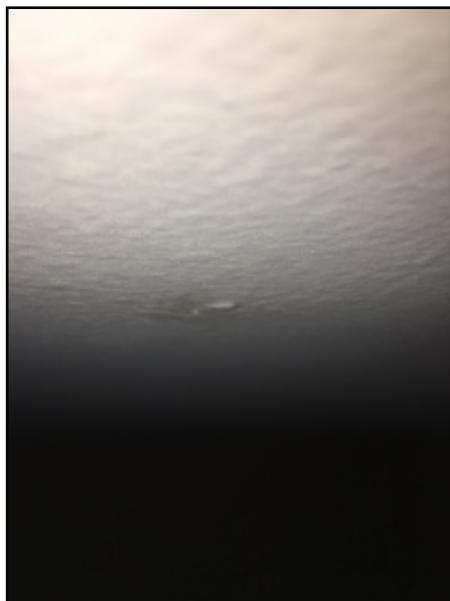
Figure 21-1

**Comment 21:**
Possible moisture in ceiling in bathroom possibly due to lack of ventilation.

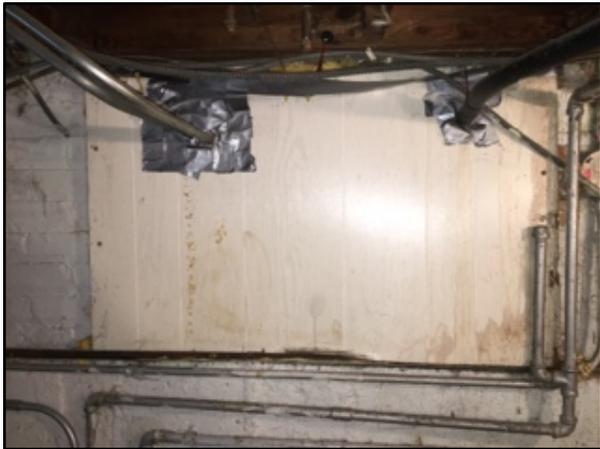
Figure 22-1

Portions of the crawlspace were not inspected.

No entry into addition at rear of the house. Appears to have an access panel in basement but it is sealed.

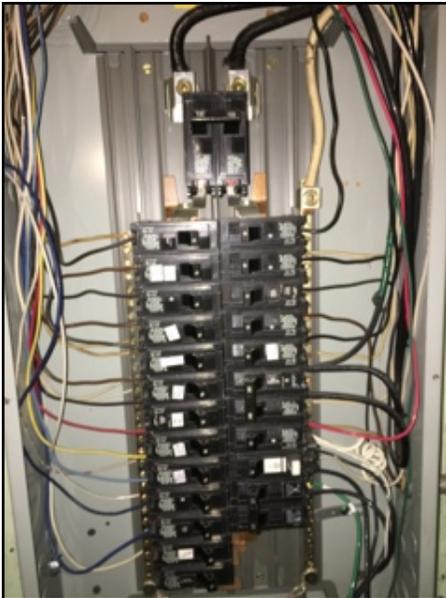
Figure 24-1

Comment 24:
Supply wiring appears to be stranded aluminum. This is not a defect but can be further evaluated by a professional electrician.

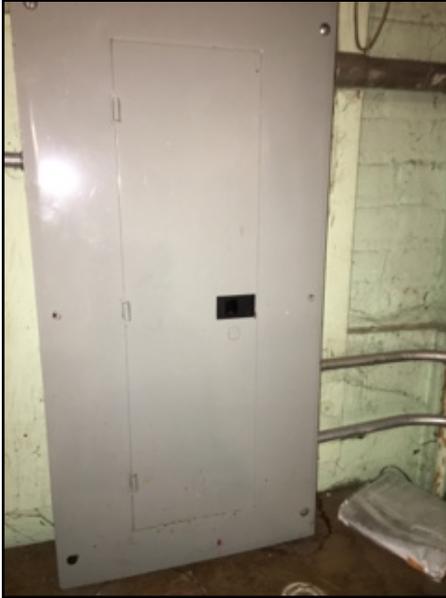
Figure 25-1

Missing screws in electrical panel. Interior screws not right size. Recommend replacing with the correct hardware to keep the panel sealed.

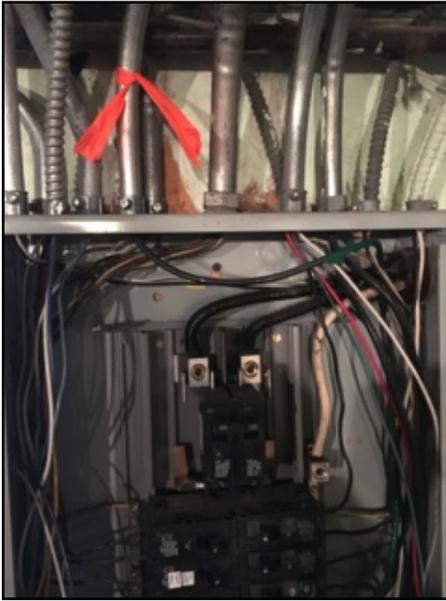
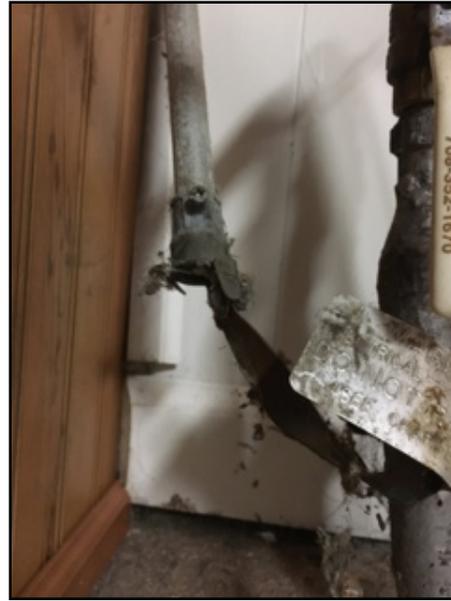
Ground wire is fed into conduit from the panel to the water main however there is no wire tied to the water pipe to ground the electrical system. Recommend having a professional electrician evaluate and repair the ground as needed.

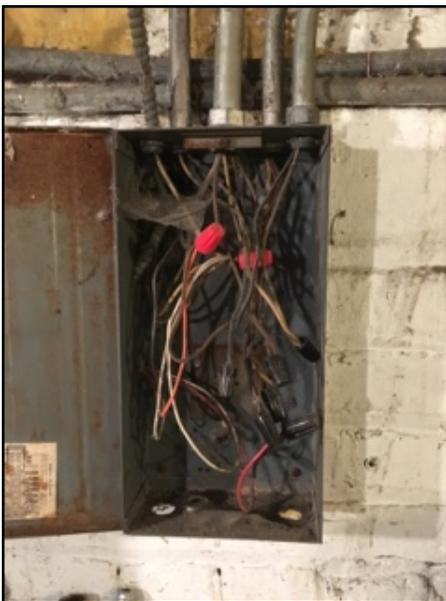
Figure 27-1

Original panel box which is not in use is housing several electrical connections. These should be placed in a junction box. Further evaluation from a professional electrician is recommended.

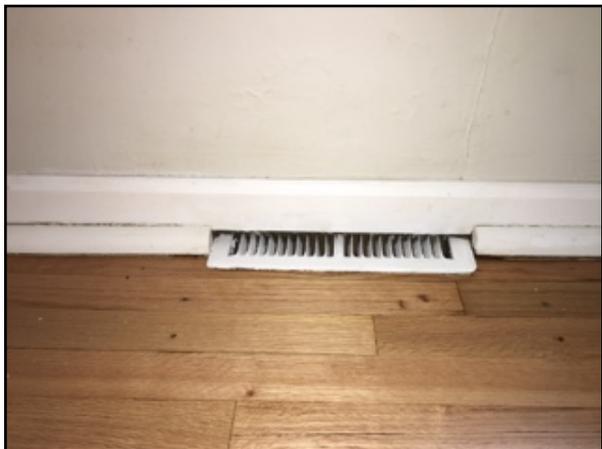
Figure 29-1

Vents are overlapped by moldings not allowing the heat to distribute properly.

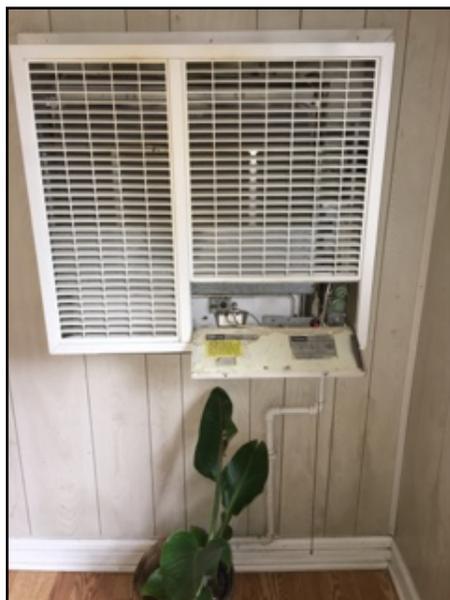
Figure 30-1

Heater located in addition. Working properly during the inspection. Adjustments are made in the access panel and the fan is activated using the pull cord on the Lowe right side.

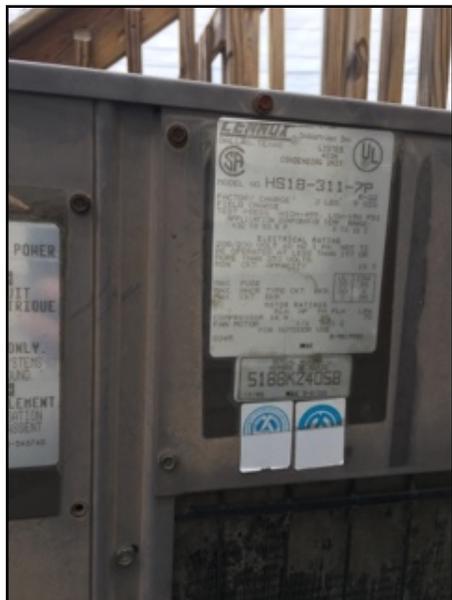
Figure 31-1

Could not test air conditioning unit. Unit was produced in October or 1988 and is beyond its expected useful life.

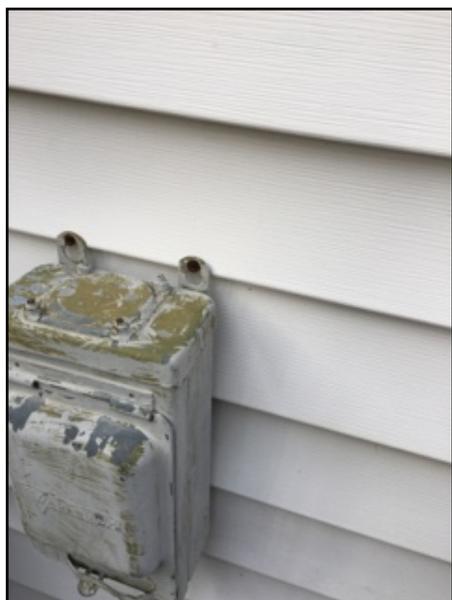
Figure 32-1

Disconnect box for air conditioning condenser is not properly secured to house and is loose. This should be checked by a professional electrician.

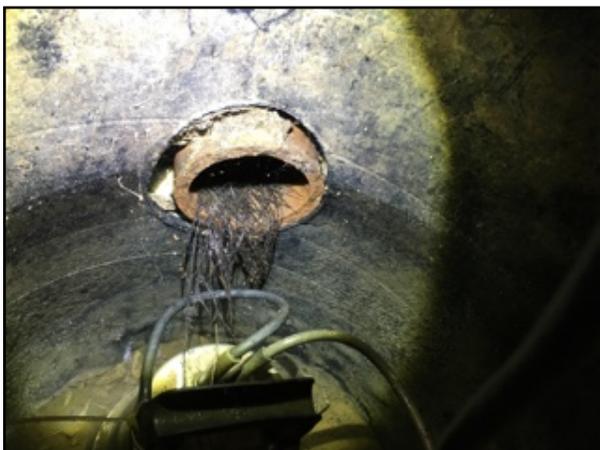
Figure 35-1

Roots entering the sump pit in the basement. Roots can clog drain lines and should be cleaned and inspected by a professional plumber periodically. Also noted the upstairs bathtub was draining slowly. Could not determine where the sump pump is ejecting water inside the crawl space area which was sealed at time of the inspection. Recommend a professional plumber inspect further.

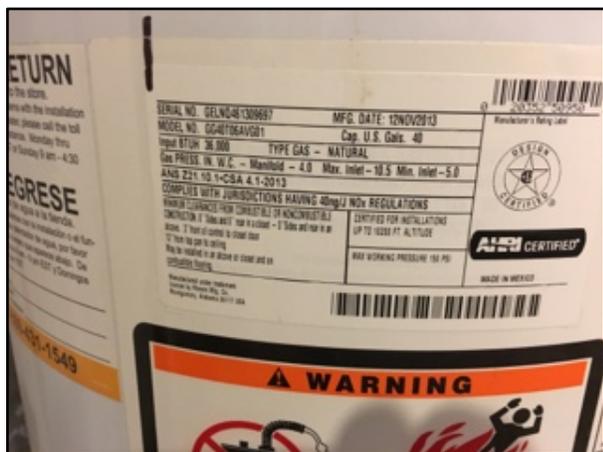
Figure 36-1

Water heater passed the draft test of combustion exhaust and is operating properly.

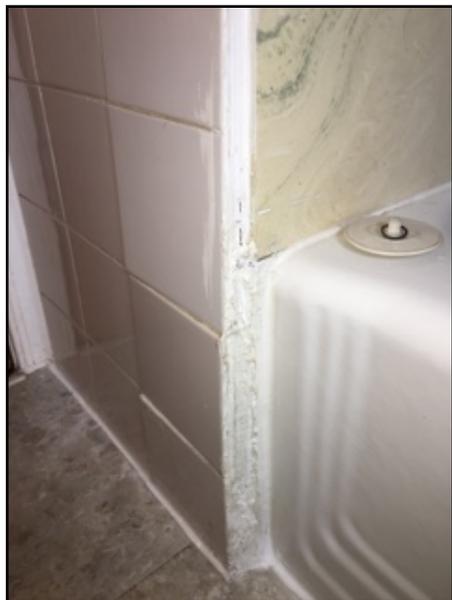
Figure 37-1

**Comment 37:**
 Moisture intrusion around tub. Tiles are coming loose from wall next to tub.
 Recommend replacing and resealing.

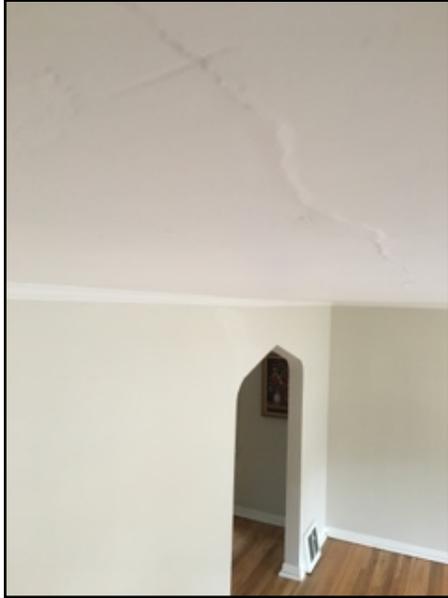
Figure 39-1

Slight cracking in the ceiling noted along with cracks in the walls. Appear to be normal settling.

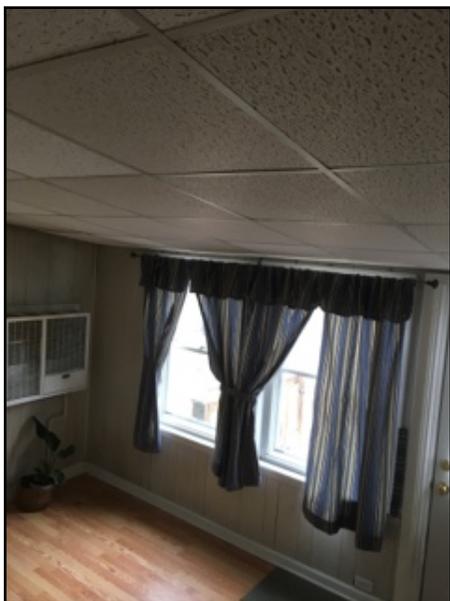
Figure 40-1

Sloping floor and brick in the entry to the room indicates that this is an addition or a finished porch area. Heating has been installed separately in the north wall. Could not inspect the area underneath this room to determine if it has a proper foundation. There were no apparent issues noted during the inspection. Further evaluation by a professional contractor or structural engineer is recommended.

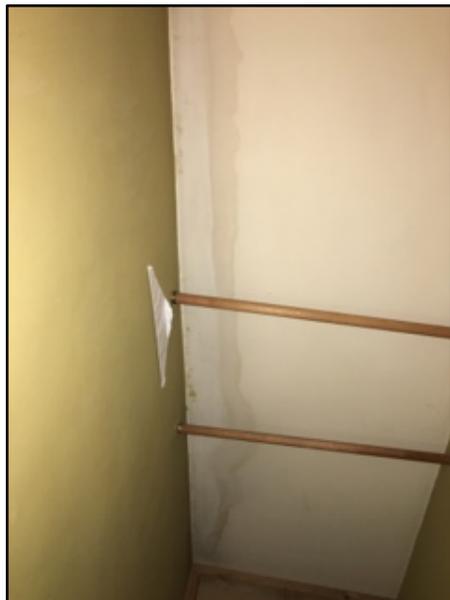
Figure 41-1

Apparent water penetration had occurred in the main bathroom closet over the staircase.

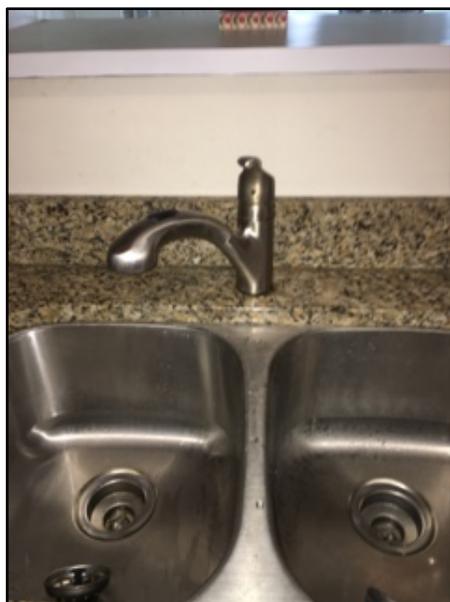
Figure 42-1

Hot water (right) and cold water (left) are switched.

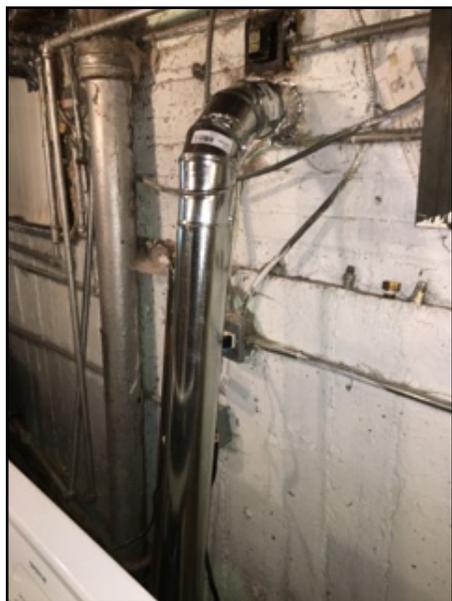
Figure 43-1

Comment 43:
Laundry dryer vent through crawl space.

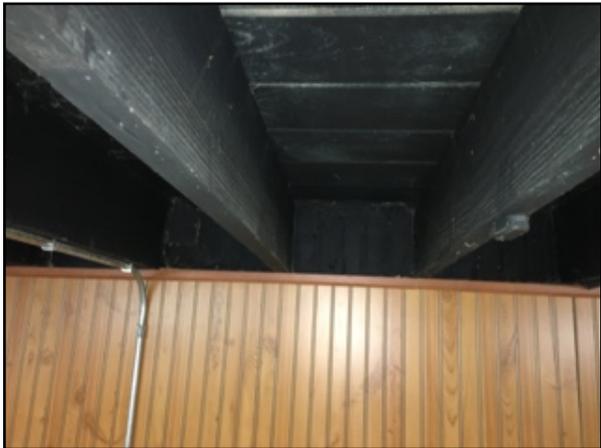
Figure 44-1

Insulating between the ceiling joists and the outer walls is recommended to prevent heat loss.

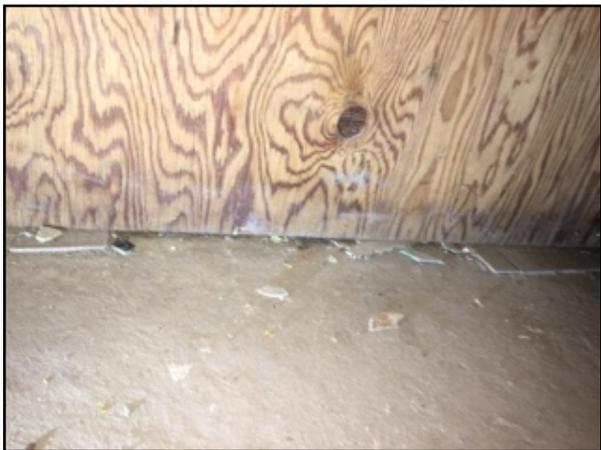
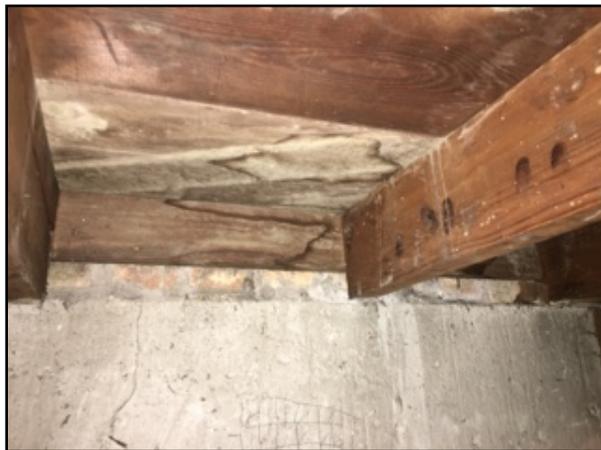
Signs of past water intrusion in the basement were visible. Cannot determine if there are continued water issues in the basement. This is located along the north wall of the home in the basement, same area noted outside where the roofing sealant was used along the foundation edge.
