| CR NUMBER 16-5932 | ACCIDENT DATE 3/13/16 | ACCIDENT TIME 1235 | DAY OF WEEK SUN | <input checked="" type="checkbox"/> DAYLIGHT <input type="checkbox"/> DAWN OR DUSK <input type="checkbox"/> DARK |
| LOCATION OF ACCIDENT (STREET NUMBER OR OTHER LOCATION DESCRIPTION) 506 E. Summit St Parking Lot | | | WEATHER cloudy / Rain | |

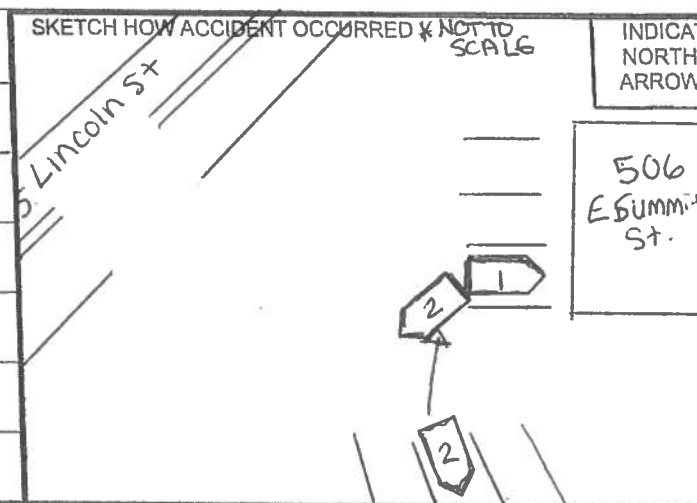
SKETCH HOW ACCIDENT OCCURRED * NOT TO SCALE

DESCRIBE HOW ACCIDENT OCCURRED
Unit 1 was parked in a parking space on the west side of 506 E Summit St. Unit 2 was backing out of a parking space on the south side of the building and struck Unit 1.
