Inspection Report

Property Address:
444 Somewhere Ln.
Anywhere NE 12345

Handy Home Inspection Services, LLC

Date: 3/28/2017	Time: 02:20 PM	Report ID: Sample 2
Property: 444 Somewhere Ln. Anywhere NE 12345	Customer: Mr. John Smith

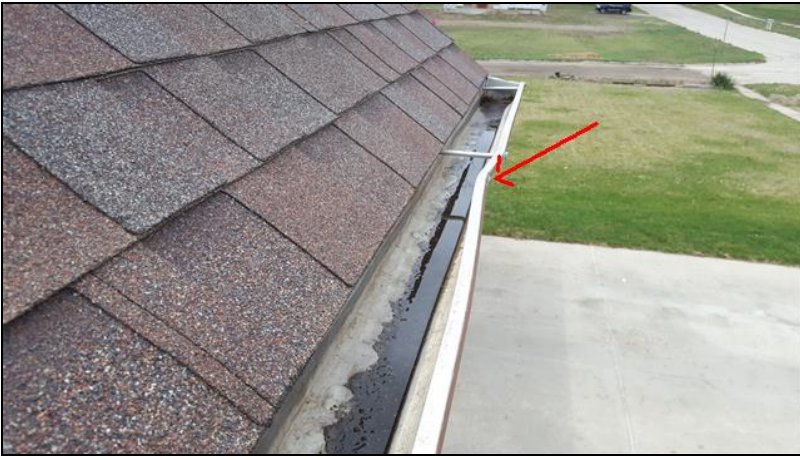
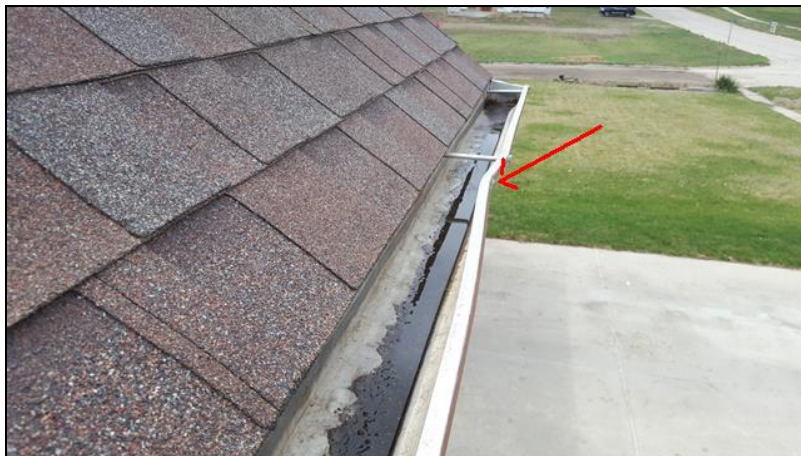
1.4 Due to the lack of recent rain, I am unable to determine if gutters leak at seams or spills water. There are several location where the gutter is bent or not attached properly to the house. The downspouts are not secured properly or have broken away from their brace. Large gaps between the pipes could potentially allow water to leak out of the downspout near the foundation of the house.

There was a little bit of standing water on the front west corner of the house at the time of inspection. This would suggest the gutter is sagging or was not installed with the proper slope. If you notice water coming out of the gutter during a rainfall, I recommend getting all gutters replaced.

The drip edge is beginning to rust. The drip edge prevents ice damming and helps direct water into the gutters. If the drip edge fails due to the rusting, the fascia will be susceptible to rot.

1.4 Item 1(Picture) Standing water in gutters above garage

Estimated remaining life on current gutters is short. I recommend budgeting for new gutters in the near future.

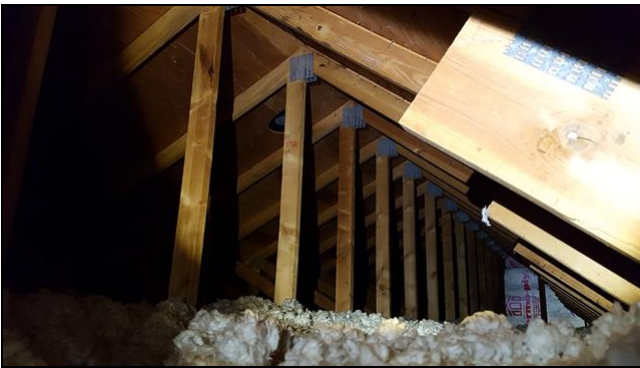
1.5 I inspected the attic from the hatch. I was unable to access it completely, as it was located in a bedroom closet full of clothing. No visible signs of leaking or condensation at time of inspection.

1.5 Item 1(Picture) Attic

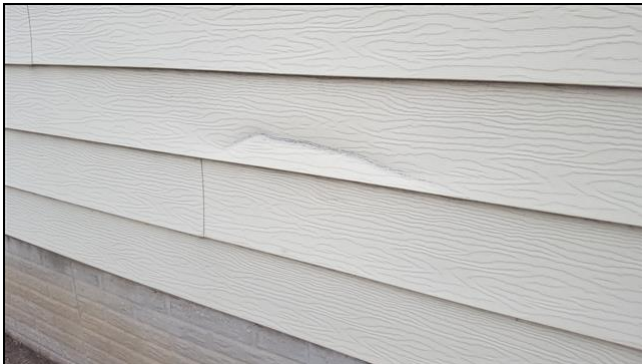
2.0 Overall, the siding was in good condition. A couple dents/ scratches - most likely from a lawn mower.

2.0 Item 1(Picture) Siding damaged by mower

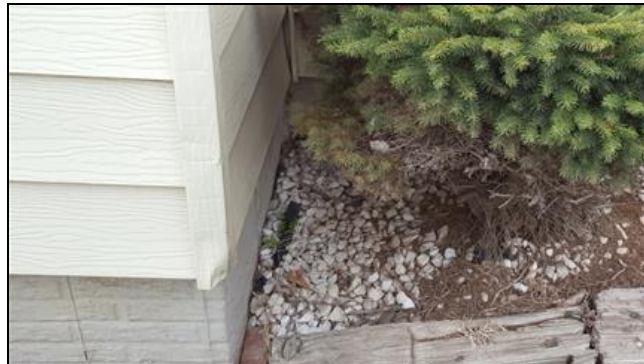
2.0 Item 2(Picture) Siding trim damaged by mower

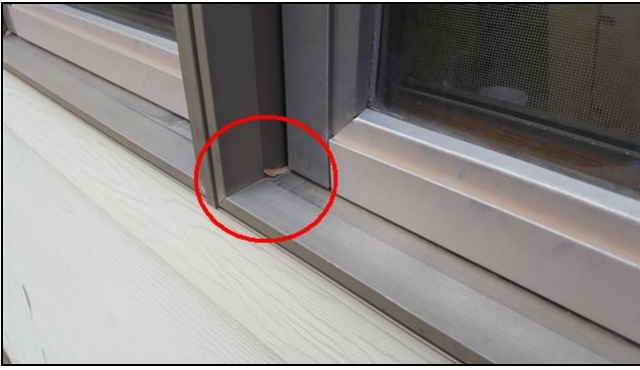
2.2 Item 1(Picture) Window caulking

2.2 The caulking around the windows and patio doors is old and brittle. I **recommend** stripping the old caulking and replacing with 100% silicone to create the most weather/air proof seal.

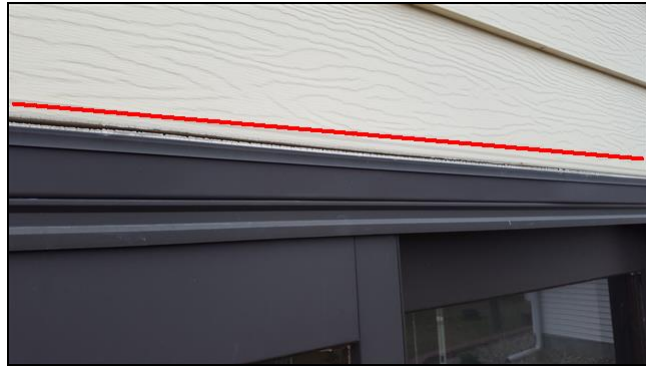
2.2 Item 2(Picture) Sliding door caulking

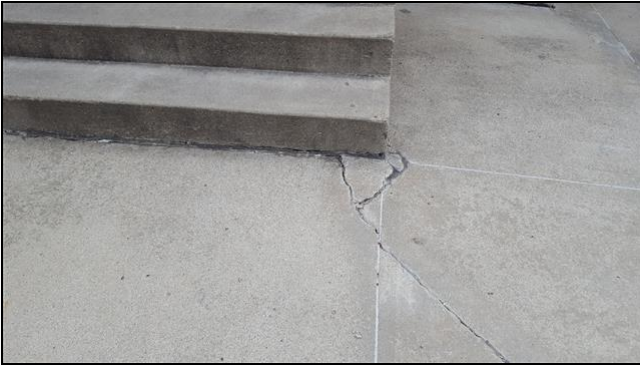
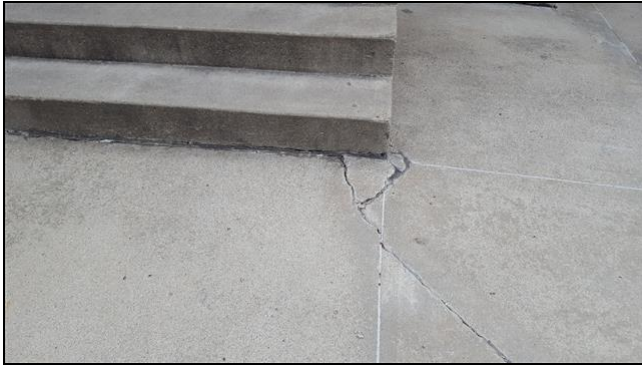
2.3 (1) typical cracking by stairs on front approachment.

2.3 Item 1(Picture) cracking on approachment

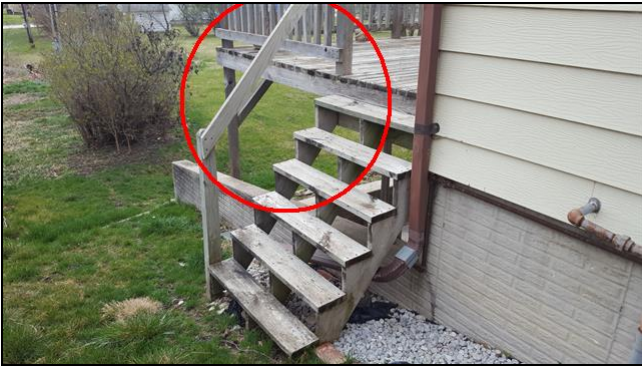
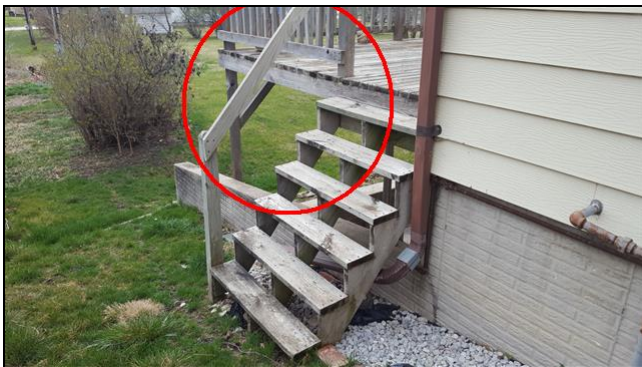
2.3 Item 2(Picture)

(2) The guardian at steps on deck at the (East side of home) does not have a guard rail with proper picket spacing. A fall or injury could occur if not corrected. A handrail with a maximum 4" spacing should be installed on both sides of stairs for safety.

There were 25+ nails popped on the deck and guardrail. This is a tripping hazard as well as a structural hazard.

Recommend having the deck evaluated by a professional contractor.

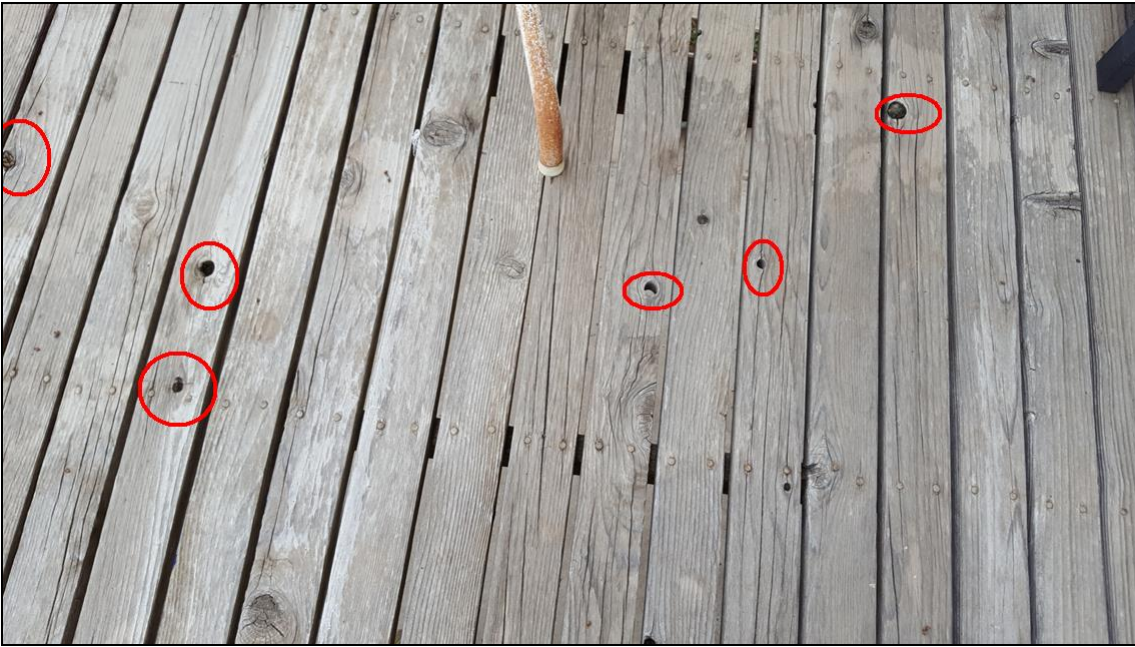
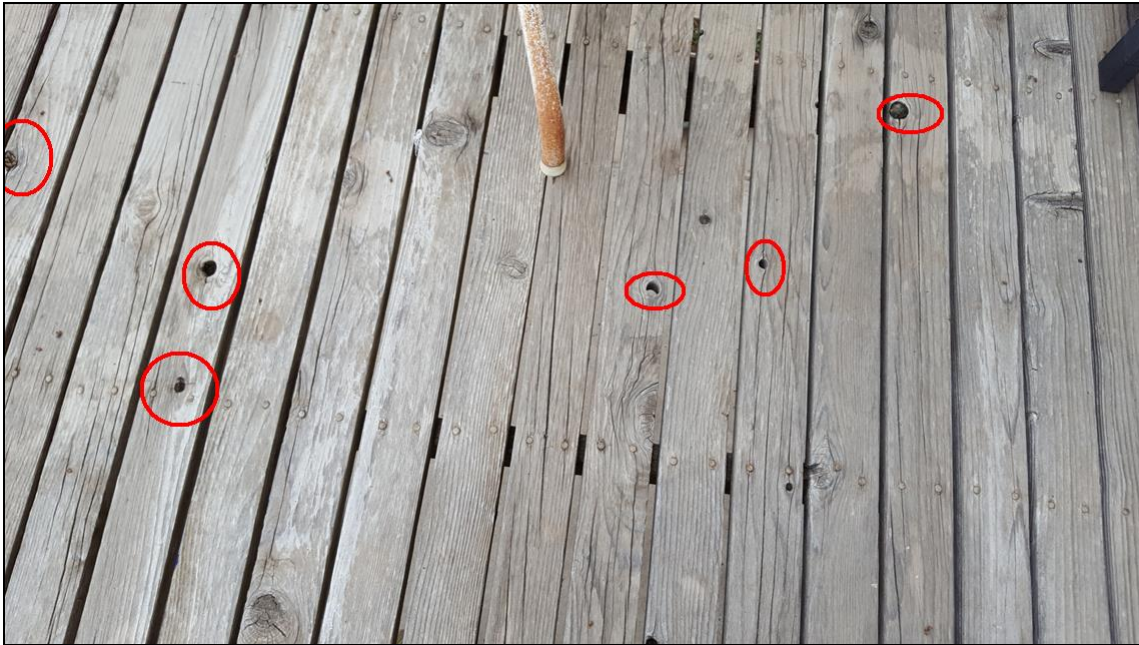
There are several knots on the base of the deck. These holes can collect debris and water and cause the wood to rot. There were several places where the wood was soft and showed signs of rot.

2.3 Item 9(Picture) knots

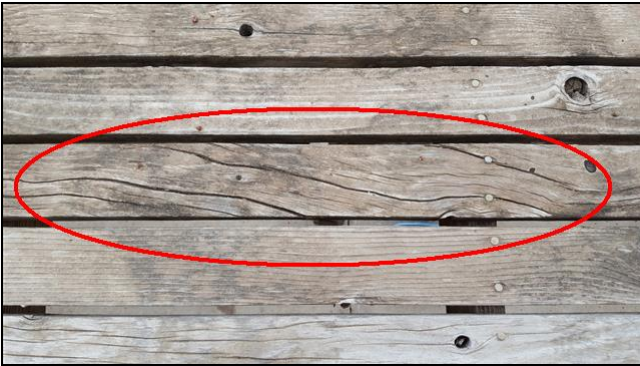
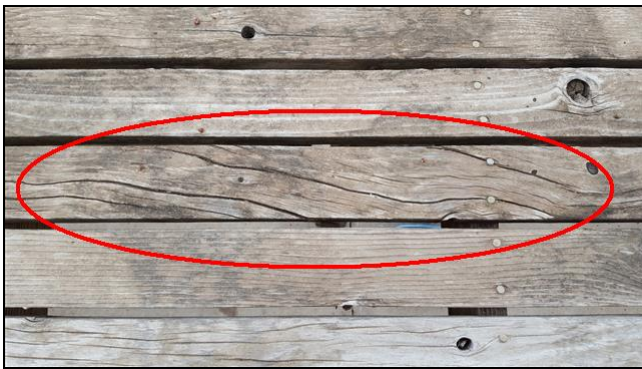
Several boards had cracks 1/4" or more deep which would indicate some rot.

2.3 Item 10(Picture) Cracking

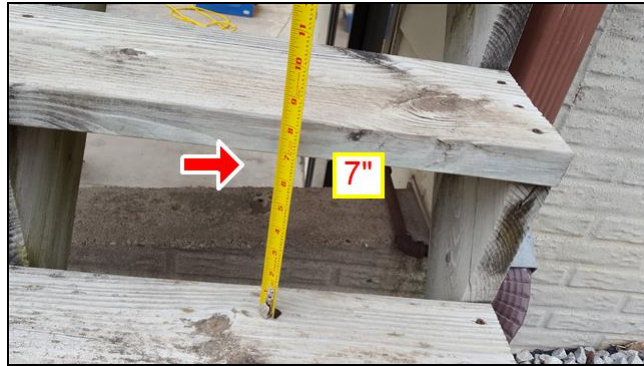
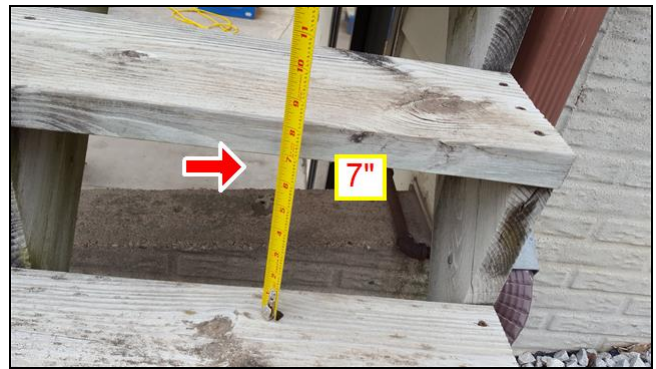
The stairs have a 7" gap in the back. This is a safety concern for children.

2.3 Item 11(Picture) Stair gap

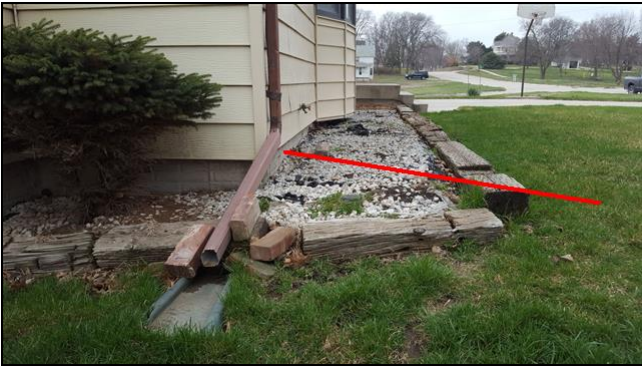
2.4 Item 1(Picture) Grading

2.4 Ideally, the grading would run at a 1/1 ratio (one inch out, one inch down) for 6". Recommend filling in a little more up against the house, especially in the front.

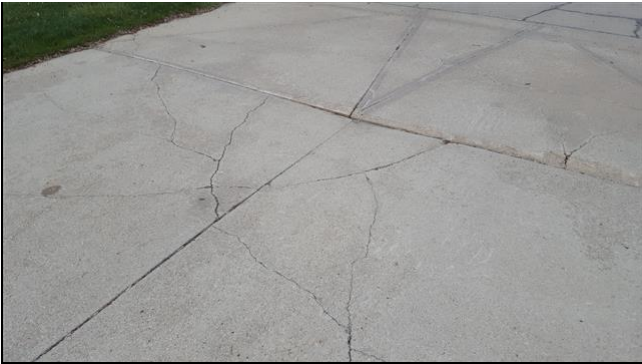
The drive is in overall good condition. Typical cracking on the north end noted.

2.4 Item 5(Picture) Driveway

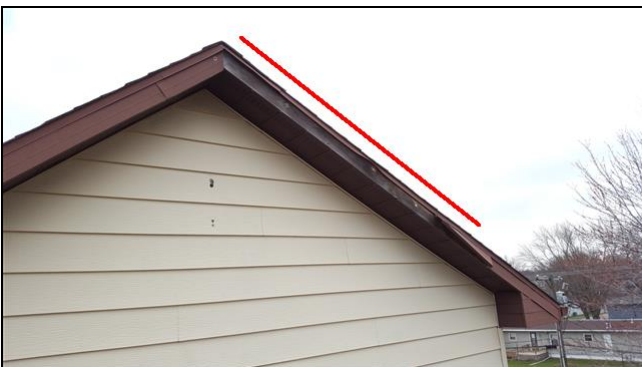
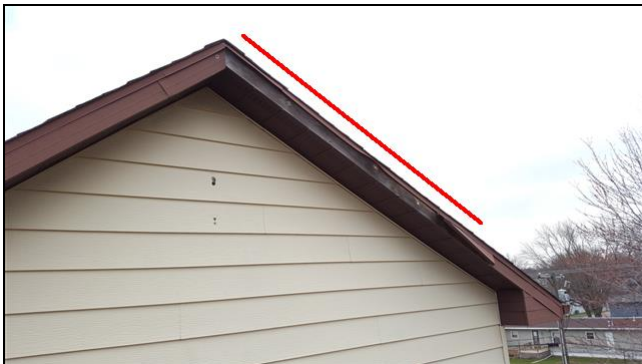
2.5 (1) There is a missing trim piece on the west side of the house near the highest point. **Recommend replacing.**

2.5 Item 1(Picture) Missing trim piece

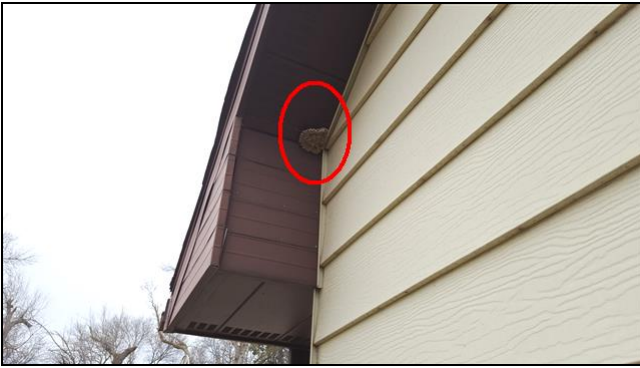
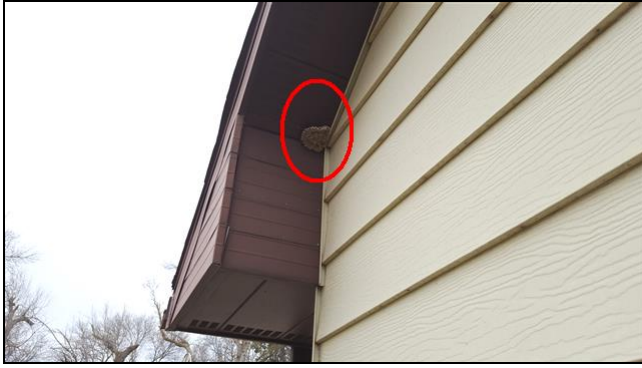
(2) Soffits are in good condition. Note, two wasp nests on west side of house.

2.5 Item 2(Picture) Wasp Nest

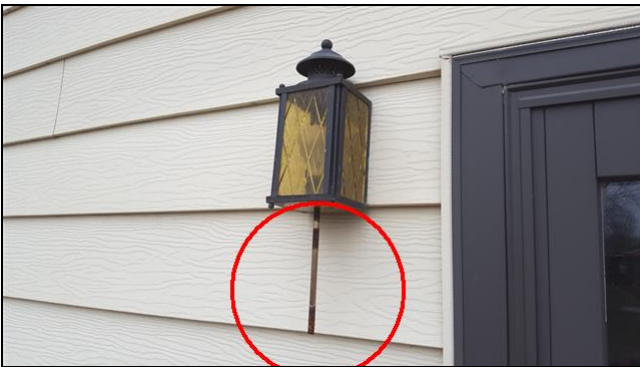
2.7 recommend removing or replacing the light fixture on the back deck area. It has a rusted tube attached to the socket. Although it is not a shocking hazard if touched, it could potentially cause the fixture or bulb to break if bumped.

2.7 Item 1(Picture) Deck light

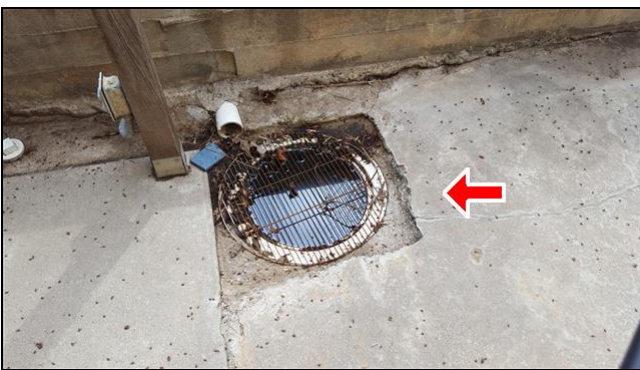
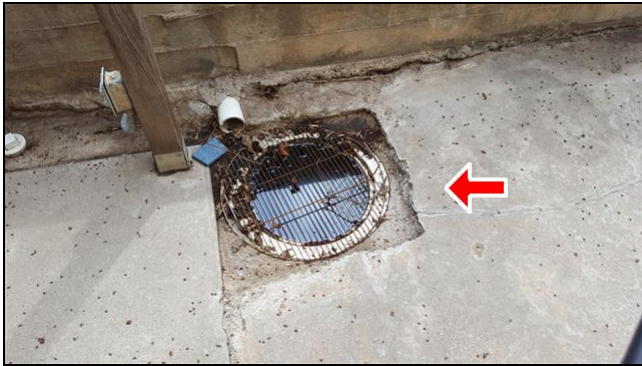
2.8 The concrete area below the deck is completely enclosed with no steps.

The water is a drowning hazard for children and needs to be drained. There was more than 18" of standing water covered by a grilling grate.

2.8 Item 1(Picture) Drain hole

Recommend draining and having the hole filled or drained properly.

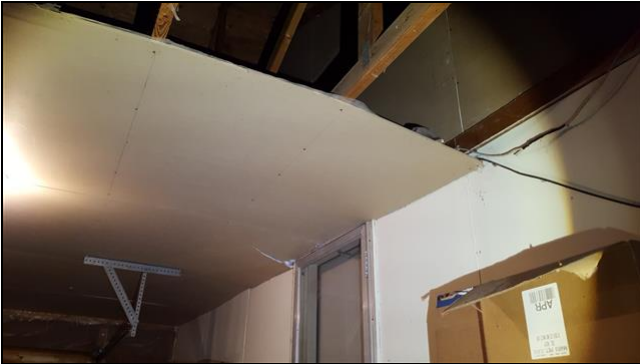
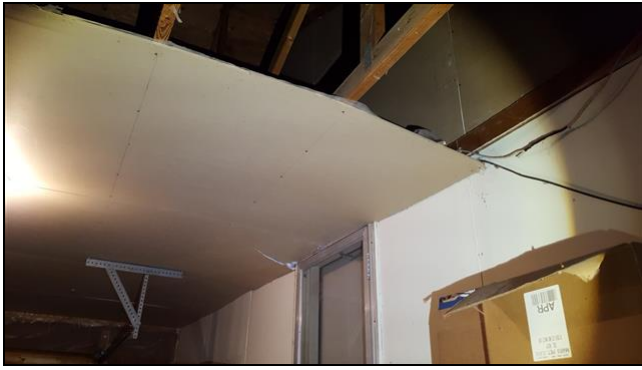
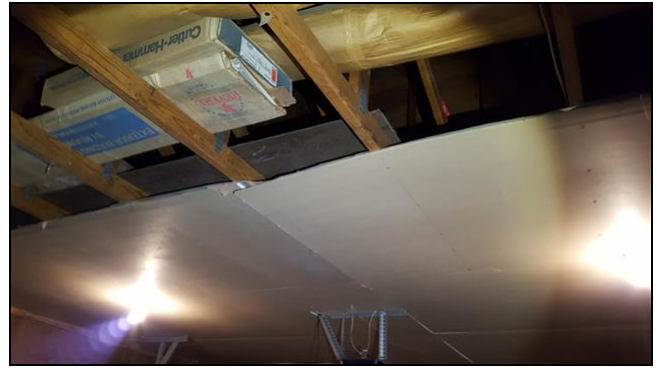
3.0 Garage ceiling is partially covered with drywall. Needs to be repaired or replaced as parts of the drywall are hanging down or broken. Can damage a car or hurt someone if it were to fall.

3.0 Item 1(Picture) Garage Ceiling

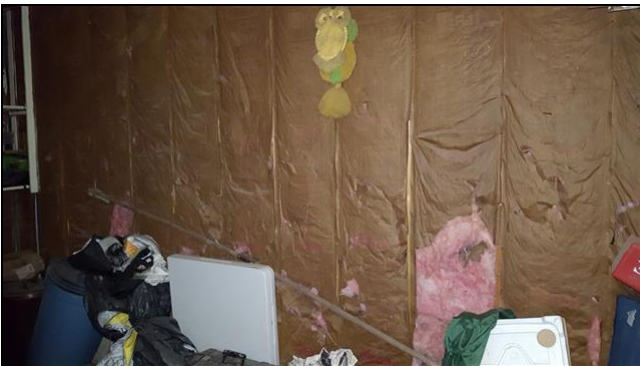
3.1 No coverings, fiberglass insulation.

3.1 Item 1(Picture) Garage walls (insulation)

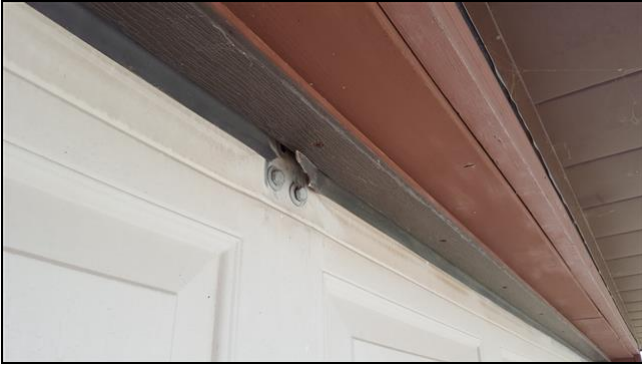
3.3 Main overhead door seal is cracked in the middle where the garage door bolts rub.

3.3 Item 1(Picture) broken seal where garage door bolts rub

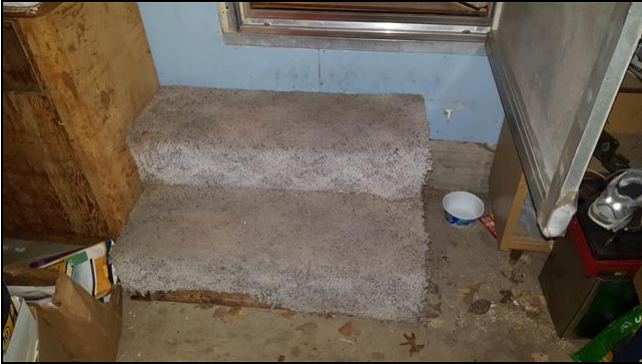
3.5 Item 1(Picture) Steps leading to occupant door

3.5 The occupant door is a screen door/ steel. **Recommend** securing the steps leading to the occupant door from the garage.

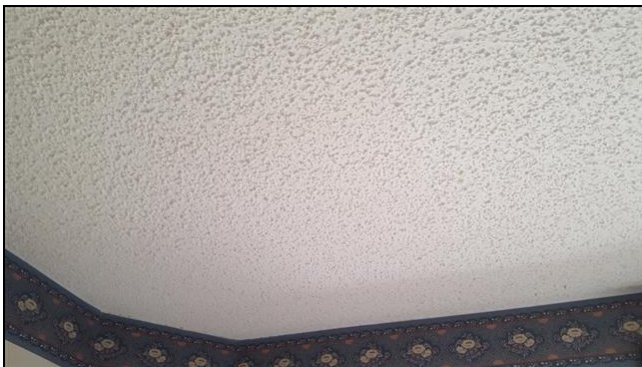
4.0 It's possible that your popcorn ceiling contains asbestos, which can cause serious health issues if you disturb the particles. The process of spraying on the textured popcorn ceiling involved applying coatings that contained asbestos. Asbestos was banned in 1979, but it is still a possibility it was being used into the mid 80's. If you intend to remove, i suggest that you have it tested for asbestos before it is removed.

4.0 Item 1(Picture) Popcorn ceiling

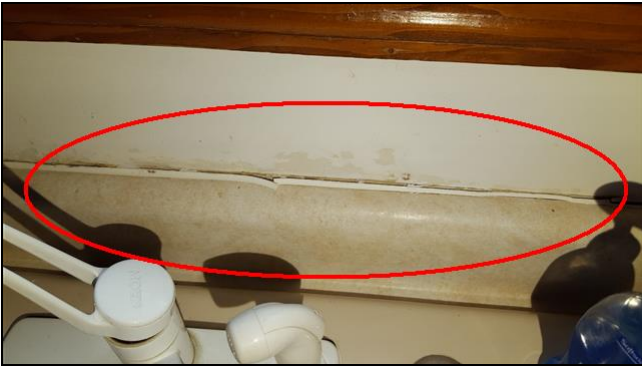
4.1 The caulking along the wall behind the sink all the way to the stove is cracked. Recommend re-caulking to prevent water from seeping behind countertop.

4.1 Item 1(Picture) countertop caulking

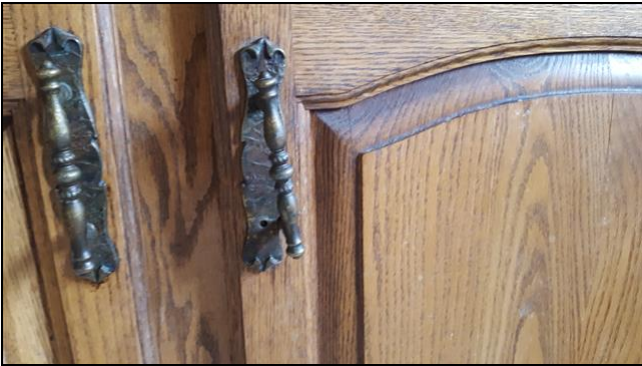
4.5 Cabinets all function properly. Several handles and knobs are loose and 1 is missing a screw.

4.5 Item 1(Picture) missing screw / loose hardware

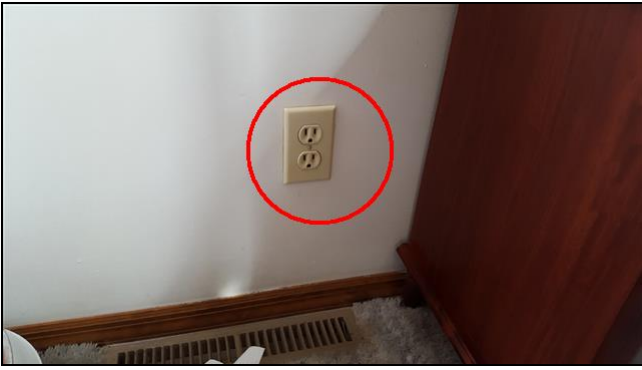
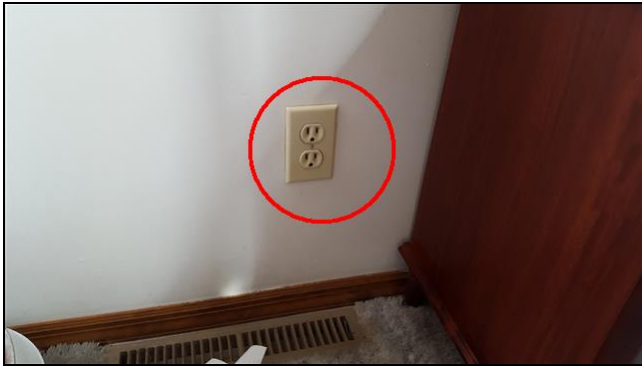
(2) The outlet on the east dining room wall was loose at time of inspection.

4.8 Item 1(Picture) East dining room wall

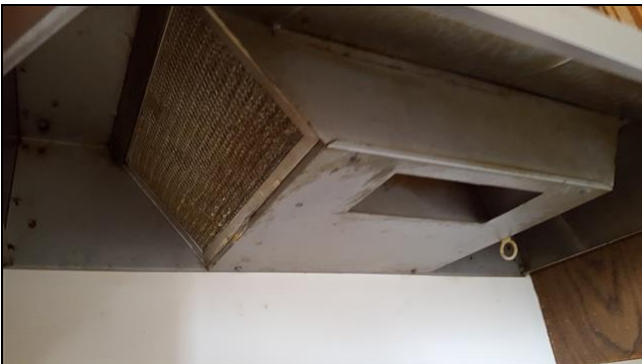
4.11 Item 1(Picture) clean or replace vent covers

4.11 wash/ replace filter screens.

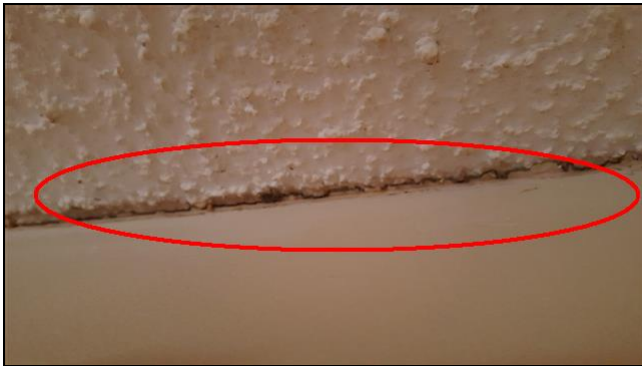
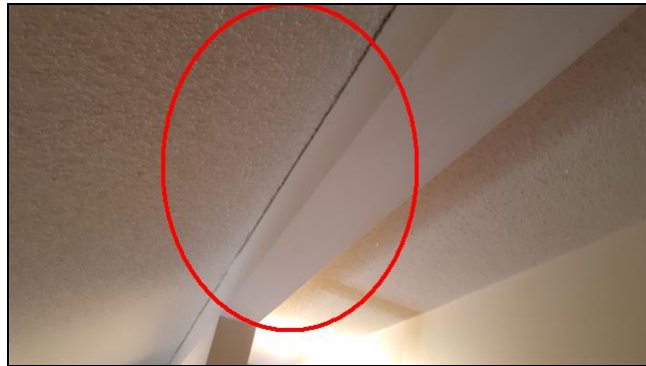
5.0 (1) It's possible that your popcorn ceiling contains asbestos, which can cause serious health issues if you disturb the particles. The process of spraying on the textured popcorn ceiling involved applying coatings that contained asbestos. Asbestos was banned in 1979, but it is still a possibility it was being used into the mid 80's. If you intend to remove, i suggest that you have it tested for asbestos before it is removed.

(2) The vaulted ceiling is caulked where it meets the upstairs wall. The caulking is brittle and discolored.

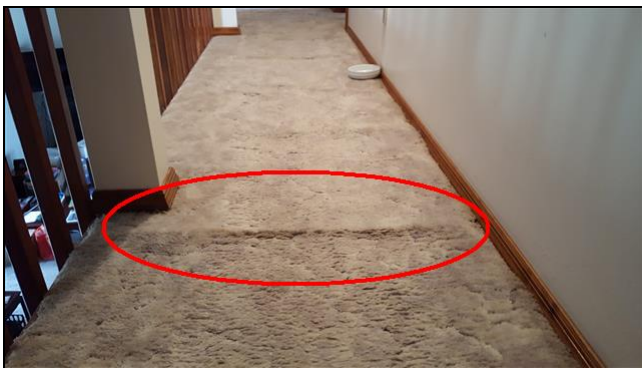
5.2 The carpet was raised in the hallway and the east bedroom. Tripping hazard.

5.2 Item 1(Picture) Carpet in hallway

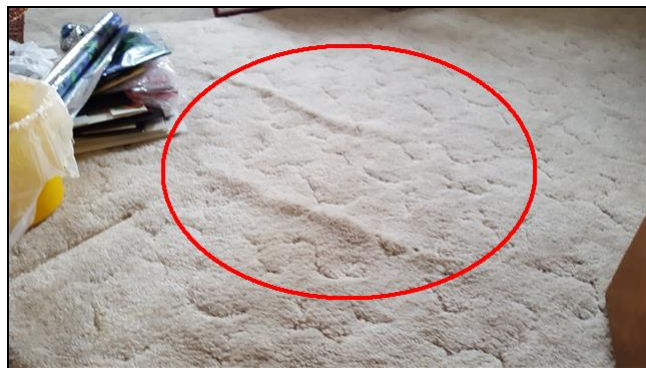
5.2 Item 2(Picture) Carpet in bedroom

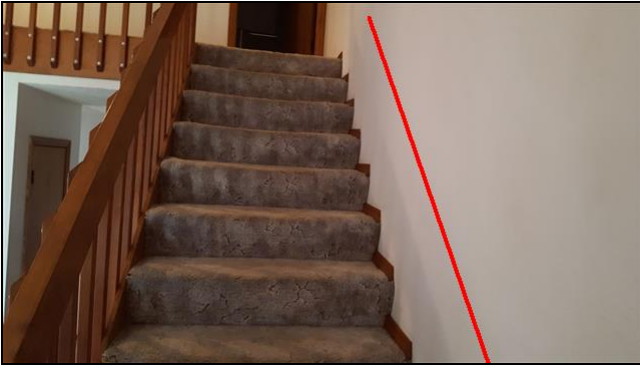
5.3 Item 1(Picture) add stair rail

5.3 Recommend installing a handrail that is easy to grasp on the main staircase. Handrails should be continuous, graspable, and smooth.

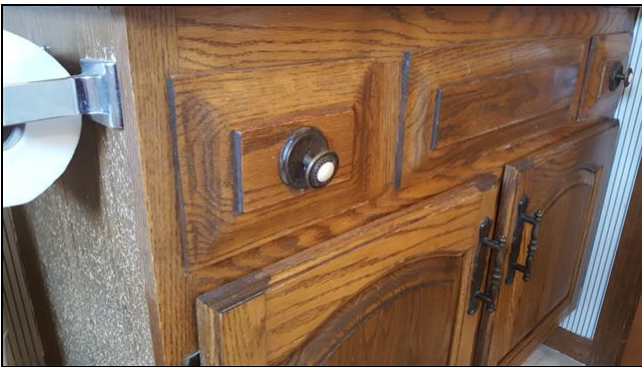
6.5 Several handles and knobs were loose in bathrooms. All cabinets function properly.

6.5 Item 1(Picture) Loose hardware

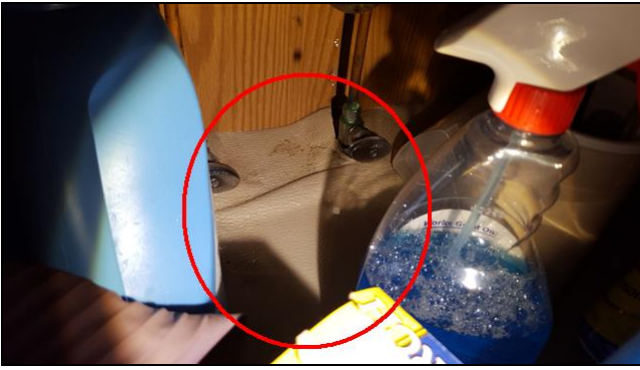
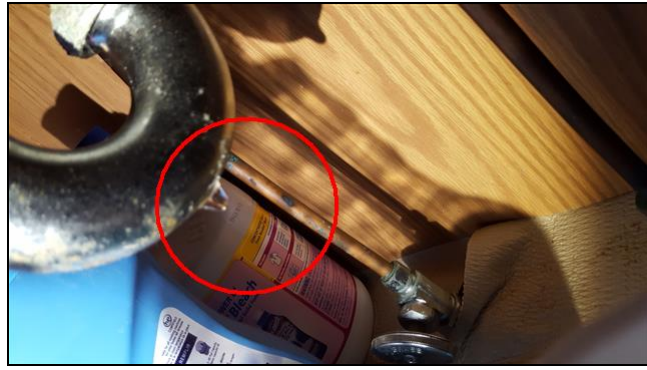
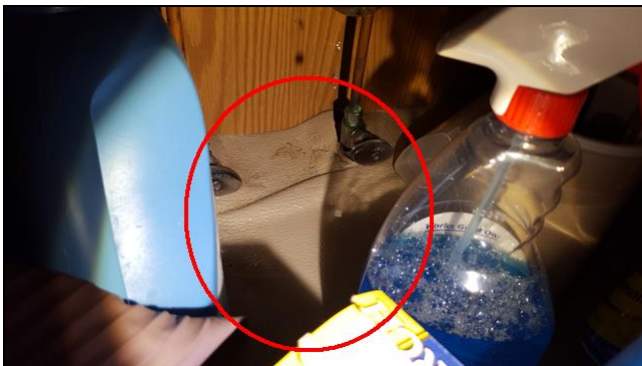
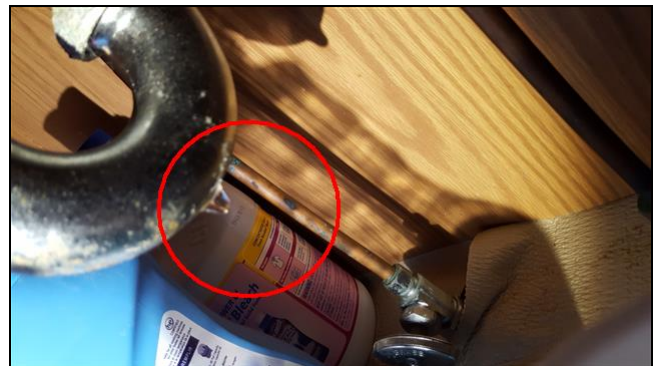
6.6 Item 1(Picture) main floor 1/2 bath/ laundry

6.6 The sink in the bathroom on the main level had a **leak** under the sink.

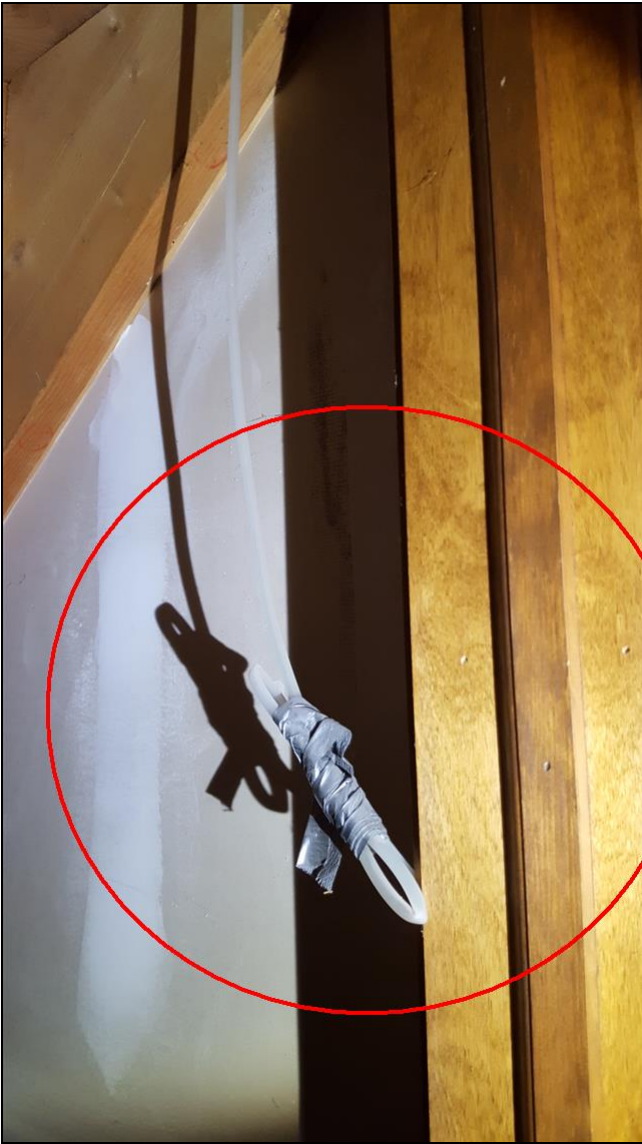
8.1 Item 1(Picture) Water line for refrigerator

8.1 Recommend shutting off the water supply for the refrigerator line if not in use to prevent the possibility of unwanted leaks. located under stairwell in basement bathroom storage area.

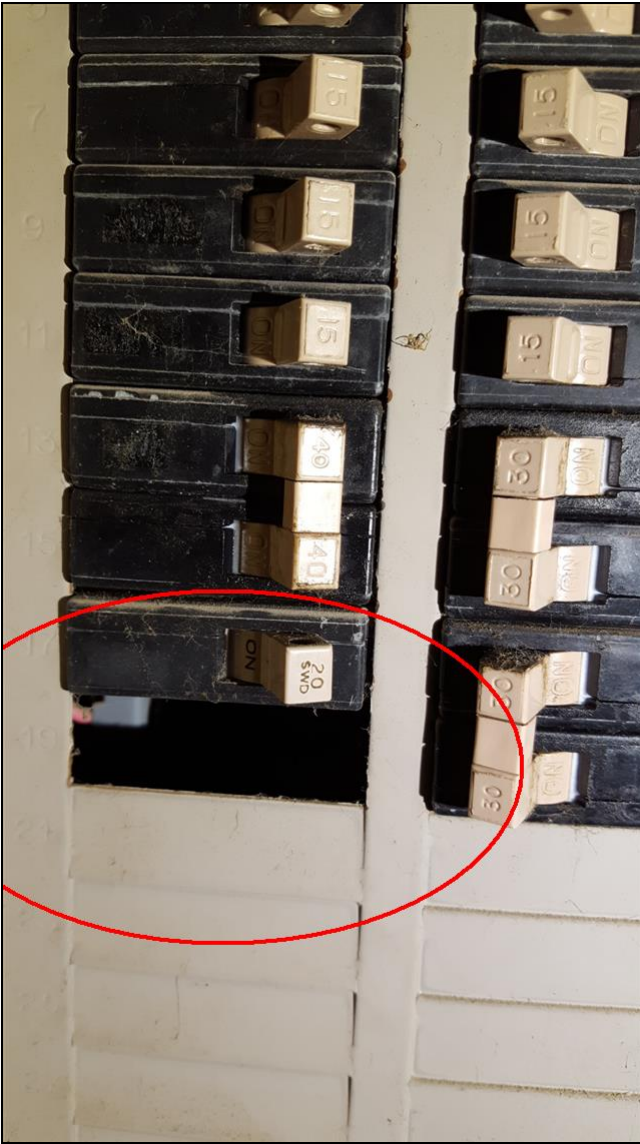
9.2 Open breaker spaces need to have a plug to prevent the risk of electrical shock.

9.2 Item 1(Picture) open breaker slot

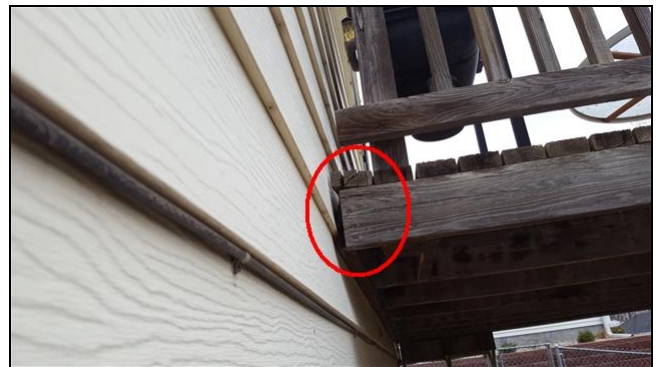
The ledger is not flush with the house. It appears that the top is pulling away from the house. **Recommend** having structure evaluated and repaired by a professional contractor.

2.3 Item 3(Picture) Ledger
