*** Residential Inspection Report ***

On
January 17, 2019

Hurricane, Utah, 84737

Date Of Inspection: January 17, 2019
Inspection Address: S. W., Hurricane, Utah, 84737

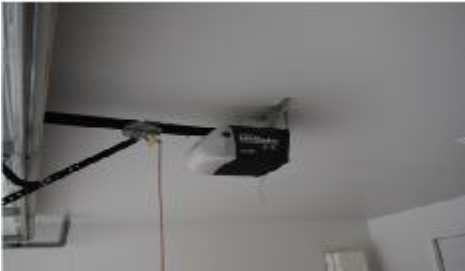
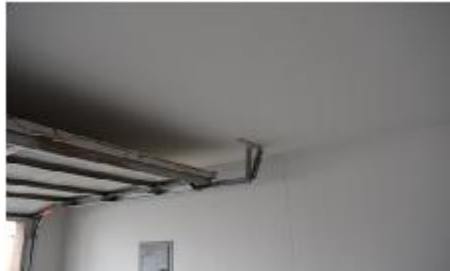
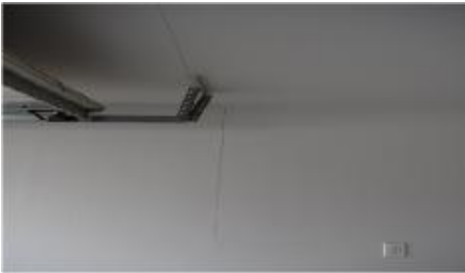
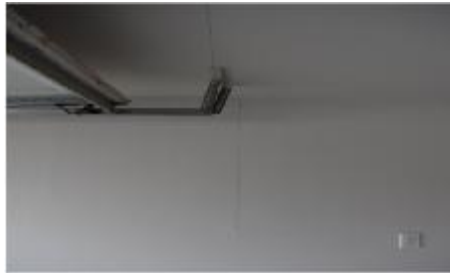
Further Comments: Minor cracks on garage wall and ceiling. Appear to be cosmetic cracks do to garage door use.
