YOUR Inspection Report

443 Madison St.
Chicago, IL

RE: Report No. JHI17-000
443 Madison St.
Chicago, IL

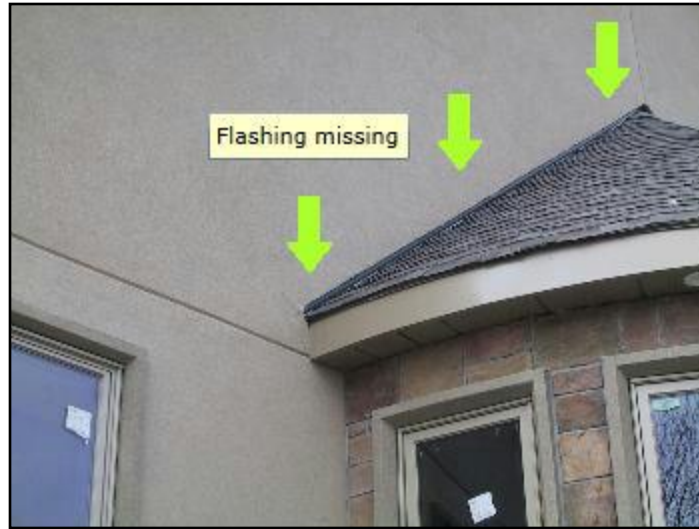
2. **Condition:** • [No kickout flashing](#)

Implication(s): Chance of water damage to contents, finishes and/or structure

Location: North First floor

1. No kickout flashing at roof/sidewall junction

Task: Improve

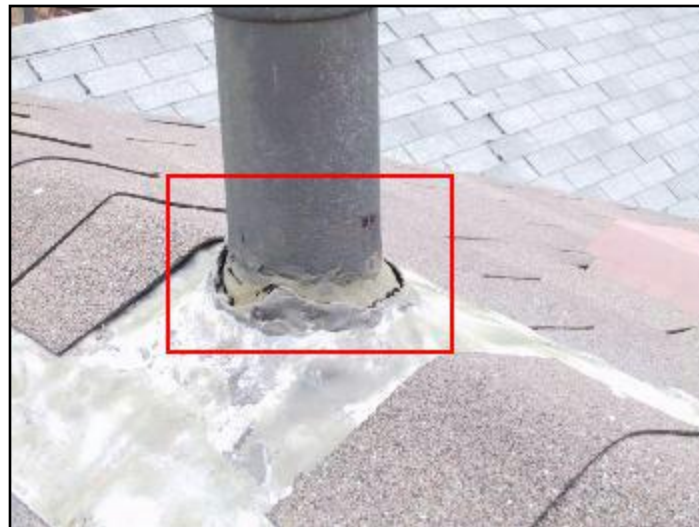
3. Condition: • [Leak](#)

Implication(s): Chance of water damage to contents, finishes and/or structure

Location: North

2. Leak

Task: Repair, immediate

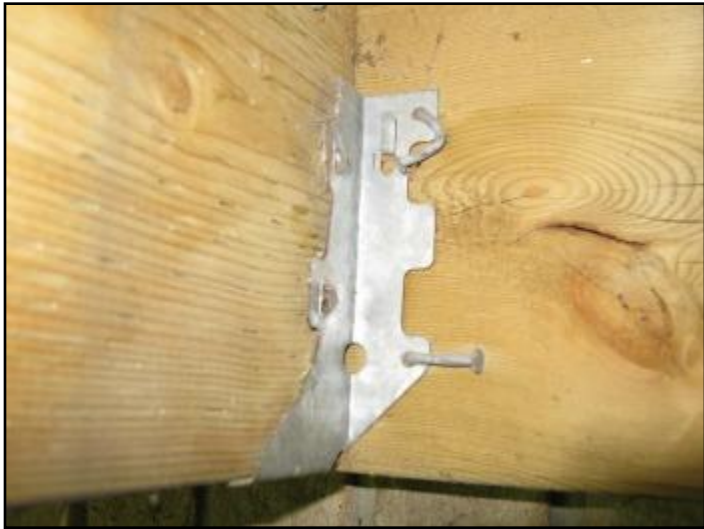
5. Condition: • [Fastener problems](#)

Joist hangers for wood deck are not properly nailed.

Implication(s): Weakened structure | Chance of movement

4. Poor end bearing, joist hanger connections

Task: Improve

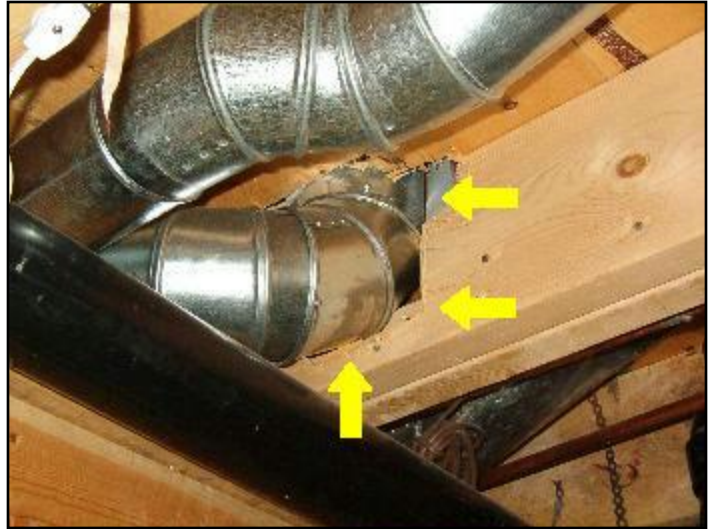
Condition: • [Notches or holes](#)

Implication(s): Weakened structure

- 6. Condition:** • [Notches or holes](#)
- Implication(s):** Weakened structure
- Location:** West
- Task:** Repair
- Time:** Immediate

5. Joists are notched and weakened

Task: Repair

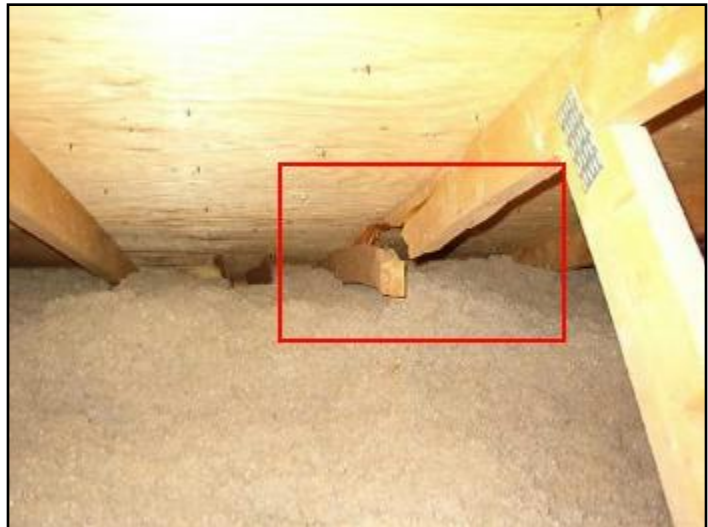
7. **Condition:** • Top chord of truss is broken

Location: North Attic

6. Top chord of truss is broken

Task: Replace

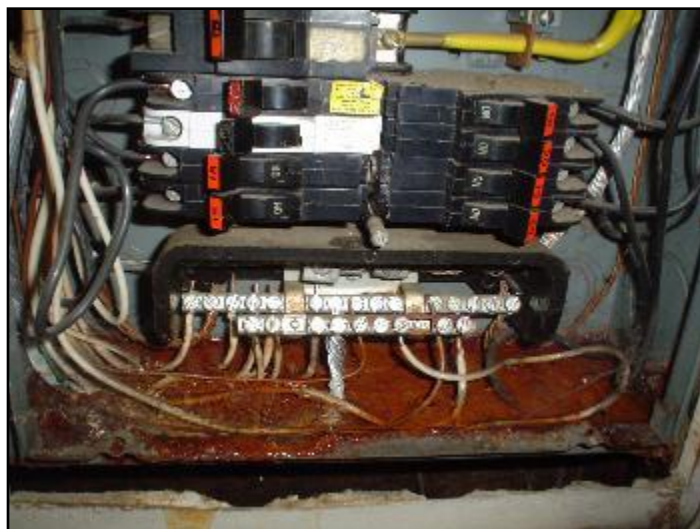
Condition: • [Rust or water in panel](#)

Implication(s): Electric shock | Fire hazard

- 9. Condition: • [Rust or water in panel](#)
- Implication(s): Electric shock | Fire hazard
- Location: North Basement
- Task: Replace
- Time: Immediate

7. Water and rust in bottom of panel

Task: Replace

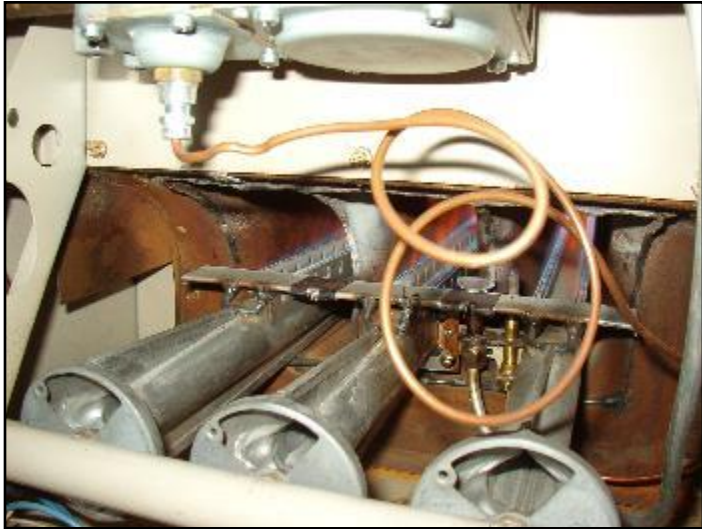
A considerable amount of rust was noted on the front of the furnace.

9. Rust at bottom of heat exchanger

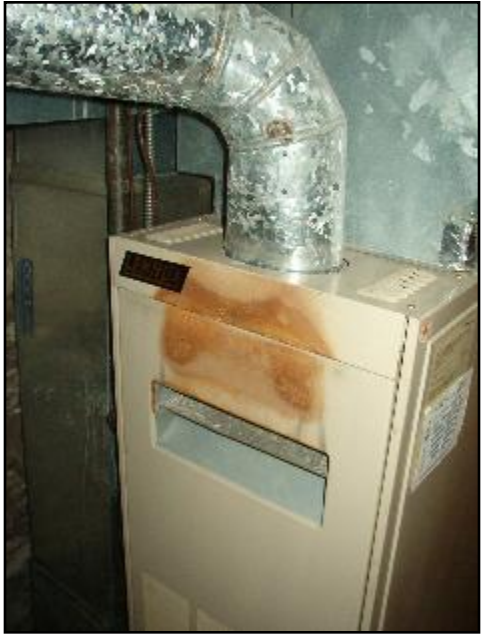
14. **Condition:** • [Draft hood spillage or backdraft](#)

This suggests a back-drafting problem, with combustion products entering the home.

This is a safety issue that should be addressed without delay.

Implication(s): Equipment not operating properly | Hazardous combustion products entering home

10. Evidence of furnace backdrafting

Task: Correct

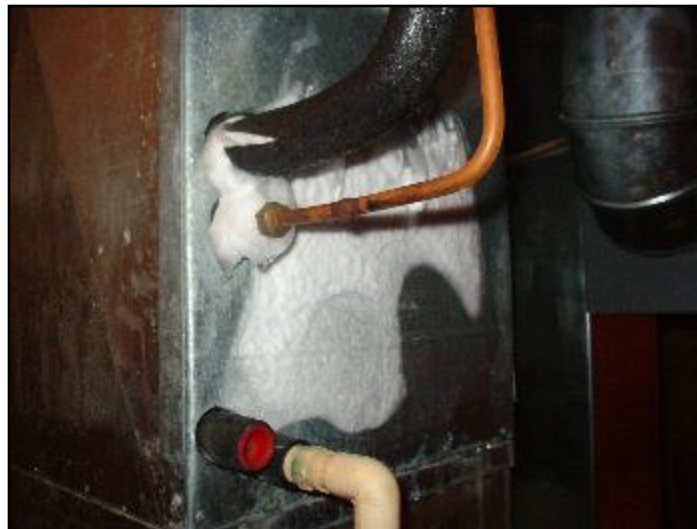
15. Condition: • [Frost](#)

Implication(s): Increased cooling costs | Reduced comfort

Location: West Basement

11. Frost visible on ductwork at AC coil

Task: Repair

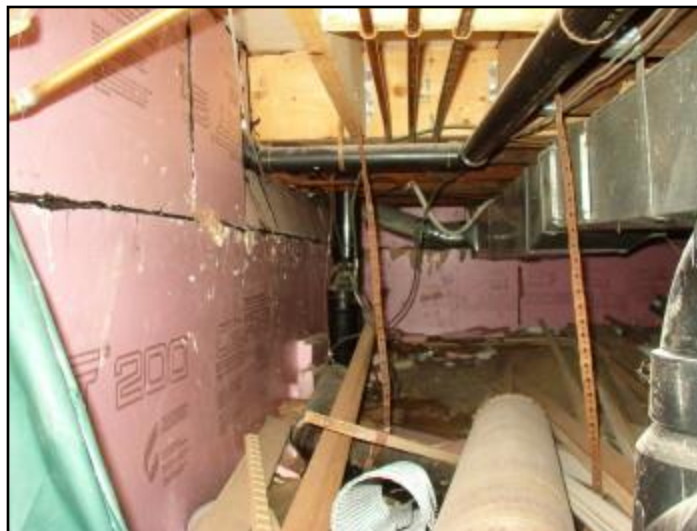
16. Condition: • [Exposed combustible insulation](#)

Implication(s): Fire hazard

Location: West Crawl space

12. Exposed polystyrene insulation is fire hazard

Task: Remove or cover with drywall

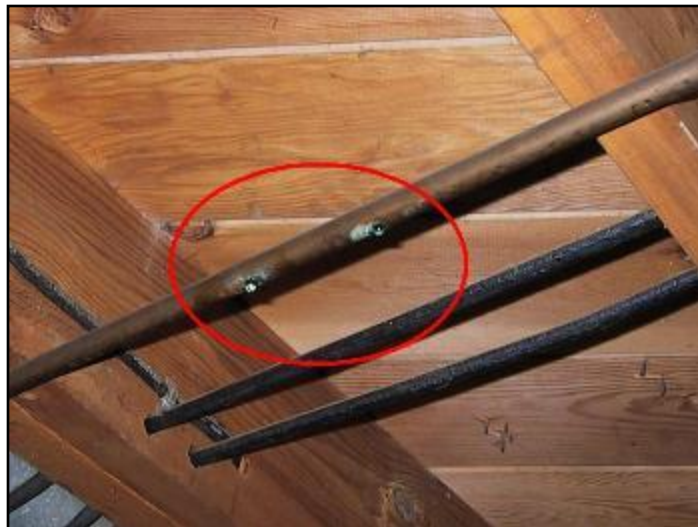
17. Condition: • [Leak](#)

Implication(s): Chance of water damage to contents, finishes and/or structure | System inoperative

Location: Northeast Basement

13. *Leaking copper supply pipe*

Task: Replace

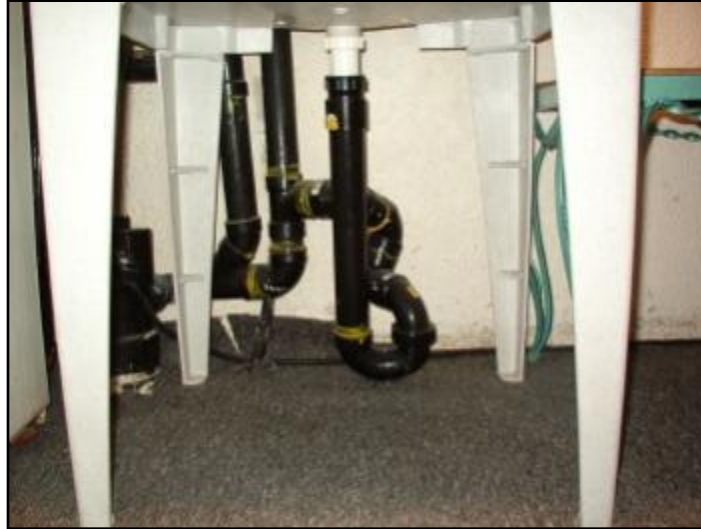
18. Condition: • [Nonstandard shape or material](#)

Implication(s): Reduced operability | Fixtures slow to drain

Location: Basement Laundry area

14. Poor trap arrangement

Task: Improve
Time: Immediate

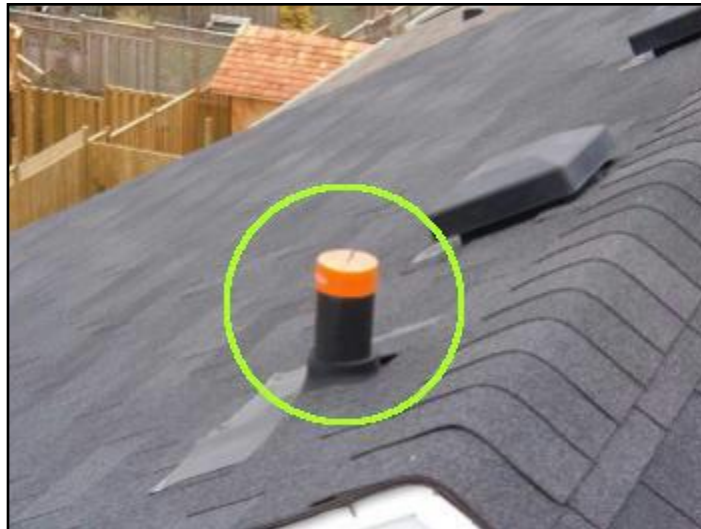
19. Condition: • [Vent termination problems](#)

Implication(s): Reduced operability | Sewer gases entering the building

Location: West central part of roof

15. Plumbing stack is capped

Task: Remove cap

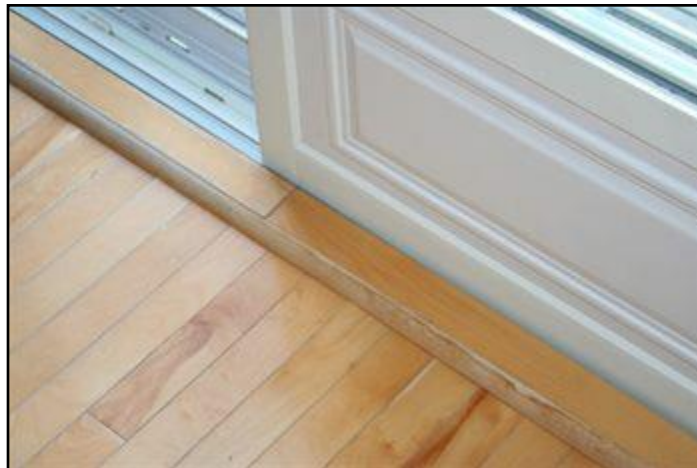
20. Condition: • [Stained](#)

Implication(s): Cosmetic defects

Location: North First Floor Family Room

16. Stained

Task: Repair

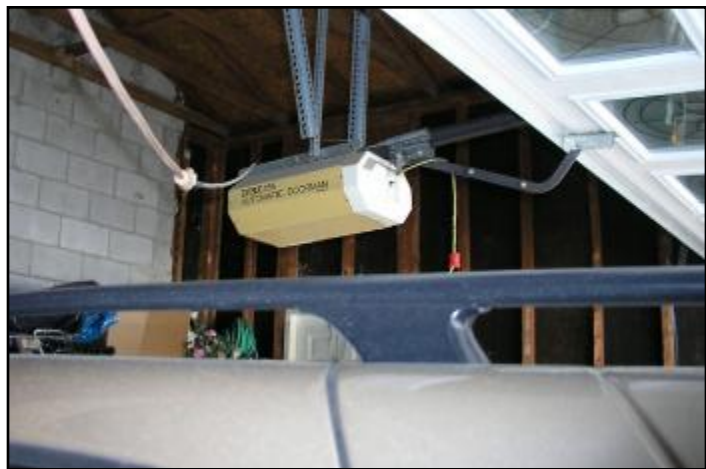
21. Condition: • [Extension cord for opener](#)

Implication(s): Electric shock

Location: Garage

17. Extension cord for west garage door opener

Task: Replace with permanent wiring
