Inspection Report

Date Inspected: 05/02/2017

Property Inspected: Main Street
Anytown PA

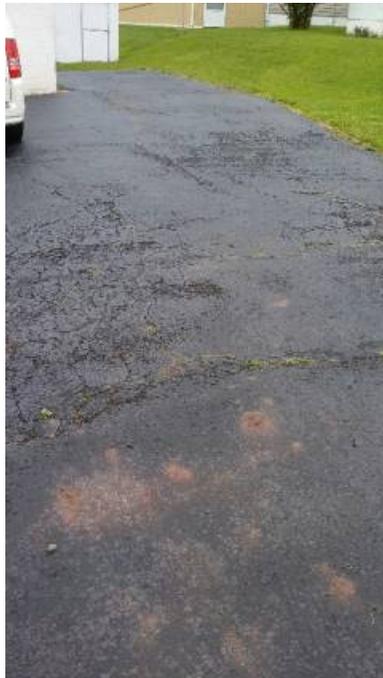
8. Driveway Material/Condition

Gravel. **There are conditions in the driveway which require maintenance.** Depressions and/or wash outs were observed and should be addressed to prevent further deterioration.

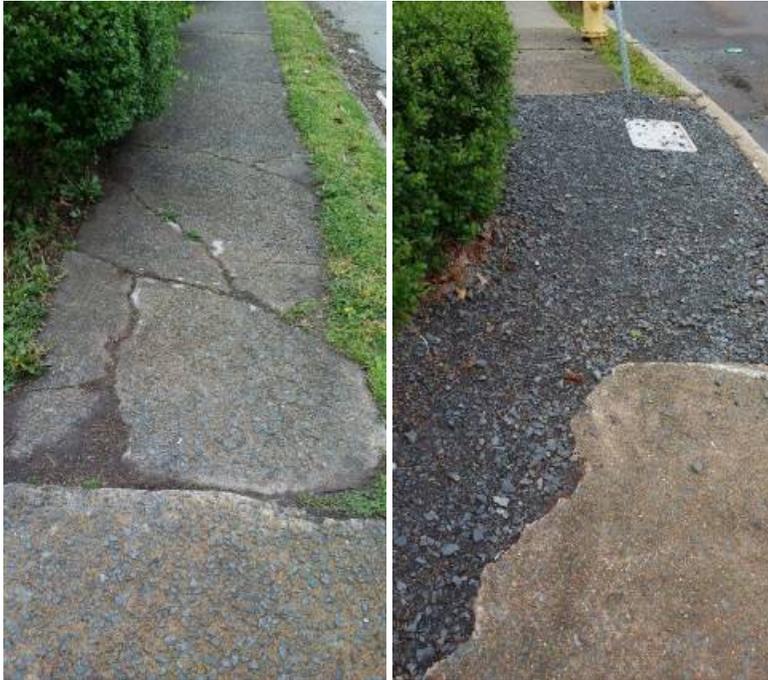
9. Walkway - Material/Condition

Concrete. The walkways need repairs in order to provide their proper/safe function.

There is a section of the walkway missing in front.

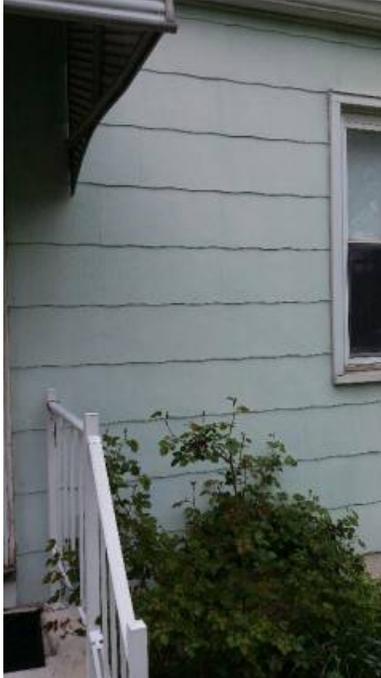
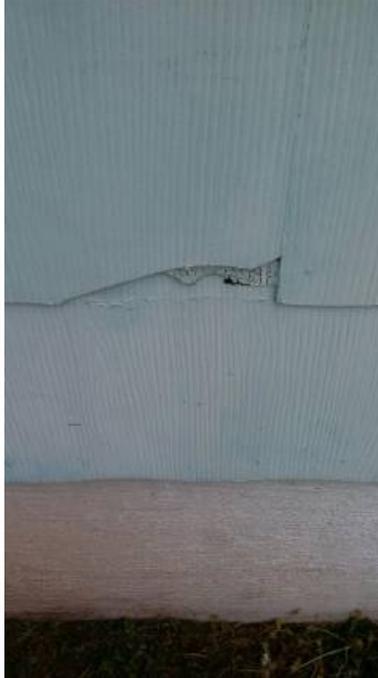
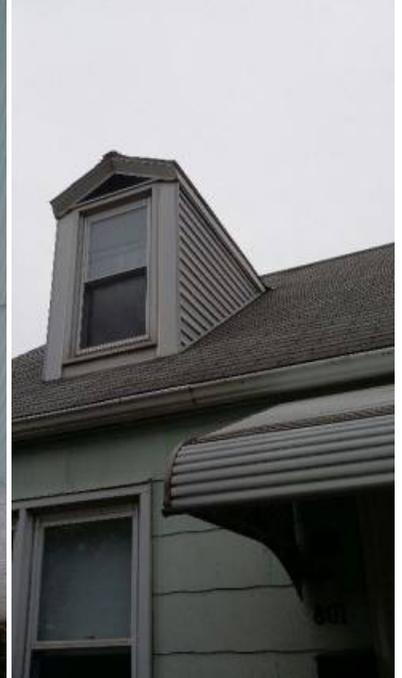
1. Primary Cover Material/Condition

Vinyl siding. Satisfactory installation of materials. Normal condition typical for the age of materials.

Asbestos type shingle. The asbestos shingles have missing or damaged shingles. Caulking and/or painting will help to prevent further deterioration.

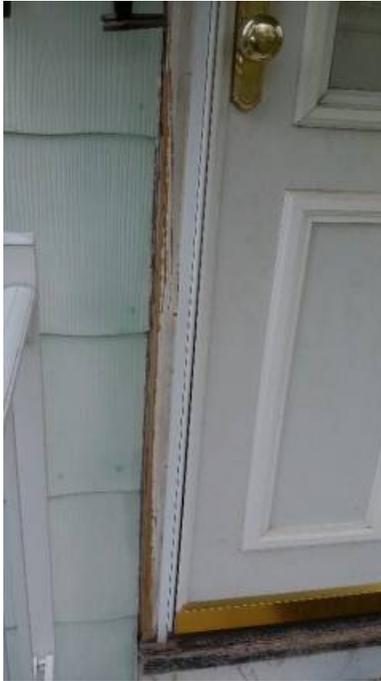
4. Painted Surfaces

The painted surfaces will need some maintenance. Corrective measures should be considered to help prevent permanent damage.

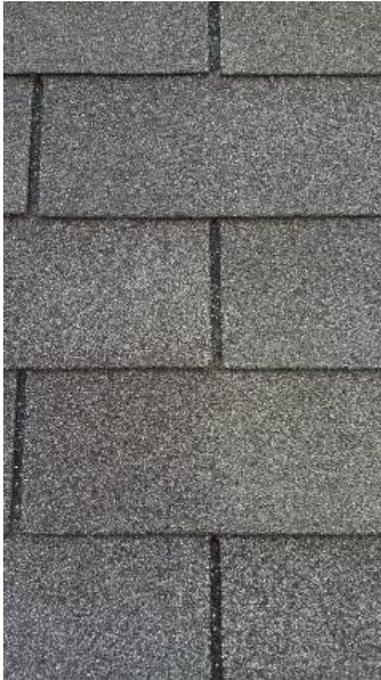
1. Roof Cover Material and Condition

Asphalt Shingles. Satisfactory condition. Normal loss of granules, deteriorated edges. Typical condition in keeping with the age of installation. **Based on the age and condition of the roof, it appears that this roof is nearing the end of its life.**

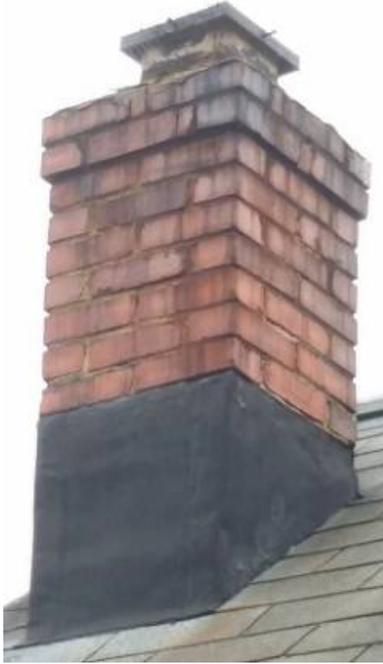
Chimney 1 is brick. The chimney is in satisfactory condition, consistent with the age of the dwelling. Note: The chimney interior is not observed as part of this inspection. It is recommended that the chimney be cleaned on a regular basis. There were no records provided to the inspector as to when it was last cleaned.

The rain hood/screening for the chimney is missing. Although not required, installation would help minimize deterioration conditions in the chimney. Moisture entry can cause rusting in the liner, flue and fire place damper.

It is recommended that an NFPA Level 1 inspection be done by a certified chimney expert prior to closing. This is a routine annual inspection. For more information on chimneys and the NFPA see - <http://www.nfpa.org/assets/files/PDF/OS.fireplaces.pdf> and <http://www.scia.org/HomeownerResources/ChimneySafetyInfo/ChimneyInspections/tabid/116/Default.aspx>.

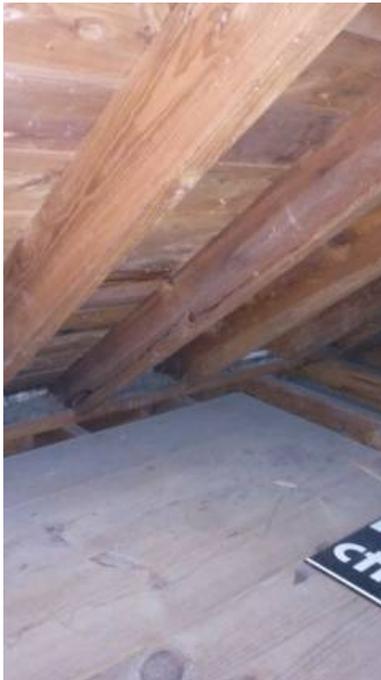
9. Indications of leaking

There were no interior moisture conditions noted due to current roof cover materials. **Visible moisture marks in the area appeared to be dry at the time of inspection. Recommend asking the current owner for the history of these marks and observing this area during heavy rains to verify if this is an active leak.**

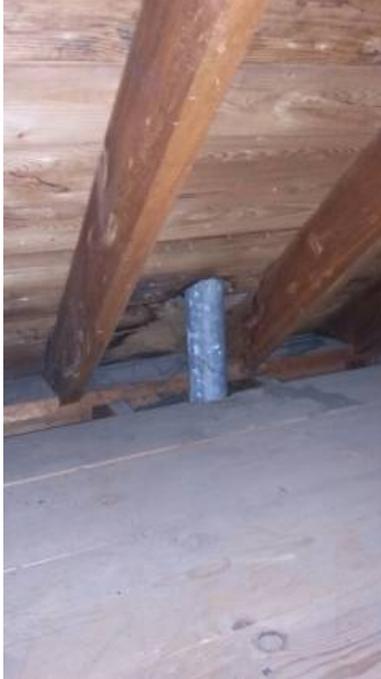
15. Waste Vent

The waste vent discharges to the exterior of the dwelling. **Visible moisture marks in the area appeared to be dry at the time of inspection. Recommend asking the current owner for the history of these marks and observing this area during heavy rains to verify if this is an active leak.**

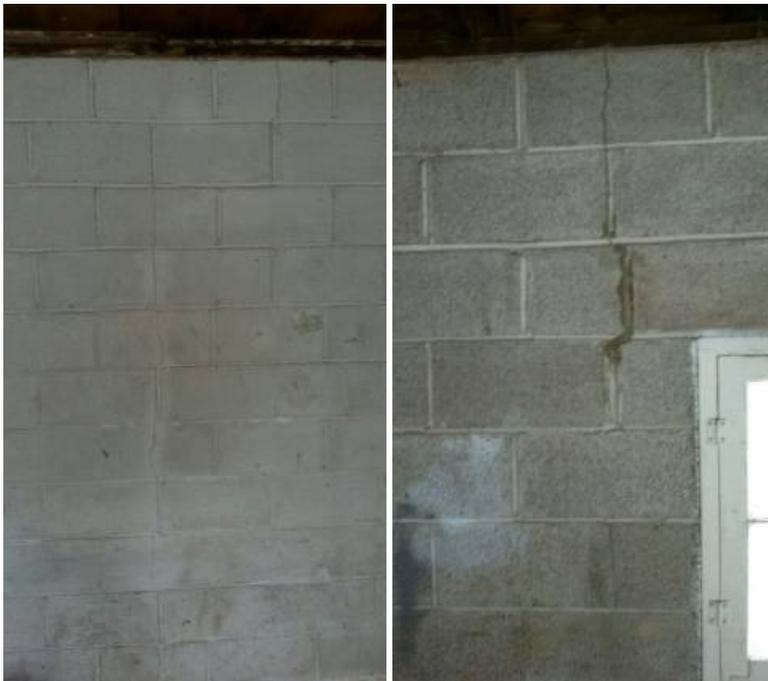
13. Foundation

Maintenance recommended. Fine cracks noted in the foundation walls are representative of expansion and contraction type movements and are not a structural concern. Recommend sealing these cracks with a silicone type sealant to prevent possible moisture and insect penetration and monitoring for any possible future movements.

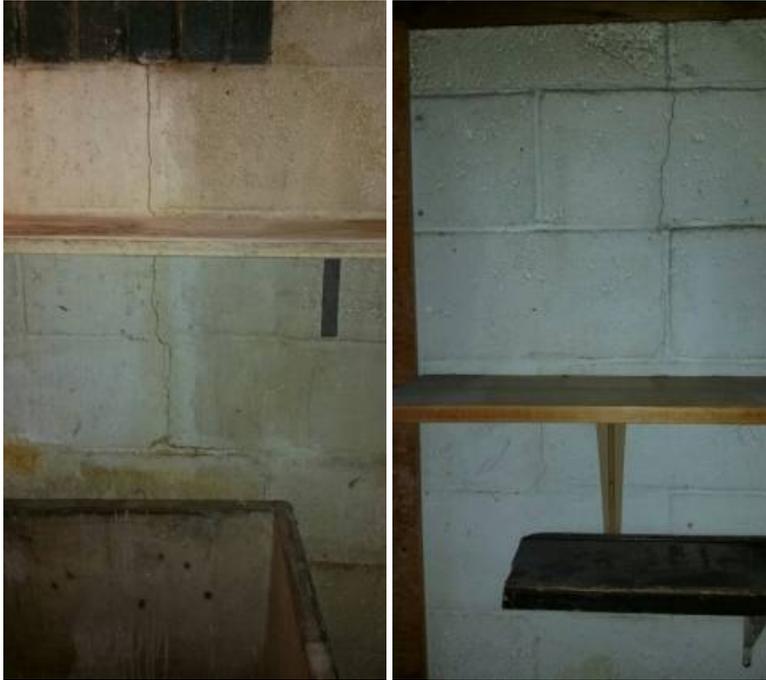
1. Foundation Wall Material/Condition

Block. Block walls tend to be more porous than concrete walls and are more susceptible to water entry. It is considered good practice to seal walls of this type with water-resistant paint. Only about 50% of the foundation walls were visible.

There are several cracks visible in the foundation walls which may be caused by shrinkage/expansion/contraction or minor foundation settlement conditions. Recommend sealing cracks and monitoring conditions for possible future movement.

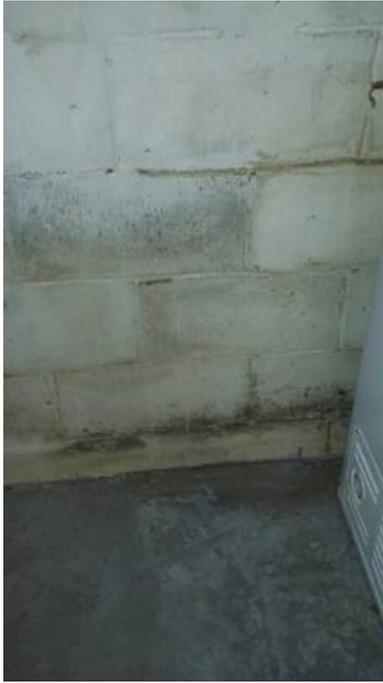
5. Moisture/Dampness

The basement walls are discolored. This would indicate that there has been some water entry through the foundation walls at some point. Efflorescence was noted on the foundation walls; this is an indication that moisture has penetrated the foundation walls. There is evidence of moisture penetration in the basement. Recommend follow-up with the owner on the history of any moisture entry. The possibility exists for future moisture entry. Check exterior grade, down spouts and drainage. Grading around foundation walls should always be pitched away from the dwelling. A 2:12 pitch is desirable. Recommend improving grade pitch to help prevent excess moisture penetration in the foundation walls.

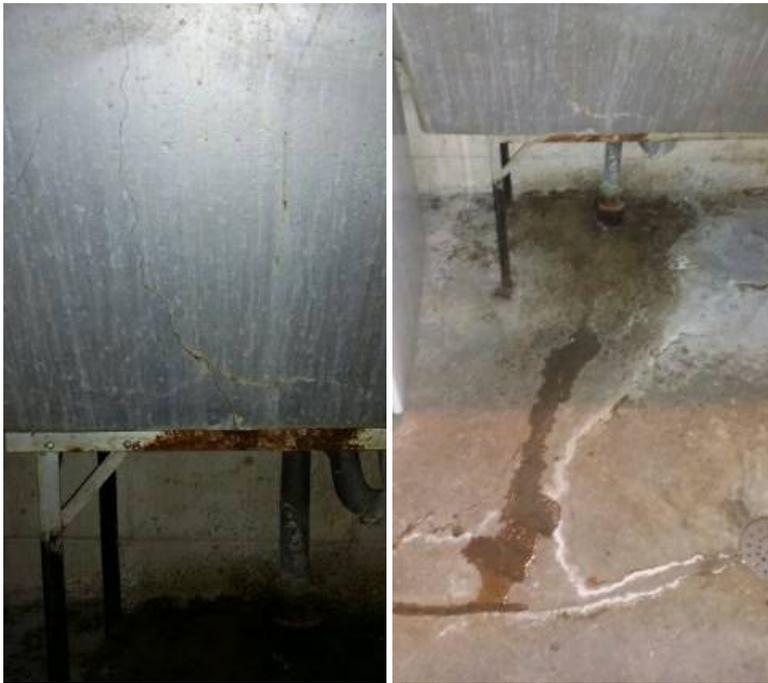
The laundry basin has a large crack. Recommend replacement by a plumber.

The laundry basin leaks.

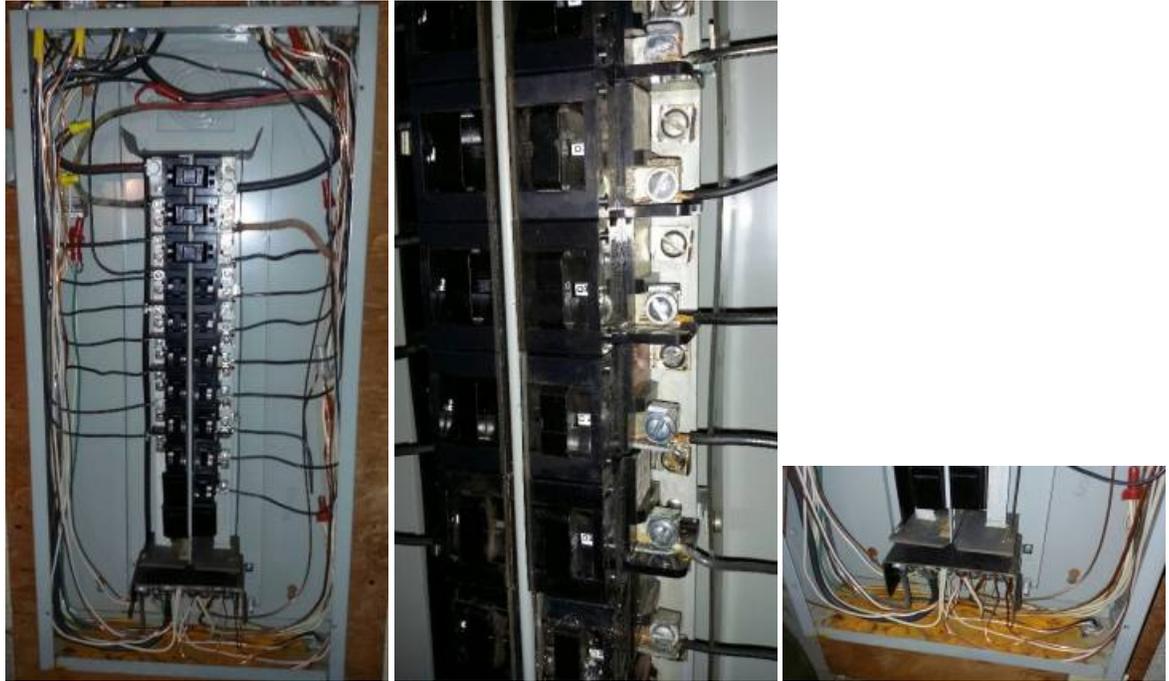
14. Panel Condition

One double tap is visible in the electric panel. This is an unsafe condition where two conductors are attached to a single circuit breaker. In most situations, it is good practice to have only one conductor on each breaker. The conductors could become loose, causing a fire. Recommend review/repair by an electrician.

Rusting is visible in or on the electric panel. Recommend review/repair by an electrician.

Circuits in the panel are identified. Spares are available in the panel.

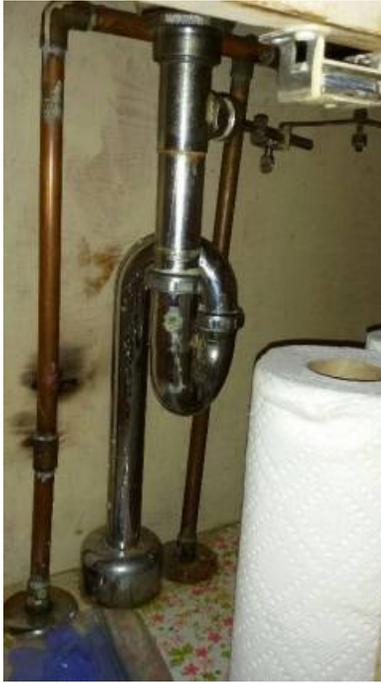
5. Under Sink Inspection

There is no shut off valve under the basin. While it is desirable to have one it is not required. **The trap under the sink is nearing the end of its life.**

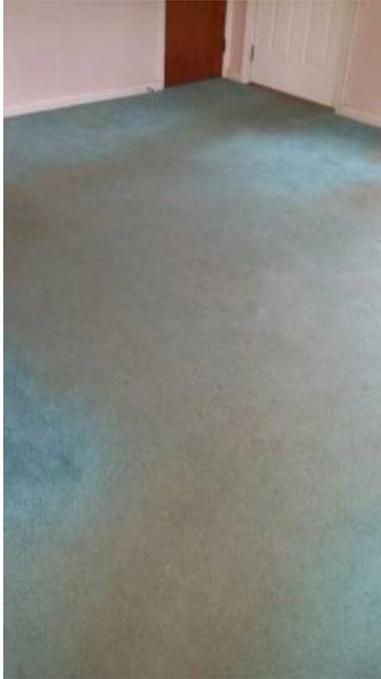
1. Floor Cover/Condition

The floor in this room has wall to wall carpeting. **Stains were noted on the flooring.**

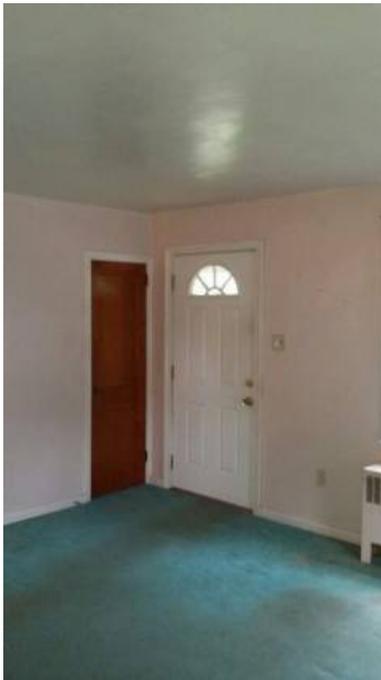
2. Ceiling Material/Condition

Plaster. The ceiling in this room is not damaged beyond that which would be consistent with the age of the dwelling. The fine cracks noted in the ceiling are not a structural concern. These are expansion and contraction type cracks. Recommend patching and sanding prior to next paint application.

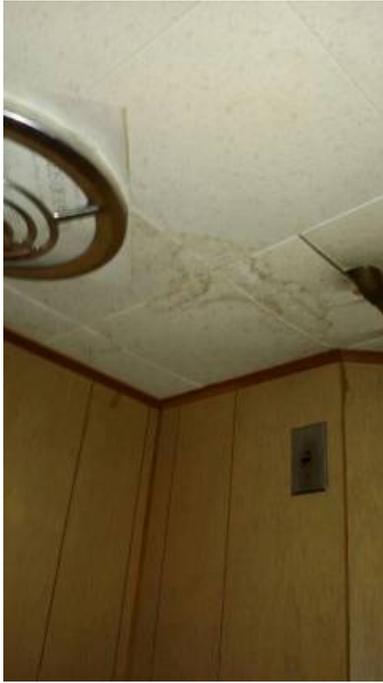
Visible moisture marks in the area appeared to be dry at the time of inspection. Recommend asking the current owner for the history of these marks and observing this area during heavy rains to verify if this is an active leak.

There is no smoke detector on this level of the dwelling, one should be installed on each level and in each bedroom.

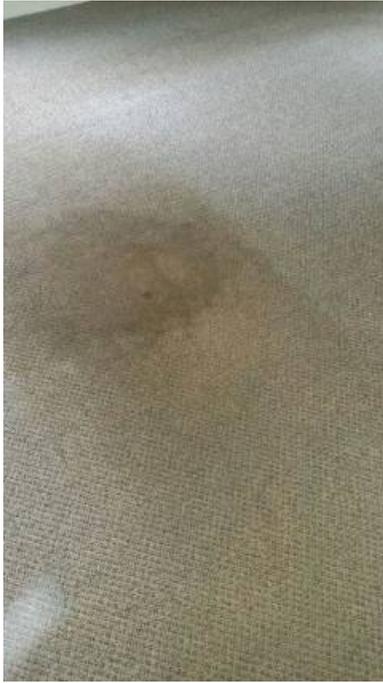
2. Floor Cover/Condition

The floor in this room has wall to wall carpeting. **Stains were noted on the flooring.**

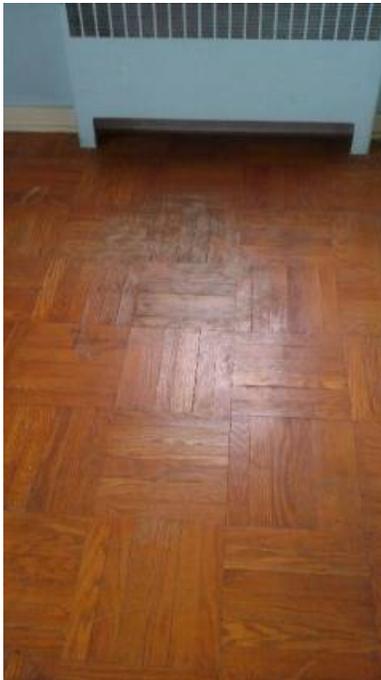
2. Floor Cover/Condition

The floor in this room is wood or a product with a wood like appearance. **Stains were noted on the flooring.**

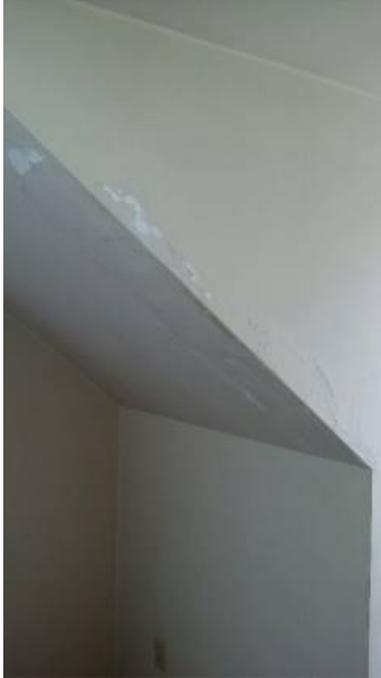
Plaster. The ceiling in this room needs maintenance. The fine cracks noted in the ceiling are not a structural concern. These are expansion and contraction type cracks. Recommend patching and sanding prior to next paint application.
