Property Inspection Report

Inspection Report

11827 Moorcreek Dr Houston TX 77070

Date of Inspection: 12/15/2023

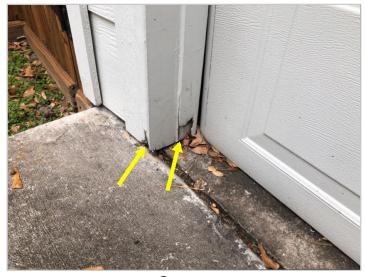
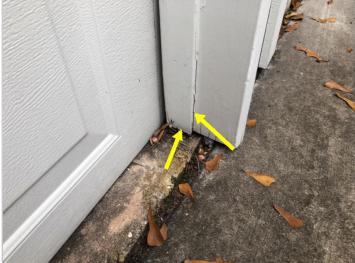
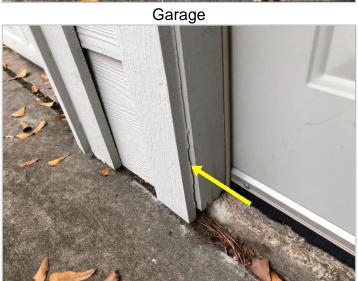
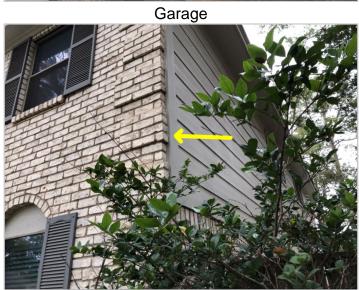
Garage

E. Walls (Interior and Ex	terior)	
	Wall Materials:		
	Comments:		
	cracks and flaws consider in drywall and plaster are	lered to be cosmetic are re minor and normal. Th	and water penetration. Minor e not typically noted. Many cracks sey are often caused by shrinking er and absorbs humidity during the
		nspector's visual observ	ning and prior finish repairs. This vations and ability to render structure.
	Caulk separation obser	ved in some areas.	
	Damaged trim boards a	nd observed on the bac	ck side (see photos).

Caulk separation

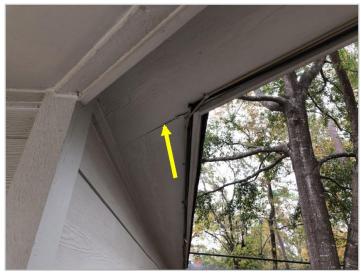
Caulk separation near garage

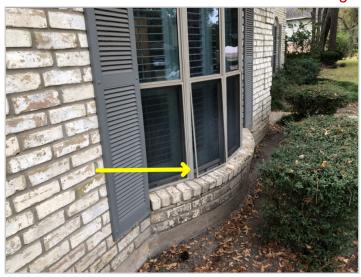
Screen is loose on front side. Two screens are missing on front side.

Loose screen

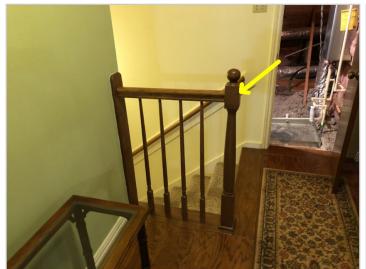
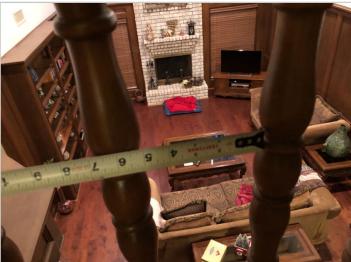
Spacing between balusters is greater than 4-inches. This is a child safety issue.

Baluster is loose see photo.

Loose banister Baluster spacing 5"

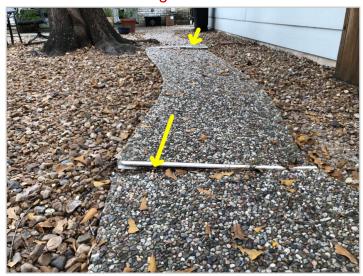
Concrete flat work is misaligned creating a trip hazzard. This was observed in the back yard.

Trip hazard in back yard

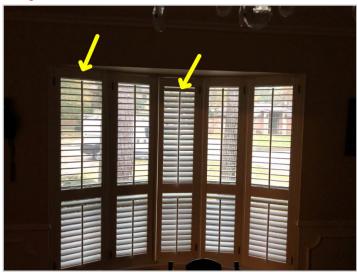
Magnetic catches to louvers in dining room were observed to be broken.

Damaged louver catches

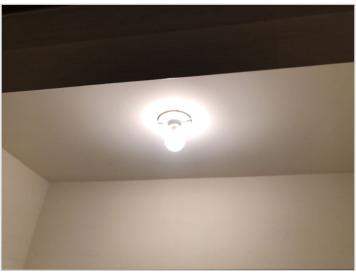
Exposed bulb observed in bedrooms 2, 3, and 4 closets. Light bulbs in this location are required to be protected with a globe in order to protect bulb from damage and occupants from injury.

Exposed bulb in closet

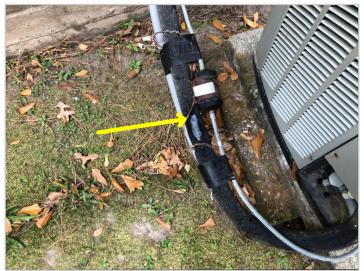
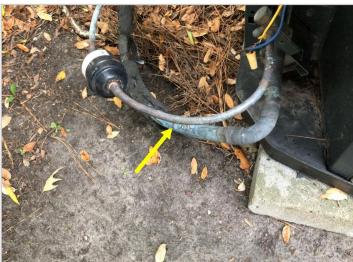
Right side

Damaged, deteriorated and/or missing insulation on the refrigerant lines should be repaired or replaced at the outside condenser.

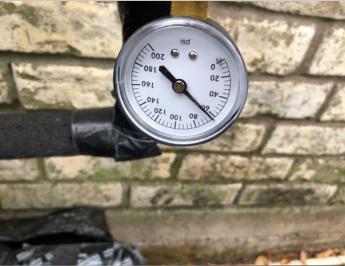
Static water pressure was 60 psi. This falls **within** the acceptable limits of 40-80 psi.

Static water pressure 60 psi

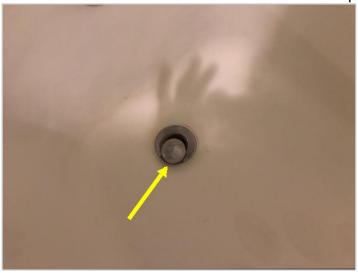
Damaged drain stop at tub in the Jack and Jill bathroom.

Damaged drain stop
