Inspection Report

955 Johndoe Street, Johndoe, California 95453

Inspection Date December 17, 2017
Client Henry Home Inspections
Inspector Keith Henry
707.354.4472
keithrhenry22@gmail.com

Henry Home Inspections

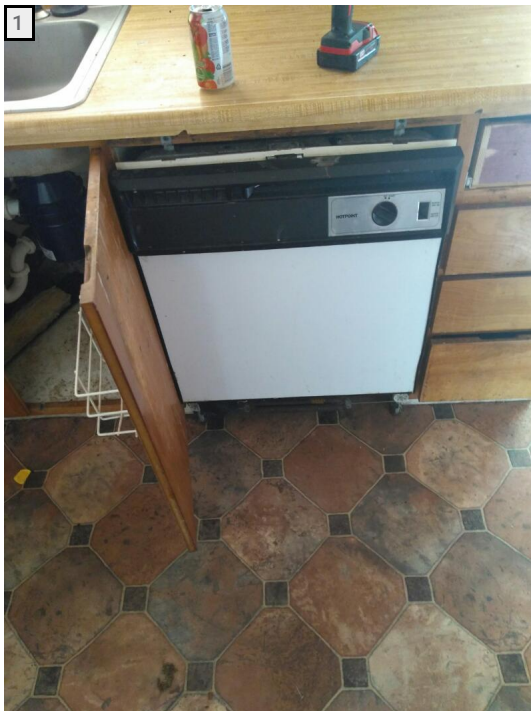
Not working

Location	Kitchen
Suggested Action	Repair or replace the unit

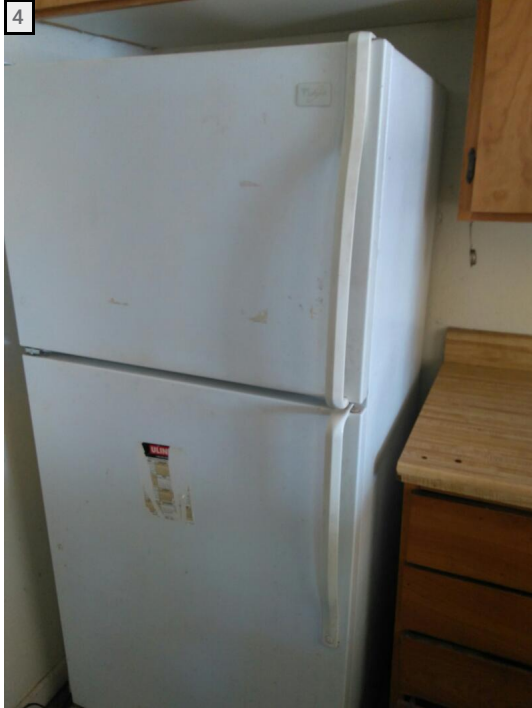
Shows sign of mold

Location	Kitchen
Impact	Mold may cause a variety of health effects to those exposed depending on your sensitivities
Suggested Action	Thoroughly clean with an anti-microbial product

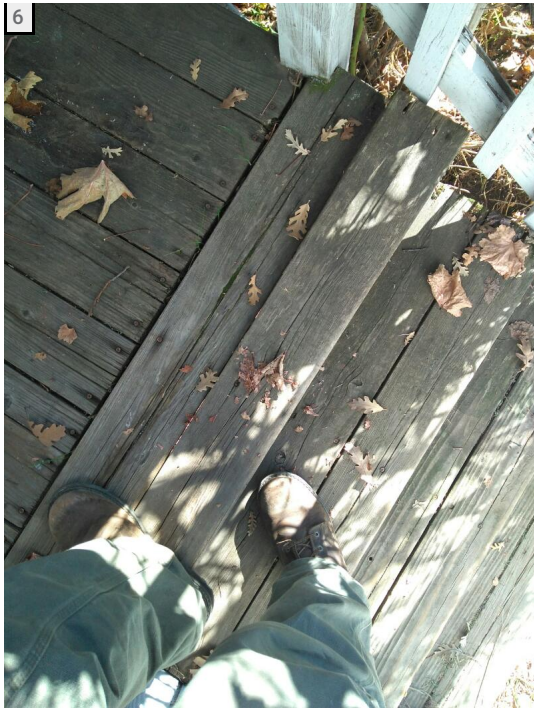
Decking boards not secured

Location	2nd Bedroom (Rear of house bedroom)
Impact	Fall hazard
Suggested Action	Have repaired by qualified carpenter

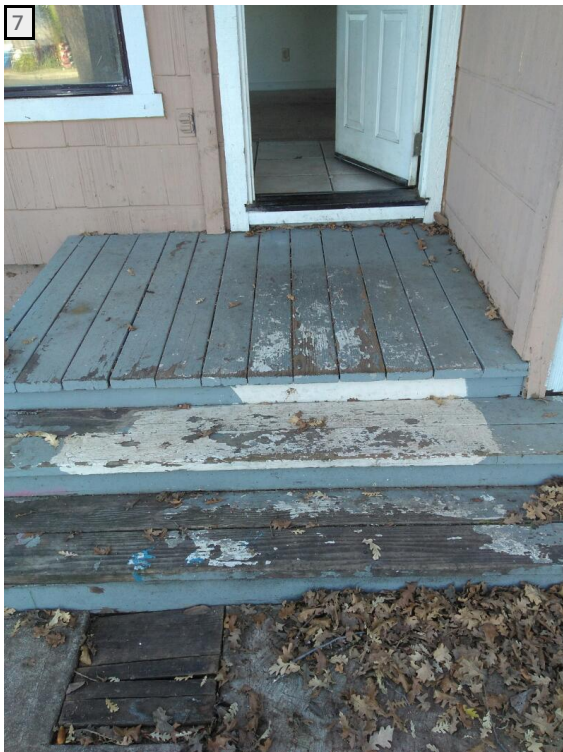
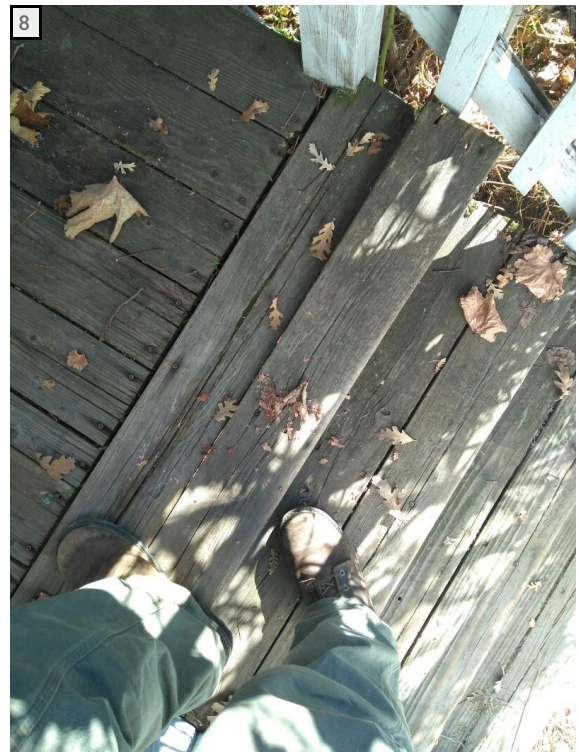
Stain, paint or sealer has peeled, faded or bleached out

Location	Living Room (Front Room living room), 2nd Bedroom (Rear of house bedroom), Family Room
Impact	Without sealer, the wood is not protected from the elements
Suggested Action	Restain and/or reseal with a weather resistant sealer

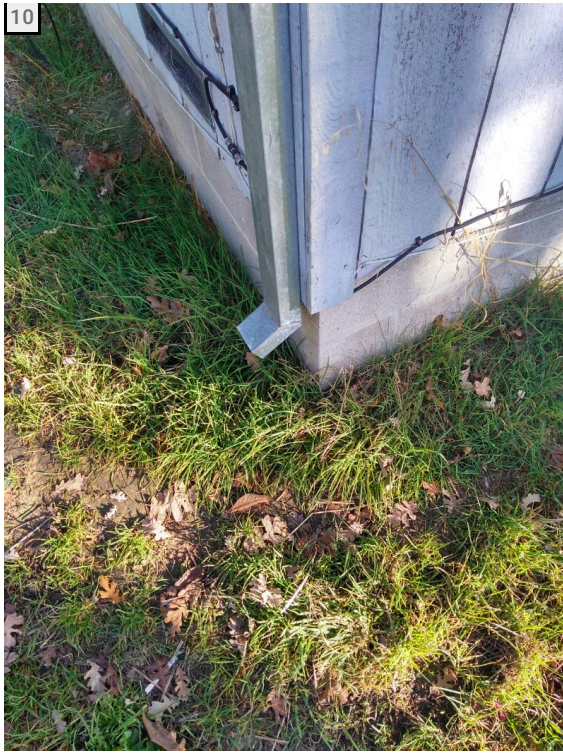
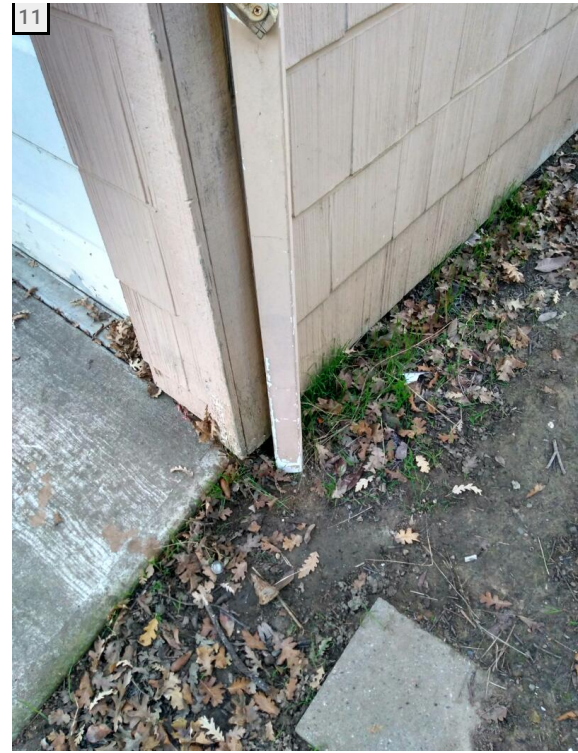
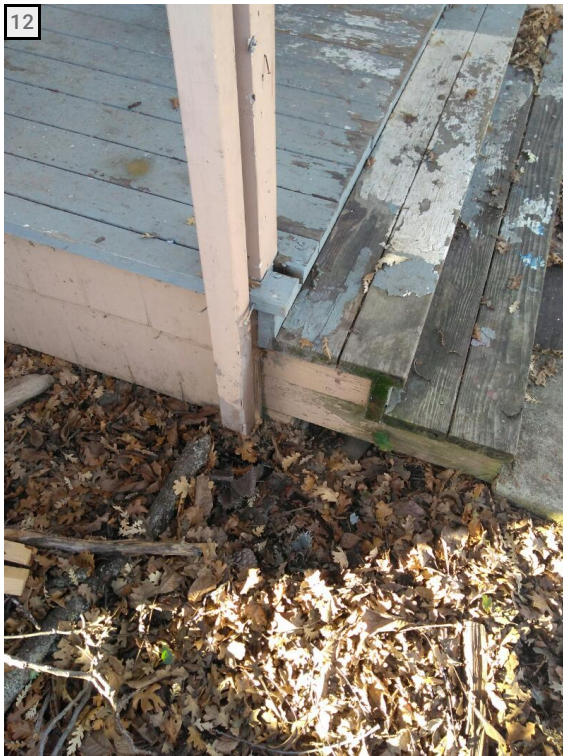
All downspouts should terminate at least 5-6 feet from foundation of house

Location	Exterior: Ground View
Impact	Possibility of foundation sinking
Suggested Action	Install downspout extensions reaching 5-6 feet from the building

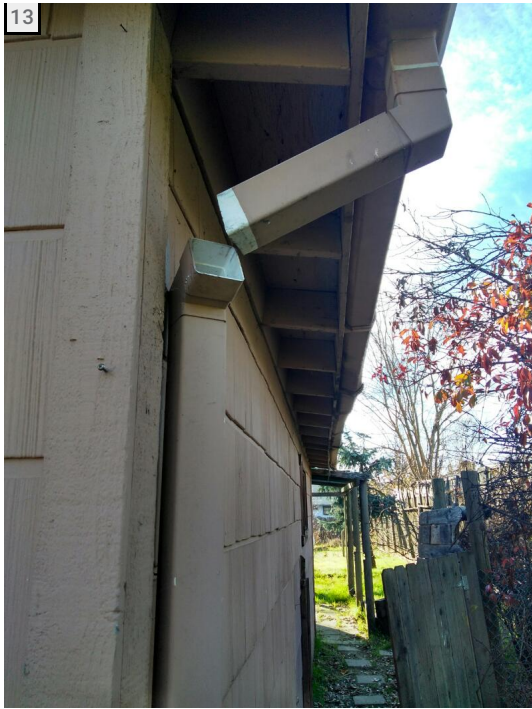
Elbow(s) are not properly connected

Location	Exterior: Ground View
Impact	Improper connections prevent water drainage is not optimally contained
Suggested Action	Secure or replace the elbow connector
Other Information	The elbow connector should be securely fastened to prevent the elbow from coming loose and assure a leak-free elbow

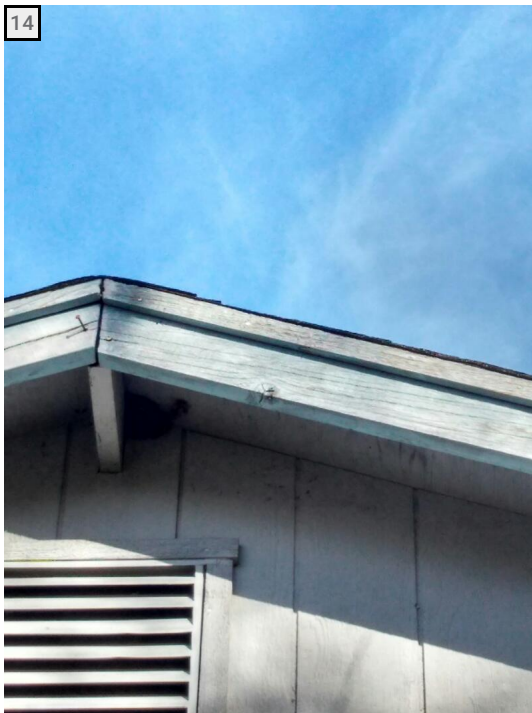
Aluminum flashing is missing

Location	Exterior: Ground View
Impact	Fascia board will deteriorate sooner
Suggested Action	Have professional contractor add flashing

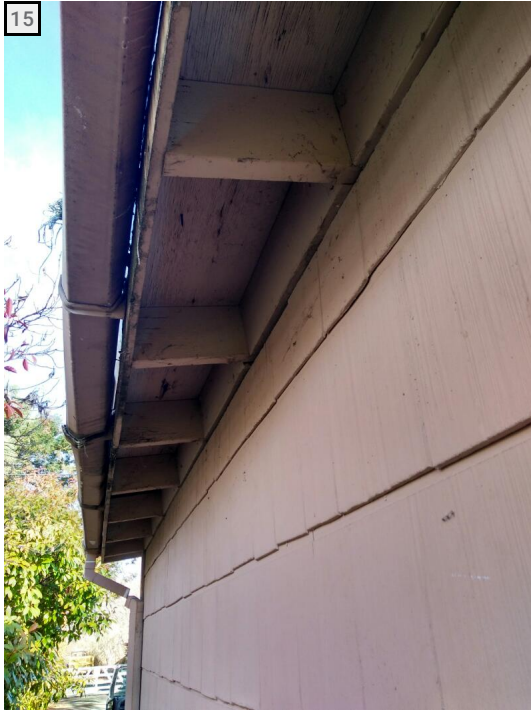
Fascia paint is chipped, faded or worn

Location	Exterior: Ground View
Impact	May cause rot
Suggested Action	Repaint

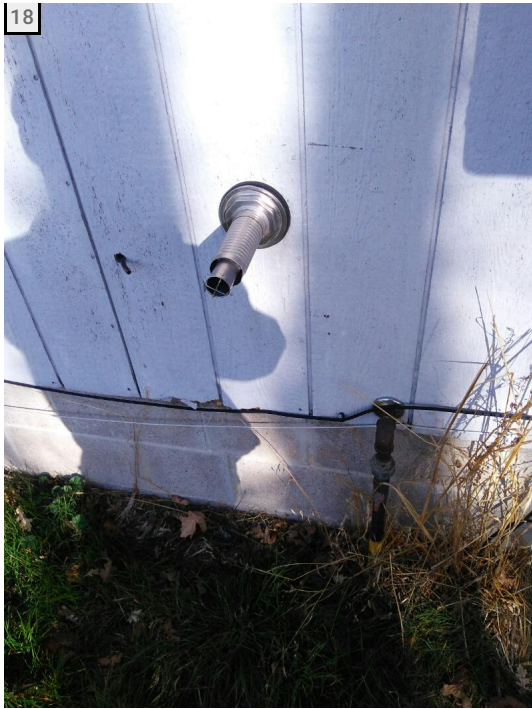
Exhaust vent is at body height

Location	Exterior: Ground View
Impact	Could cause burn
Suggested Action	Relocate vent or cover with open cage

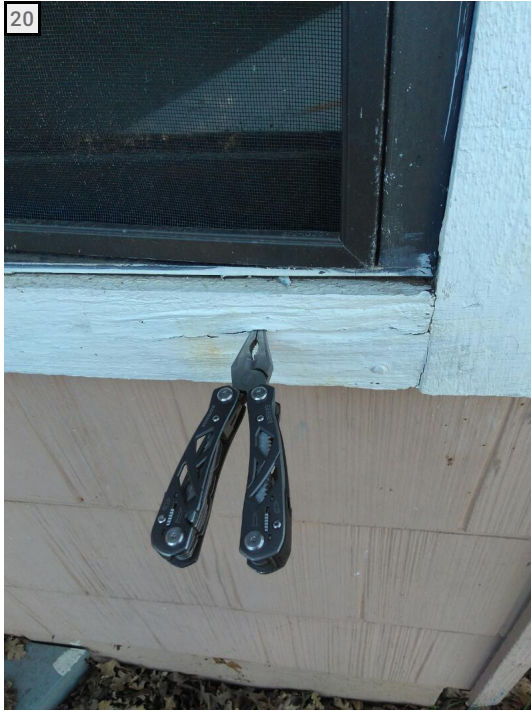
Rotting

Location	Exterior: Ground View
Impact	Can cause water damaged inside
Suggested Action	Replace the rotting trim

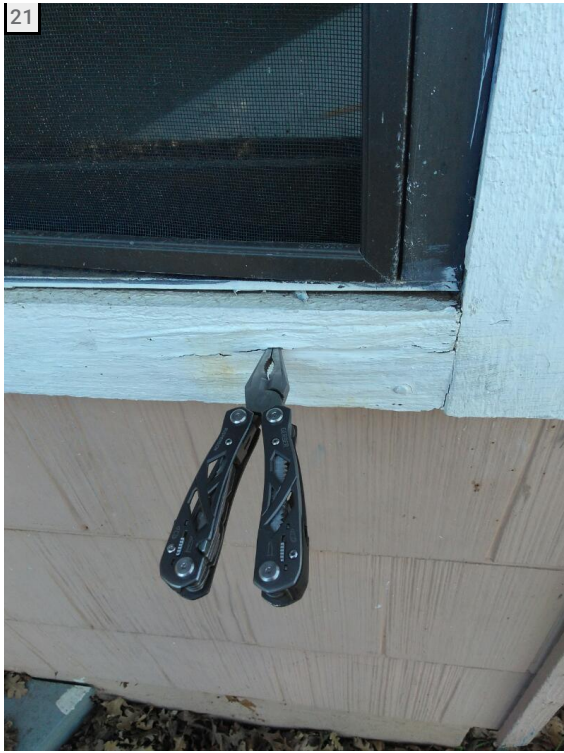
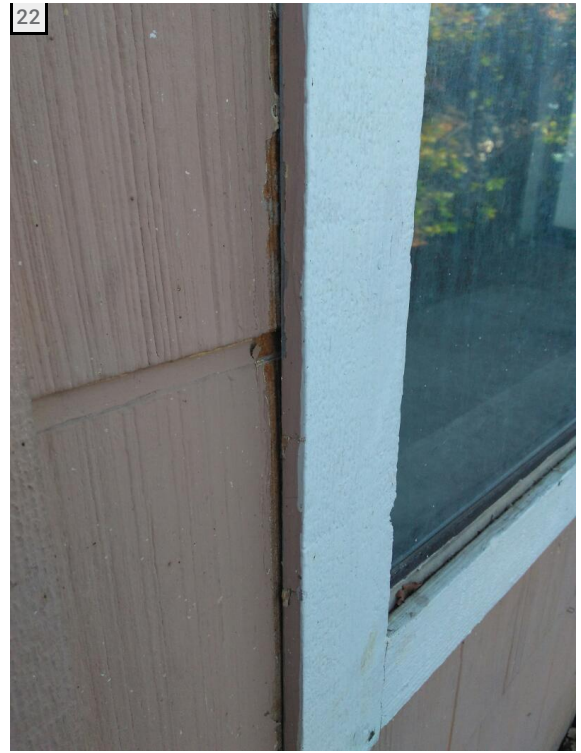
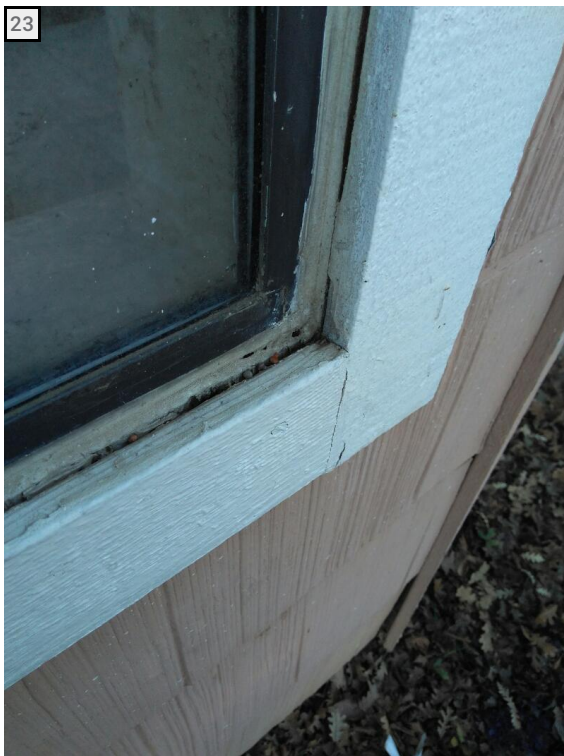
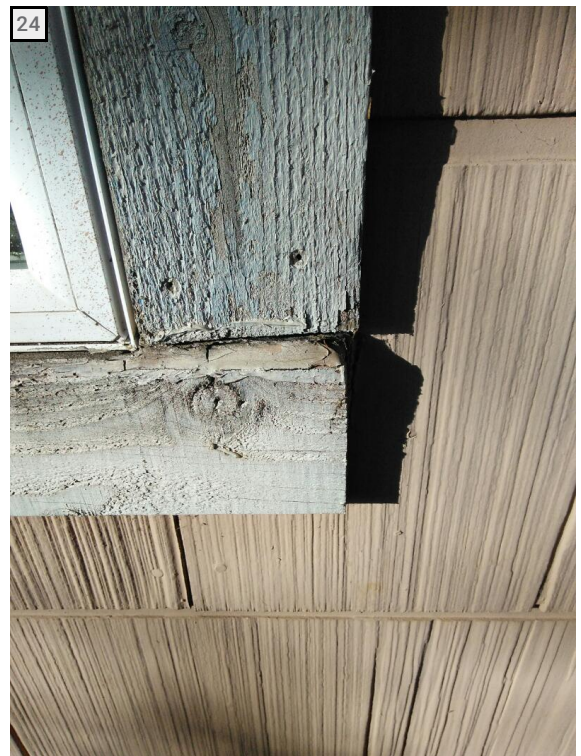
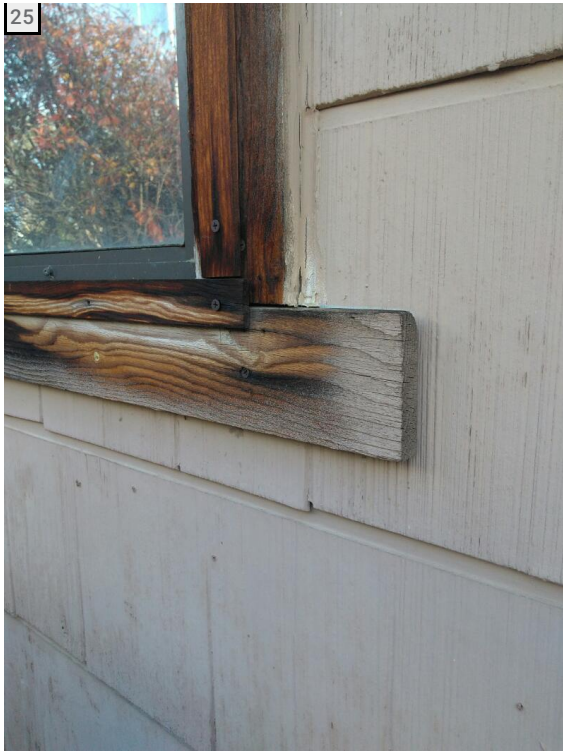
Caulk has aged leaving holes or gaps

Location	Exterior: Ground View
Impact	The gaps could allow for moisture and insect intrusion which may cause cause damage to the wood over time
Suggested Action	Repair the caulking

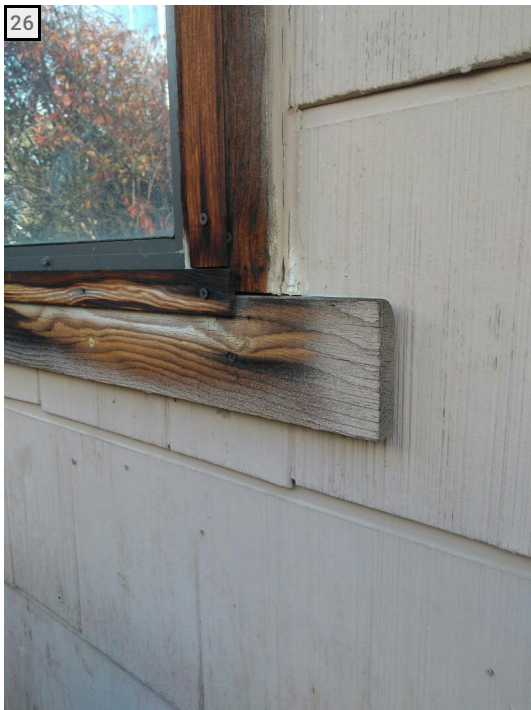
Extremely worn

Location	Exterior: Ground View
Suggested Action	Replace the trim

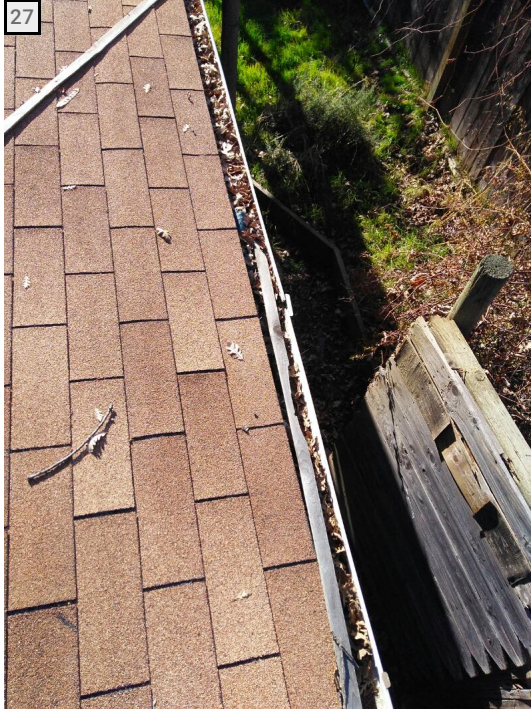
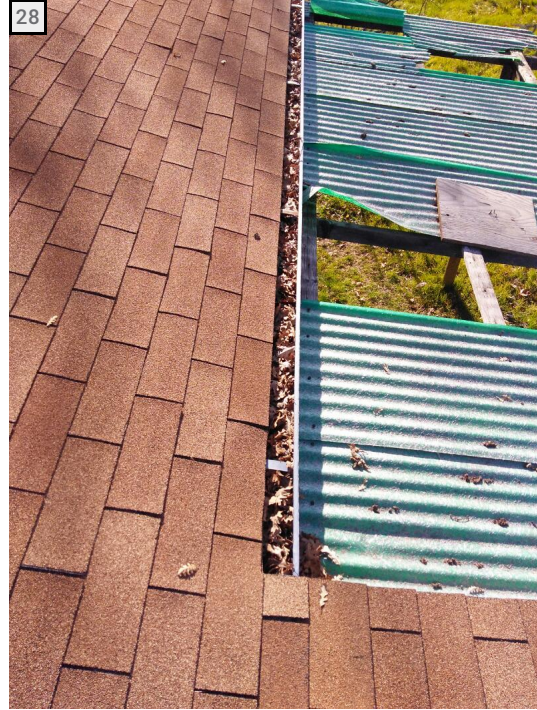
In need of cleaning

Location Exterior: Roof View
Impact The gutters may clog causing water to overflow and run down fascia board, potentially wearing wood before its time
Suggested Action Clean the gutters

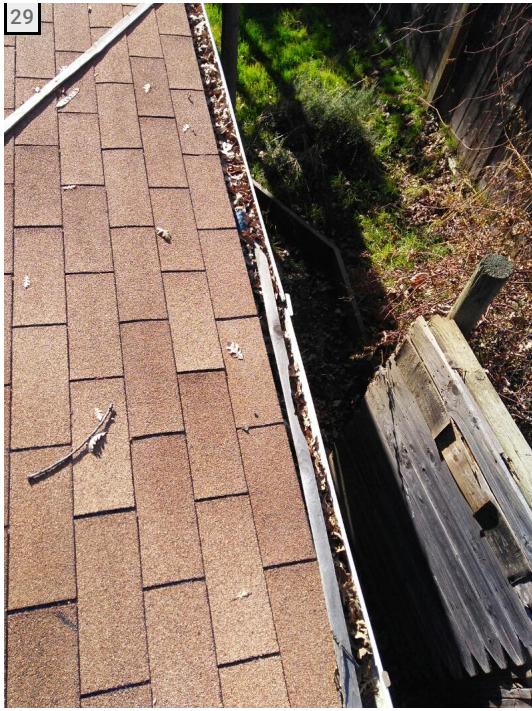
Not secured properly to the fascia boards

Location Exterior: Roof View
Impact The gutter could further pull away and / or fall down and over time cause damage to the fascia material
Suggested Action Remount the gutters

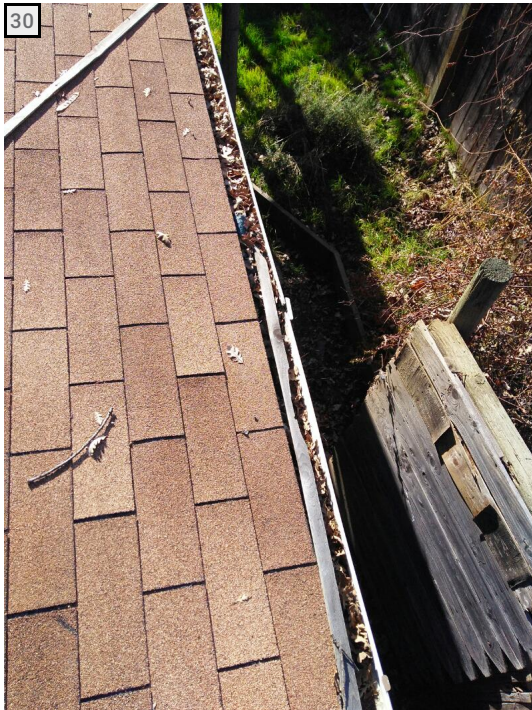
Seam is separated

Location	Exterior: Roof View
Impact	The separated seam means the gutter has a strong potential for leaking
Suggested Action	Clean out the gutter and re-seal the seam with a weather resistant gutter seam sealer

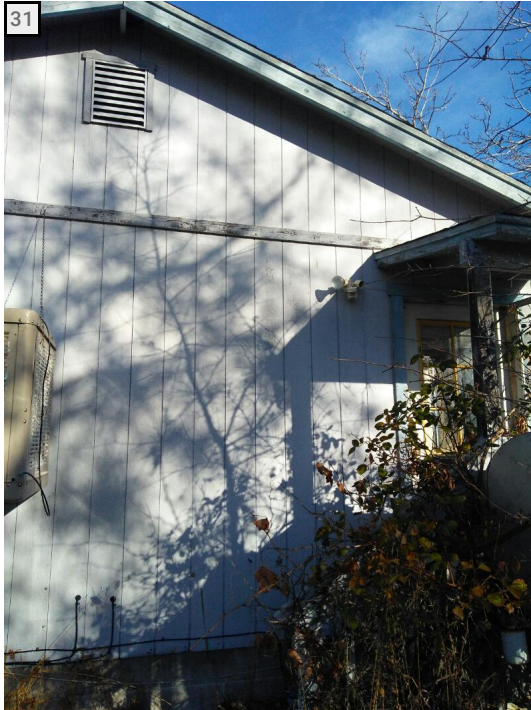
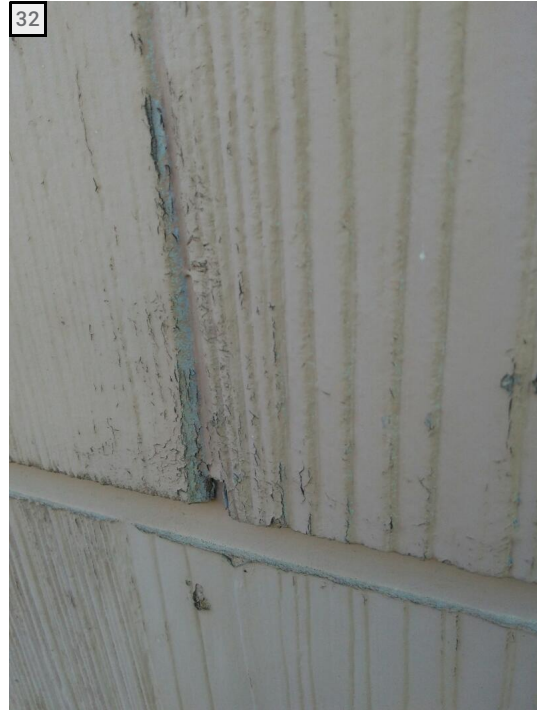
Paint or stain is peeling, worn or faded

Location	Exterior: Ground View
Impact	This makes the siding at risk of premature aging due to exposure to the elements
Suggested Action	Repaint or reseal

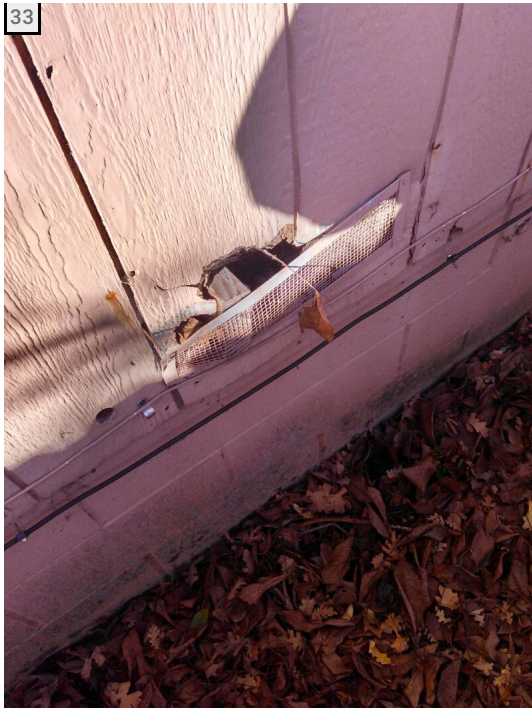
Siding is rotted

Location	Exterior: Ground View
Impact	Water and mold damage inside of home
Suggested Action	Have a professional siding contractor repair the siding

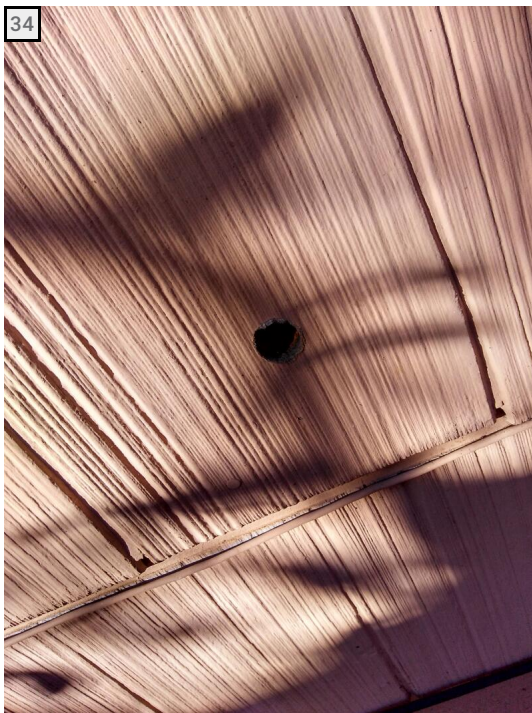
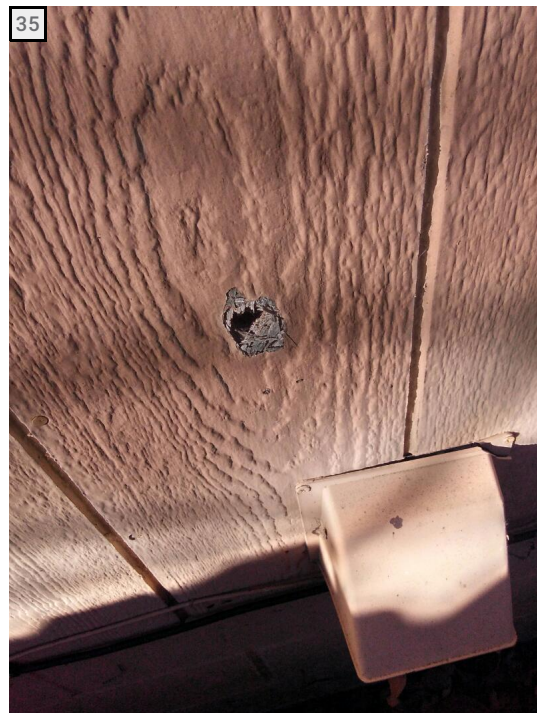
Hole in siding.

Location	Exterior: Ground View (East)
Impact	Water damage
Suggested Action	Should be sealed

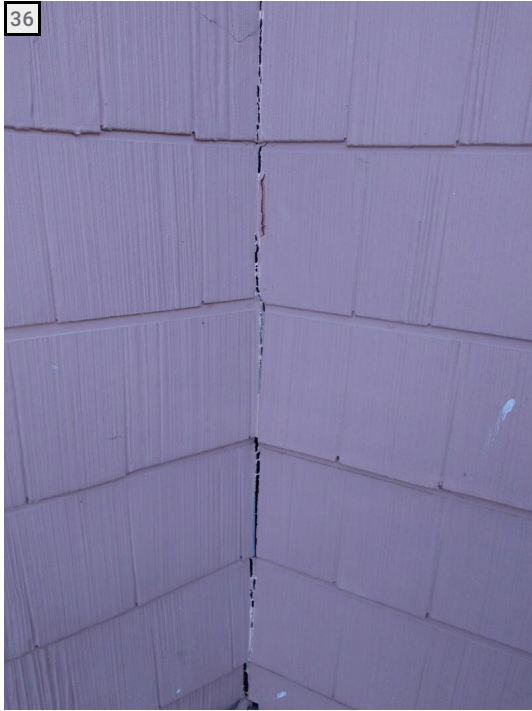
Shifting caused gap in siding

Location	Exterior: Ground View
Impact	Allows weather and animals into home
Suggested Action	Have sealed by professional

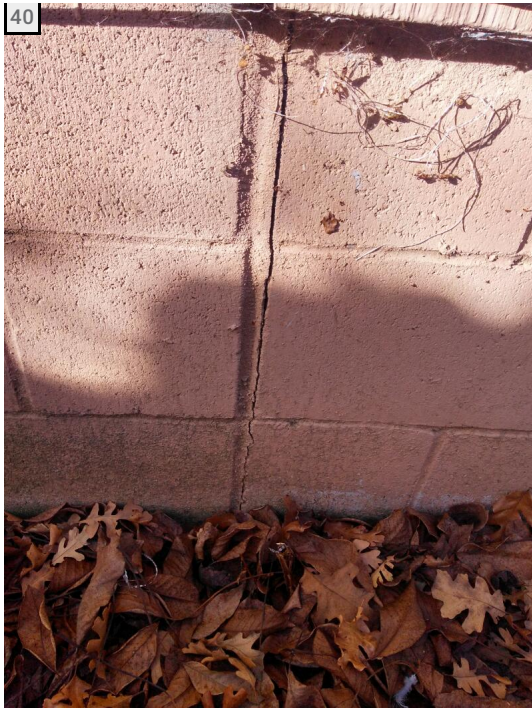
Exhibits moderate vertical cracking

Impact The cracking may allow moisture intrusion

Suggested Action Have epoxy injected into the crack by a licensed waterproofing contractor

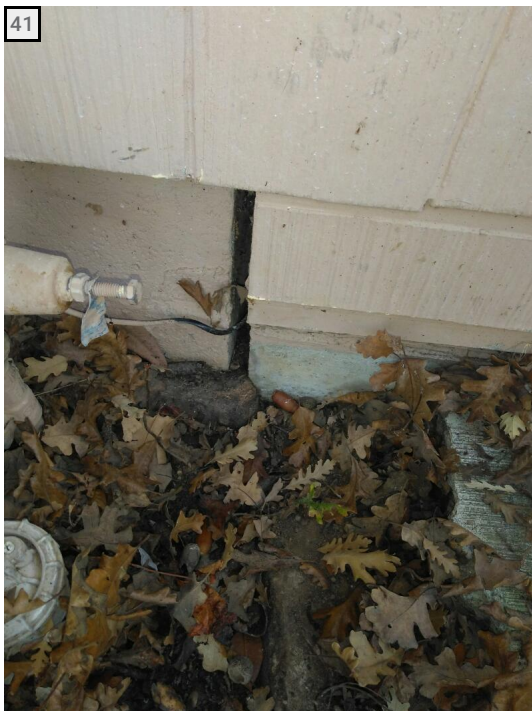
Garage slab has separated from foundation of house

Location	Exterior: Ground View
Impact	Allows moisture and animals to enter
Suggested Action	Have sealed by professional

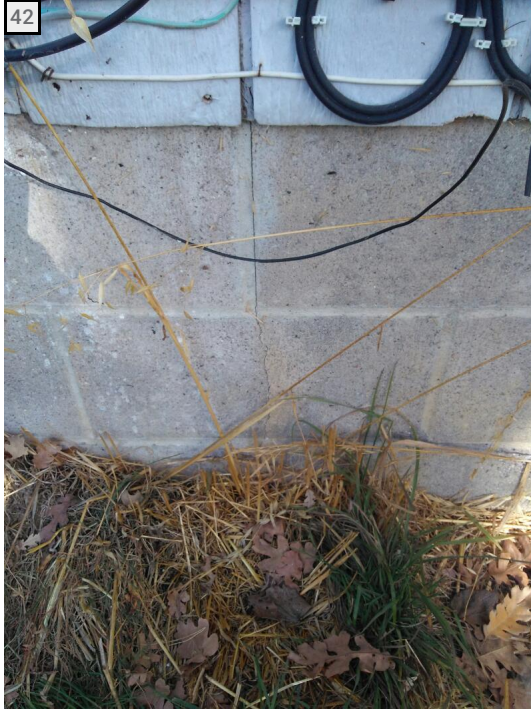
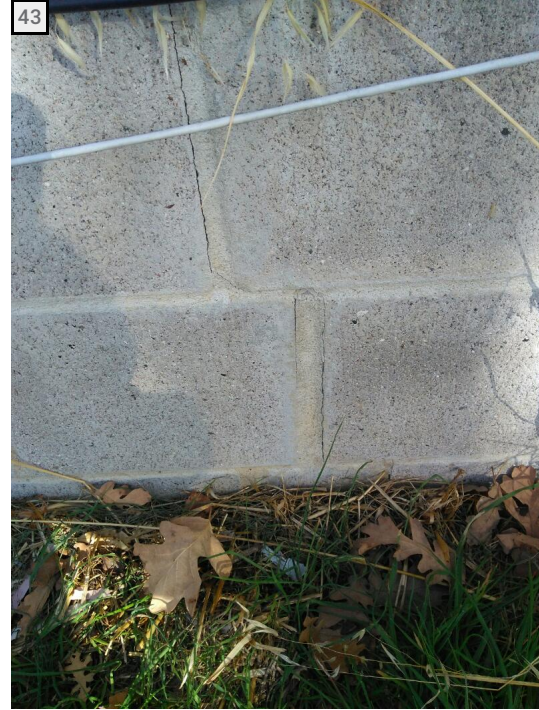
Exhibits hairline vertical cracking

Location	Exterior: Ground View
Impact	The cracking may worsen allowing moisture intrusion
Suggested Action	Monitor for further cracking. If the cracks widen have epoxy injected into the crack by a licensed waterproofing contractor

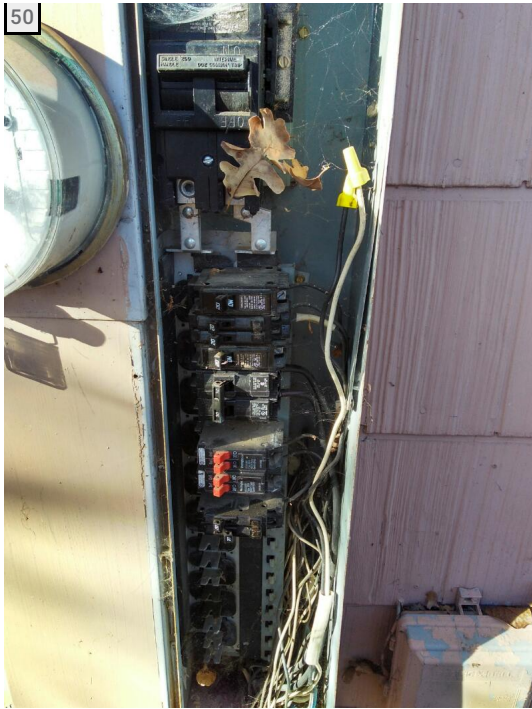
Dead front panel is missing

Location	Exterior: Ground View
Impact	Electrocution
Suggested Action	Have professional install cover

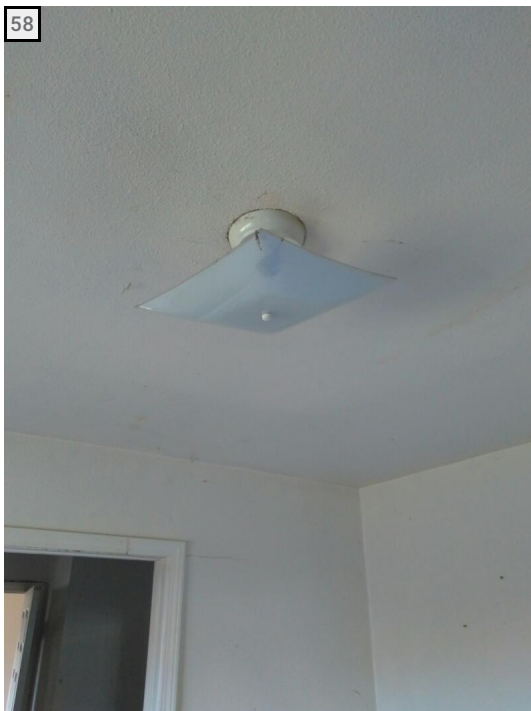
Not working

Location	Bonus Room #1 (Between living room and bathroom other room)
Suggested Action	Replace the light fixture

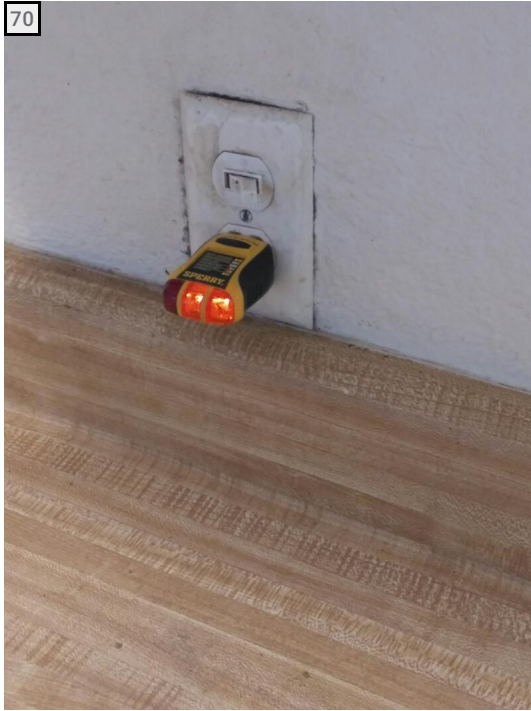
Minor Concern**Outlets are correct but should be GFCI protected in kitchen**

Location	Kitchen
Impact	Possible electrical hazard
Suggested Action	Update to GFCI outlet

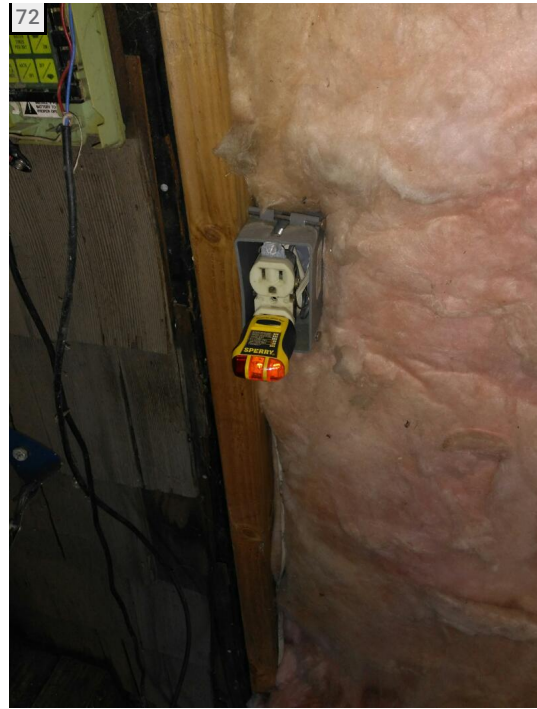
**Minor Concern****Wired correctly but not GFCI protected**

Location	Attached Garage, Exterior: Ground View
Impact	Electrical hazard if moisture enters
Suggested Action	Have repaired by qualified electrician

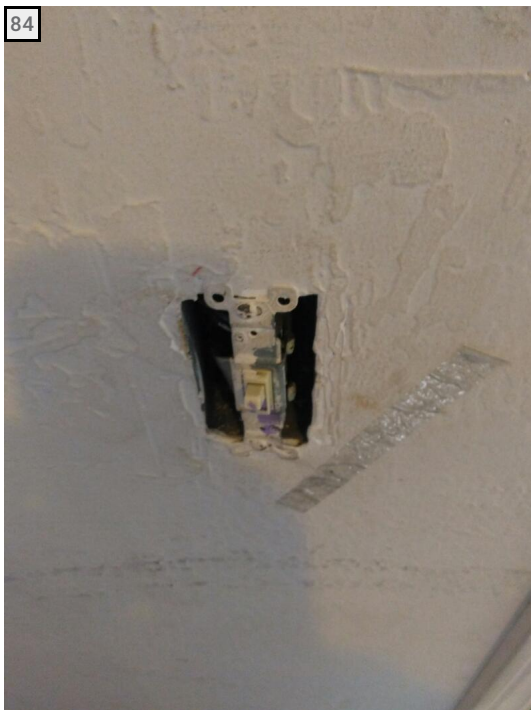
Cover is missing

Location	Bonus Room 2
Impact	Without a cover plate, can cause electrical shock if touched
Suggested Action	Install a cover

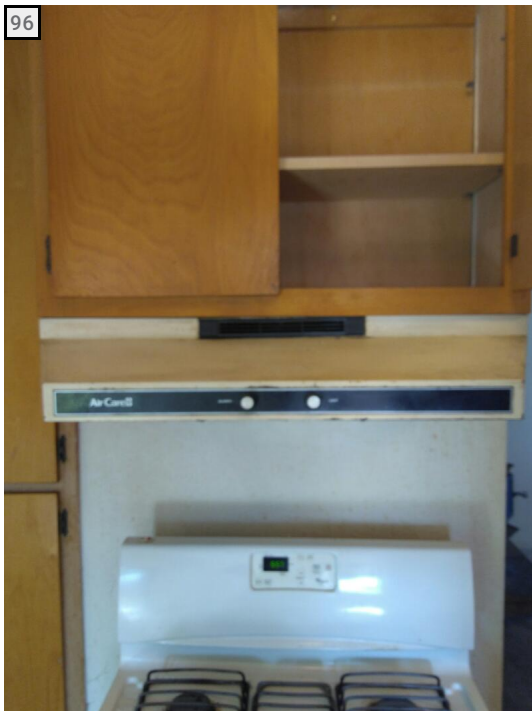
Not working

Location	Kitchen
Impact	Without a working exhaust fan, moisture can not be removed
Suggested Action	Replace the exhaust fan would assist in prompt removal of moisture to avoid moisture damage

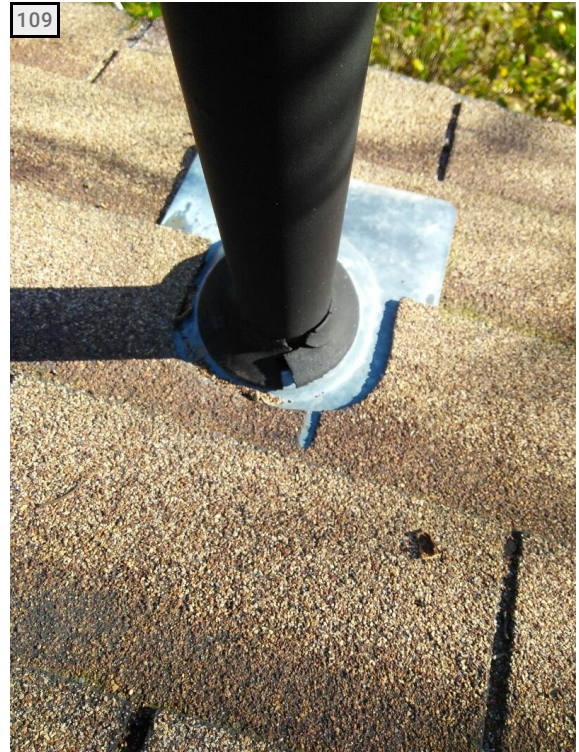
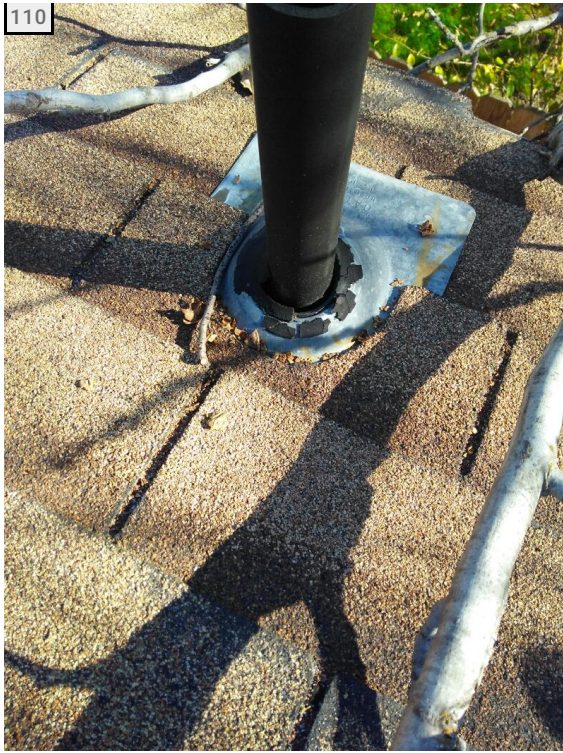
Rubber boot flashing is damaged

Location	Exterior: Roof View
Impact	The damage may cause the vent to leak
Suggested Action	Replace the flashing

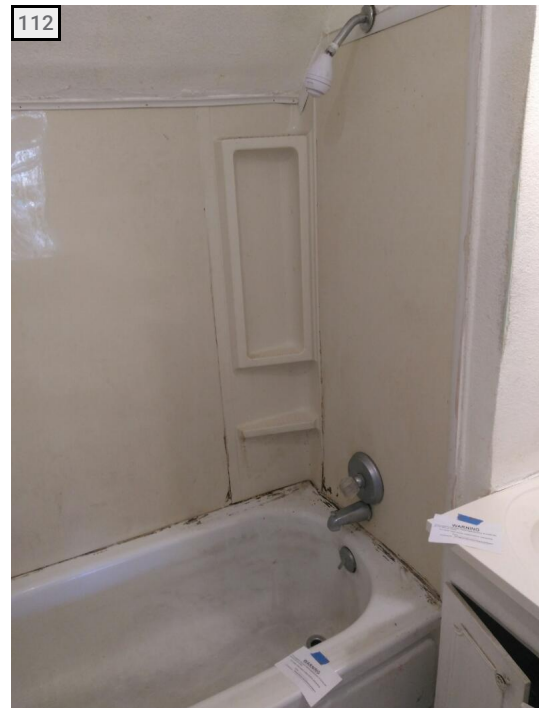
Caulking is deteriorated

Impact Without the seal that caulk provides, moisture may leak into surrounding areas causing damage to floors and walls

Suggested Action Clean out the existing caulk and re-caulk the seams

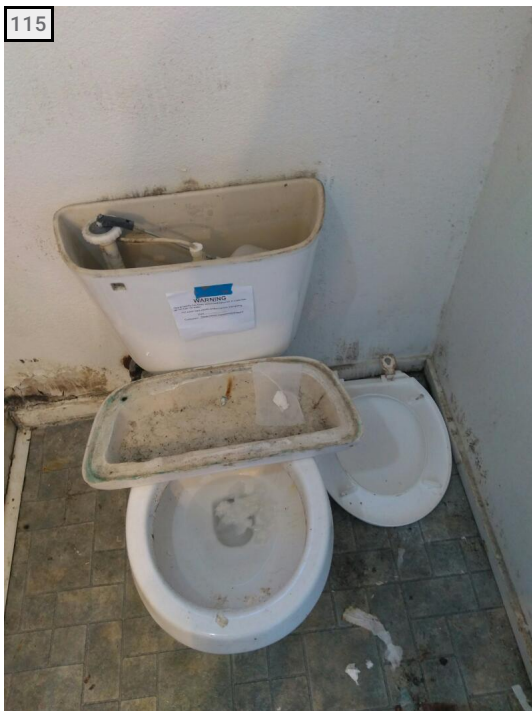
Flush mechanism is not working

Location	1st Bathroom (Between bonus room and second bedroom bathroom)
Suggested Action	Replace the toilet flush mechanism

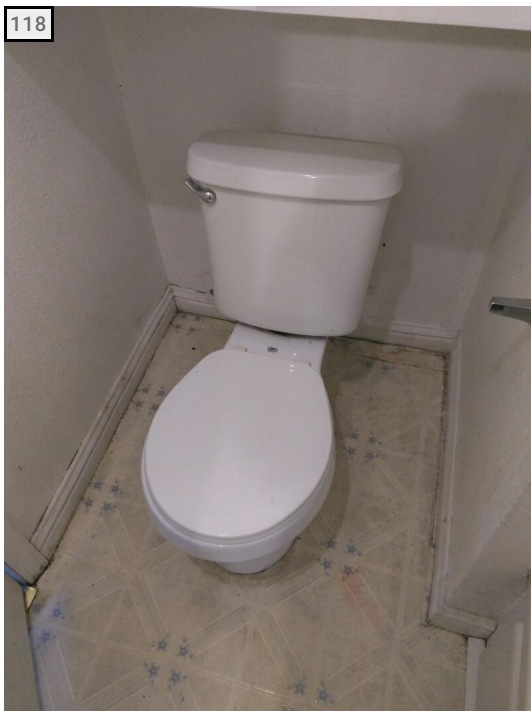
Tank is loose

Location	2nd Bathroom (west of living room bathroom)
Impact	Leak
Suggested Action	Tighten or replace toilet

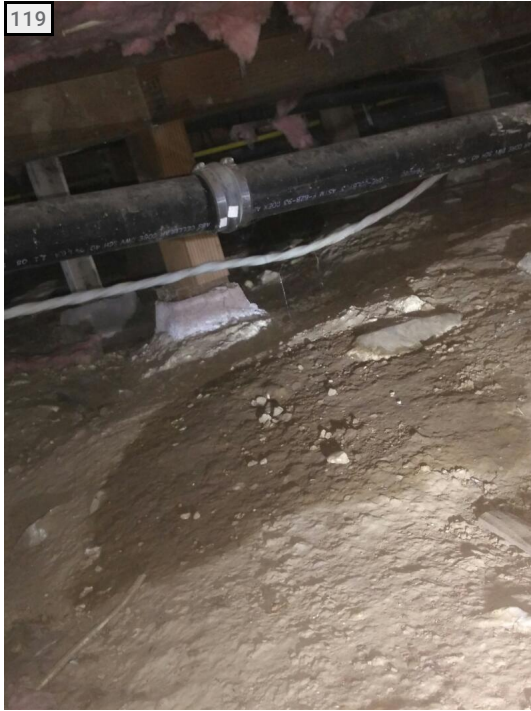
Leaking

Location	Crawl Space
Impact	The leak allows raw sewage to escape causing a health hazard
Suggested Action	Have repaired by a plumber

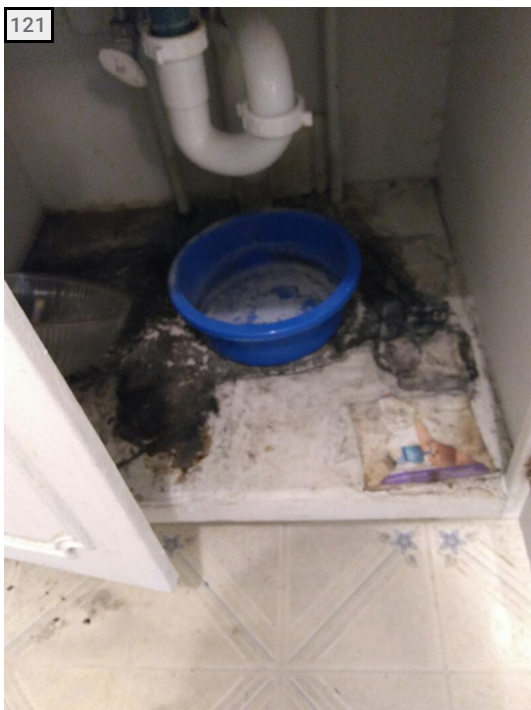
Bowl may indicate a leak

Location	2nd Bathroom (west of living room bathroom)
Impact	Water damage
Suggested Action	Repair pipe

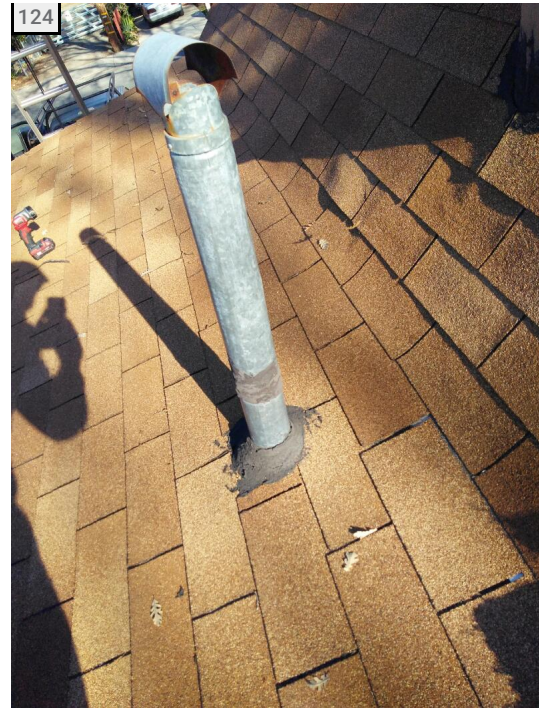
Flashing is missing

Location	Exterior: Roof View
Impact	Roof leak
Suggested Action	Have repaired by qualified professional

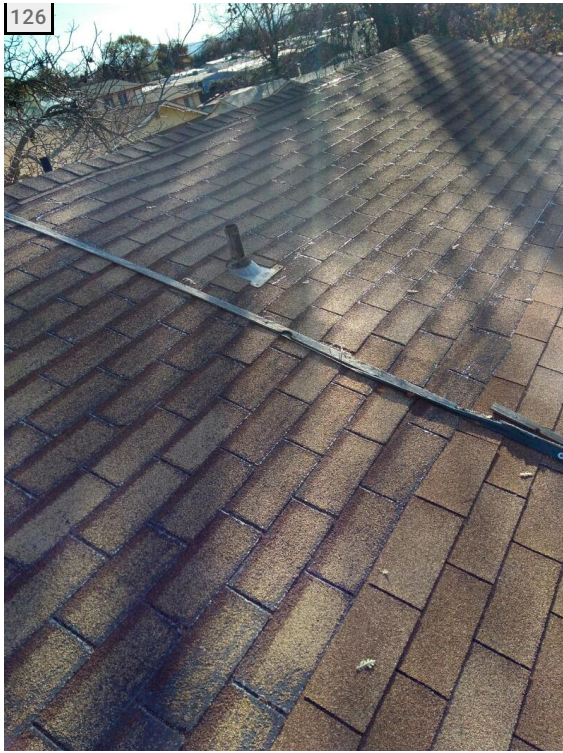
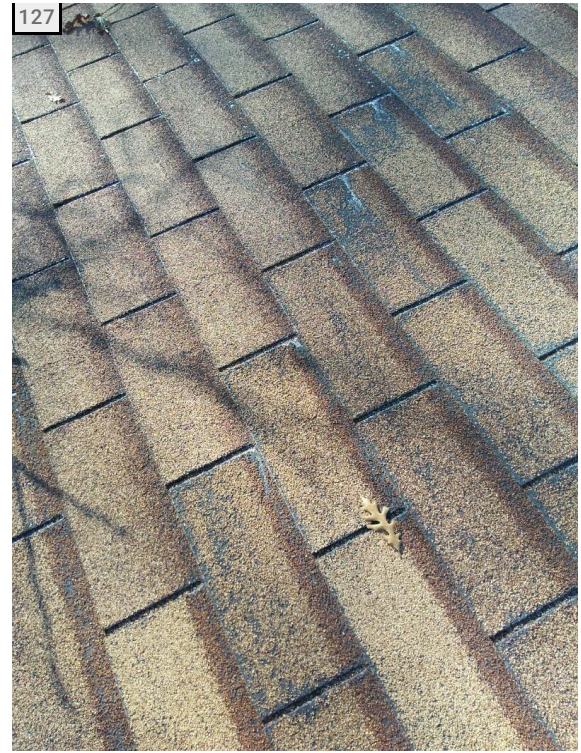
Shows signs of excessive wear

Location	Exterior: Roof View
Impact	The condition of the roof will further deteriorate and water could infiltrate causing interior damage
Suggested Action	Budget for a new roof. In the interim, a higher level of maintenance can be expected
Other Information	Excessive wear is a sign that the roof is nearing the end of its useful life

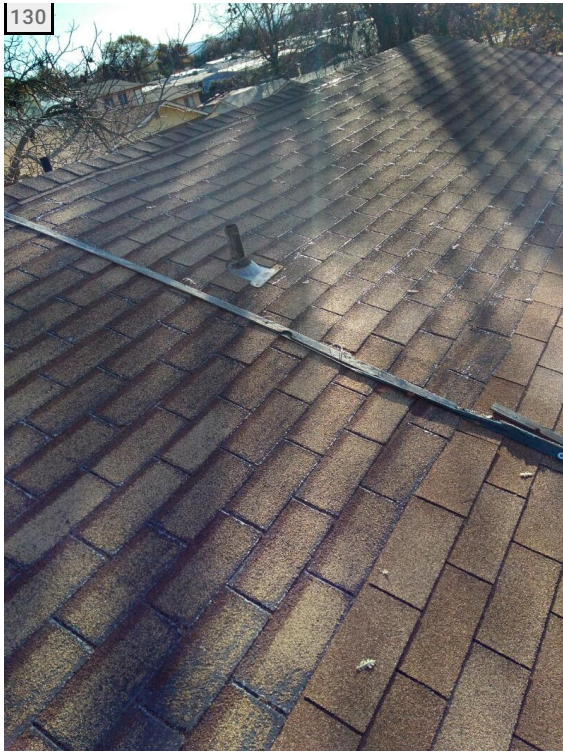
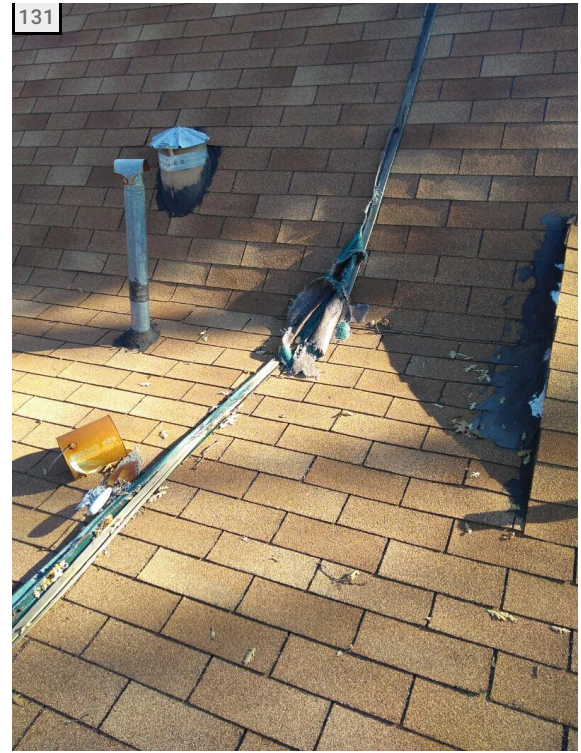
Tarp was screwed into roof creating new holes

Location	Exterior: Roof View
Impact	Roof leak
Suggested Action	Have repaired by a qualified roofing contractor

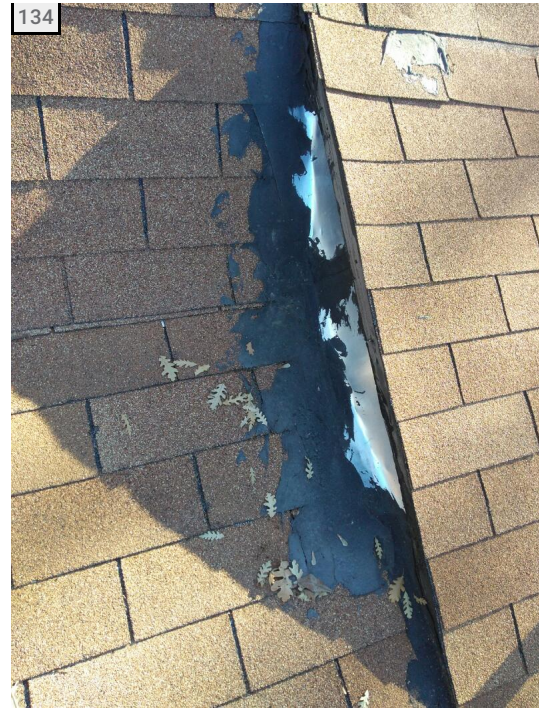
Repair was done improperly

Location	Exterior: Roof View
Impact	Because the roof material was installed incorrectly and lack proper stability and protection
Suggested Action	Have repaired by a qualified roofing contractor

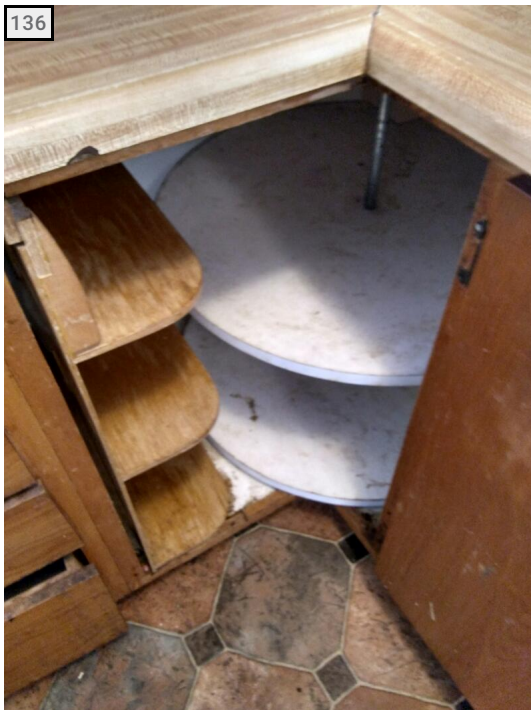
Door is missing

Location	Kitchen
Impact	The missing door renders the cabinet drawer unusable
Suggested Action	Install a door
