Inspection Report

955 Johndoe Street, Johndoe, California 95453

Inspection Date December 17, 2017
Client Henry Home Inspections
Inspector Keith Henry
707.354.4472
keithrhenry22@gmail.com

Henry Home Inspections

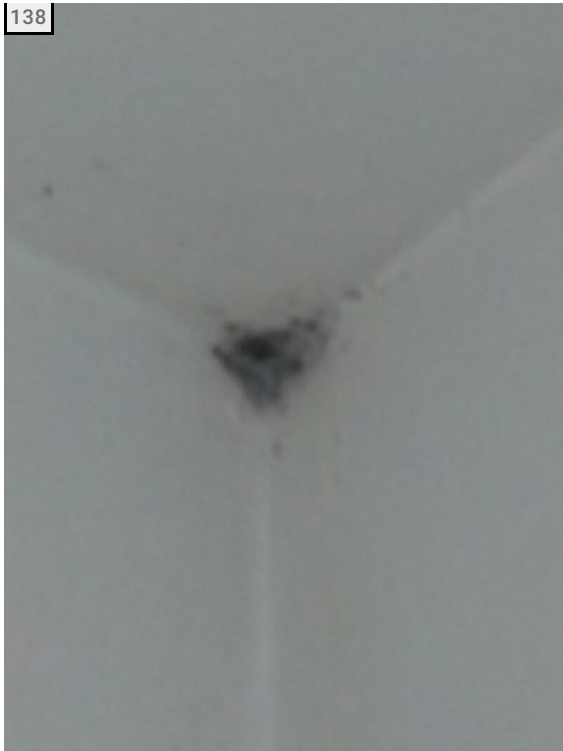
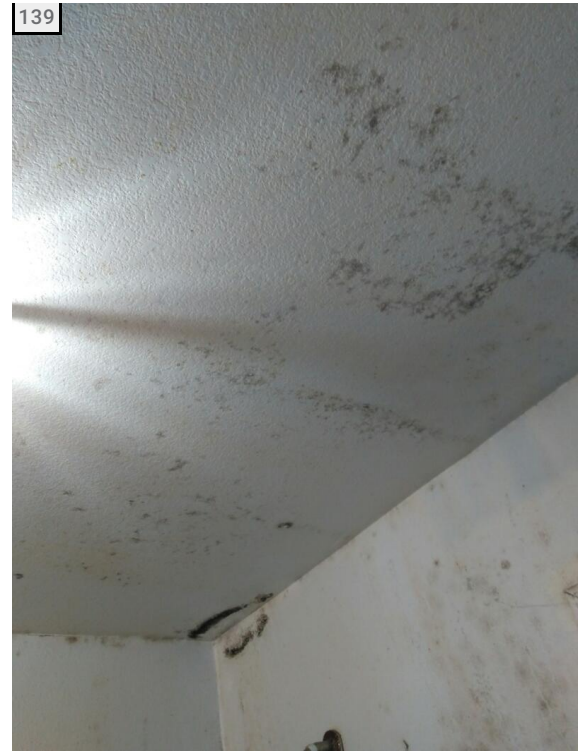
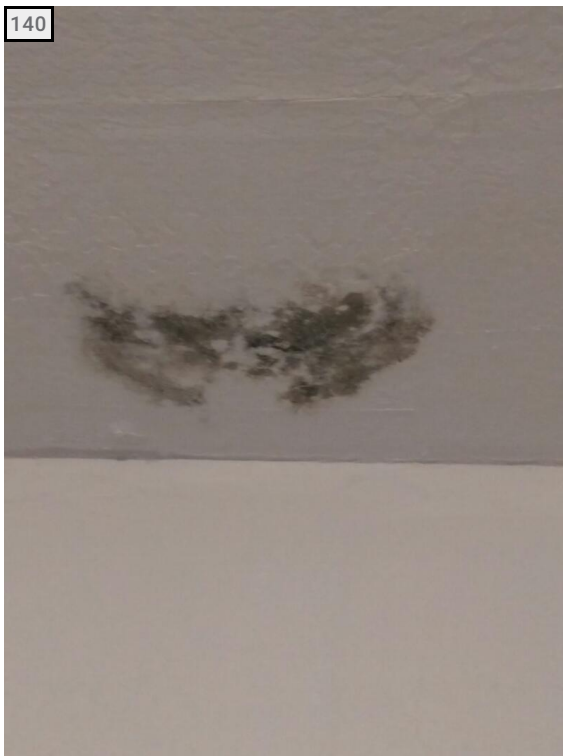
Location	Bonus Room 2, Bonus Room #1 (Between living room and bathroom other room), 1st Bathroom (Between bonus room and second bedroom bathroom)
Impact	Indicates leak, it is unhealthy to live with mold
Suggested Action	Have repaired by a qualified contractor

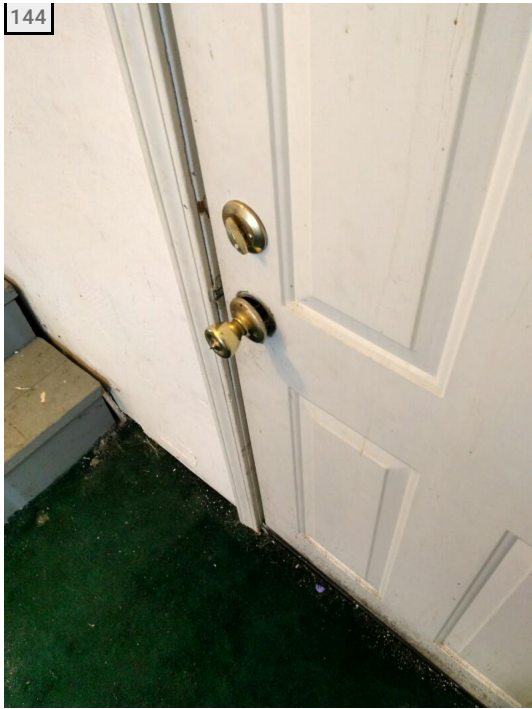
Handle is damaged

Location	Hallway and Stairs (Between kitchen and second bonus room hallway and stairs)
Impact	Doesn't work
Suggested Action	Replace the handle

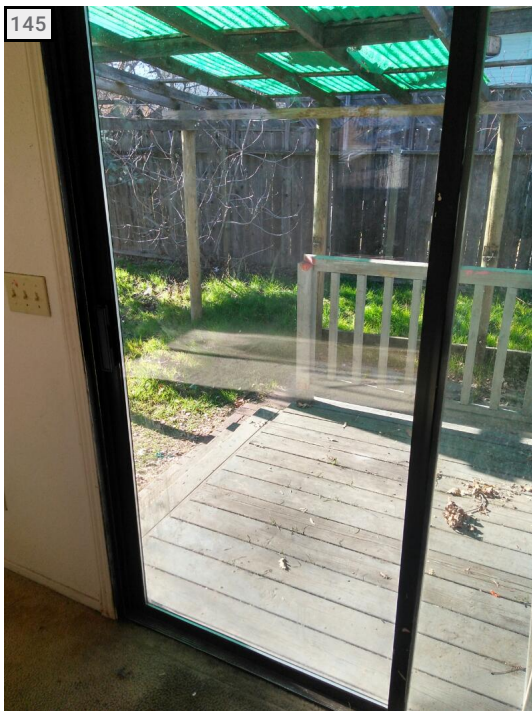
Locking mechanism doesn't open

Location	Family Room
Impact	Can't unlock
Suggested Action	Have repaired by professional

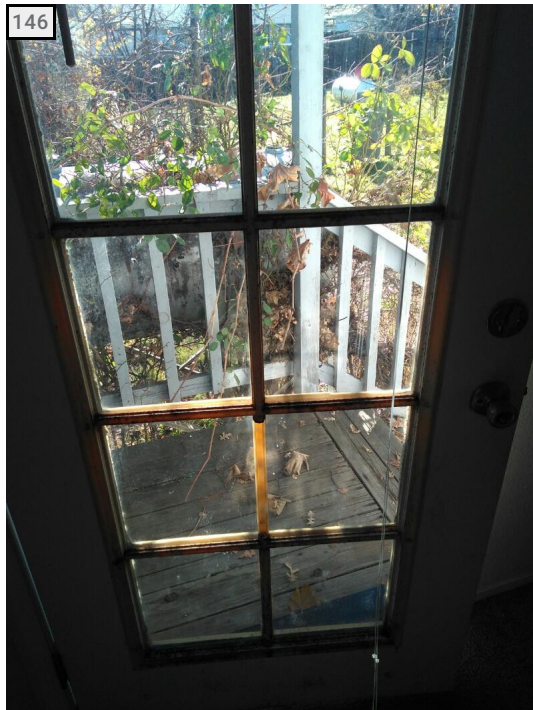
Grille is damaged

Location	2nd Bedroom (Rear of house bedroom)
Suggested Action	Have repaired by professional

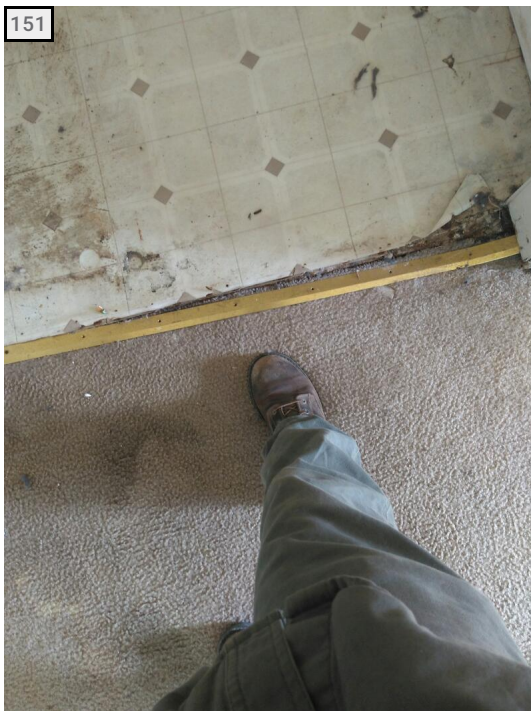
Location	Family Room
Impact	Will eventually become a hole
Suggested Action	Have subfloor replaced

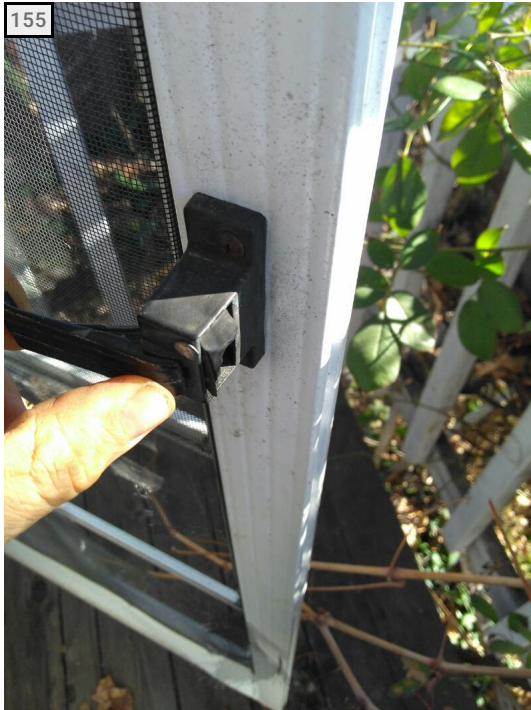
Handle is missing or broken

Location 2nd Bedroom (Rear of house bedroom)
Suggested Action Replace the handle. If not possible, replace the entire door

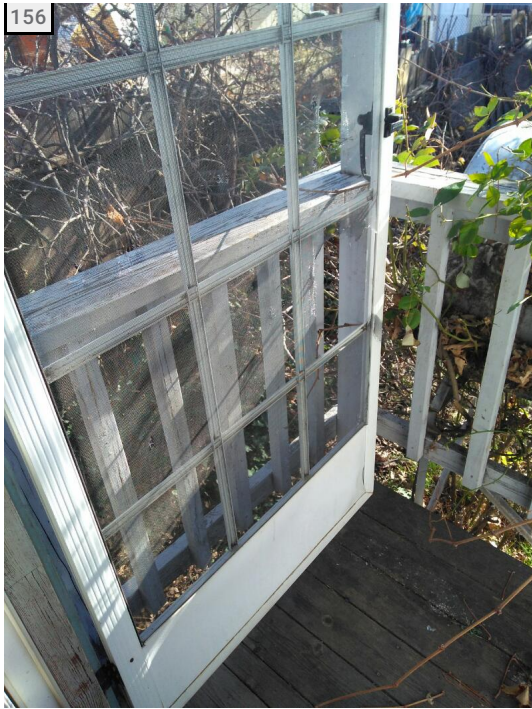
Screen is ripped

Location 2nd Bedroom (Rear of house bedroom)
Suggested Action Replace the screen

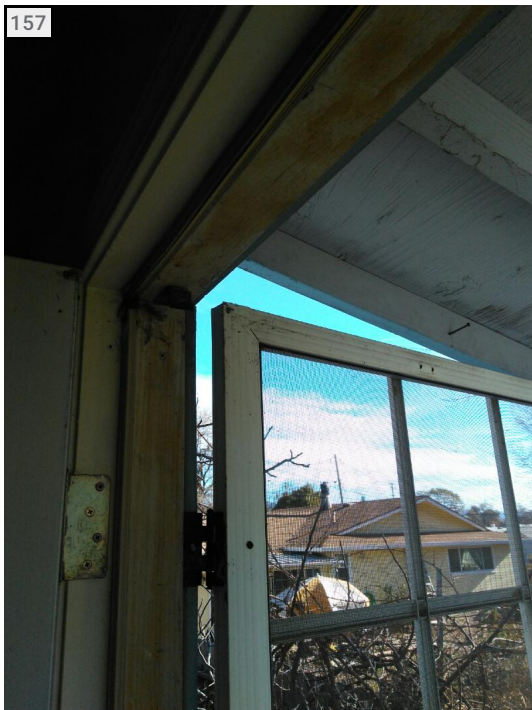
Stop chain and pump are missing

Location	2nd Bedroom (Rear of house bedroom)
Impact	Without the mechanism to control the closing of the door, the storm door could become damaged
Suggested Action	Install a new stop chain and pump

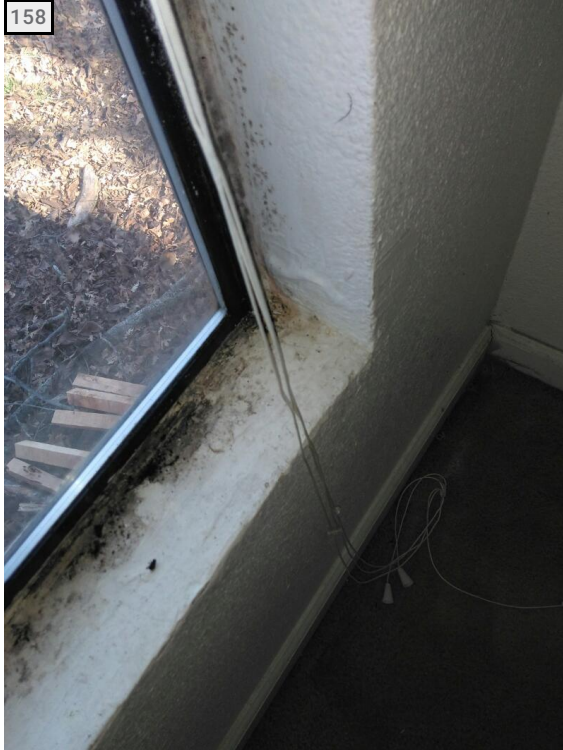
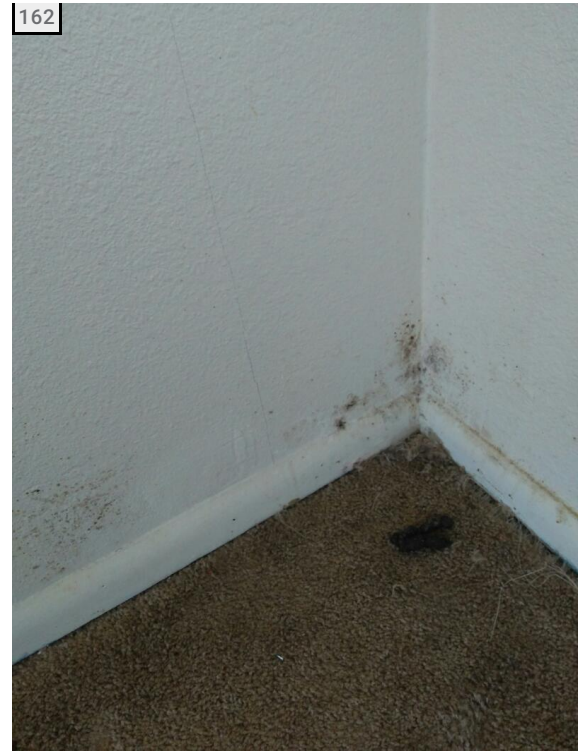
Black mold on drywall

Impact Indicates leak and it is a health hazard to live with mold

Suggested Action Have repaired by a qualified contractor

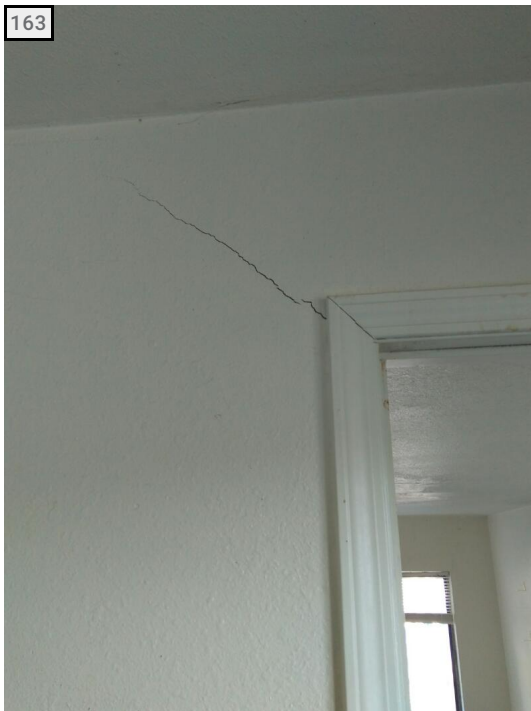
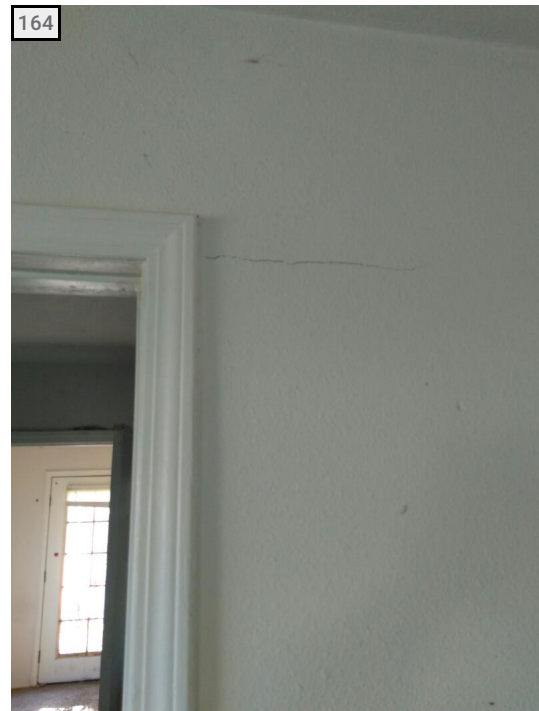
Drywall crack at door

Location	Bonus Room #1 (Between living room and bathroom other room)
Impact	Could indicate weak header or settling
Suggested Action	Have repaired by a qualified contractor

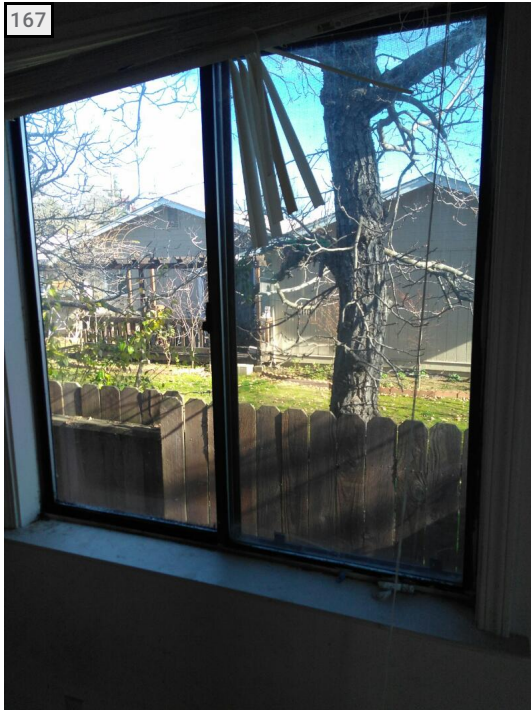
Blinds are damaged

Location Family Room, 2nd Bedroom (Rear of house bedroom)
Suggested Action Repair or replace
