# **Inspection Report**

12345 Mountain Orchard Dr., Lake County, California 12345

**Inspection Date** March 16, 2018 **Inspector** Keith Henry 707.354.4472 keithrhenry22@gmail.com

**Henry Home Inspections**

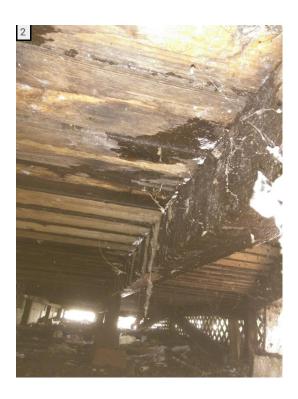
## **Wood rot fungis**

Location Exterior: Ground View
Impact Deck will continue to rot
Suggested Action Have rotted boards replaced

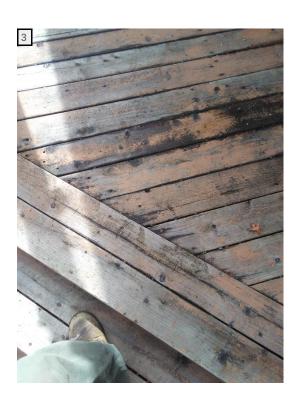
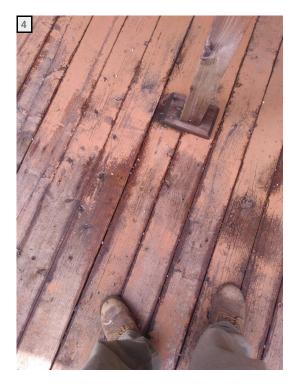
## **Decking is deteriorated or damaged**

Impact The sub-standard decking material dimishes structural integrity of the

planking

Suggested Action Replace deteriorating decking

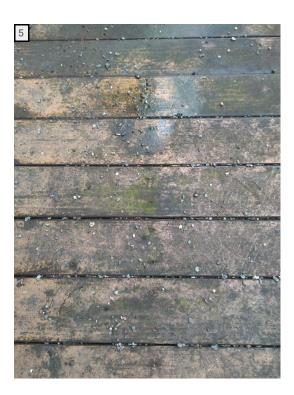
#### **Decking has organic growth**

Impact With excessive exposure to moisture, the wood may prematurely

deteriorate

Suggested Action Remove the moss and ensuring the water source is remediated Other Information The moss is a sign that the deck is regularly exposed to moisture.

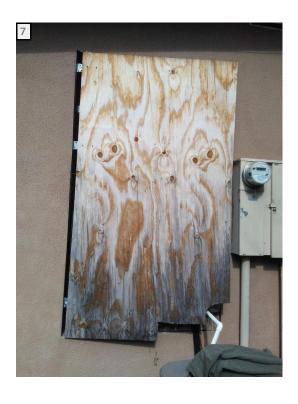
#### Incorrect.

Impact Does not have a moisture barrier

Suggested Action Have repaired by a qualified siding contractor

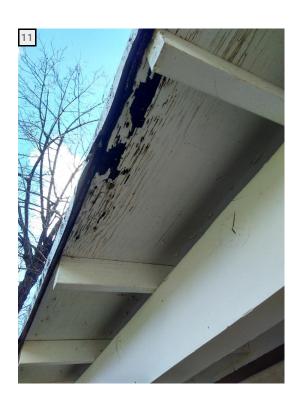
## **Roof is leaking**

Location **Exterior: Ground View** Roof sheathing will begin to rot if leak is not fixed Have repaired by a licensed contractor Impact

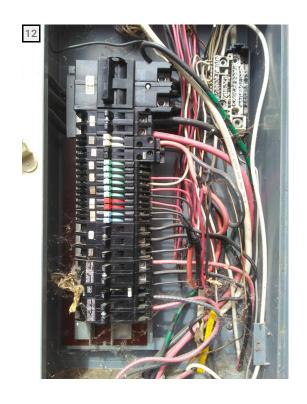
#### **Dead front panel is missing**

**Impact** Electrocution

Suggested Action Have professional install cover

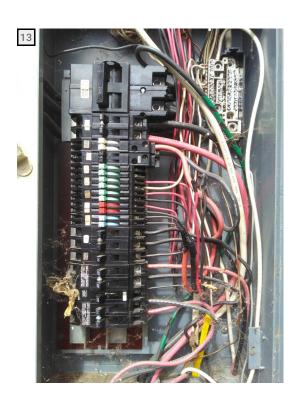
## **Exposed ends of wires**

Location Exterior: Ground View Could cause electrocution

Suggested Action Have qualified person install wire nuts

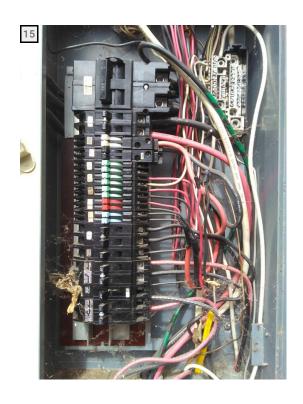
## **Zinsco brand service box**

Impact Zinscos are know as fire and electrocution hazards
Suggested Action Have replaced by licensed electrician

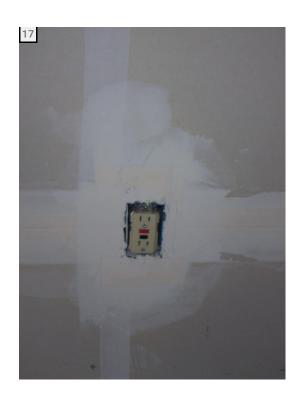
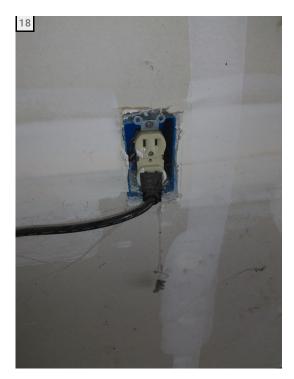
## **Cover is missing**

Impact Without a cover plate, can cause electrical shock if touched

Suggested Action Install a cover

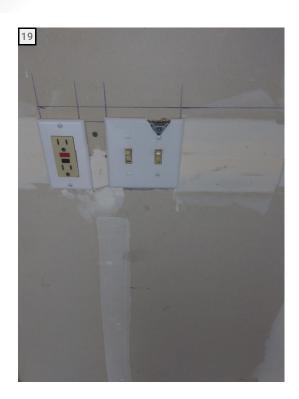
## **Cover is cracked**

Location Detached Garage Suggested Action Replace the cover

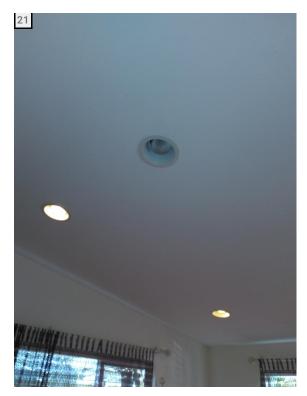
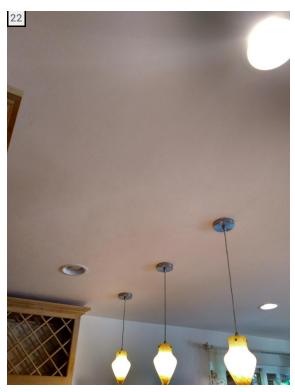
## **Bulb** is burned out/missing

Location Kitchen, Living Room, 1st Bedroom (Master Bedroom bedroom)

Suggested Action Replace the bulb

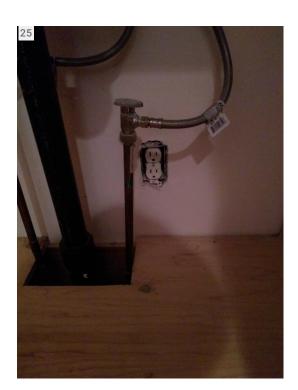
## **Cover plate is missing**

Impact Without a cover plate, can cause electrical shock if touched

Suggested Action Install a cover

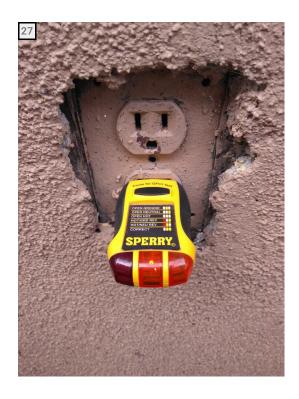
## Not in outdoor outlet box

Impact Could become electrocution hazard when wet

Suggested Action Have repaired by a licensed electrician

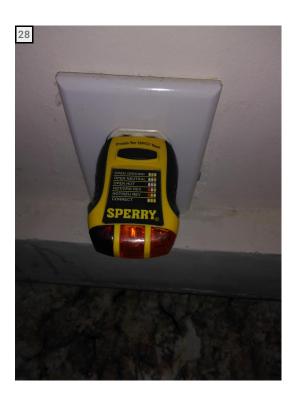
#### **Tester shows hot neutral reverse**

Impact A hot neutral reverse outlet can cause electrical shock or damage an

appliance

Suggested Action Have repaired by qualified electrician

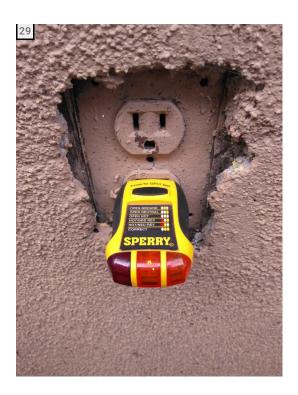
#### **Tester shows open ground**

Impact An open ground outlet can cause an electrical surge to the appliance

resulting in damage or electrical shockut

Suggested Action Have repaired by qualified electrician

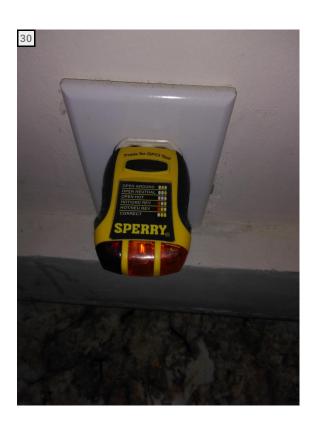
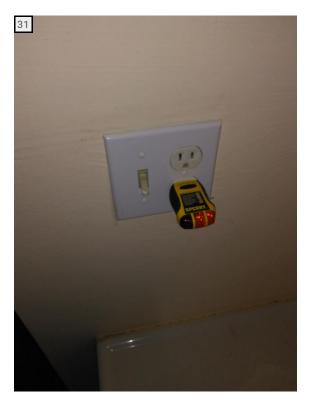
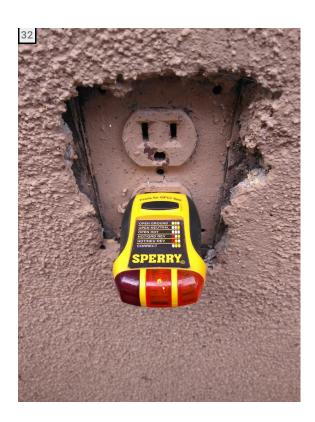
## **Not GFCI protected**

Exterior: Ground View, 1st Bathroom (Main Bathroom bathroom), 2nd Bathroom (Master Bathroom bathroom) Location

Possible electrical hazard Impact

**Suggested Action** Have repaired by a licensed electrician

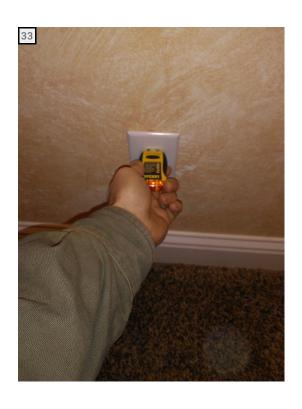
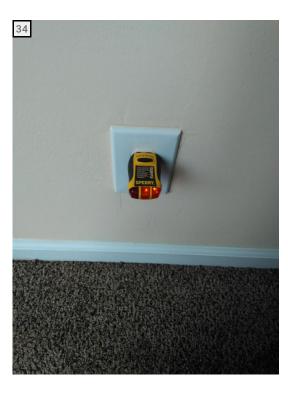
## **Outlet box is loose inside wall**

Impact Wires could become loose

Suggested Action Have repaired by a licensed electrician

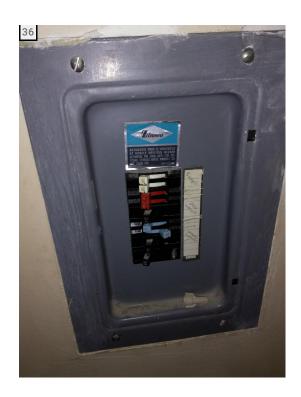
## A Zinsco panel

Location 1st Bedroom (Master Bedroom bedroom) Impact The panel may overheat and portions may melt Suggested Action Have replaced by a licensed electrician Other Information

Zinsco panels often fail to meet increased energy demands of modern

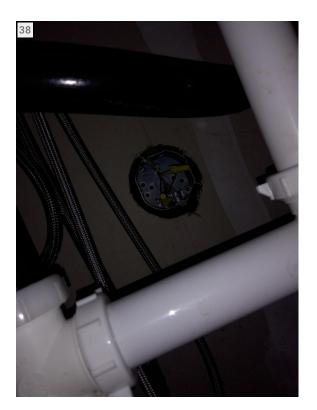
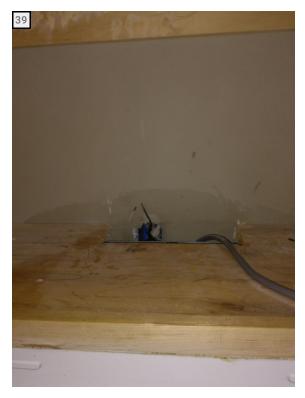
## **Exposed**

Impact Exposed wiring can cause electrical shock if touched Suggested Action Place the wiring in a junction box with a cover plate

Other Information Exposed wiring should be capped and in a junction box with a cover plate or

removed

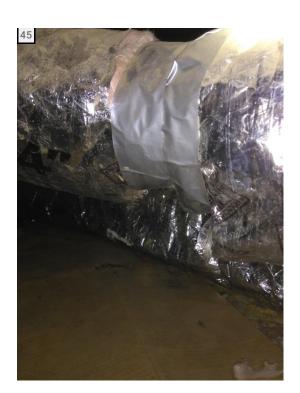
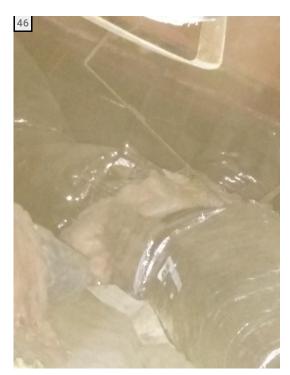
#### **Damaged**

Impact The damage is preventing the heating and/or cooling from operating at

optimal efficiency and potentially causing poor air quality

Suggested Action Have repaired by an HVAC service professional

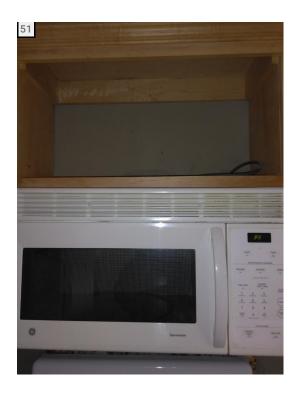
Impact When exhausting to the interior, humidity or other particulates are not

Suggested Action Re-route the exhaust to exit to the exterior using an exterior wall or roof

vent

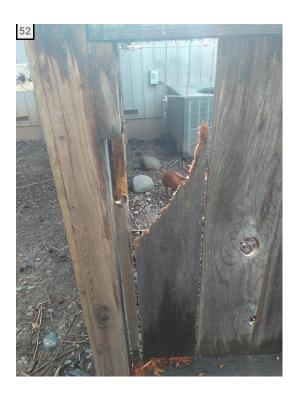
## **Boards are damaged**

Impact The damaged boards decrease the asthetic value and function of the fence

Suggested Action Repair the damaged areas

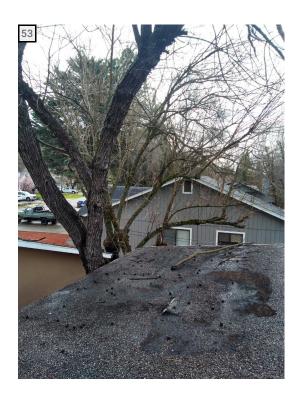
Impact Can fall and/ damage building during high winds

Suggested Action Pruning or removing

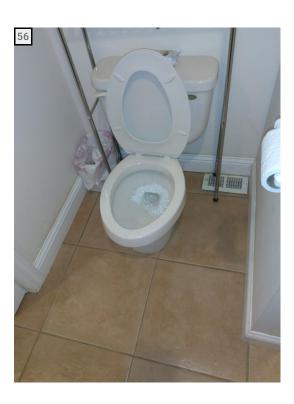
mpact Most likely the wax ring seal is broken and water/sewage is leaking and

causing water damage

Suggested Action Have toilet repaired by qualified professional

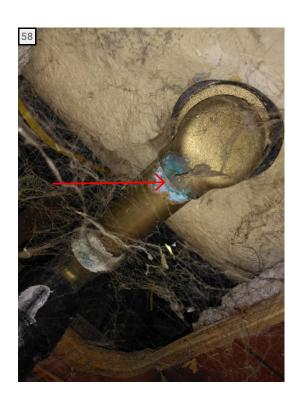
# Leaking

Impact Leaky pipes may cause damage to surrounding areas

Suggested Action Replace the leaking water pipes

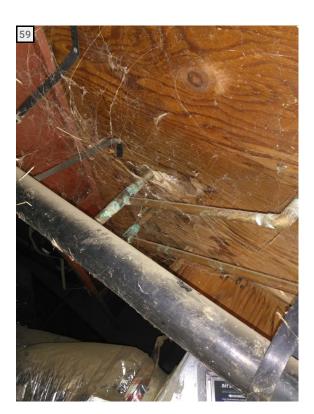
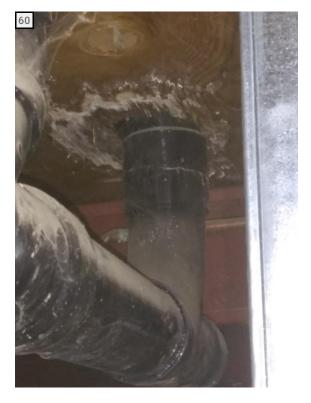
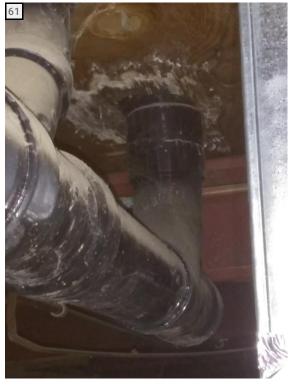
### Subfloor has evidence of moisture intrusion

Location Crawl Space (Main bathroom toilet, Main BR toilet)
Impact If moisture continues to be present, the subfloor could rot

Suggested Action Stop leak

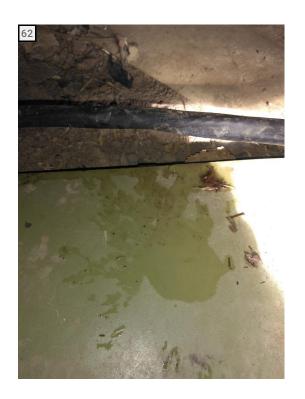
## Water dripping onto ground

Location Crawl Space Impact Indicates leak

Suggested Action Have repaired by a plumber

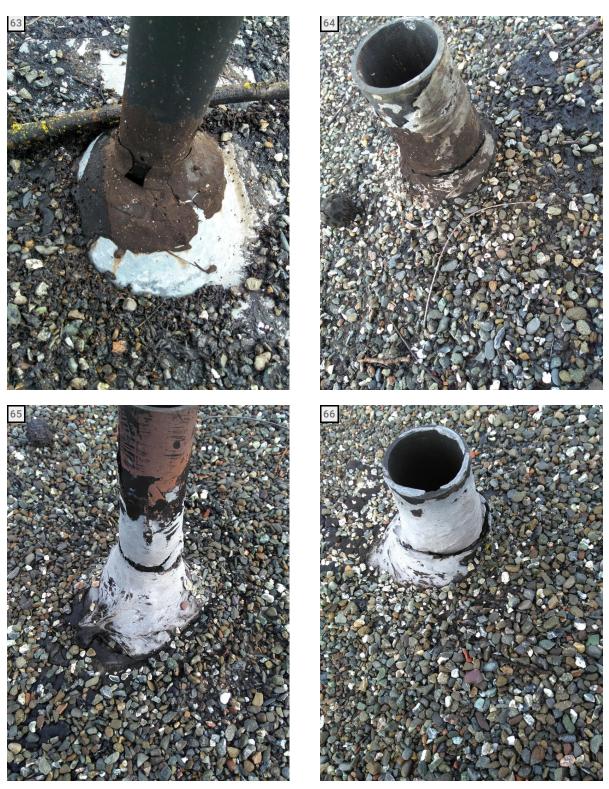
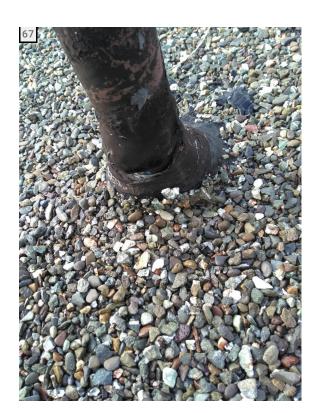
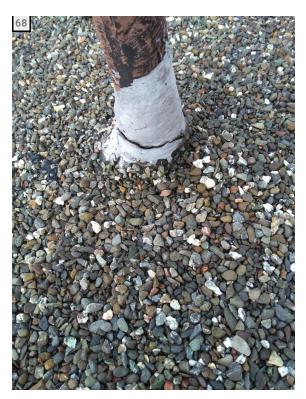
**Cracked caulking**

Impact May leak

Suggested Action Have repaired by qualified professional

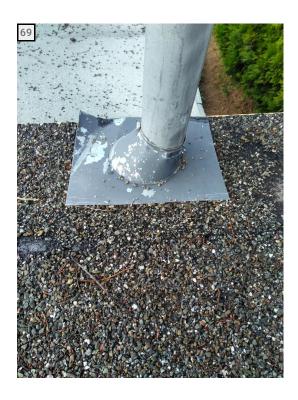
## **Improper installation**

Location Exterior: Roof View Impact Can cause roof leak

Suggested Action Have repaired by qualified professional

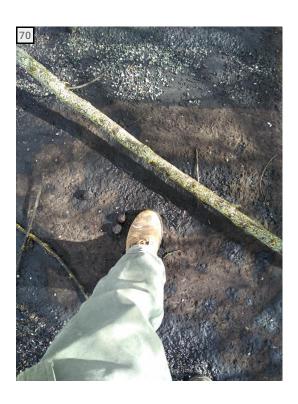
## Can hear air/moisture being squeezed out of roof when walking on

Impact Moisture entering building structure

Suggested Action Have repaired by a licensed roofing contractor

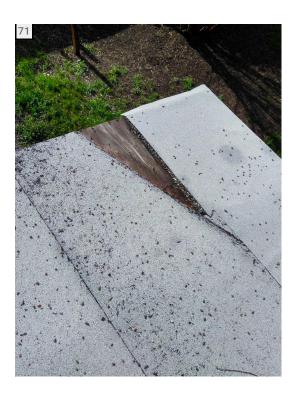
#### **Cracked or broken**

elements and may cause roof leaking

Suggested Action Have the damaged roof material replaced by a tile roofing professional

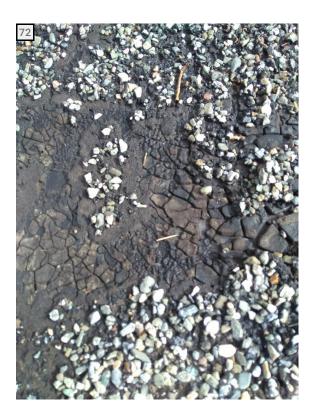
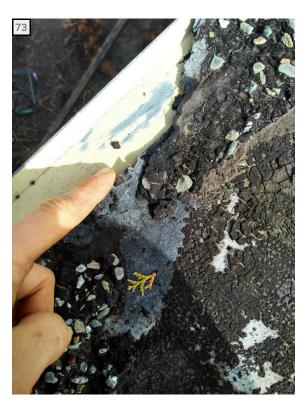
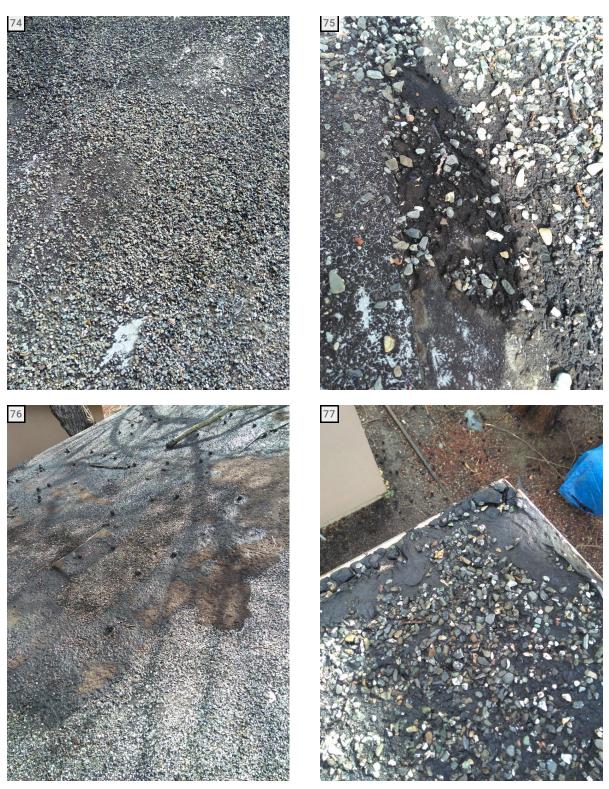
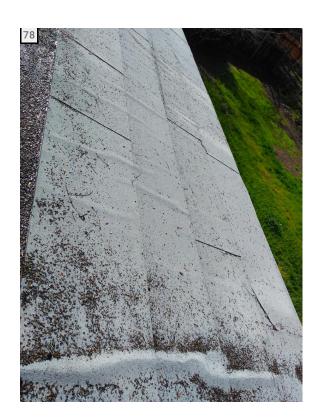
# Nearing the end of its useful life

New roof will be needed in 0-5 years Budget for a newer unit. In the interim, a higher level of maintenance can be **Suggested Action**

expected

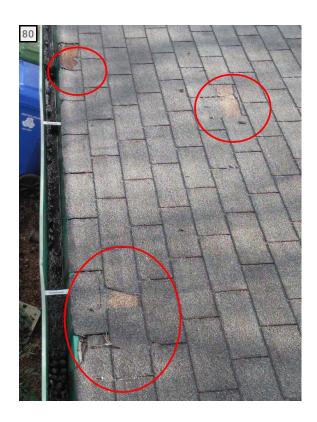
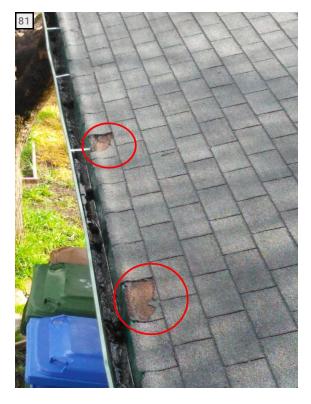
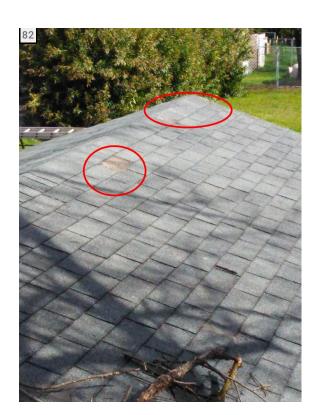
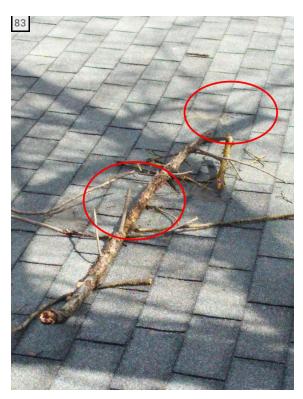
# **Damaged in isolated areas**

Impact The damaged areas may expose the underlying sheathing to potential water

damage

Suggested Action Replace the roof material in the damaged areas

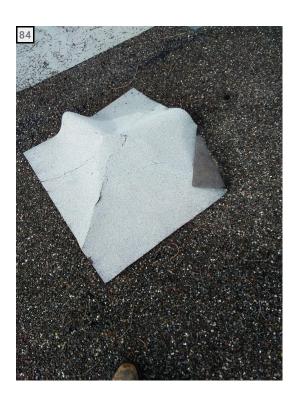
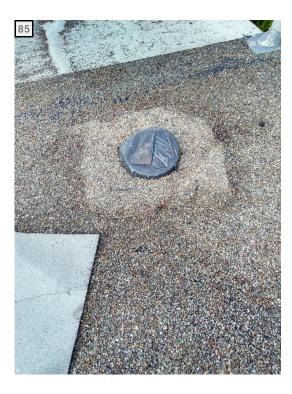
# Repair was done improperly

and protection

Suggested Action Have repaired by a qualified roofing contractor

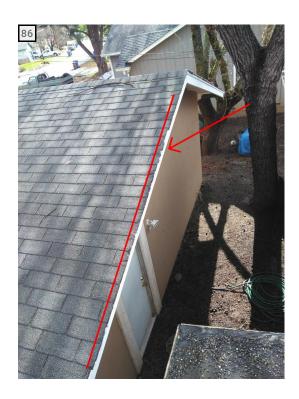
# **Damaged by tree branches**

Location Exterior: Roof View Impact Will leak sooner Suggested Action Monitor for leaks

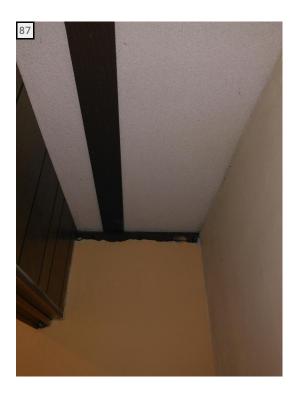
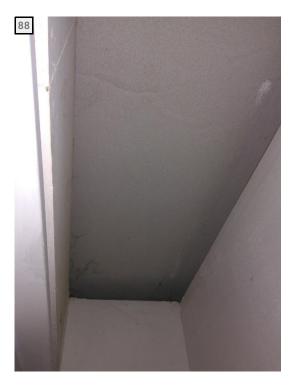
Impact This affects the insulation and fire protection provided by drywall

Suggested Action Have repaired by a qualified contractor

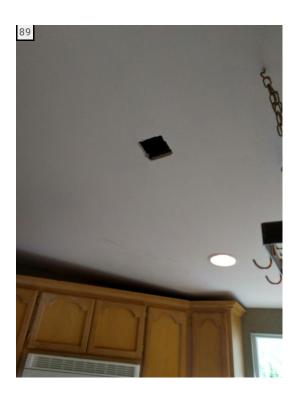
### Hole in drywall

Impact This affects the insulation and fire protection provided by drywall

Suggested Action Have repaired by a qualified contractor

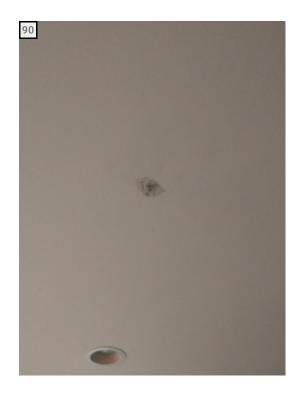
# **Ceiling repair**

Impact Could indicate leak

Suggested Action Have repaired by a qualified contractor

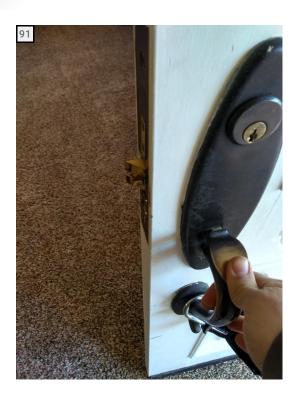
# Doorknob doesn't work, key must be used always to open door

Location Living Room
Suggested Action Have door knob replaced

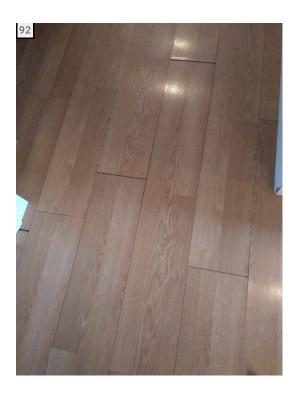
**Location** Kitchen

Impact Water can enter, floor could be pulled up Suggested Action Have repaired by qualified professional

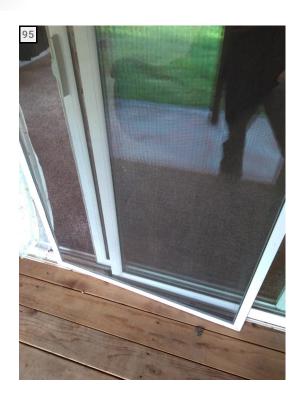
**Location** Living Room

Suggested Action Have repaired. Replacing rollers may be necessary.

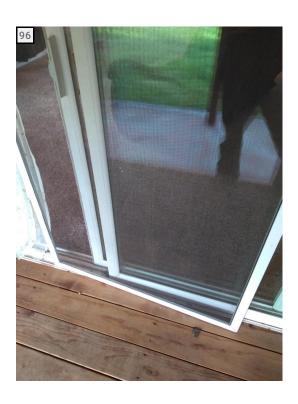
### **Torn or damaged**

Impact Should the window be open, lacks protection from insects

Suggested Action Replace the screen

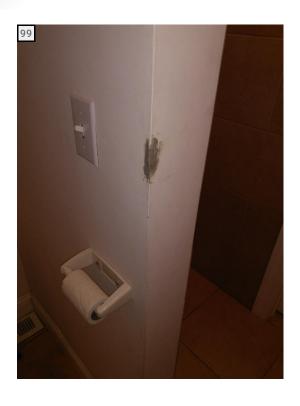
# **Drywall defects**

**Location** 1st Bathroom (Main Bathroom bathroom) Suggested Action Have repaired by drywall specialist
