# Inspection Report

1122 Behind the Moon Blvd., Northern, California 12345

**Inspection Date** March 28, 2018  
**Inspector** Keith Henry  
707.354.4472  
[keithrhenry22@gmail.com](mailto:keithrhenry22@gmail.com)

**Henry Home Inspections**

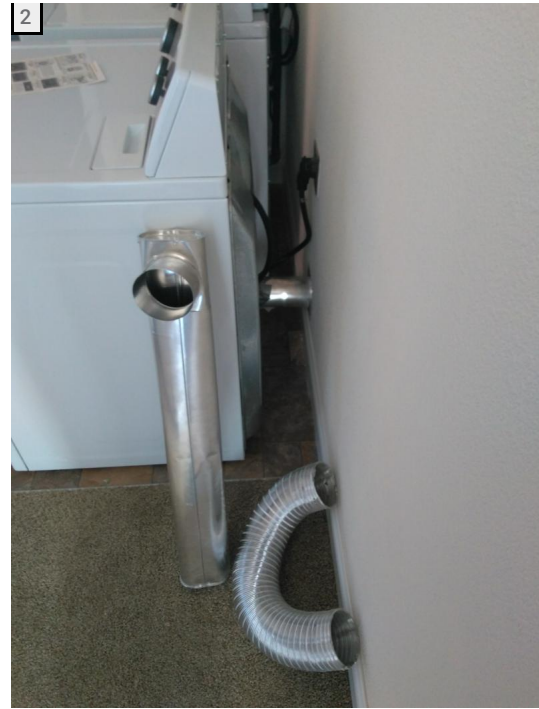
#### Vent not connected

Location	Laundry Room / Mudroom, Hallway and Stairs
Impact	Will vent to interior
Suggested Action	Connect vents

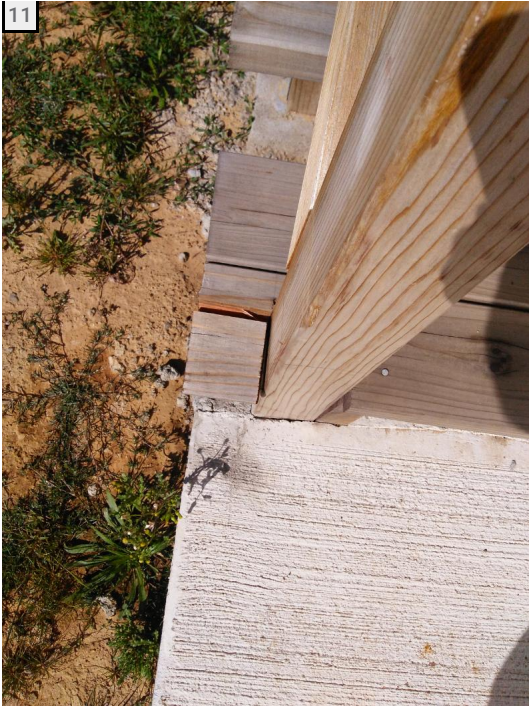
**Deck has minor damage**

Location Exterior: Ground View  
Suggested Action Have board replaced by carpenter

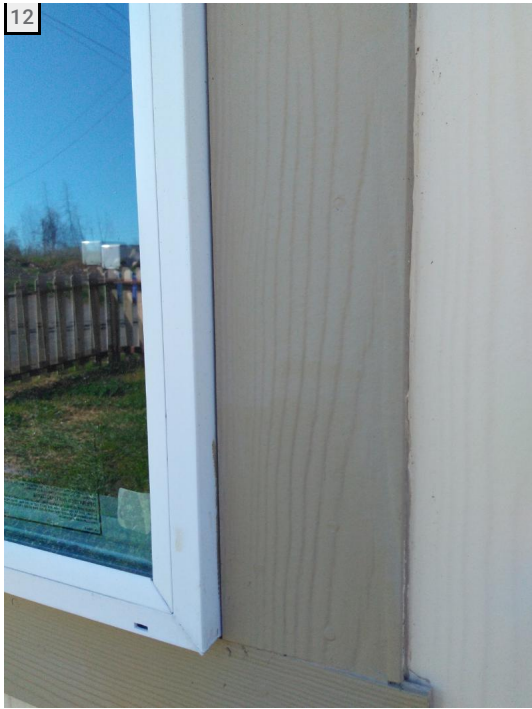
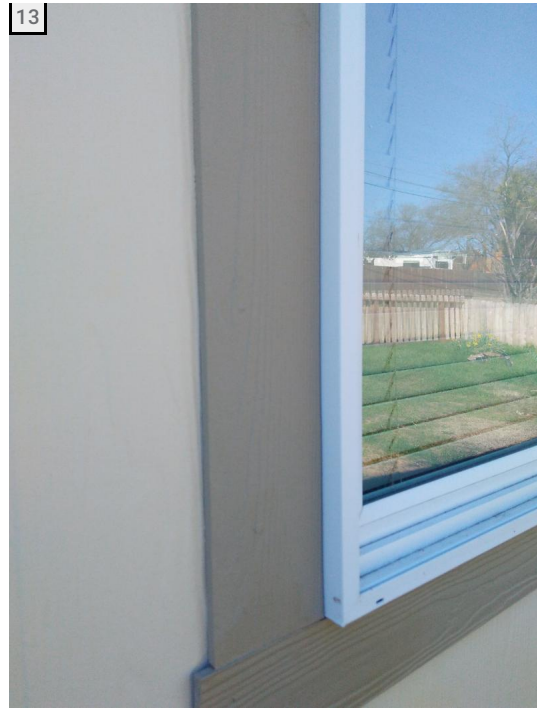
#### Caulking needed around windows

Location	Exterior: Ground View
Impact	The gaps could allow for moisture and insect intrusion which may cause cause damage to the wood over time
Suggested Action	Have caulked by a professional

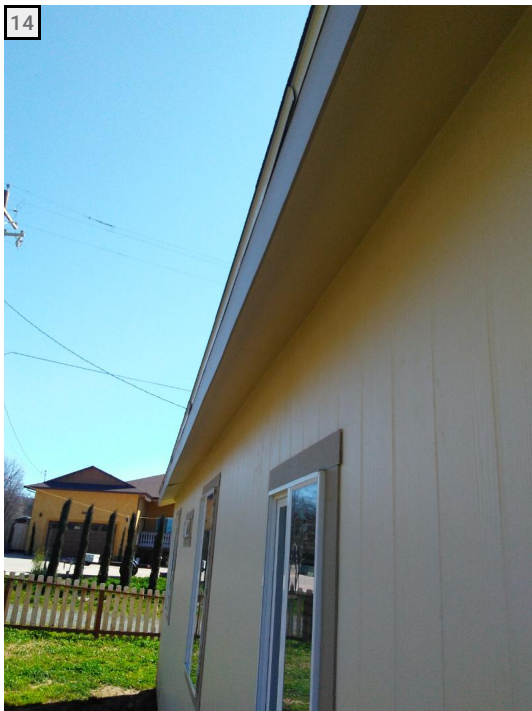
Missing

Location Exterior: Ground View

Impact Water flow is not contained which may cause premature aging of fascia and soffits and is not draining away from the foundation in a timely fashion

Suggested Action Install gutters

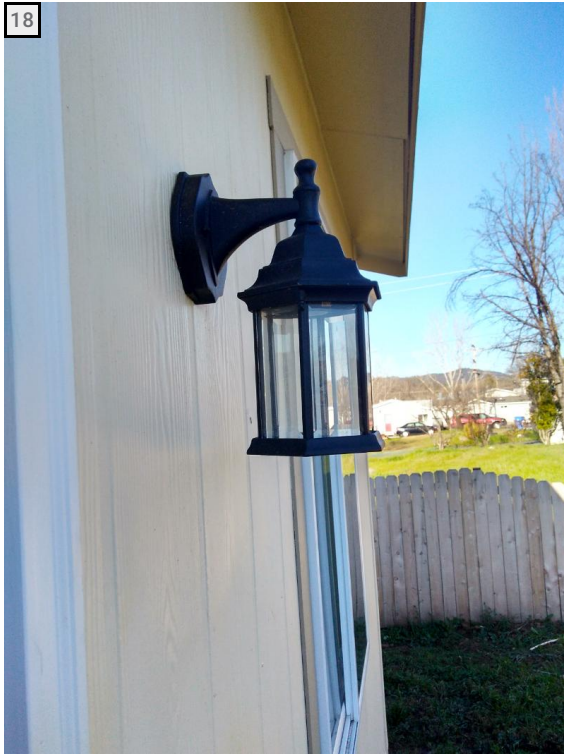
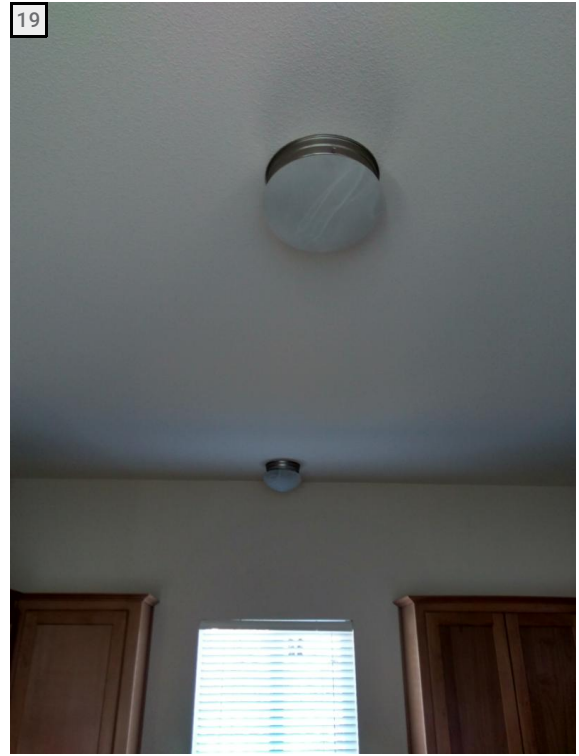
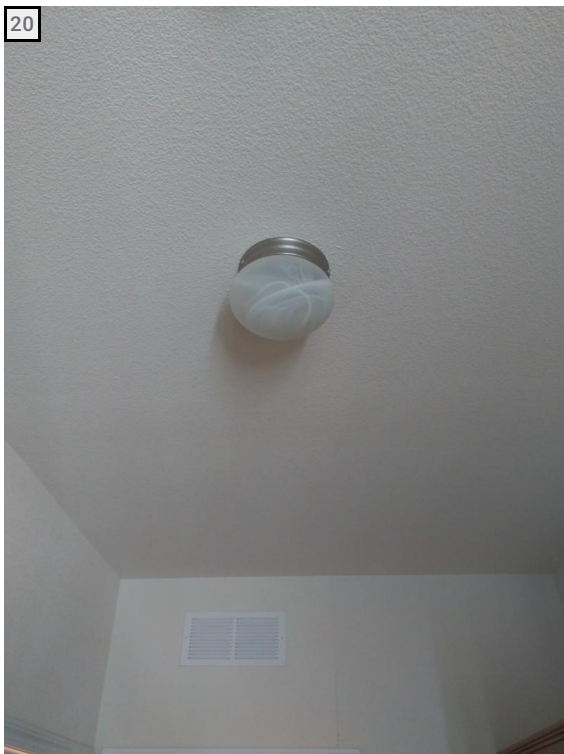
**Bulb is burned out/missing**

Location Hallway and Stairs, Kitchen, Living Room (Front room living room)  
Suggested Action Replace the bulb

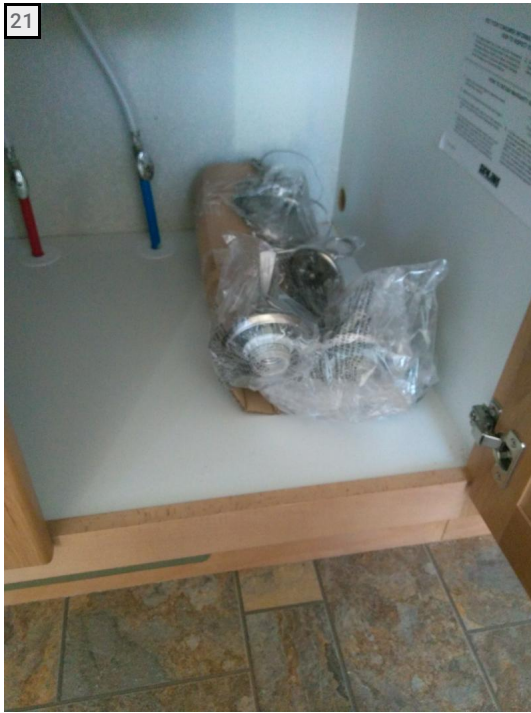
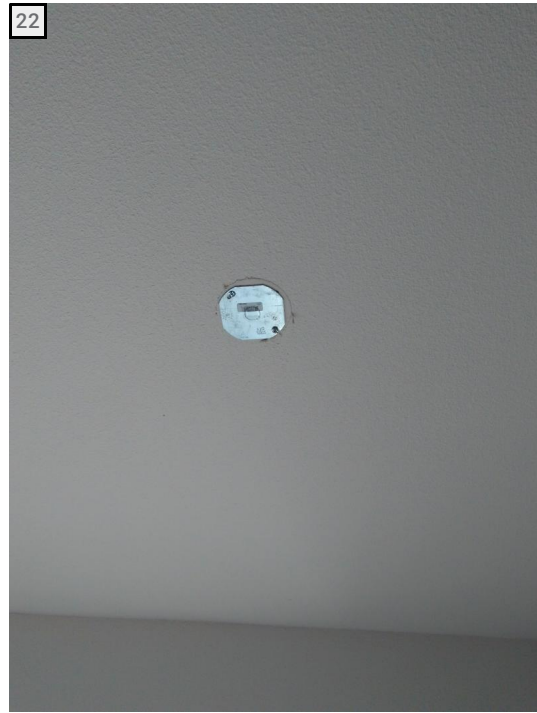
**Fixture needs installed**

Location Kitchen

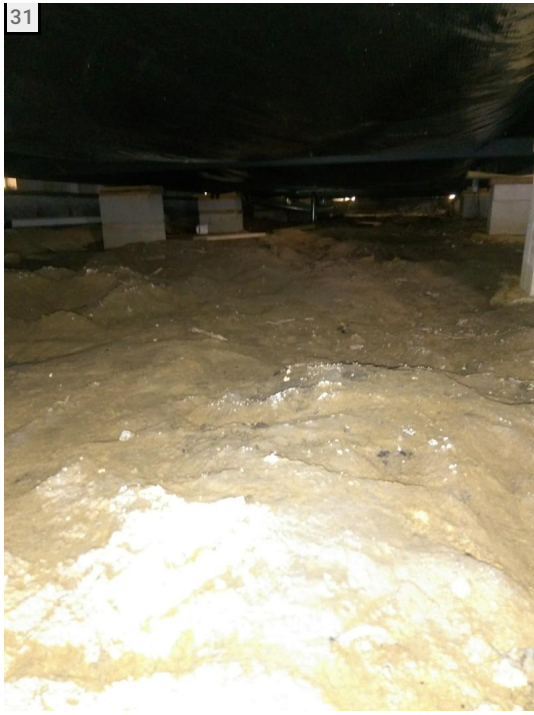
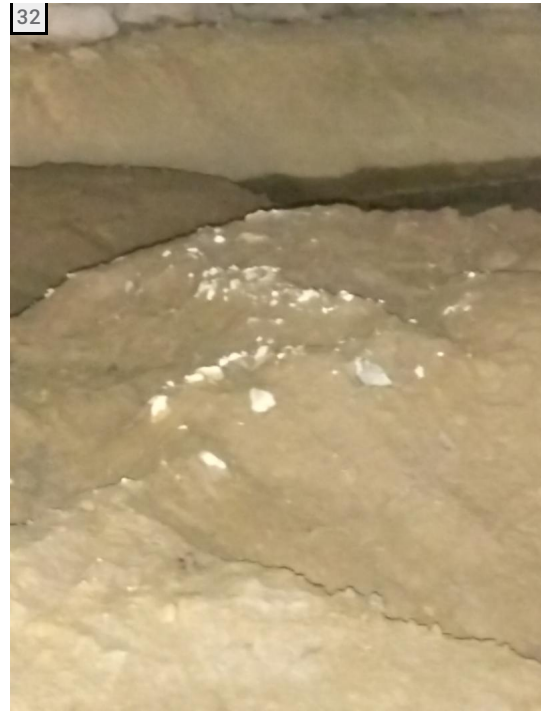
#### Inadequate for the crawl space. There is mold/fungis growing in the crawlspace.

Location	Crawl Space
Impact	Without proper ventilation, moisture will build up in the crawl space. Moist or wet wood is considered to be a conducive condition for wood rot
Suggested Action	The source of the excessive moisture should be determined and fixed. Have a contractor add ventilation in the most appropriate method for the crawl space.
Other Information	The foundation area should be liberally ventilated. Three sides of the structure should have venting within three feet of the corners

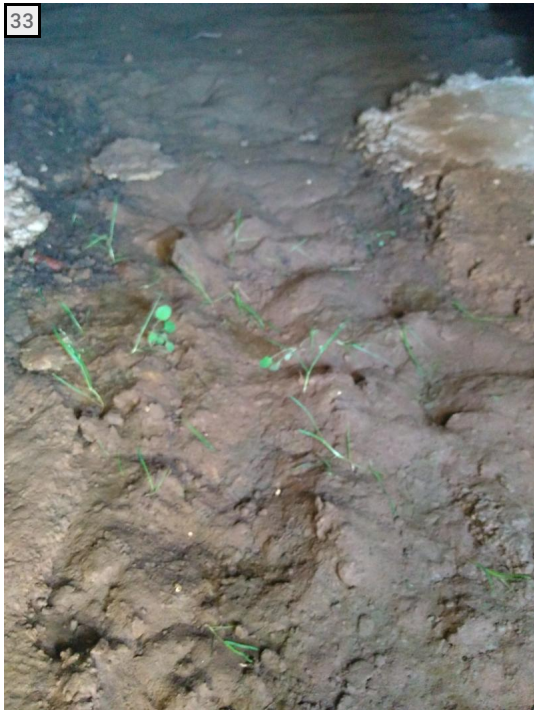
**Damp in crawlspace**

<b>Location</b>	Crawl Space
<b>Impact</b>	If ventilation is insufficient, mold will grow creating an unhealthy environment
<b>Suggested Action</b>	If needed, add vents or prevent moisture from entering crawlspace

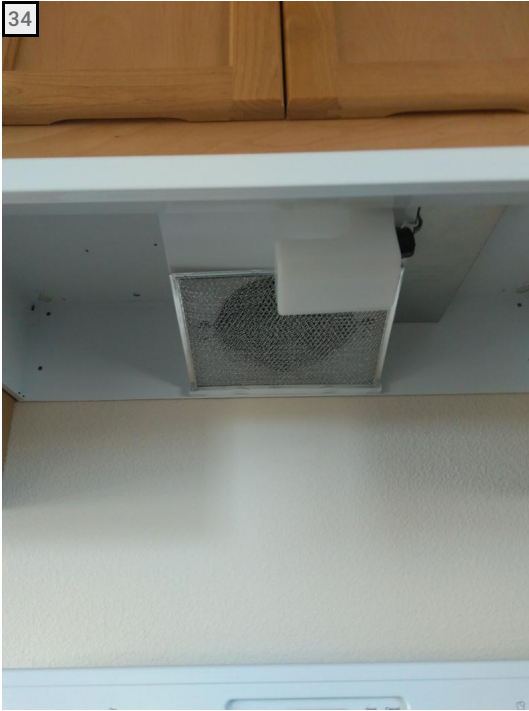
**Light bulb is missing/burnt out**

Location Kitchen

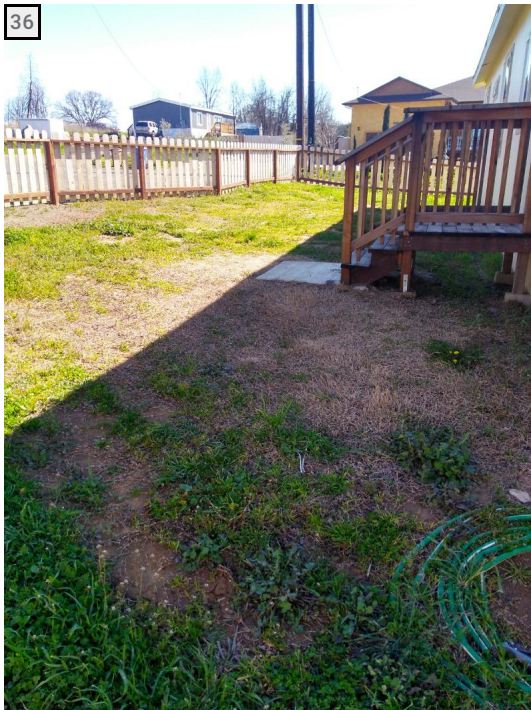
#### Does not have a positive grade

<b>Location</b>	Exterior: Ground View
<b>Impact</b>	Directing more moisture towards the foundation increases the risk of moisture intrusion
<b>Suggested Action</b>	Monitor the area for moisture buildup. Should it arise, If possible, regrading the area to achieve a slope away from the home. If regrading is not possible, add drain tile to re-direct water away from the home. Also, consult with a licensed waterproo (...)
<b>Other Information</b>	Water should be directed away from all standing foundations to prevent potential water intrusion. The drainage strategy of the foundation is important. Expansive soils can be very destructive to the foundation if the moisture content of the perimeter varies

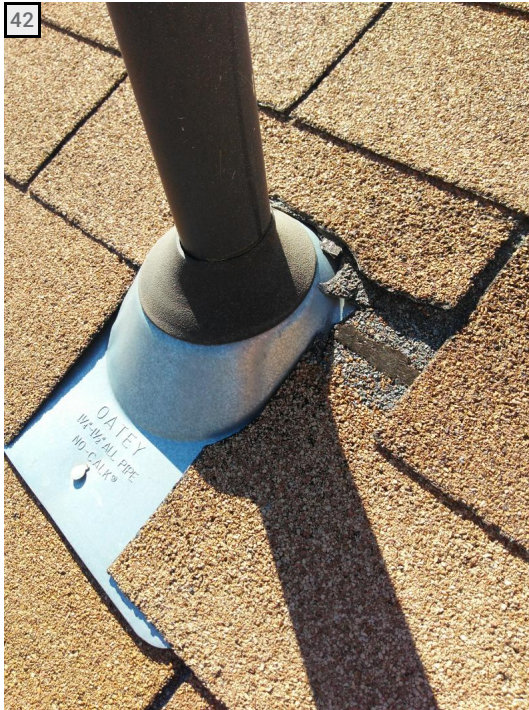
**Exposed nail head**

Location Exterior: Roof View

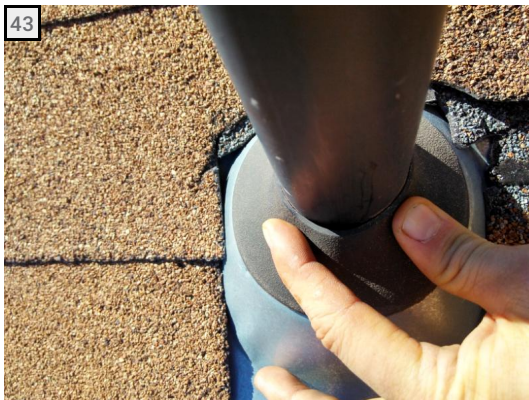
**Rubber boot is loose around vent pipe**

Location Exterior: Roof View

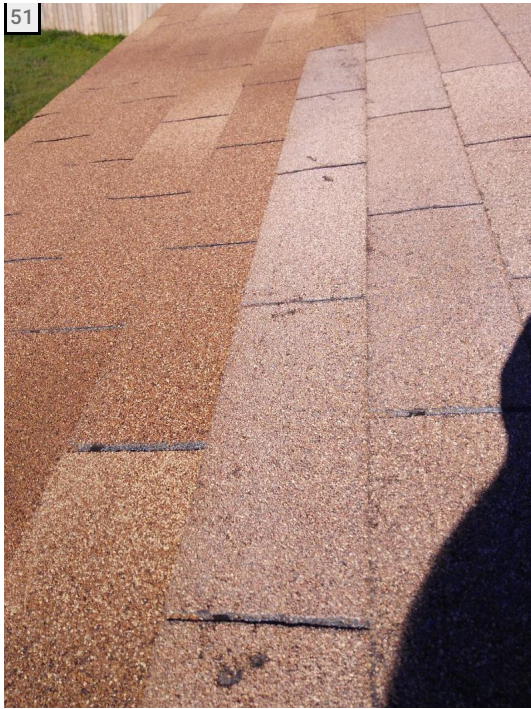
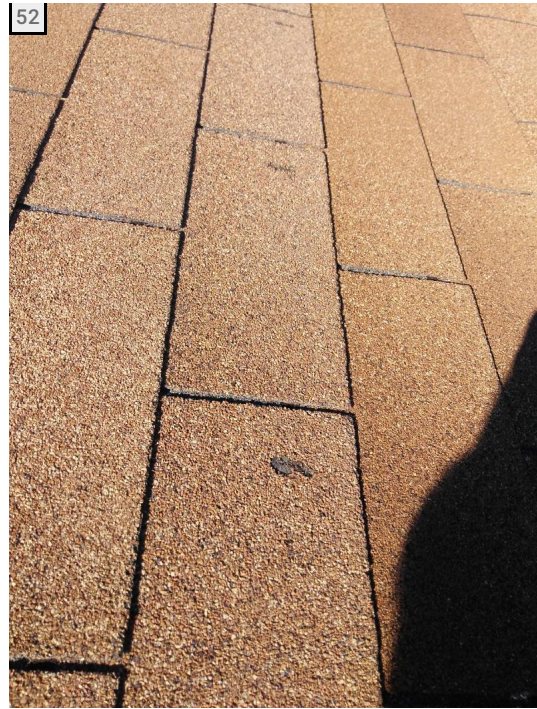
#### Slight damage

Location	Exterior: Roof View
Impact	Could leak before end of roofs life
Suggested Action	Monitor and repair if necessary.

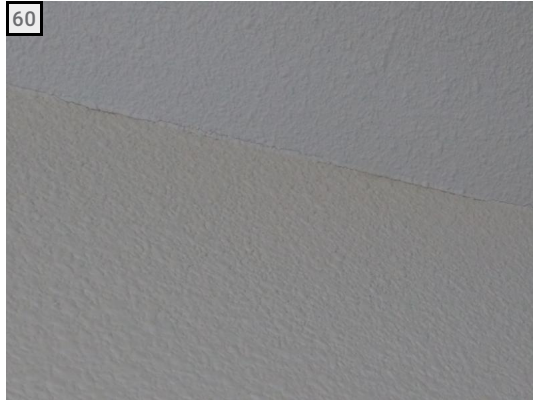
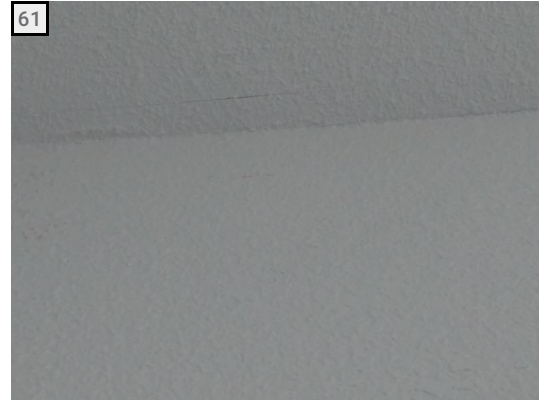
**Drywall crack**

Location	Living Room (Front room living room)
Impact	C
Suggested Action	Have repaired by a qualified contractor

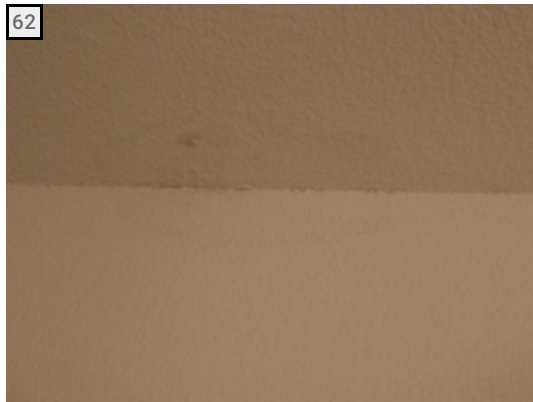
**Ceiling has current water damage. White mold is growing.**

Location	1st Bathroom
Impact	Will worsen over time if leak is not fixed
Suggested Action	Find and fix leak. Replace drywall that has been damaged.

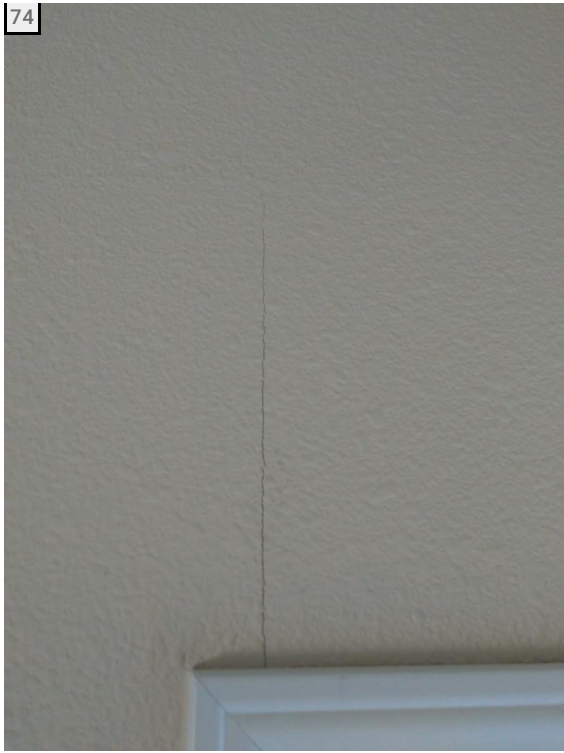
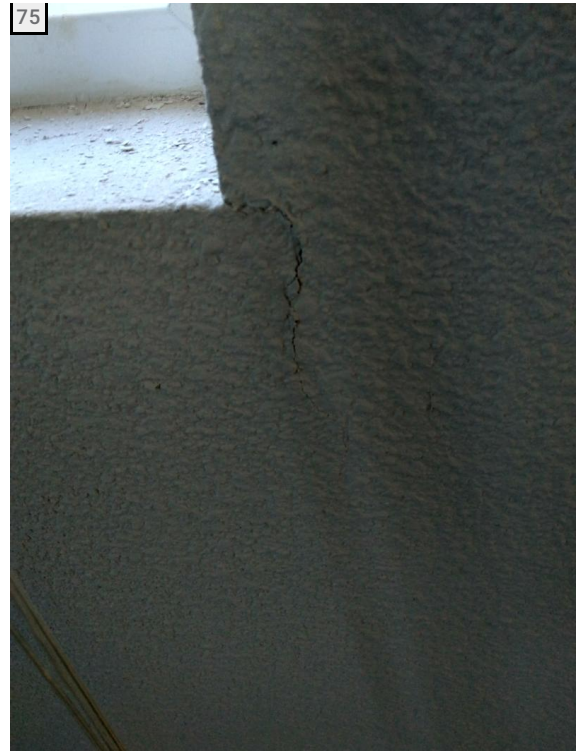
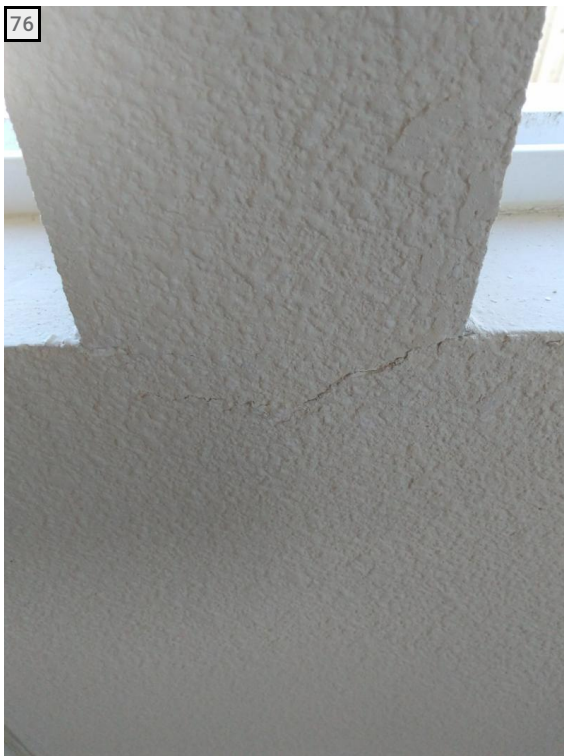
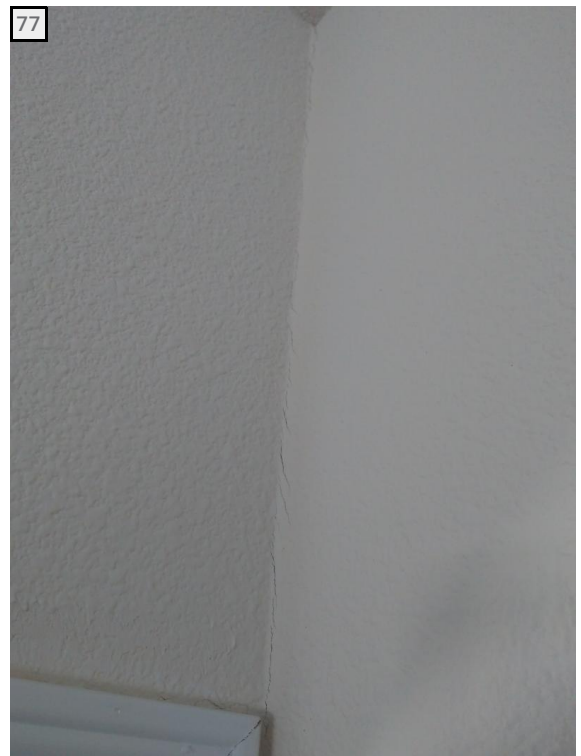
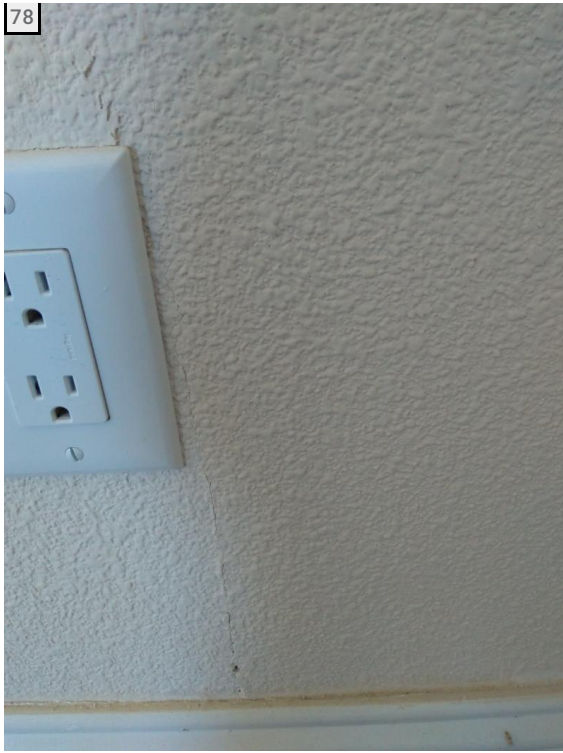
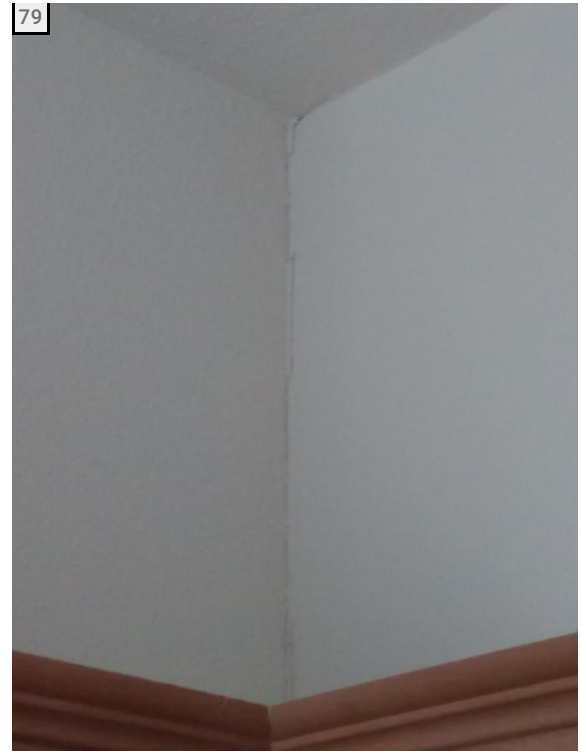
### Drywall crack

<b>Location</b>	Hallway and Stairs, Kitchen, Living Room (Front room living room), 1st Bathroom, 1st Bedroom (Spare bedroom, center of home bedroom), 2nd Bedroom (Master bedroom, east side of house bedroom)
<b>Impact</b>	Should be monitored. Could indicate settling foundation or weak framing if crack grows.
<b>Suggested Action</b>	Have repaired by a qualified contractor
<b>Other Information</b>	Drywall cracks are expected when setting a mobile home. In this situation the cracks can normally be considered cosmetic.
