Inspection Report

111 11th Street, Lake County, California 11111

July 7, 2018 Inspector Keith Henry 707.354.4472 keithrhenry22@gmail.com

Henry Home Inspections

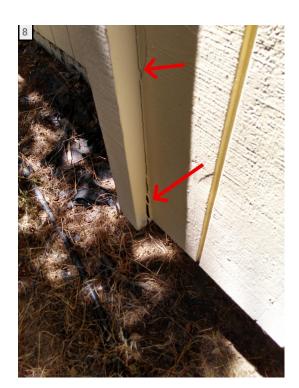
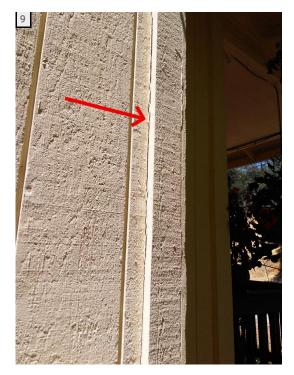
Caulk has aged leaving holes or gaps

Location Exterior: Ground View

Impact The gaps could allow for moisture and insect intrusion which may cause

cause damage to the wood over time

Suggested Action Repair the caulking

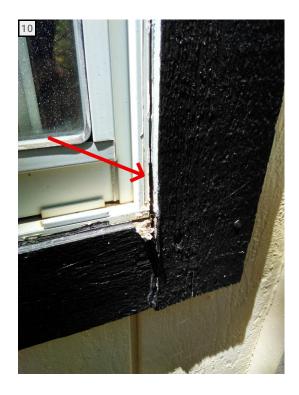
Cracked caulking around windows

Location Exterior: Ground View

Impact The gaps could allow for moisture and insect intrusion which may cause

cause damage to the wood over time

Suggested Action Repair the caulking

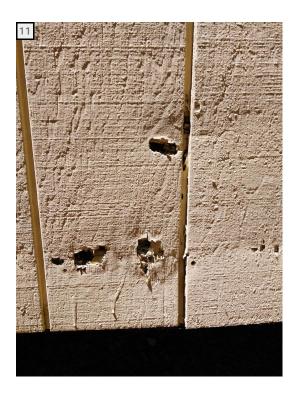
Siding is rotted

Location Exterior: Ground View

Impact Allows water and mold damage inside of home. Damage could be from

moisture or pests

Other Information Siding should be at least 6 inches up from ground or roof surface

Suggested Action Have a professional siding contractor repair the siding

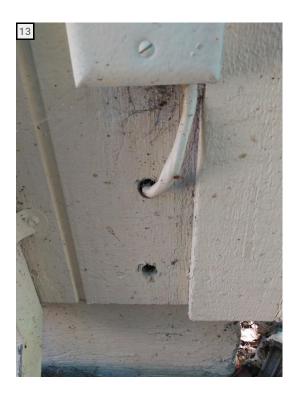
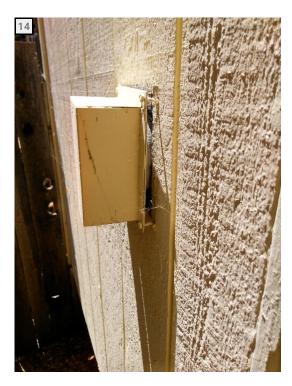
Hole in siding.

Location Exterior: Ground View

Impact Water and pests may enter home

Suggested Action Should be sealed

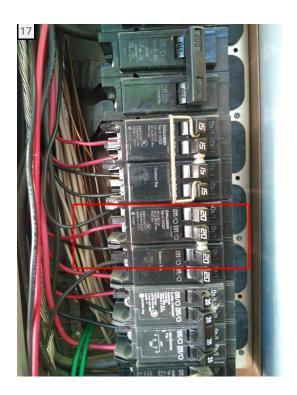
Improper wire gauge/ breaker amerage

Location Exterior: Ground View Overheating could occur

Suggested Action Have evaluated by licensed electrician

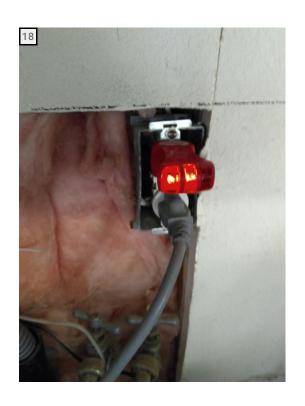
Cover is missing

Location Attached Garage

Impact Without a cover plate, can cause electrical shock if touched

Suggested Action Install a cover

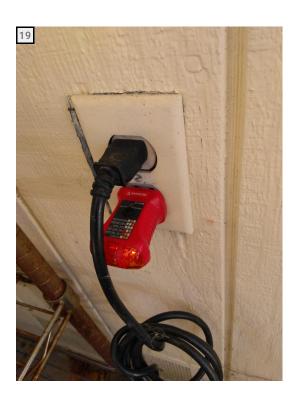
Weatherproof cover is missing

Location Exterior: Ground View Without a cover, the receptacle is a shock hazard Suggested Action Add a weatherproof cover to the GFCI receptacle

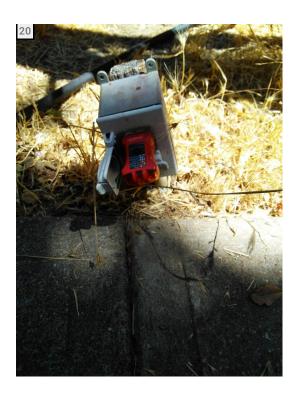
No power

Location Exterior: Ground View

Suggested Action Have repaired by a licensed electrical technician

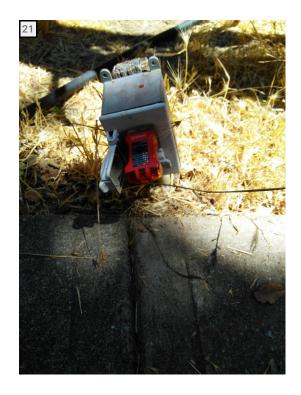
Junction box is loose

Location Exterior: Ground View

Impact Could break and cause electrocution
Suggested Action Have repaired by a licensed electrician

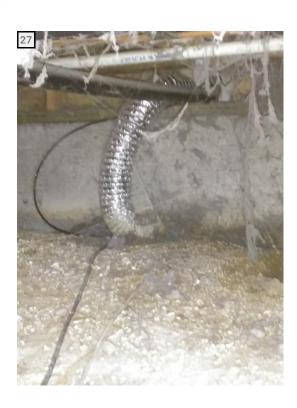
Dryer vent doesn't terminate outside

Location Crawl Space

Impact Add moisture to crawlspace, build up of lint could be fire hazard

Suggested Action Vent to exterior

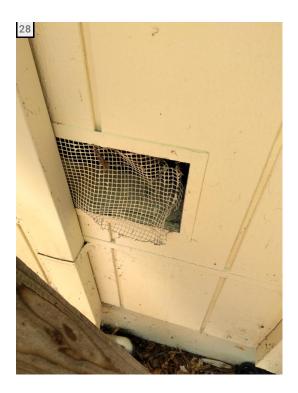
Screen is broken

Location Exterior: Ground View

Impact Allows animals to enter crawlspace

Suggested Action Repair screen

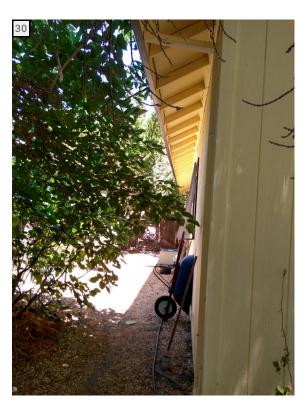
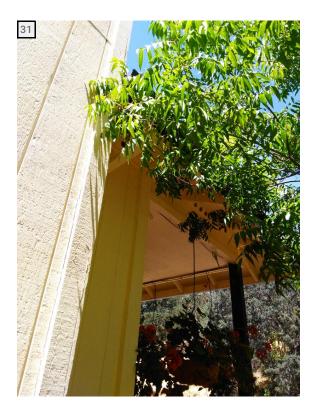
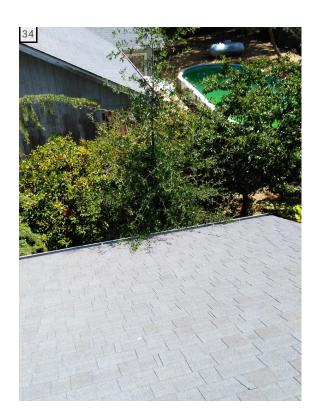
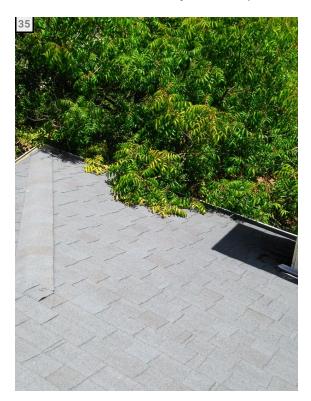
Tree branches are in contact with building

Location Exterior: Ground View, Exterior: Roof View

Impact The tree branches provide an environment where moisture and/or insects

could intrude and also may cause damage or excess wear to the siding or

roofing material

Suggested Action Regularly trim the trees to achieve a clearance of at least 6 - 8 feet

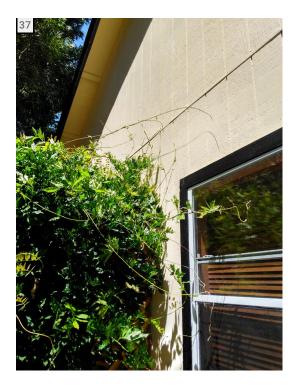
Ivy growth on exterior walls

Location Exterior: Ground View

Impact The ivy could cause deterioration to siding and potential of insect infiltration Suggested Action Remove the ivy

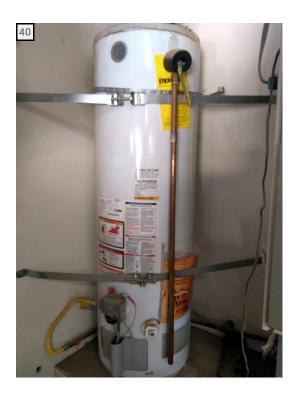
Insufficient seismic straps

Location Attached Garage

Impact Water heaters that are not property secured may fall over in the event of an

earthquake, rupturing rigid water and gas connections

Suggested Action Have straps properly installed. Building code states that two metal straps

must wrap all the way around and be secured to wall.

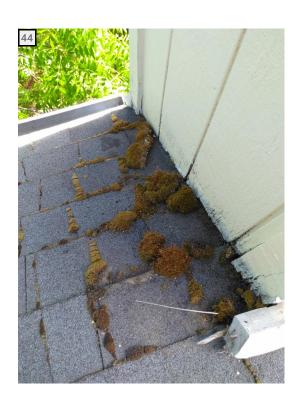
Has excessive moss build-up

Location Exterior: Roof View

Impact In extreme cases, the moss will grow under the shingles damaging the

underlying sheathing

Suggested Action If possible, remove or cut back any trees that may be causing excessive

shade. To remove the existing moss, use a roof cleaner targeted at moss growth to adjust the PH level below that which moss flourishes (e.g. Spray

and Forget)

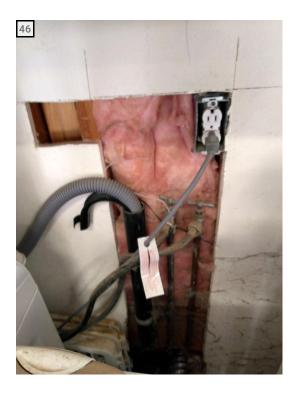
Damaged

Location Attached Garage

Impact Should a fire ignite in the garage, the fire will spread more quicky to the

living areas of the home

Suggested Action Repair the damaged areas with fire-resistant material, such as drywall Other Information The firewall is intended to slow the spread of fire from the garage to the

living space

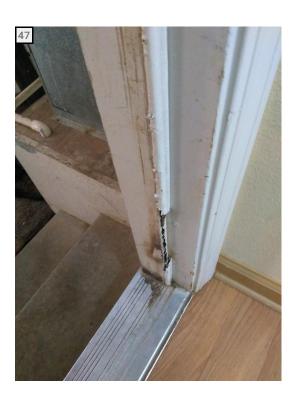
Door seal is missing/damaged

Location Attached Garage Impact Exhaust fumes from garage can enter living area

Suggested Action Have weather seal installed on door

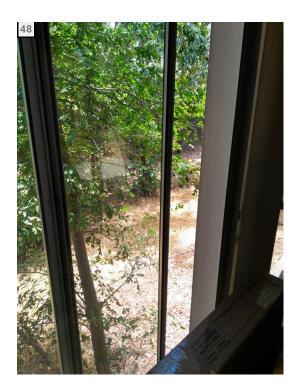
Missing/not installed

Location Kitchen

Should the window be open, lacks protection from insects

Suggested Action Consult with seller to identify if screens exist. If they do not, install screens

as needed

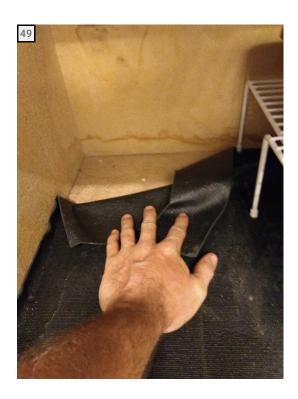
Shows signs of water damage or stains

Location 1st Bathroom (Master bath bathroom)

Impact If leak is still active, it must be fixed before any cosmetic repairs are made

Suggested Action Replace the vanity as desired

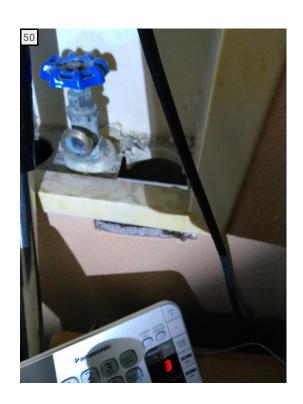
Hole in wall

Location Hallway and Stairs

Impact Reduces insulation and could allow rodents to enter home

Suggested Action Have hole covered by a professional
