# RSH ENGINEERING, INC.

**PRE-POUR #2 INSPECTION REPORT**

**INSP#: S08156**

**Address: 1234 Anywhere St, Anywhere, TX**

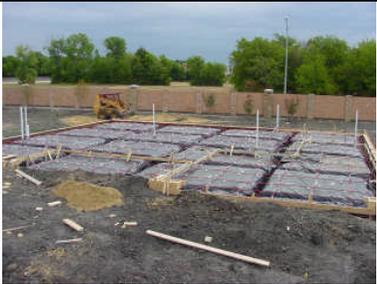
<p><b>FRONT VIEW OF HOUSE INSPECTED</b>  <b>GENERAL NOTE: SEVERAL PLACES THE TRENCHES HAS CAVED IN. THUS VIOLATING THE 26-INCH MINIMUM DEPTH REQUIREMENT (ONE EXAMPLE IS THE BACK TRENCH). REMOVE SOIL SUCH THAT THE TRENCHES WILL HAVE 26-INCH DEPTH.</b></p>	2

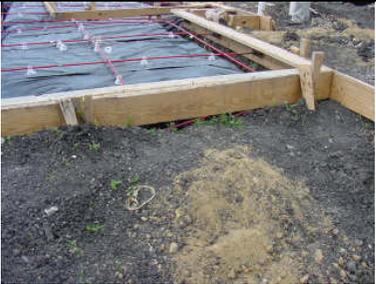
<p><b>LEFT SIDE OF HOUSE:</b>            1. <b>GENERAL NOTE:</b> ADD SOIL TO SUPPORT THE SIDES OF ALL THE FORMS WHERE THERE ARE VOIDS.            2. <b>TO AVOID CAVES</b> INS IT WILL BE NECESSARY TO INSTALL ADDITIONAL FORMS BELOW THE EXISTING FORMS AND DIAGONAL BRACING AND STAKES ALL AROUND WHERE THERE ARE GAPS BETWEEN FORMS AND SOIL</p>	4

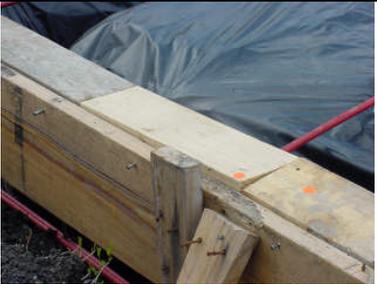
<p><b>LEFT SIDE OF HOUSE:</b>            1. ROUGH BRICK LEDGE - PROVIDE A SINGLE PIECE 2x4 MEMBER RATHER THAN SEVERAL PIECES TOE NAILED TO EACH OTHER.            2. BRICK LEDGE NOT LEVEL ALL AROUND - MANY PLACES IT IS NEGATIVELY SLOPED TOWARD THE HOUSE.</p>

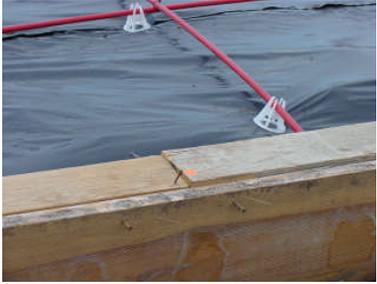
<p><b>LEFT SIDE OF HOUSE:</b>            1. ROUGH BRICK LEDGE PROVIDE A SINGLE PIECE 2x 4 MEMBERS RATHER THAN SEVERAL PIECES TOE NAILED TO EACH OTHER.            2. BRICK LEDGE NOT LEVEL ALL AROUND - MANY PLACES IT IS NEGATIVELY SLOPED TOWARD THE HOUSE.</p>	6

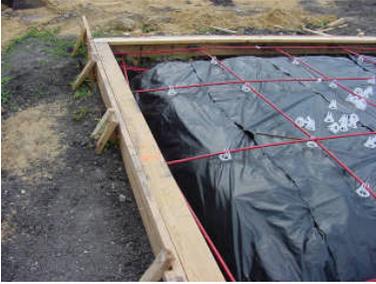
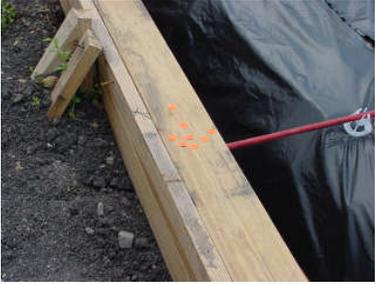
<p><b>LEFT SIDE OF HOUSE:</b>            LEFT REAR CORNER OF SLAB WILL BE HIGH. A LASER LEVEL WAS USED TO CHECK THE LEVEL OF THE FORM - HERE THE FORM WAS OFF LEVEL.</p>	7

<p><b>LEFT SIDE OF HOUSE:</b>            CLOSE-UP OF PIC. # 6. THE ARROW SHOWS THE DIRECTION OF THE SLOPE.</p>	8

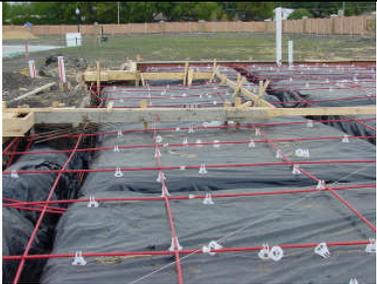
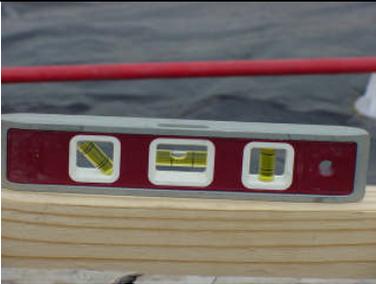
<p><b>FRONT SIDE OF HOUSE:</b> FORM NOT LEVEL. CORRECT FORM SUCH THAT IT IS LEVEL – SEE NEXT PICTURE FOR A VIEW OF THE LEVEL BUBBLE.</p>	10

<p><b>FRONT SIDE OF HOUSE:</b> CLOSE-UP OF PIC. # 9.</p>	11

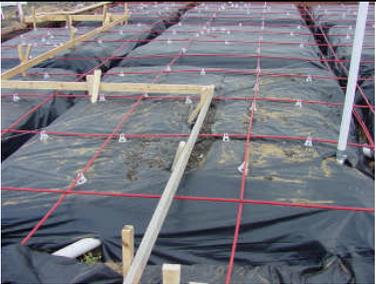
<p><b>FRONT SIDE OF HOUSE:</b> VAPOR BARRIER DAMAGED. - REPAIR AND OVERLAP THE VAPOR BARRIER PROPERLY AND SEAL WITH TAPE SUCH THAT NO SAND IS VISIBLE.</p>	12

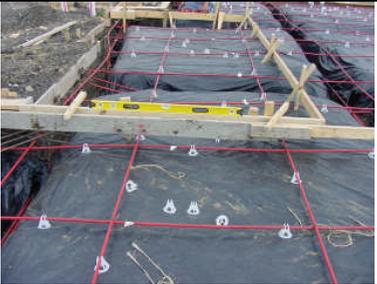
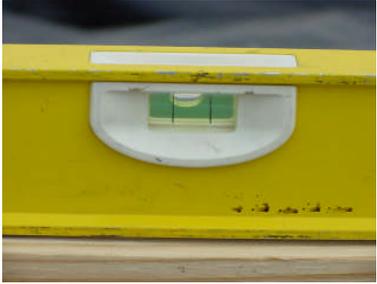
<p><b>FRONT SIDE OF HOUSE:</b> FORM NOT LEVEL. CORRECT FORM SUCH THAT IT IS LEVEL – SEE NEXT PICTURE FOR A VIEW OF THE LEVEL BUBBLE.</p>
13

<p><b>FRONT SIDE OF HOUSE:</b> CLOSE-UP OF PIC. # 12</p>	14

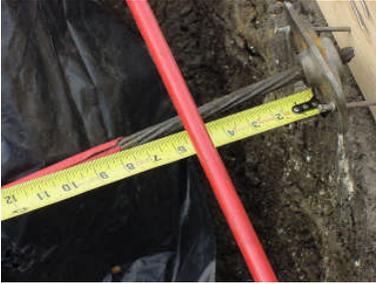
<p><b>FRONT SIDE OF HOUSE:</b> GENERAL NOTE: MOST OF THE ENDS OF SLEEVING NOT WITHIN 2 INCHES OF BRACKET. THIS IS IN VIOLATION OF THE NOTE FROM THE BUILDER'S FOUNDATION DRAWING. USE TAPE AND/OR SLEEVING TO COVER THE POST TENSION EXPOSED END.</p>	15

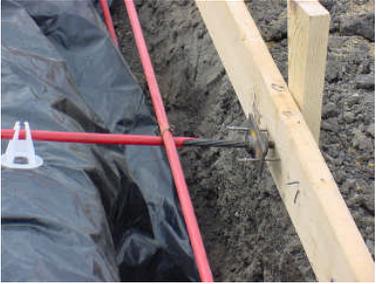
<p><b>FRONT SIDE OF HOUSE:</b> GENERAL NOTE: MOST OF THE ENDS OF SLEEVING NOT WITHIN 2 INCHES OF BRACKET. THIS IS IN VIOLATION OF THE NOTE FROM THE BUILDER'S FOUNDATION DRAWING. USE TAPE AND/OR SLEEVING TO COVER THE POST TENSION EXPOSED END.</p>	16

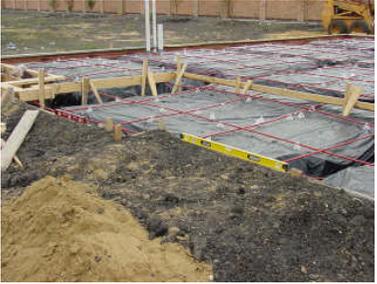
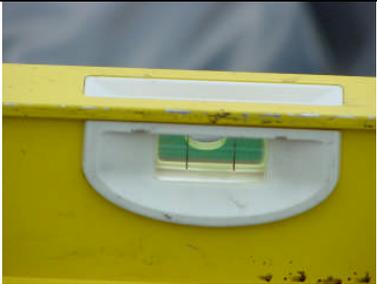
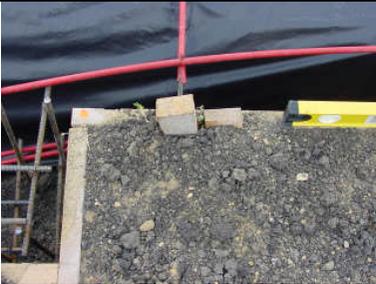
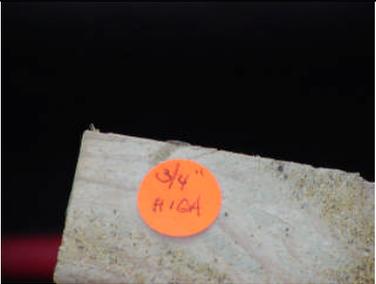
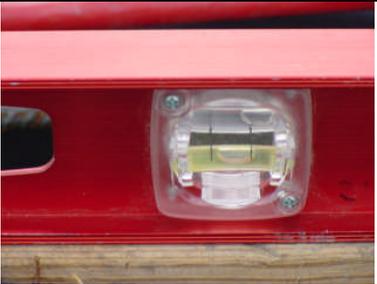
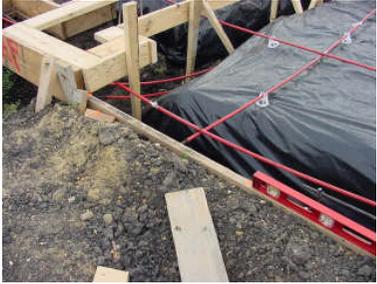
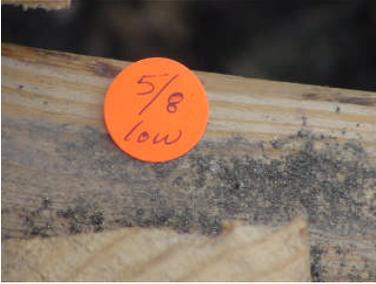
<p><b>FRONT SIDE OF HOUSE:</b> FORM NOT LEVEL. CORRECT FORM SUCH THAT IT IS LEVEL – SEE NEXT PICTURE FOR A VIEW OF THE LEVEL BUBBLE.</p>

<p><b>FRONT SIDE OF HOUSE:</b> CLOSE-UP OF PIC. # 16.</p>	18

<p><b>FRONT SIDE OF HOUSE:</b> CLOSE-UP OF PIC. # 16 THIS END IS 3/4 INCH HIGHER THAN THE OTHER END OF THIS SECTION OF FORM.</p>	19

<p><b>FRONT SIDE OF HOUSE:</b> CLOSE-UP OF PIC. # 16. NOTE SHOWEING THE MEASUREMENT TAKEN</p>	20

<p><b>FRONT SIDE OF HOUSE:</b> CLOSE-UP OF PIC. # 16.CLOSEUP SHOWING THE BUBBLE NOT BETWEEN LINES.</p>
21

<p><b>FRONT SIDE OF HOUSE:</b> CLOSE-UP OF PIC. # 16</p>	22

<p><b>FRONT SIDE OF HOUSE:</b> CLOSE-UP OF PIC. # 16</p>	23

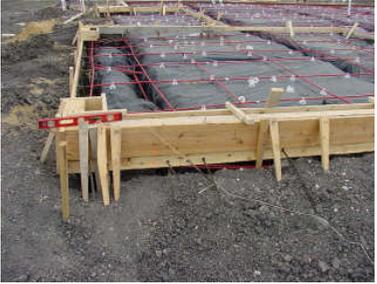
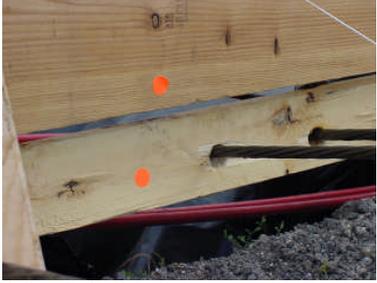
<p><b>RIGHT SIDE OF HOUSE:</b></p> <ol style="list-style-type: none"> <li>1. FORM ARE SEPARATED TOP TO BOTTOM AND SIDE TO SIDE AND ARE NOT FLUSH OR PLUMB.</li> <li>2. USE A SINGLE FORM AND/OR USE MORE STAKES TO PROPERLY SUPPORT BOTH THE TOP AND BOTTOM FORMS (POSITION IT SUCH THAT ALL GAPS ARE ELIMINATED) TO PREVENT MISTAKES AND POSSIBLE SHIFTING DURING THE ACTUAL POUR.</li> </ol>

<p><b>RIGHT SIDE OF HOUSE:</b> CLOSE-UP OF PIC. # 24.</p>	26

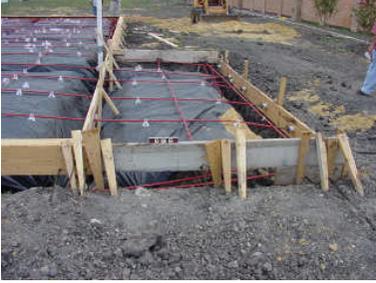
<p><b>RIGHT SIDE OF HOUSE:</b> FORM NOT LEVEL. IT IS WAY OFF LEVEL – CHECK THE LOCATION OF THE BUBBLE ON THE LEVEL.</p>	27

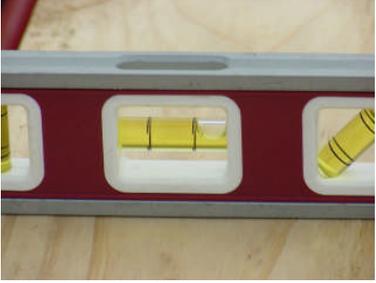
<p><b>RIGHT SIDE OF HOUSE:</b> CLOSE-UP OF PIC. # 27</p>	28

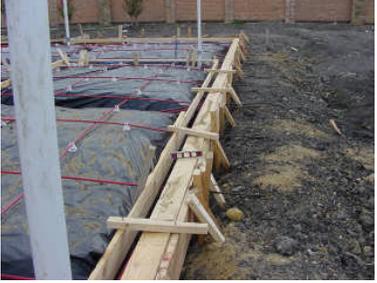
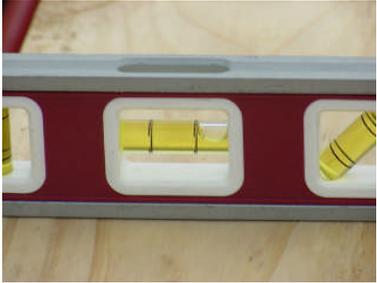
<p><b>RIGHT SIDE OF HOUSE:</b> GENERAL NOTE: BRICK LEDGE NEGATIVELY SLOPED TOWARDS HOUSE. WILL RETAIN SOME WATER IN THE ENVELOPE.</p>
29

<p><b>RIGHT SIDE OF HOUSE:</b> CLOSE-UP OF PIC. # 28.</p>	30

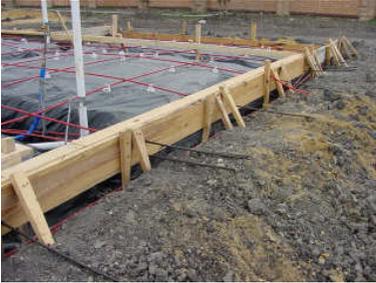
<p><b>RIGHT SIDE OF HOUSE:</b></p> <ol style="list-style-type: none"> <li><b>GENERAL NOTE:</b> ADD SOIL TO SUPPORT THE SIDES OF ALL THE FORMS WHERE THERE ARE VOIDS.</li> <li><b>TO AVOID CAVE-INS</b> IT WILL BE NECESSARY TO INSTALL ADDITIONAL FORMS BELOW THE EXISTING FORMS AND DIAGONAL BRACING ALL AROUND WHERE THERE ARE GAPS BETWEEN FORMS AND SOIL</li> </ol>	31

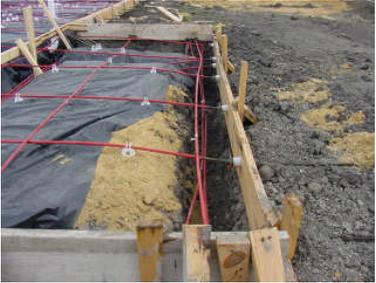
<p><b>RIGHT SIDE OF HOUSE:</b></p> <ol style="list-style-type: none"> <li>VAPOR BARRIER COVERAGE INADEQUATE.</li> <li>GENERAL NOTE: SEVERAL PLACE THE TRENCHES CAVED IN. THUS VIOLATING THE 26-INCH MINIMUM DEPTH. REMOVE SOIL SUCH THAT THE TRENCHES WILL HAVE 26-INCH DEPTH.</li> </ol>	32

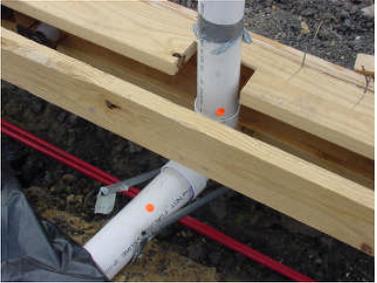
<p><b>RIGHT SIDE OF HOUSE:</b> DRAIN PIPE NOT SECURED. INADEQUATE PRIMER AT PVC JOINT.</p>

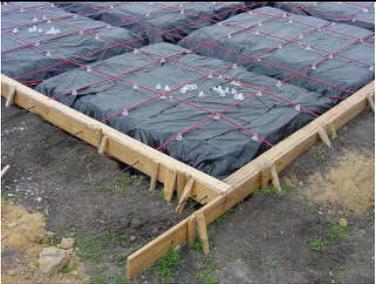
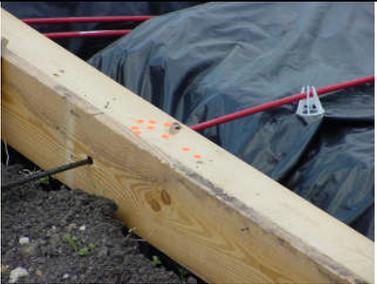
<p><b>BACK SIDE OF HOUSE:</b> LEFT REAR CORNER OF SLAB IS HIGH</p>	36

<p><b>BACK SIDE OF HOUSE:</b> CLOSE-UP OF PIC. # 35.</p>
37

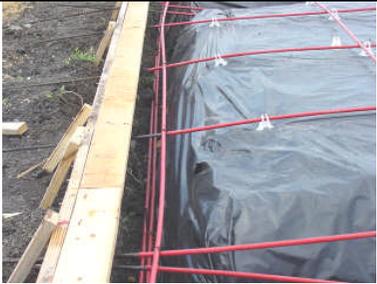
<p><b>BACK SIDE OF HOUSE:</b> TRENCHES CAVED IN.</p>	38

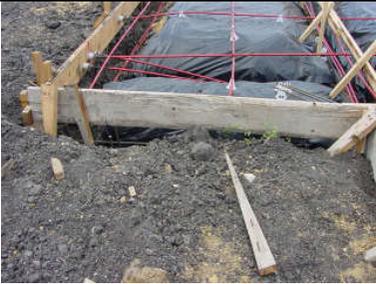
<p><b>BACK SIDE OF HOUSE:</b></p> <ol style="list-style-type: none"> <li><b>GENERAL NOTE:</b> ADD SOIL TO SUPPORT THE SIDES OF ALL THE FORMS WHERE THERE ARE VOIDS.</li> <li><b>TO AVOID CAVES:</b> IT WILL BE NECESSARY TO INSTALL ADDITIONAL FORMS BELOW THE EXISTING FORMS AND DIAGONAL BRACING ALL AROUND WHERE THERE ARE GAPS BETWEEN FORMS AND SOIL</li> </ol>	39	<p>NOTE: THIS SLAB DESIGN REQUIRES THAT TOOL JOINTS BE PLACED/LOCATED IN BRICK VENEER @ 20-FT. SEE PAGE # 6</p>	40	<p>THE TRENCH PER DRAWING SHOULD BE LOCATED AT 13-FEET 6-INCHES. THE TRENCH WAS LOCATED AT 12-FEET 2 INCHES FROM END. HAVE THE FOUNDATION ENGINEER EVALUATE THIS AND RECOMMEND REPAIR. RSH ENGINEERING, INC. RECOMMENDS THAT THE TRENCH BE WIDENED TO MEET THE REQUIREMENTS. SEE PAGE # 7</p>

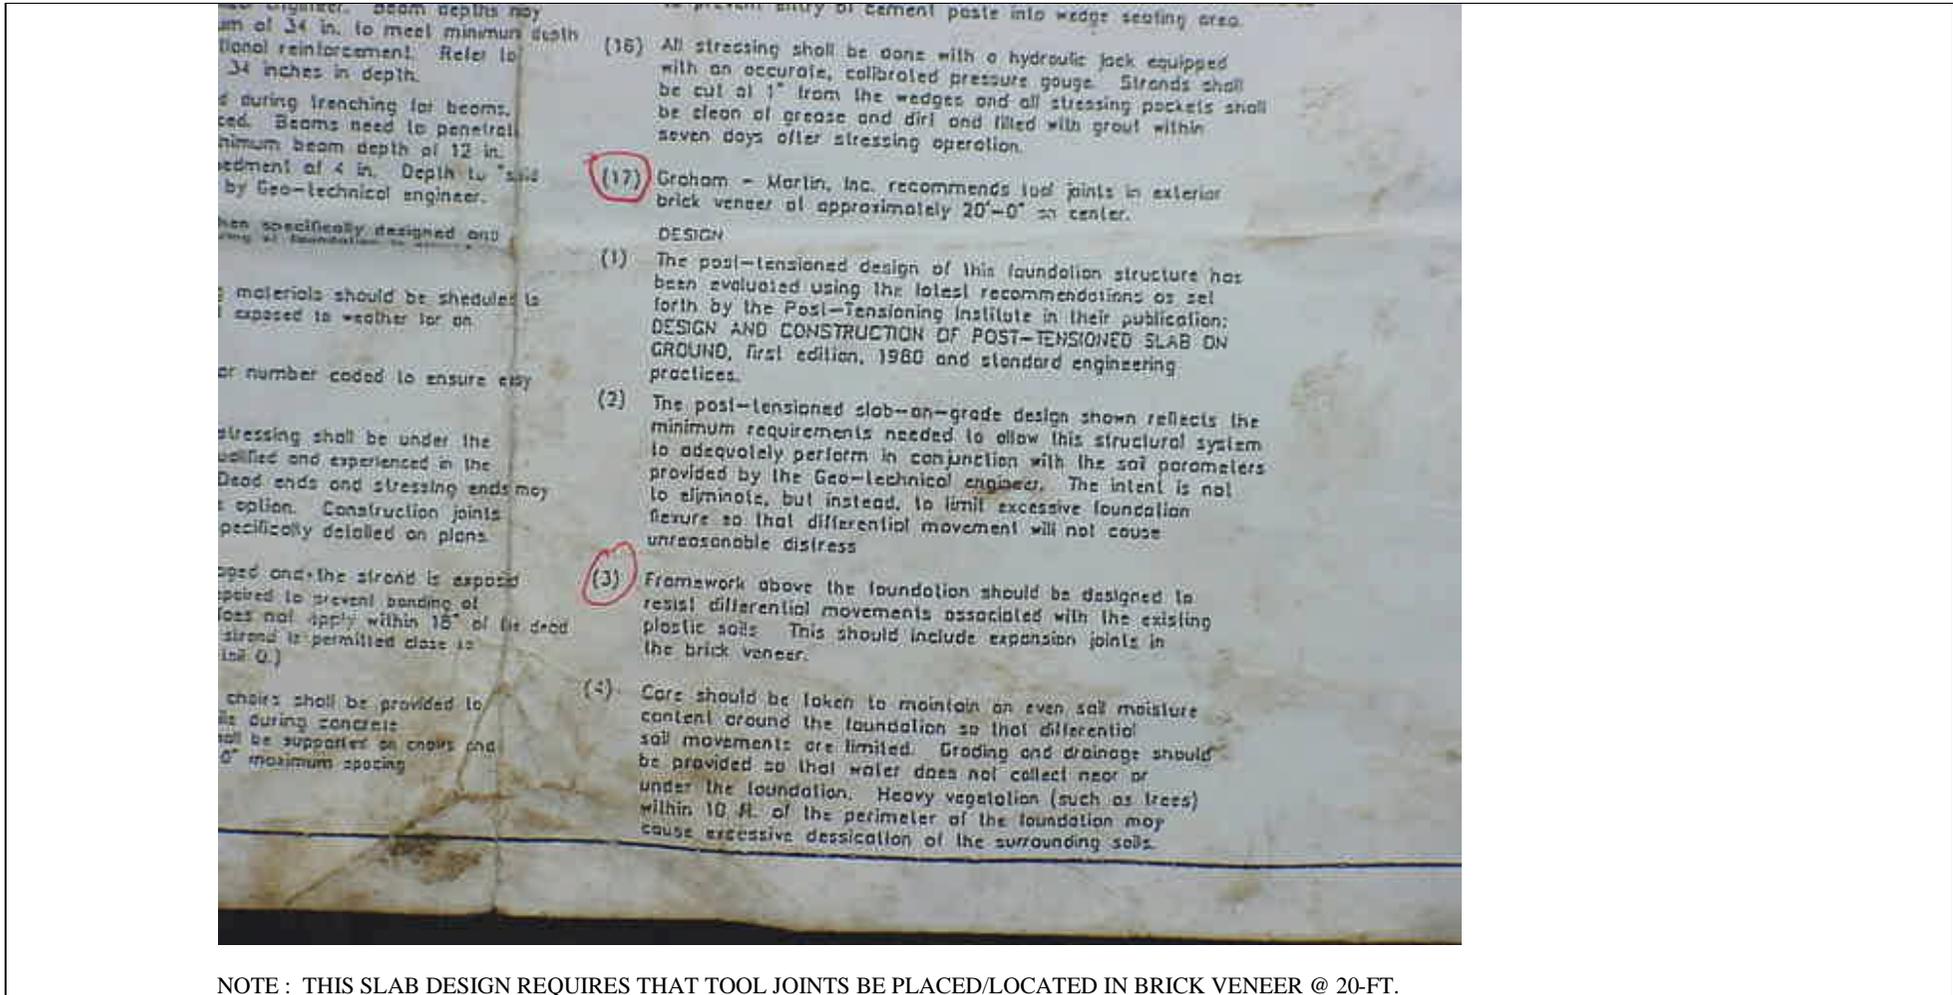
NOTE : THIS SLAB DESIGN REQUIRES THAT TOOL JOINTS BE PLACED/LOCATED IN BRICK VENEER @ 20-FT.

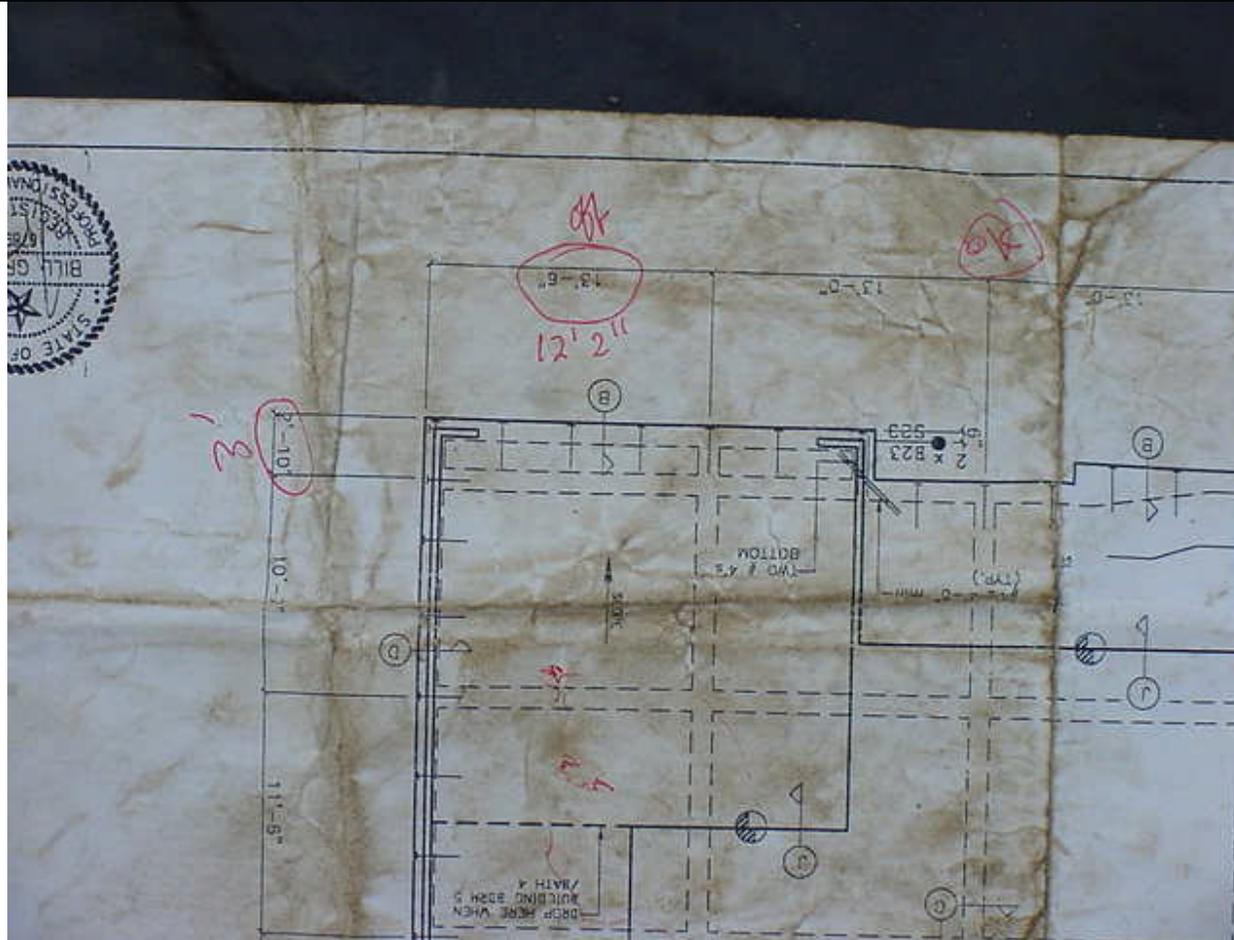
THE TRENCH PER DRAWING SHOULD BE LOCATED AT 13-FEET 6-INCHES. THE TRENCH WAS LOCATED AT 12-FEET 2 INCHES FROM END. HAVE THE FOUNDATION ENGINEER EVALUATE THIS AND RECOMMEND REPAIR. RSH ENGINEERING, INC. RECOMMENDS THAT THE TRENCH BE WIDENED TO MEET THE REQUIREMENTS.
