RSH ENGINEERING, INC.

END OF BUILDERS WARRANTY INSPECTION REPORT

INSP#: K00001

Owner: A.B. Henry

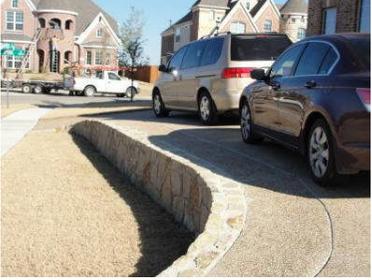
<p>FRONT SIDE OF HOUSE: RECOMMEND INSTALLING RAILING ALONG THE RETAINING WALL TO PREVENT ACCIDENTS. ONE COULD UNKNOWINGLY PARK TOO CLOSE TO THE EDGE AND FALL WHEN EXITING THE VEHICLE OR ONE COULD LOSE BALANCE WHEN EXITING AND FALL.</p>
13

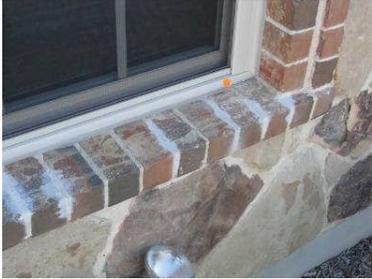
<p>FRONT SIDE OF HOUSE: GENERAL NOTE: THE CAULKING AROUND DOORS AND WINDOWS THROUGHOUT THE HOUSE IS CRACKING. IT SEEMS THE CAULKING MAY HAVE BEEN FROZEN AT SOME POINT IN TIME PRIOR TO USE OR THAT IT MAY BE POOR QUALITY CAULKING. RE-CAULK ALL DOORS AND WINDOW FRAME / BRICK INTERFACES WHERE THE CAULKING HAS CRACKED.</p>	14

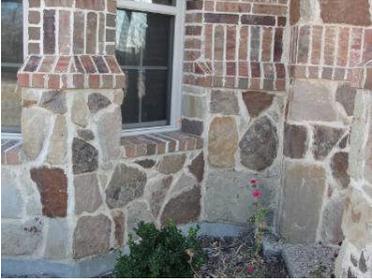
<p>FRONT SIDE OF HOUSE: SEE NOTES AT PIC. # 13.</p>	15

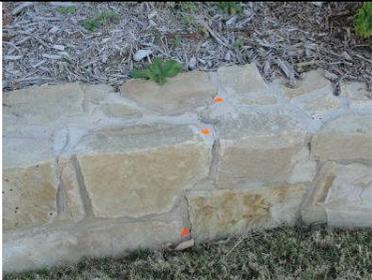
<p>FRONT SIDE OF HOUSE: MORTAR CRACK BETWEEN THE STONES OF THE RETAINING WALL.</p>	18

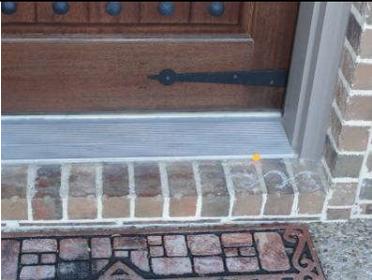
<p>FRONT SIDE OF HOUSE: THERE EXISTS A VOID IN THE CAULKING OF THE THRESHOLD.</p>	19

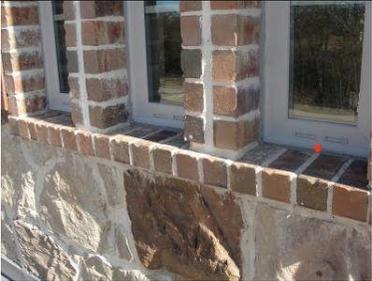
<p>FRONT SIDE OF HOUSE: CLOSE-UP OF PIC. # 22. GENERAL NOTE: THE CAULKING AROUND DOORS AND WINDOWS THROUGHOUT THE HOUSE IS CRACKING.</p>	24

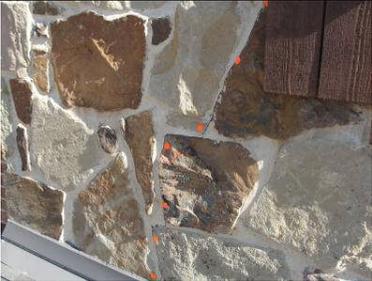
<p>FRONT SIDE OF HOUSE: CLOSE-UP OF PIC. # 22. MORTAR CRACK BETWEEN THE STONES.</p>

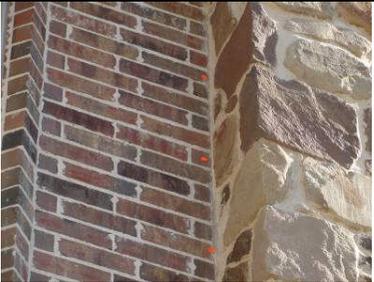
FRONT SIDE OF HOUSE: CLOSE-UP OF PIC. # 26. FILL/ SEAL THE MORTAR VOIDS/CRACKS WITH MORTAR.	28

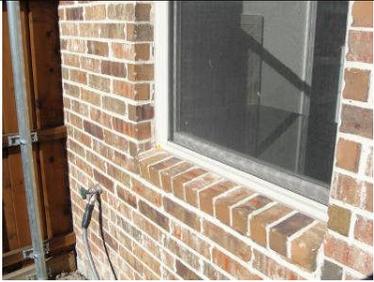
RIGHT SIDE OF HOUSE: GENERAL NOTE: THE CAULKING AROUND DOORS AND WINDOWS THROUGHOUT THE HOUSE IS CRACKING.	30

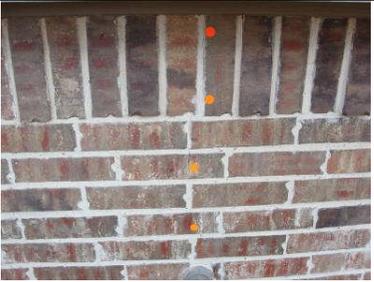
RIGHT SIDE OF HOUSE: CLOSE-UP OF PIC. # 30. BRICKS AND MORTAR CRACKS BELOW THE WINDOW FROM THE WINDOW TO THE SLAB.	32

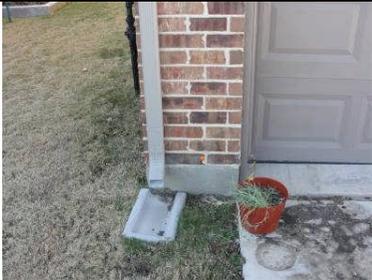
<p>BACK SIDE OF HOUSE: WEEP HOLES MISSING – ADD WEEP HOLES. WEEP HOLES SHOULD BE LOCATED AT THE FIRST COURSE ABOVE THE FOUNDATION WALL OR SLAB, AND OTHER POINTS OF SUPPORT, INCLUDING STRUCTURAL FLOORS, SHELF ANGLES AND LINTELS 2006 INTERNATIONAL RESIDENTIAL CODE SECTION 703.7.5.</p>	38

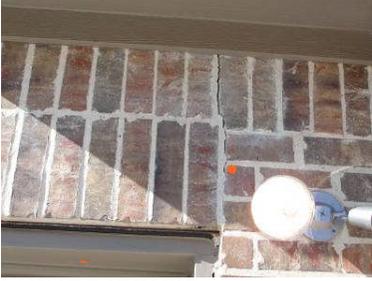
<p>BACK SIDE OF HOUSE: THE BOWED LINTEL HAS RESULTED IN CRACKS IN THE BRICK AND THE MORTAR BETWEEN THE BRICKS.</p>	43

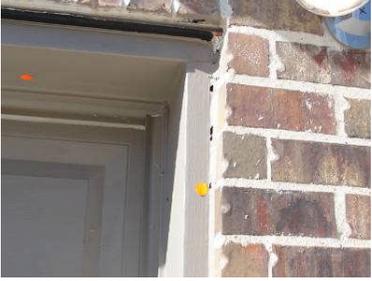
<p>BACK SIDE OF HOUSE: SEPARATION OF THE DOOR FRAME AND BRICKS HAS RESULTED IN VOIDS IN THE CAULKING.</p>	44

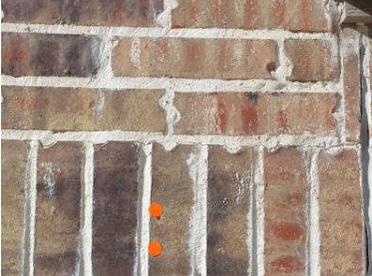
BACK SIDE OF HOUSE: CLOSE-UP OF PIC. # 45. THE BOWED LINTEL HAS RESULTED IN A HORIZONTAL CRACK BETWEEN THE SOLDIER COURSE AND THE COURSE ABOVE IT.	47

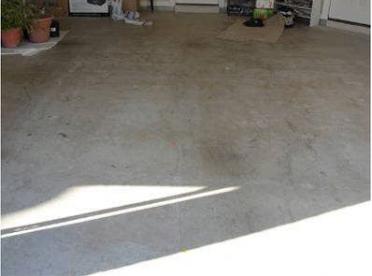
BACK SIDE OF HOUSE: SURFACE CRACK(S) IN GARAGE SLAB
49

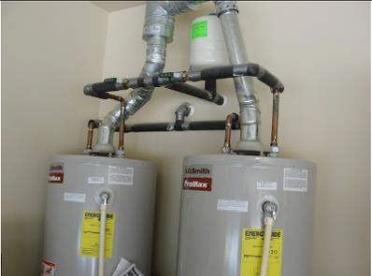
BACK SIDE OF HOUSE: INSULATION MISSING AT WATER PIPES ABOVE THE WATER HEATER. INSULATE THESE PIPES ACCORDING TO THE WATER HEATER INSTALLATION INSTRUCTIONS.	52

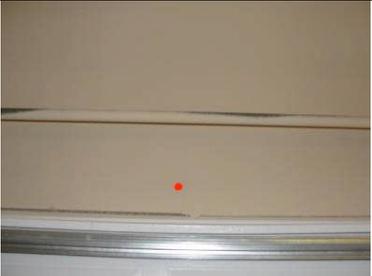
BACK SIDE OF HOUSE: DRYWALL CRACK ABOVE THE GARAGE DOOR OPPOSITE THE MORTAR AND BRICK CRACKS OUTSIDE. THIS IS DIRECTLY BELOW THE WALL ABOVE. THERE MAY BE A LOAD TRANSFER FAULT CAUSING THE DRYWALL CRACK AND MORTAR AND BRICK CRACKS.

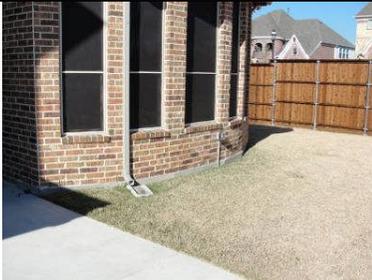
<p>BACK SIDE OF HOUSE: LOW SPOT/NEGATIVE SLOPE AREA TOWARDS THE HOUSE WHERE WATER PONDS. GENERAL NOTE: AT ALL FLAT/LOW/NEGATIVE SLOPED AREAS GRADE SURFACE AWAY FROM THE FOUNDATION MINIMUM 6.0-INCHES DROP IN 10- FEET (2006 INTERNATIONAL RESIDENTIAL CODE # 401.3)</p>	54

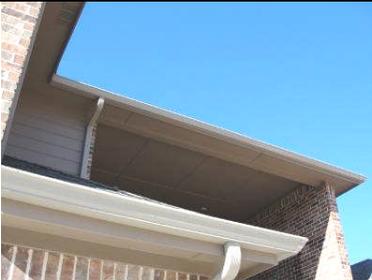
<p>BACK SIDE OF HOUSE: GENERAL NOTE: SOFFIT VENTS ARE MISSING – ADD SOFFIT VENTS. PROVIDE ADEQUATE # OF SOFFIT VENTS TO MEET THE NET FREE VENT OPENINGS OF 1/300 (IF VAPOR BARRIER IS PRESENT) OR 1/150 (IF VAPOR BARRIER IS NOT PRESENT). 2006 INTERNATIONAL RESIDENTIAL CODE # 806.1& # 806. 2.</p>	55

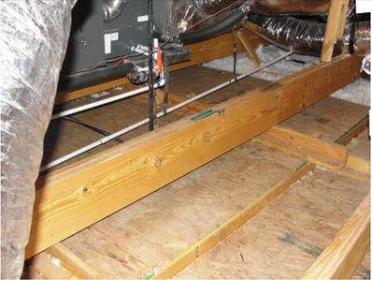
<p>ATTIC: DIAGONAL BRACES MISSING FOR THE FLOATING LOAD BEAM. THIS BEAM MOVES EXCESSIVELY WHEN HAND PRESSURE IS APPLIED TO IT.</p>

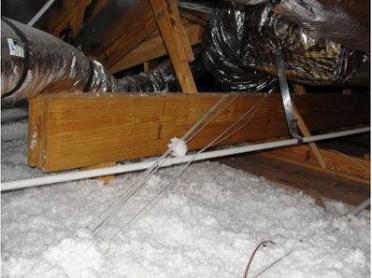
<p>ATTIC: DIAGONAL BRACES MISSING FOR THE FLOATING LOAD BEAM</p>
65

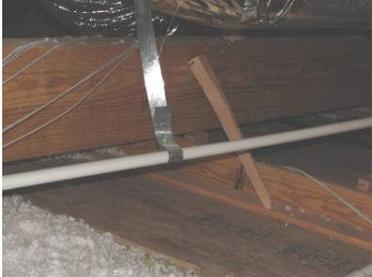
<p>ATTIC: CLOSE-UP OF PIC. # 64. THE DIAGONAL BRACE FOR THE LOAD BEAM IS SPLIT AND NOT CONNECTED/FASTENED.</p>	66

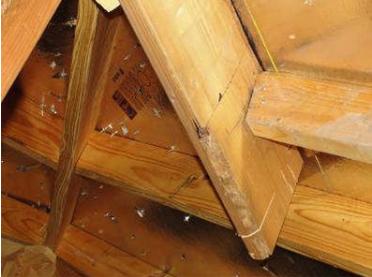
<p>ATTIC: RIDGE BOARD MISSING STRUT SUPPORT AT END. INSTALL/ADD STRUT SUPPORT FOR RIDGE BOARD AND HAVE THE STRUT TERMINATED TO A LOAD BEARING WALL/POINT.</p>	67

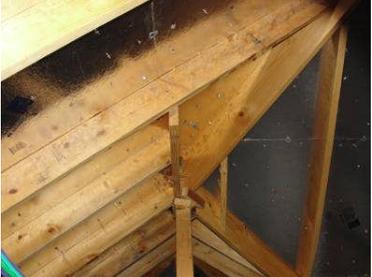
<p>ATTIC: 2006 IRC SECTION R802.3- HIP AND VALLEY RAFTERS SHALL BE SUPPORTED AT THE RIDGE BY A BRACE TO A BEARING PARTITION. BLOCKS DO NOT MEET THE REQUIREMENT OF THE CODE. BLOCKS SPLIT ALONG THE GRAIN LEAVING NO SUPPORT. THEY ALSO DO NOT PROVIDE THE REQUIRED 1-1/2-INCH BEARING FOR LOAD TRANSFER.</p>	68

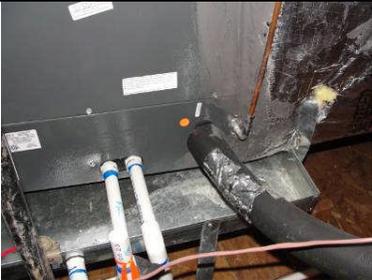
<p>ATTIC: EXCESSIVE AIR LEAK AT FREON LINE ENTRANCE.. OIL LEAK – SEE NEXT PICTURE.</p>	71

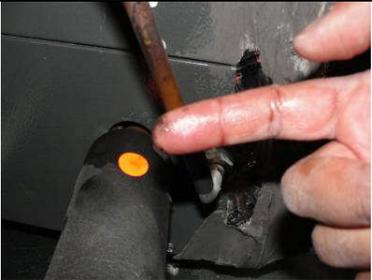
<p>ATTIC: SEE NOTES AT PIC. # 70. REFRIGERANT OIL PRESENT AT THE FITTING – HAVE THIS CHECKED OUT.</p>	72

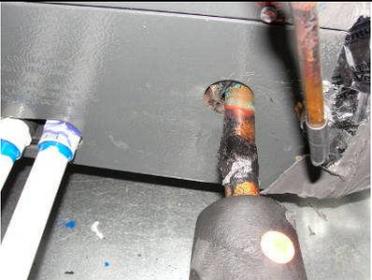
<p>ATTIC:</p> <ol style="list-style-type: none"> 1. EXCESSIVE AIR LEAK AT FREON LINE ENTRANCE. 2. INSULATION MISSING AT FREON LINE. 3. REFRIGERANT OIL LEAK PRESENT.
73

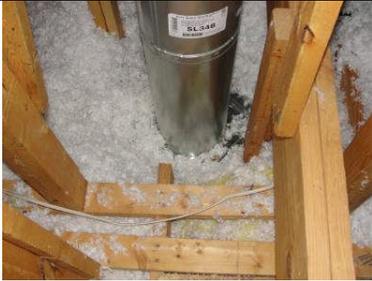
<p>ATTIC: INSULATION/COMBUSTIBLES IN CONTACT WITH THE FLUE – PROVIDE CLEARANCE PER THE FLUE MANUFACTURERS' REQUIREMENTS (USUALLY IT IS AROUND 1-2 INCHES TO ALL COMBUSTIBLES) 2006 IRC M1306; M1307.</p>	74

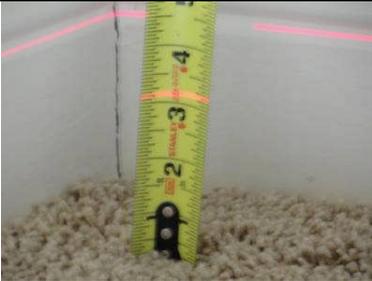
<p>INSIDE MASTER BEDROOM: CLOSE-UP OF PIC. # 81. THE BEAM IS MEASURED HERE AT 3-1/8-INCH INDICATING THE REAR WALL IS 7/8-INCH HIGHER THAN THE POINT WHERE THE LEVEL WAS POSITIONED. THIS IS LIKELY CAUSED BY THE FLAT SOIL GRADE AT THE BACK OF THE HOUSE. REFER TO PIC. # 53.</p>	83

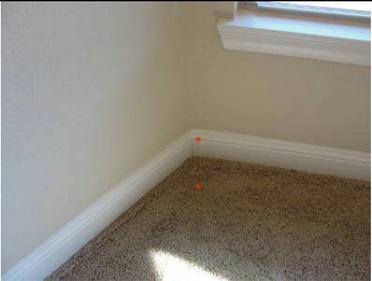
<p>INSIDE MASTER BEDROOM: BASEBOARD JOINT CRACK.</p>	84

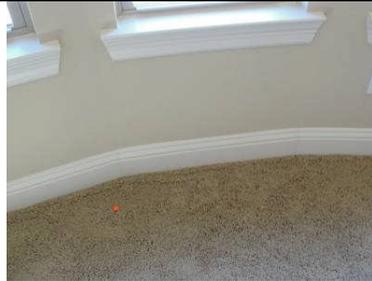
<p>INSIDE MASTER BEDROOM: BASEBOARD JOINT CRACK.</p>

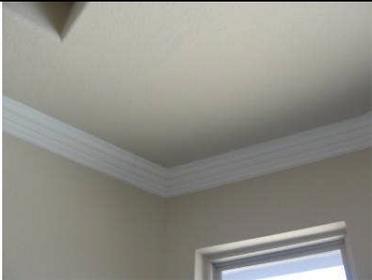
INSIDE MASTER BEDROOM: CROWN MOLDING JOINT CRACKS.	86

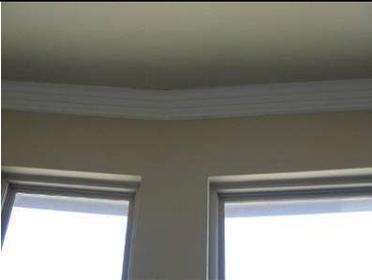
INSIDE MASTER BEDROOM: CROWN MOLDING JOINT CRACKS.	87

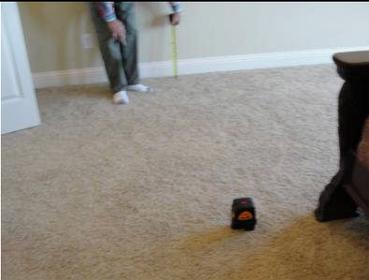
INSIDE MASTER BEDROOM: THE FLOOR IS OFF LEVEL IN THE AREA SHOWN BY 1/2-INCH IN 6.5-FEET.	88

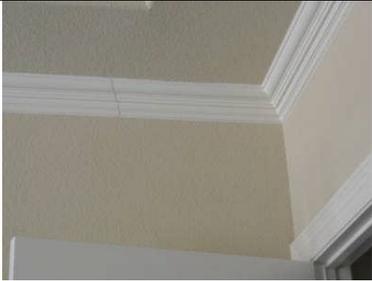
INSIDE MASTER BEDROOM: CROWN MOLDING JOINT CRACKS.	90

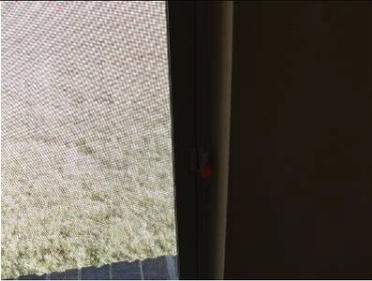
INSIDE MASTER BEDROOM: THE WINDOW ALARM CONTACT IS LOOSE AT THE MIDDLE WINDOW.	91

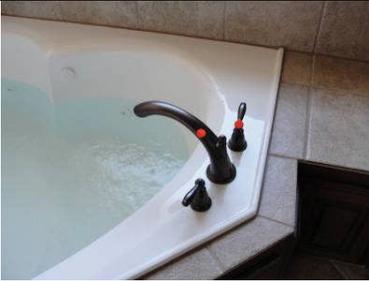
INSIDE MASTER BATH: 1. THE WATER PRESSURE AT THE TUB SPOUT IS SO HIGH THAT WATER SPLASHES ONTO THE DRYWALL WHEN THE TUB FIRST BEGINS TO FILL.	92

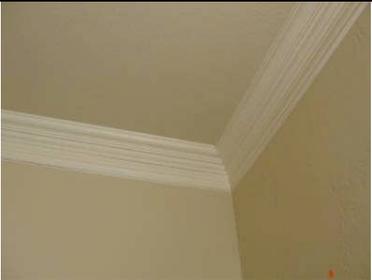
<p>INSIDE: CROWN MOLDING JOINT CRACKS.</p>	96

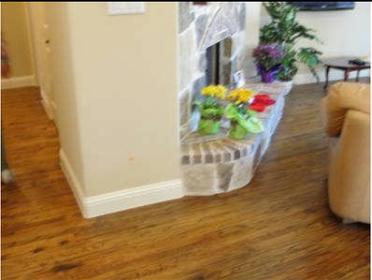
<p>INSIDE FAMILY ROOM: AC OUTLET MISSING. 2006 IRC SECTION E3801.2.1 SPACING. RECEPTACLES SHALL BE INSTALLED SO THAT NO POINT ALONG THE FLOOR LINE IN ANY WALL SPACE IS MORE THAN 6 FEET (1829 MM), MEASURED HORIZONTALLY, FROM AN OUTLET IN THAT SPACE. RECEPTACLES SHALL, INsofar AS PRACTICABLE, BE SPACED EQUAL DISTANCES APART.</p>
97

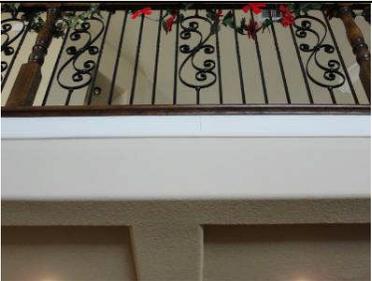
<p>INSIDE FAMILY ROOM: SEPARATION CRACK IN THE TRIM BELOW THE RAILING.</p>	100

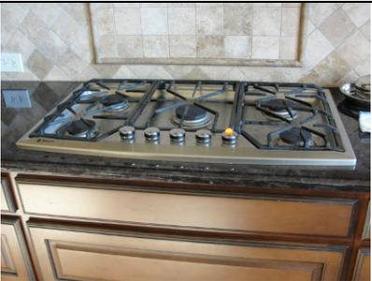
<p>INSIDE KITCHEN: THE FRONT RIGHT BURNER DOES NOT BURN PROPERLY AND THE IGNITER OPERATES CONTINUOUSLY FOR THIS BURNER REGARDLESS OF THE POSITION OF THE VALVE IF NOT IN THE OFF POSITION.</p>

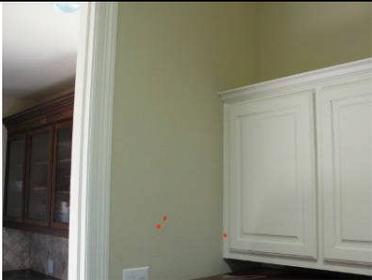
<p>INSIDE UTILITY ROOM: EXCESSIVE WALL MOVEMENT AT TIME DOOR CONTACTS THE JAMB AS IT IS BEING CLOSED. THE MOVEMENT CAUSES SEPARATION CRACKS BETWEEN THE CABINET AND THE WALL ON EACH SIDE OF THIS WALL.</p>	102

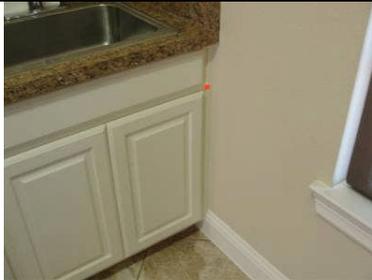
<p>INSIDE UTILITY ROOM: SEPARATION CRACKS AT CABINET AND WALL. THIS MAY BE RELATED TO THE ISSUES NOTED IN PIC. # 101.</p>	104

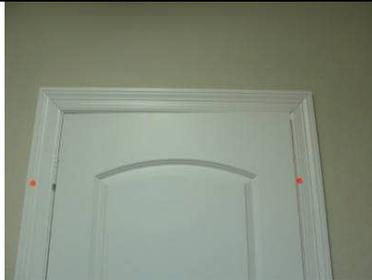
<p>INSIDE: DOOR TRIM JOINT CRACKS.</p>
105

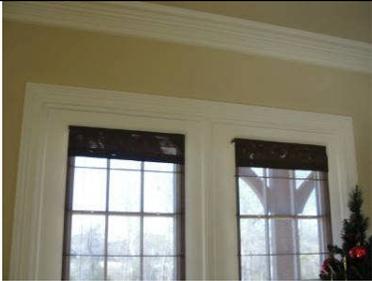
<p>INSIDE DINING ROOM: DOOR TRIM JOINT CRACKS.</p>	106

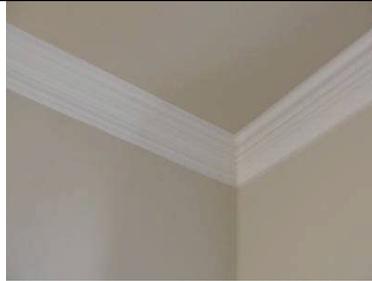
<p>INSIDE DINING ROOM: CROWN MOLDING JOINT CRACKS.</p>	107

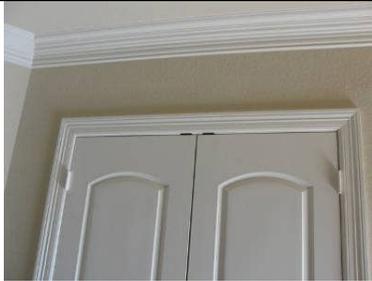
<p>INSIDE DINING ROOM: DOOR TRIM JOINT CRACKS.</p>	108

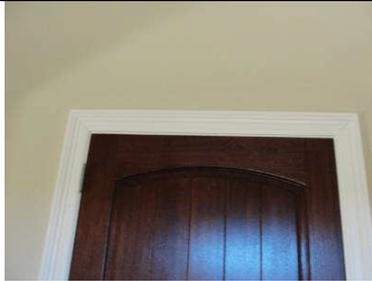
<p>INSIDE FOYER: DOOR TRIM JOINT CRACKS.</p>
109

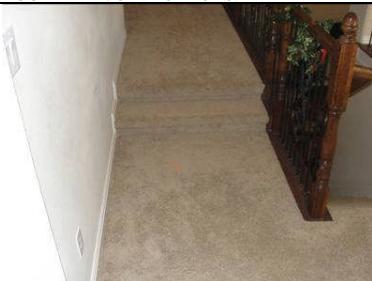
<p>INSIDE: FLOOR POPS / SQUEAKS.</p>	110

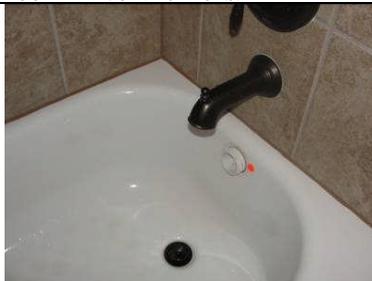
<p>INSIDE JACK-N-JILL BATH: SEAL THE GAP BETWEEN THE EMERGENCY OVERFLOW DRAIN PIPE AND THE TUB TO PREVENT WATER LEAKS.</p>

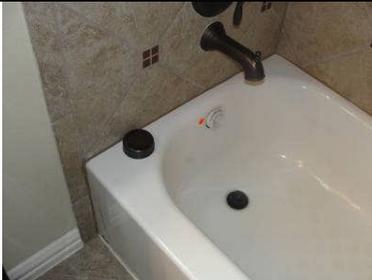
INSIDE UPSTAIRS RIGHT BATH: SEAL THE GAP BETWEEN THE EMERGENCY OVERFLOW DRAIN PIPE AND THE TUB TO PREVENT WATER LEAKS.	114

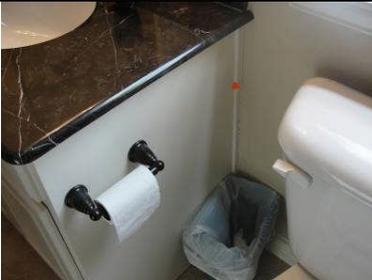
INSIDE UPSTAIRS RIGHT BATH: WATER STAIN ON WALL.	115

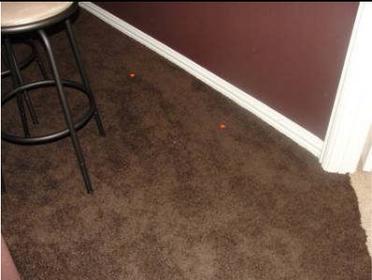
INSIDE MEDIA ROOM: FLOOR POPS / SQUEAKS. REMOVE THE CARPET AND PROPERLY SECURE THE DECKING.	116

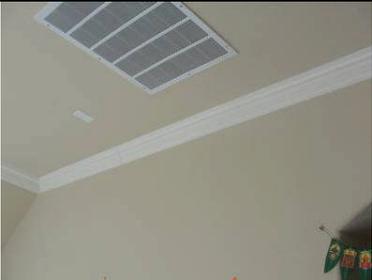
INSIDE GAME ROOM: CROWN MOLDING JOINT CRACKS.
117

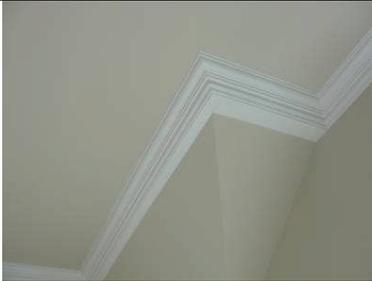
INSIDE GAME ROOM: CROWN MOLDING JOINT CRACKS.	118

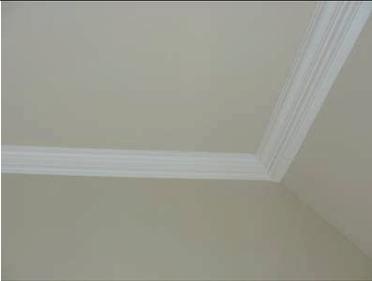
INSIDE GAME ROOM: CROWN MOLDING JOINT CRACKS.	119

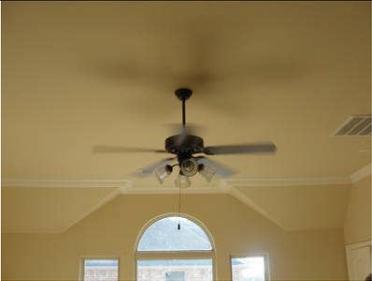
INSIDE GAME ROOM: NOISY FAN.	120

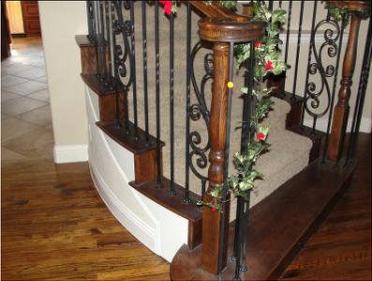
INSIDE FOYER: LOOSE BALUSTER.
121

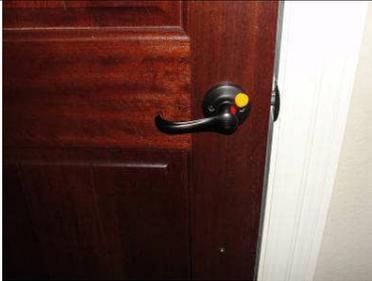
INSIDE FOYER: WRONG SIZE SCREW IN DOOR KNOB PLATE. THIS RESULTS IN COLD AIR COMING IN AROUND THE SCREW.	122	NOTE: CHECK YOUR BUILDERS' WARRANTY & PERFORMANCE/QUALITY GUIDELINES DOCUMENT TO SEE THE REQUIREMENTS ON CAULKING AND LOOSENESS OF ITEMS	123

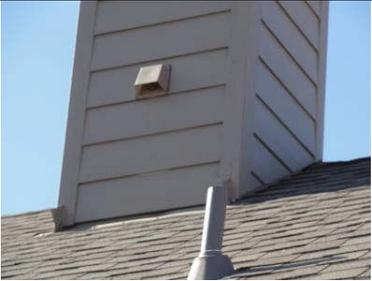
ROOF: CAULK TRIM/FLASHING INTERFACES WHERE VOIDS ARE PRESENT	124

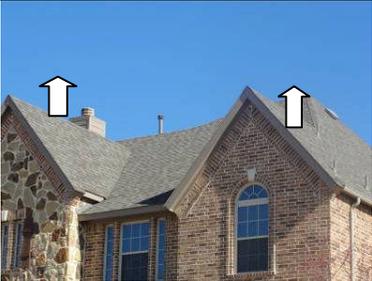
FRONT: ROOF VENTS MISSING AT FRONT GABLES
