RSH ENGINEERING, INC

FOUNDATION ANALYSIS

Subject: XYZ Anytown, TX

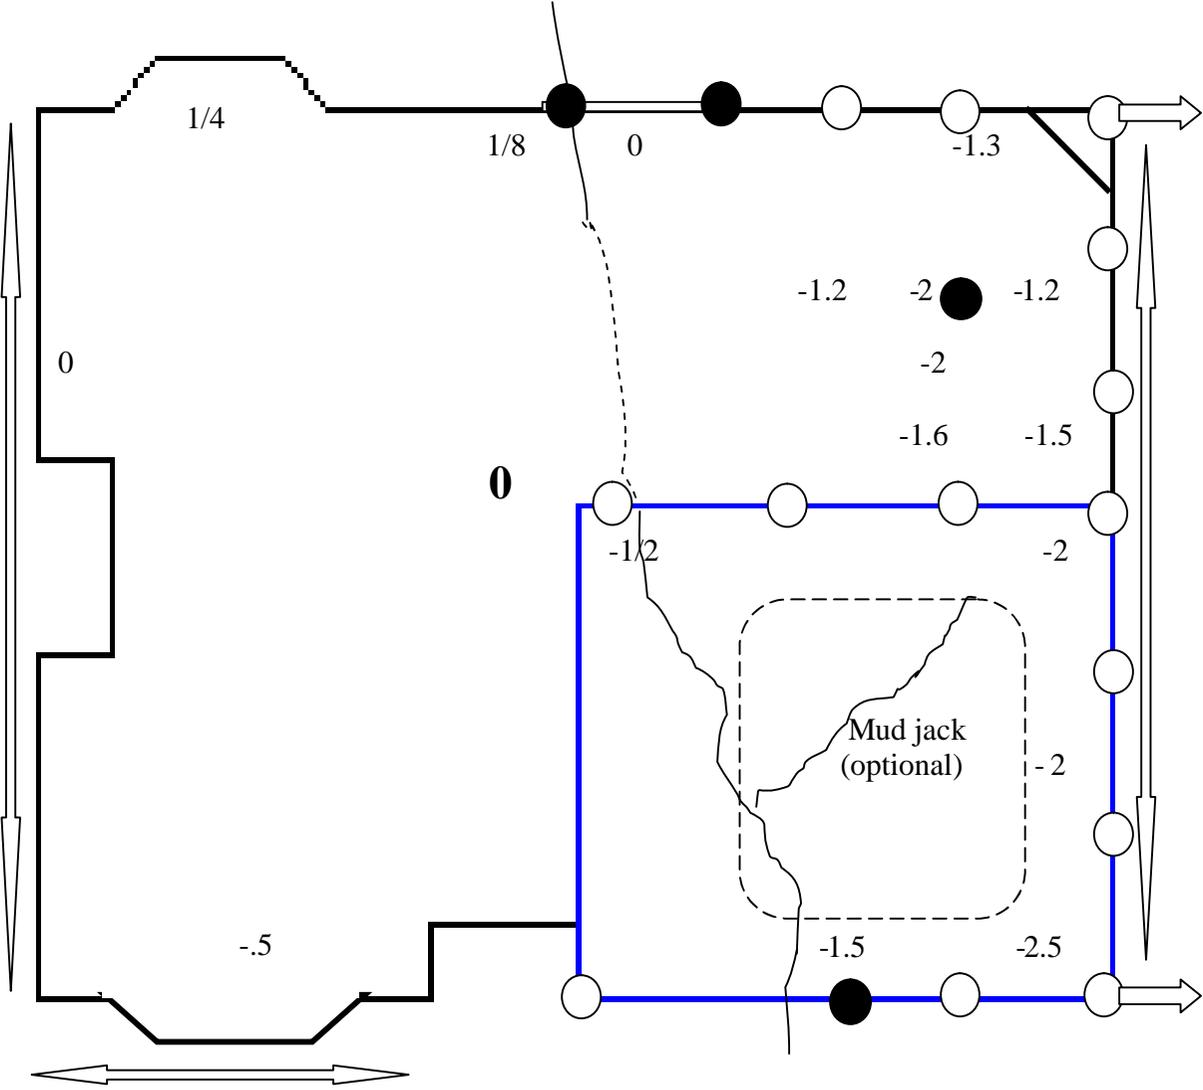
**FOUNDATION REPAIR PLAN-XYZ
Anytown, TX**

The elevation diagram indicates that the foundation is not within allowable limits and acceptable tolerances. The foundation exhibits differential movement that needs to be adjusted. It also has a crack that runs from the garage entrance to the inside breakfast room under the tiles to the patio slab. There was also a slab edge crack on the back side of the patio slab.

The results of our elevation survey are shown on the attached diagram.

The foundation is in need of adjustment. The elevation diagram indicates that the foundation is not within acceptable tolerances and allowable limits. It is recommended the installation of **4 new piers** as shown on the attached foundation repair plan. The foundation plan also shows areas that may have the existing piers, per the homeowner, in the locations shown. If after the excavation, they do not find the existing piers, install the piers at the missing locations.

- Add Pressed Piers
- Jack up these areas and adjust/shim the existing Pressed Piers. See notes below regarding concrete breakouts. **RSH is not sure if existing piers are present. If piers are missing, add the piers at these locations.**

- ↔ Provide positive drainage
Slope of 1-inch of drop for the 1st five feet away from the foundation
- Provide minimum of 3 -feet downspout extenders to all gutter downspouts around the house.
