RSH ENGINEERING, INC.

COMMERCIAL (CHURCH) INSPECTION REPORT

INSP#: 9904048 DATE:08/30/06 PAGE #: 1

Client: Baptistcostalpresborean Church

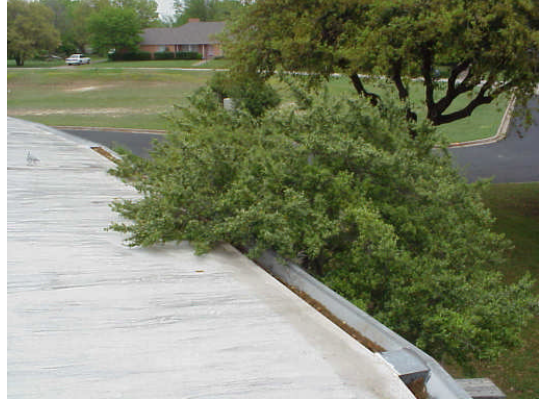
ROOF: 1. TRIM BACK TREE BRANCHES FROM ROOF
4

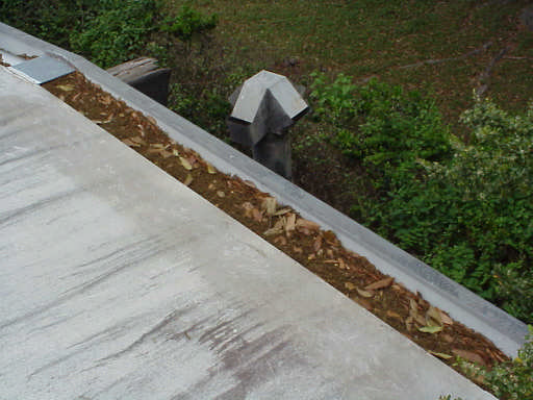
ROOF: 1. CLEAN OUT GUTTERS OF LEAVES AND DEBRIS 2. RAFTER END DAMAGE	5

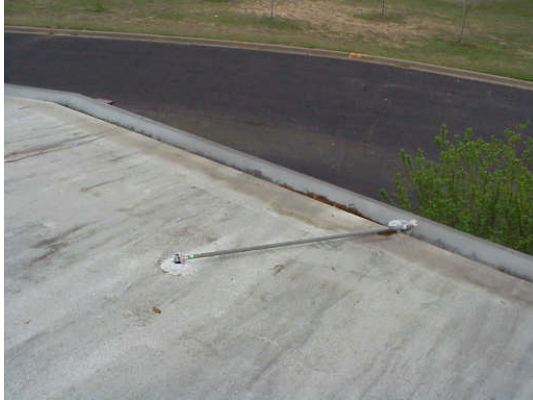
ROOF: 1. ANOTHER LIGHT POST FALLEN DOWN EXPOSING OPENING IN ROOF	6

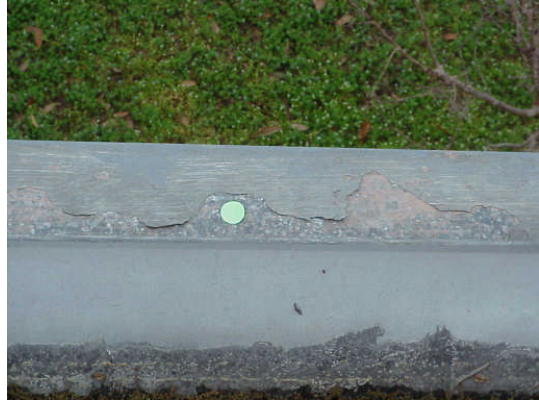
ROOF: 1. GUTTER NEEDS TO BE PAINTED

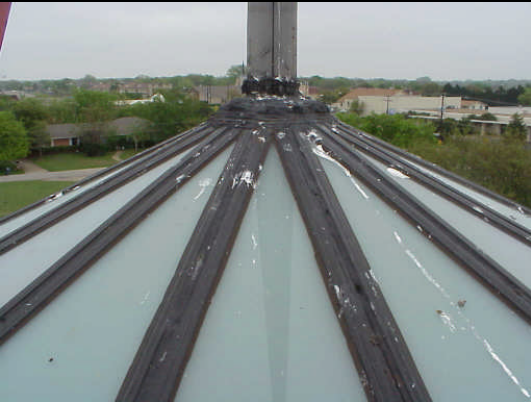
<p><u>ROOF: TOP OF STEEPLE</u> 1. AREA WHERE THERE ARE SEVERAL HOLES IN ROOF.</p>	20

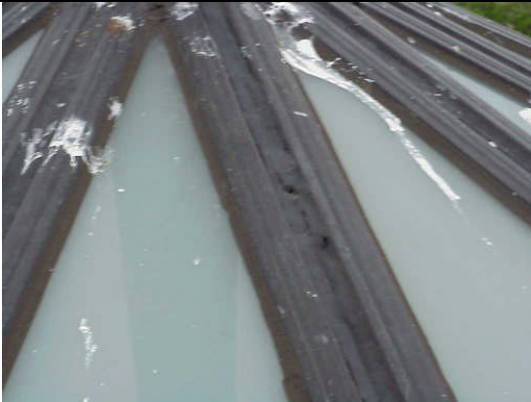
<p><u>ROOF: TOP OF STEEPLE</u> 1. AREA WHERE THERE ARE CRACK IN THE RUBBER SEALANT.</p>	21

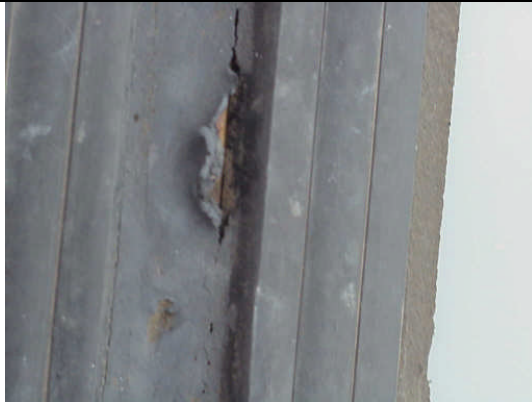
<p><u>ROOF: TOP OF STEEPLE</u> 1. AREA WHERE THERE ARE CRACK IN THE RUBBER SEALANT.</p>
22

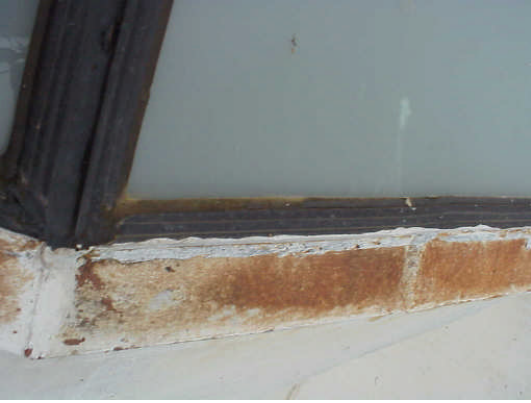
<p><u>ROOF: TOP OF STEEPLE</u> 1. RE-PAINT ALL SKYLIGHTS WHERE IT IS RUSTING</p>	23

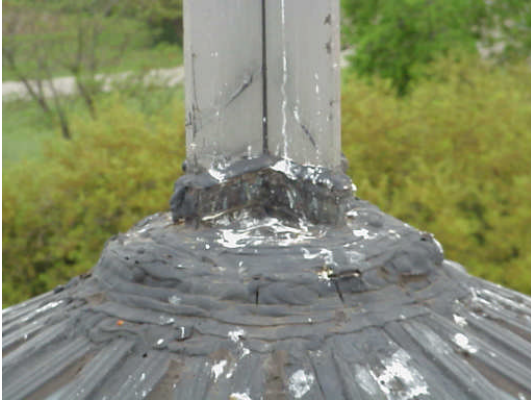
<p><u>ROOF: TOP OF STEEPLE</u> 1. AREA WHERE THERE ARE CRACK IN THE RUBBER SEALANT.</p>	24

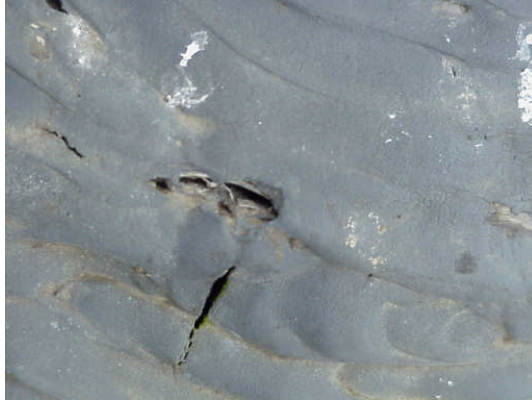
<p><u>ROOF: TOP OF STEEPLE (CLOSE-UP)</u> 1. AREA WHERE THERE ARE CRACK IN THE RUBBER SEALANT.</p>

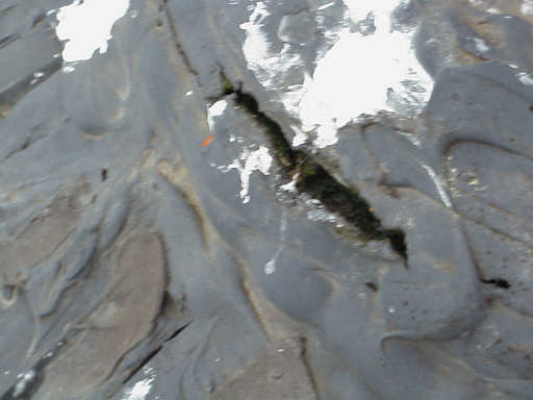
ROOF: TOP OF STEEPLE (CLOSE-UP) 1. AREA WHERE THERE ARE CRACK IN THE RUBBER SEALANT.	26

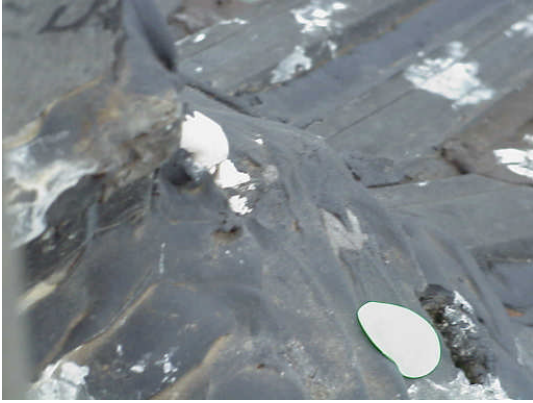
ROOF: TOP OF STEEPLE (CLOSE-UP) 1. AREA WHERE THERE ARE CRACK IN THE RUBBER SEALANT.	27

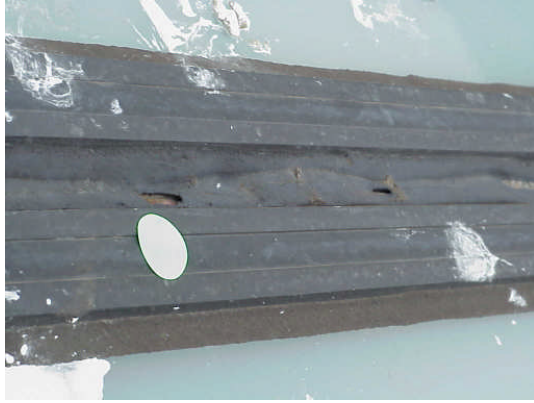
ROOF: TOP OF STEEPLE (CLOSE-UP) 1. AREA WHERE THERE ARE CRACK IN THE RUBBER SEALANT.
28

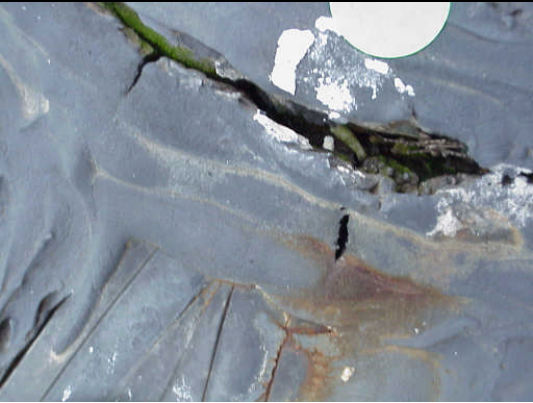
ROOF: TOP OF STEEPLE (CLOSE-UP) 1. AREA WHERE THERE ARE CRACK IN THE RUBBER SEALANT.	29

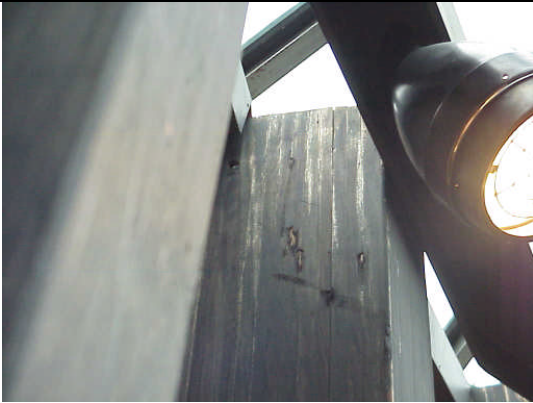
ROOF: INSIDE THE SKYLIGHTS AT THE TOP OF STEEPLE. 1. WATER DAMAGE TO THE RAFTER TOP – 2. RE-PAINT	30

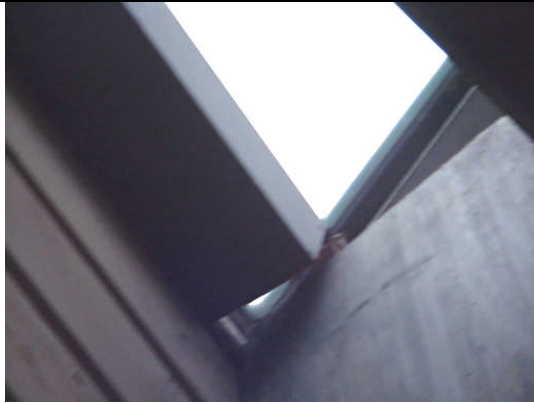
ROOF: INSIDE THE SKYLIGHTS AT THE TOP OF STEEPLE. 1. NOTICE THIS SIDE PANEL IS RESTING ON THE NAILS – IT I SABOUT TO FALL OFF? (SEE PIC. #33 FOR CLOSE-UP) SHOT

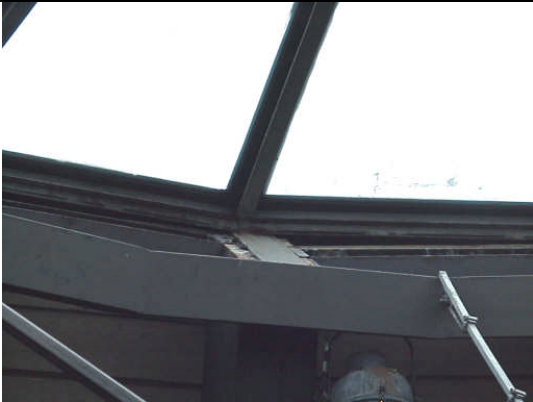
<p><u>ROOF: INSIDE THE SKYLIGHTS AT THE TOP OF STEEPLE.</u></p> <ol style="list-style-type: none"> 1. NOTICE THAT THE TOP OF THE RAFTER END IS NOT PAINTED – RECOMMENED PAINTING OF TOP OF RAFTER 	33

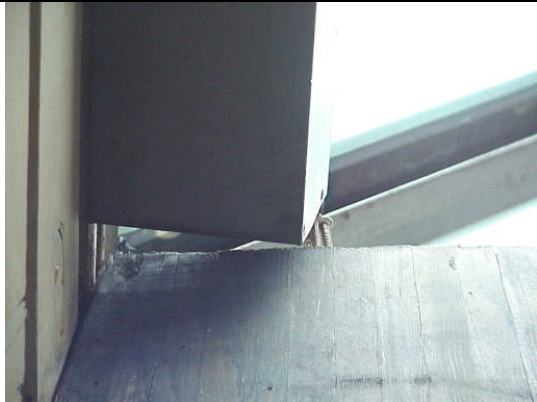
<p><u>ROOF: INSIDE THE SKYLIGHTS AT THE TOP OF STEEPLE.</u></p> <ol style="list-style-type: none"> 1. NOTICE THIS SIDE PANEL IS RESTING ON THE NAILS – IT I SABOUT TO FALL OFF?
34

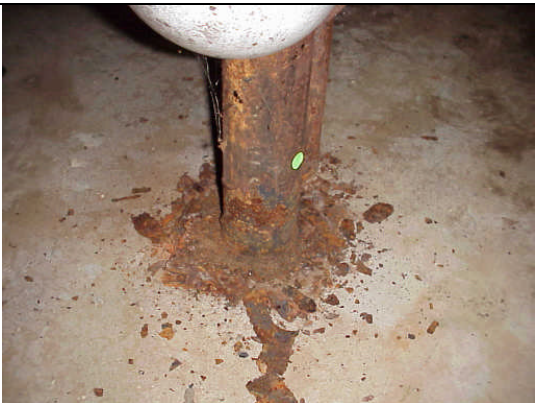
<p><u>BASEMENT:</u></p> <ol style="list-style-type: none"> 1. RUSTED SUPPORTS FOR PIPING 2. SAND AND TREAT FOR RUST AND THEN PAINT 	35

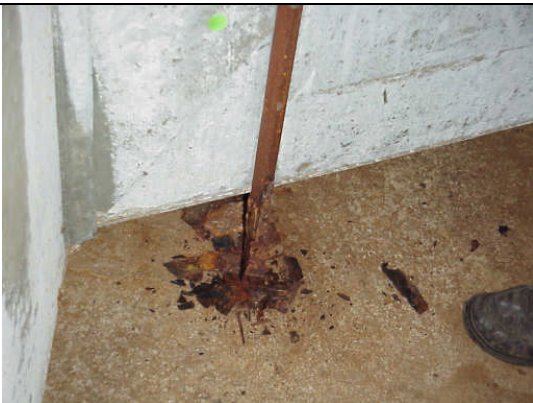
<p><u>BASEMENT:</u></p> <ol style="list-style-type: none"> 1. SUPPORTS FOR AIRHANDLER RUSTED OUT – REPLACE OR SUPPORT WITH CINDER BLOCKS 	36	  <p><u>BASEMENT:</u></p> <ol style="list-style-type: none"> 1. SUPPORTS FOR AIRHANDLER RUSTED OUT – REPLACE OR SUPPORT WITH CINDER BLOCKS

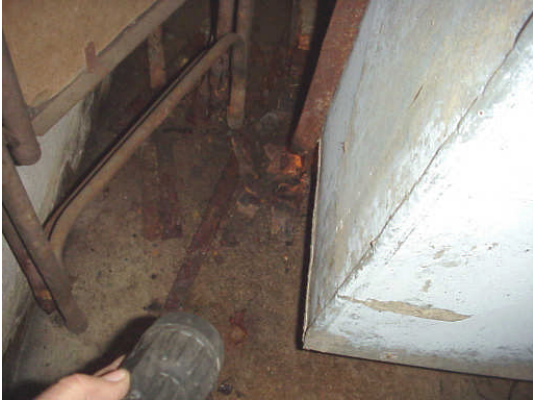
<p><u>BASEMENT:</u></p> <ol style="list-style-type: none"> SUPPORTS FOR AIRHANDLER RUSTED OUT – REPLACE OR SUPPORT WITH CINDER BLOCKS 	38

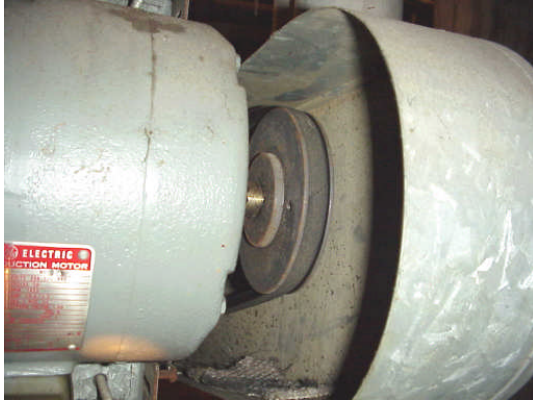
<p><u>AIR HANDLER:</u></p> <ol style="list-style-type: none"> THE BELT OF THE AIR HANDLER NEAR THE BASEMENT STAIRS ARE LOOSE – RE-PLACE WITH NEW. 	39

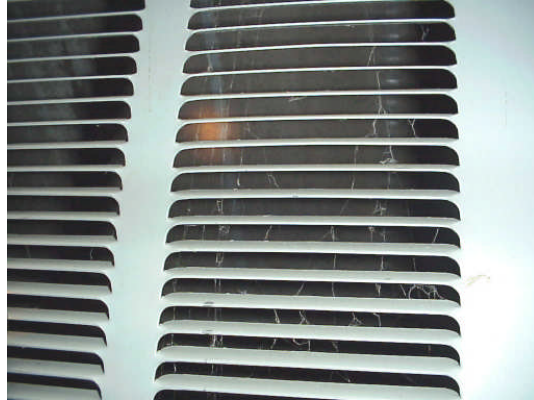
<p><u>OUTSIDE UNITS:</u></p> <ol style="list-style-type: none"> COILS ARE DIRTY – HAVE A LICENSED AC/HEAT TECHNICIAN SERVICE THE UNITS
40

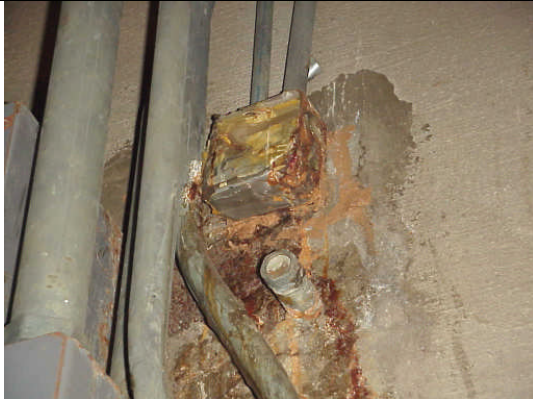
<p><u>BASEMENT: (ABOVE ELECTRICAL SWITCH PANELS)</u></p> <ol style="list-style-type: none"> EVIDENCE OF PAST LEAK – CHECK FOR LEAK AND SEAL PROPERLY – THIS AREA SHOULD ALWAYS BE DRY SINCE IT IS ABOVE THE ELECTRICAL WIRING AND PANELS. 	42

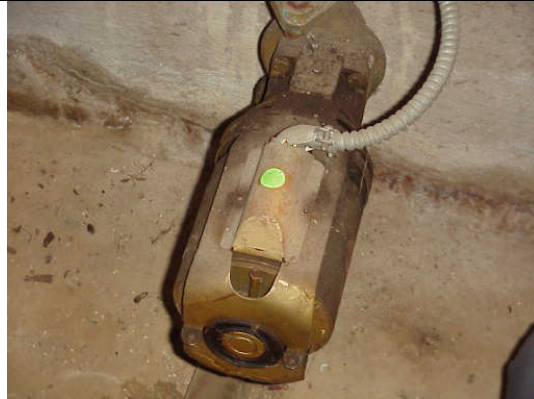
<p><u>BASEMENT: HOT WATER HEATER PUMP</u></p> <ol style="list-style-type: none"> THIS PUMP IS JAMMED AND NOT FUNCTIONAL. (REPLACE.)

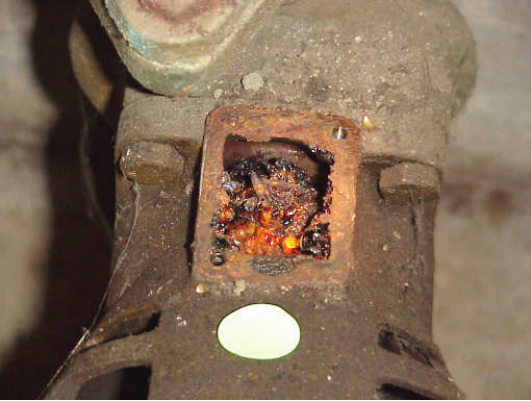
<p><u>BASEMENT: (CLOSE-UP OF PIC.#42)</u></p> <ol style="list-style-type: none"> 1. HOT WATER HEATER PUMP 2. THIS PUMP IS JAMMED AND NOT FUNCTIONAL. (REPLACE.) 	44

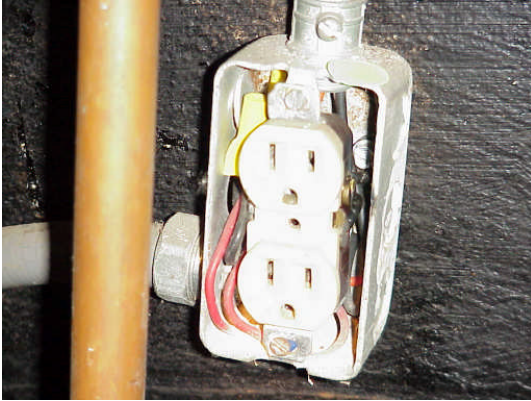
<p><u>BASEMENT:</u></p> <ol style="list-style-type: none"> 1. EXPOSED PLUG/WIRING (PROVIDE COVER) 	45

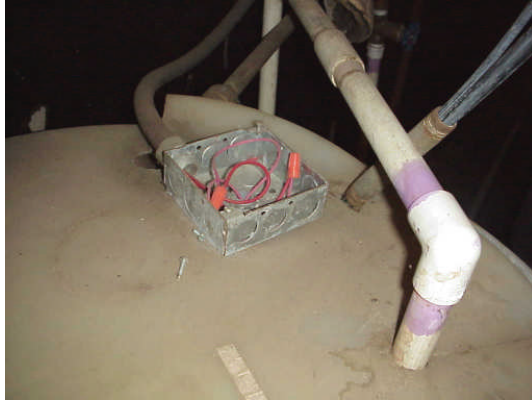
<p><u>BASEMENT (NEAR THE FREON TANK):</u></p> <ol style="list-style-type: none"> 1. EXPOSED JUNCTION BOX – COVER JUNCTION BOX.
46

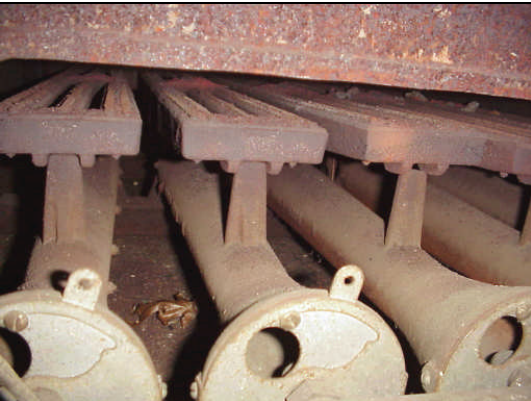
<p><u>BASEMENT:</u></p> <ol style="list-style-type: none"> 1. CLOSE—UP OF FURNACE (INSIDE) – EXCESSIVE RUST INSIDE CHAMBER. PRESENTLY WORKING GOOD. 	47

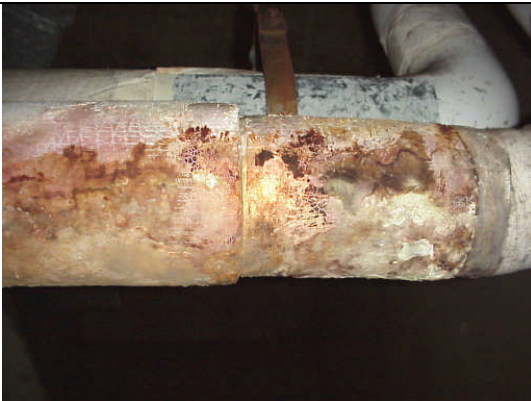
<p><u>BASEMENT:</u></p> <ol style="list-style-type: none"> 1. AN AREA WHERE THE RUST MARKS ARE EVIDENT ON THE PIPE INSULATION. CHECK FOR WATER LEAK INSIDE THE INSULATION. 	48

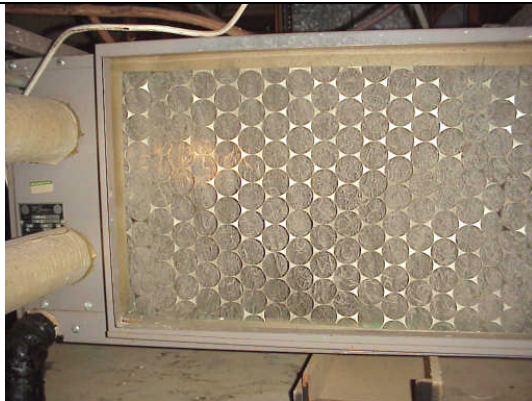
<p><u>ORGAN COOLING SYSTEM:</u></p> <ol style="list-style-type: none"> 1. GRILL MISSING FROM THE UNIT 2. REPLACE FILTER

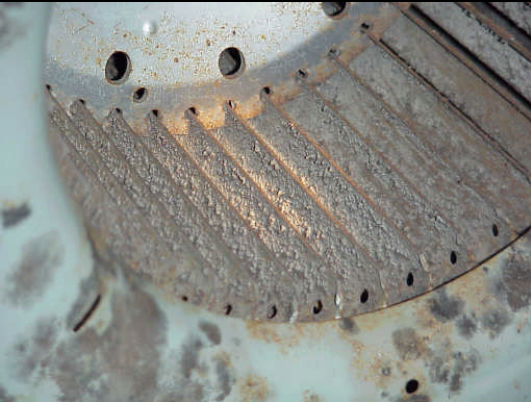
<p>ORGAN COOLING SYSTEM:</p> <ol style="list-style-type: none"> 1. BLOWER MOTOR IS DIRTY – NEEDS CLEANING 	50

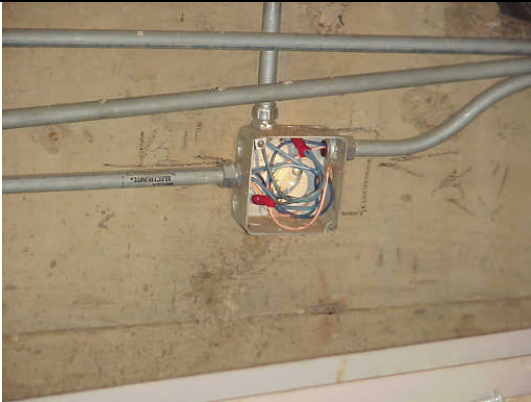
<p>NEAR ORGAN COOLING SYSTEM:</p> <ol style="list-style-type: none"> 1. EXPOSED WIRING / COVER JUNCTION BOX 	51

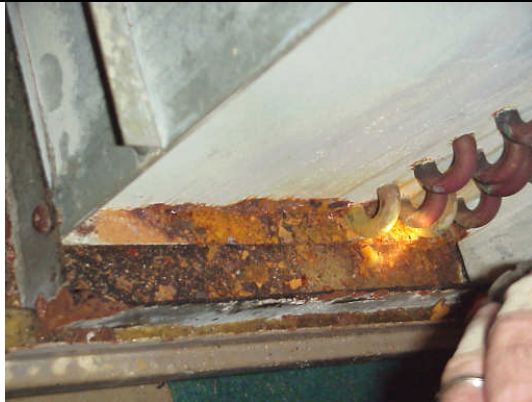
<p>ORGAN COOLING SYSTEM:</p> <ol style="list-style-type: none"> 1. EXCESSIVE RUST BELOW EVAPORATOR COILS.
52

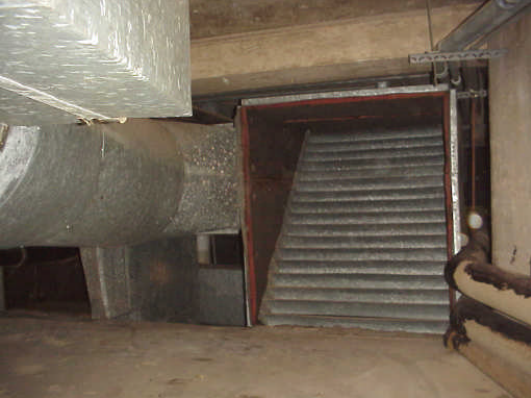
<p>BASEMENT:</p> <ol style="list-style-type: none"> 1. THE AIR RETURNS ARE NOT ISOLATED FROM THE BASEMENT BOILER AREA 2. RECOMMENED SEALING ALLSIDES OF THE AIR RETURNS TO MAKE I T A CLOSED SYSTEM. 	53

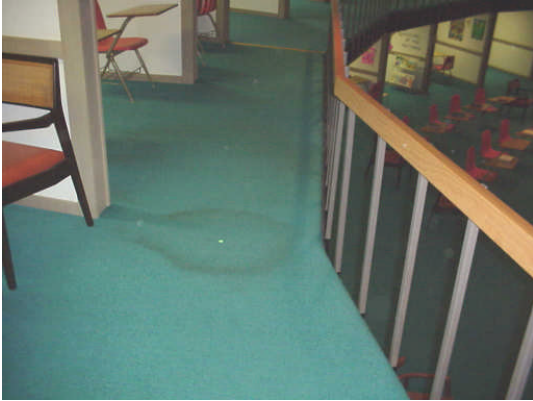
SUNDAY SCHOOL: WATER LEAK MARK ON THE CARPET	56

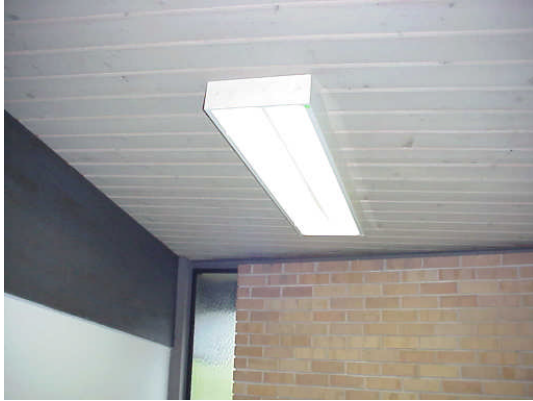
SUNDAY SCHOOL: WATER LEAK MARK ON THE CEILING BELOW THE AREA SHOWN IN PIC#55	57

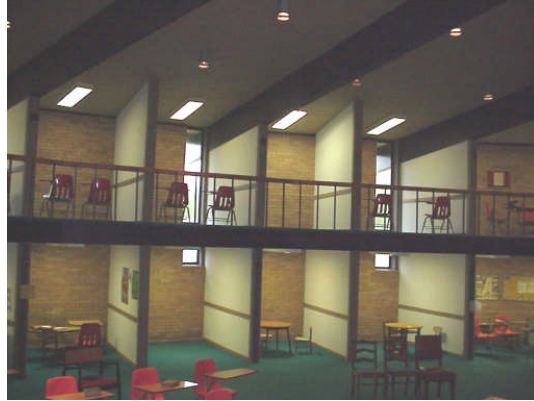
SUNDAY SCHOOL: THE RIGHT SIDE AREA SHOWN IN THE PICTURE HAVE BRICK WALLS THAT MOVE. SEE DOTS ON WALL FOR LOCATION AT SECOND LEVEL
58

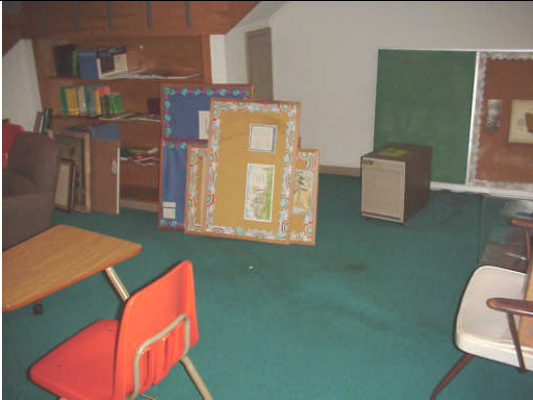
SUNDAY SCHOOL: WATER LEAK MARK ON THE CARPET	59

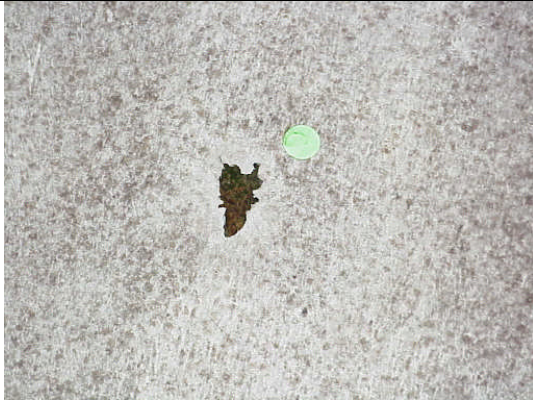
ROOF: AREA ABOVE THE WATER LEAK AT ROOF SHOWING HOLE IN ROOF. PATCH TO COVER HOLE.	60

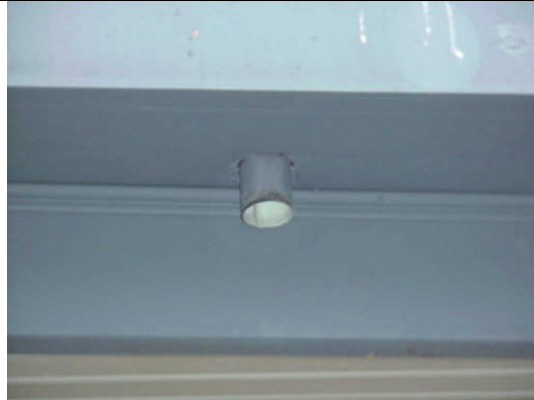
OUTSIDE: SEVERAL AREAS WHERE DOWNSPOUTS ARE MISSING

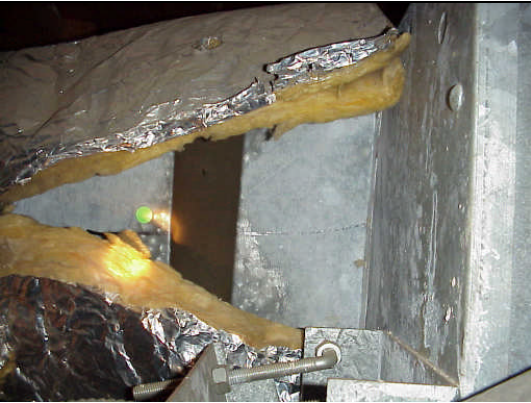
<p><u>NURSERY (ANOTHER SHOT OF PIC.#66)</u></p> <ol style="list-style-type: none"> 1. THE INSULATION HAS COME LOOSE FOR THE AC DUCTS ABOVE THE NURSERY 	68

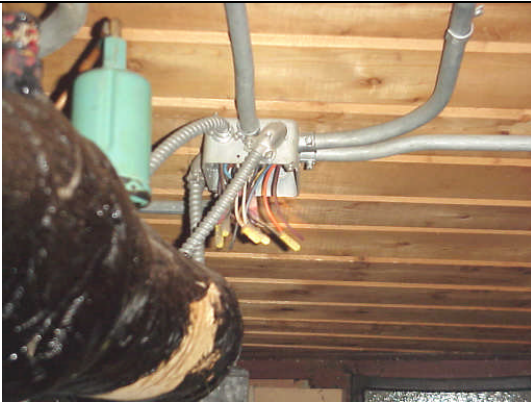
<p><u>NURSERY ATTIC:</u></p> <ol style="list-style-type: none"> 1. EXPOSED WIRING / COVER JUNCTION BOX 	69	<p>NURSERY</p>

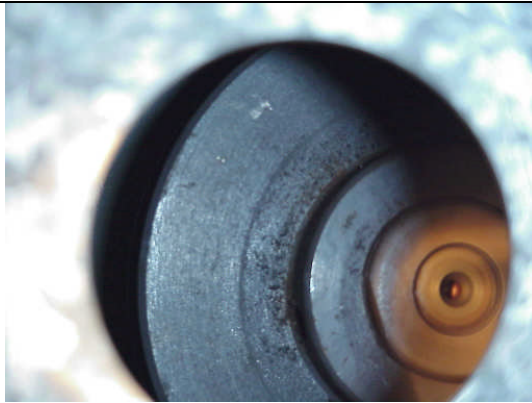
<p><u>NURSERY ATTIC:</u></p> <ol style="list-style-type: none"> 1. BLOWER MOTOR MAKING EXCESSIVE NOISE DURING OPERATION. HAVE A LICENSED AC/HEAT TECHNICIAN PROVIDE REPAIR RECOMMENDATION
70

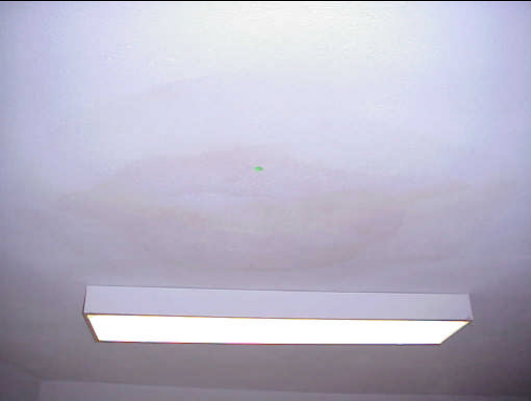
<p><u>NURSERY CEILING BELOW THE AC/HEAT UNIT:</u></p> <ol style="list-style-type: none"> 1. WATER STAIN MARKS ON CEILING. 2. EMERGENCY SECONDARY DRAIN PIPES/PAN MISSING 	71

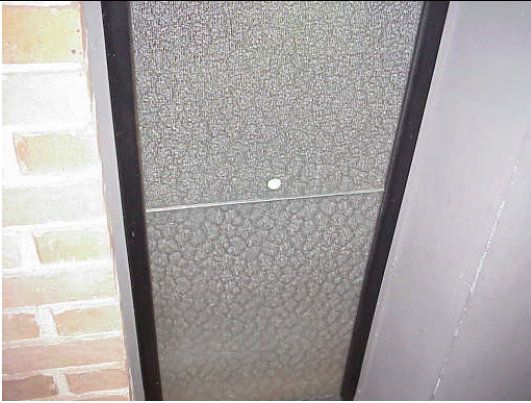
<p><u>NURSERY:</u></p> <ol style="list-style-type: none"> 1. CRACK IN WINDOW PANE 	72

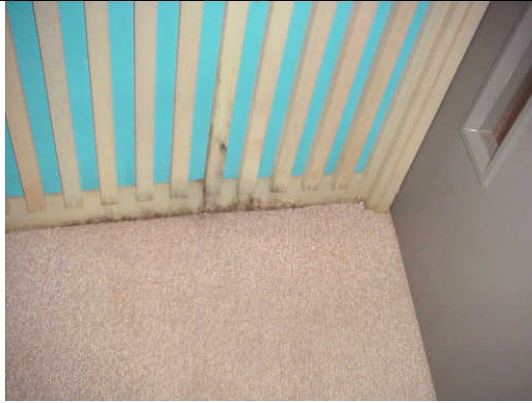
<p><u>SANCTUARY:</u></p> <ol style="list-style-type: none"> 1. AN AREA BELOW THE SKYLIGHT WHERE THERE IS WATER LEAK MARKS. 2. CLEAN/ SAND/ RE-STAIN

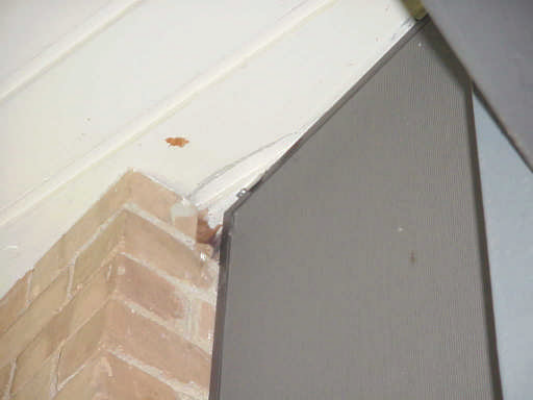
<p>OUTSIDE:</p> <ol style="list-style-type: none"> 1. AT THE WINDOW /BRICK TOP INTERFACE: 2. HOLE IN BRICK WHERE BIRDS HAVE NESTS. SEAL ALL HOLES AROUND THE BRICK / WINDOW INTERFACE ESPECIALLY AT THE TOP. 	80

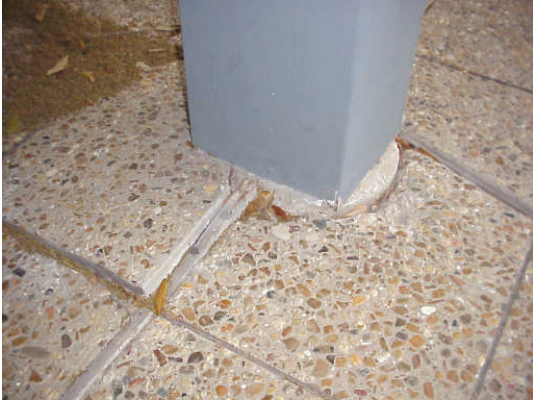
<p>OUTSIDE:</p> <ol style="list-style-type: none"> 1. THE STONE SLAB (S) AROUND THE PIER IS NOT CUT CORRECTLY. 2. PROVIDE CLEARANCE AROUND THE PIER TO PREVENT THE STONE SLAB FROM INTERFERING WITH THE PIER. 	81

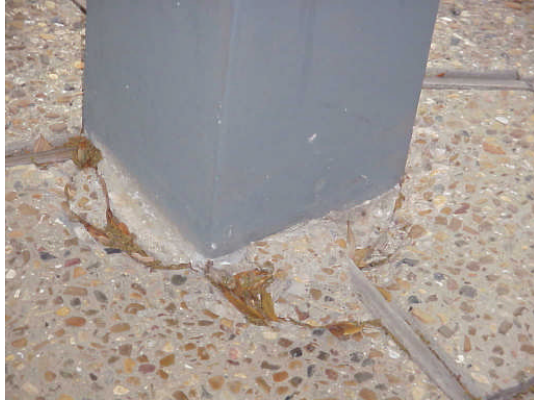
<p>OUTSIDE:</p> <ol style="list-style-type: none"> 1. THE STONE SLAB (S) AROUND THE PIER IS NOT CUT CORRECTLY. 2. PROVIDE CLEARANCE AROUND THE PIER TO PREVENT THE STONE SLAB FROM INTERFERING WITH THE PIER.
82

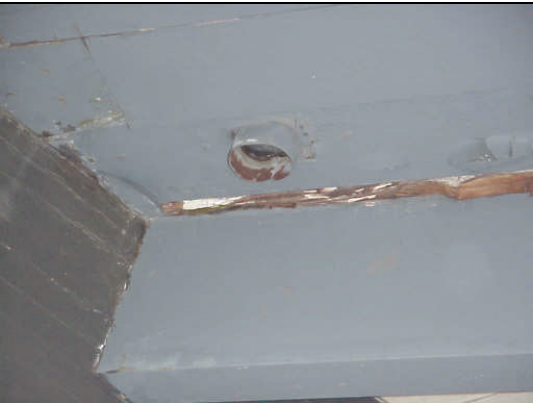
<p>OUTSIDE:</p> <ol style="list-style-type: none"> 1. GUTTER DOWNSPOUT MISSING 2. TRIM DAMAGE 	83

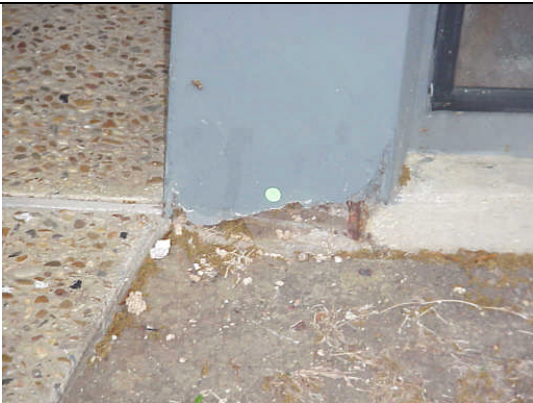
<p>OUTSIDE:</p> <ol style="list-style-type: none"> 1. EXPOSED REBAR OF PILLAR. 2. RE-PATCH WITH CEMENT. 	84

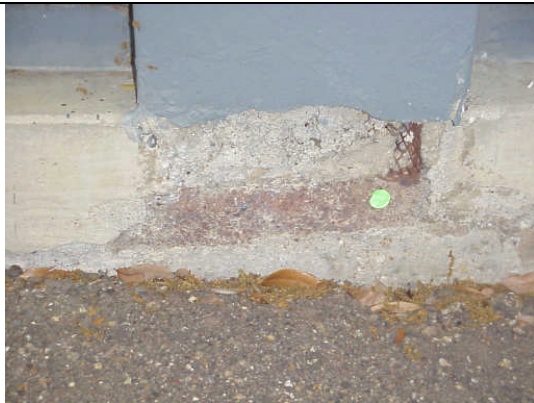
<p>OUTSIDE:</p> <ol style="list-style-type: none"> 1. EXPOSED REBAR /WIRE MESH OF PILLAR. 2. RE-PATCH WITH CEMENT.

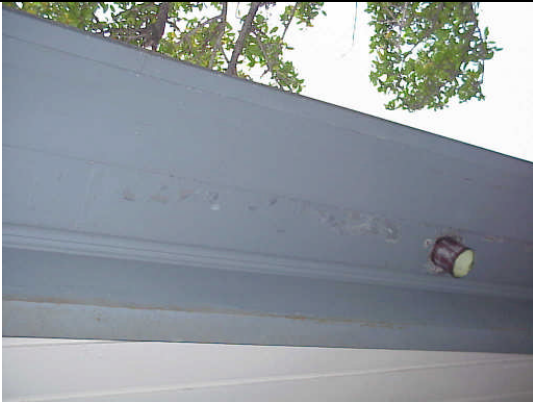
<p>OUTSIDE:</p> <ol style="list-style-type: none"> 1. SEVERAL GUTTER AREAS WHERE IT HAS RUSTED. 	86

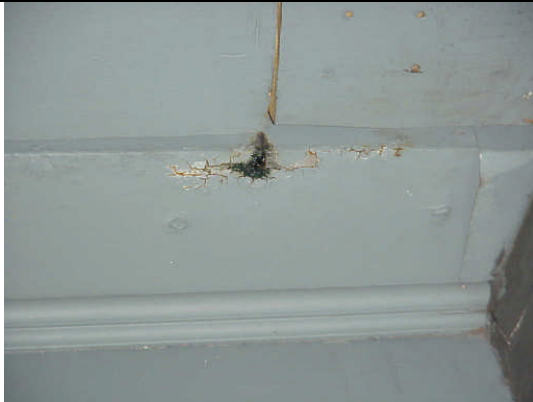
<p>OUTSIDE:</p> <ol style="list-style-type: none"> 1. SEVERAL GUTTER AREAS WHERE IT HAS RUSTED. 	87

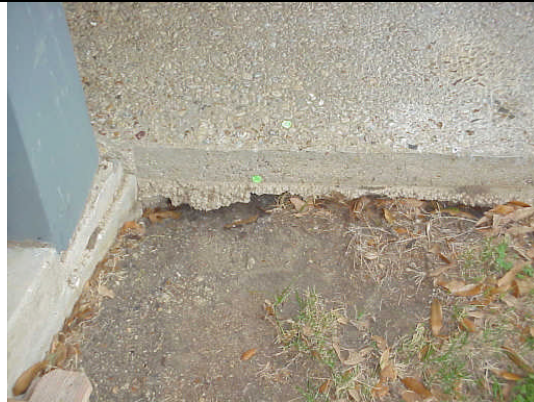
<p>OUTSIDE:</p> <ol style="list-style-type: none"> 1. AN AREA AT THE ENTRANCE WHERE SOIL NEEDS TO BE ADDED. ADD "FHA" TYPE SOIL COMPACT IT DOWN AND COVER HOLE.
88

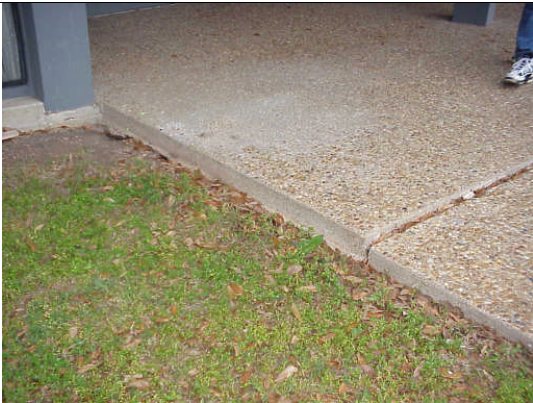
<p>OUTSIDE (ANOTHER VIEW):</p> <ol style="list-style-type: none"> 1. AN AREA AT THE ENTRANCE WHERE SOIL NEEDS TO BE ADDED. ADD "FHA" TYPE SOIL COMPACT IT DOWN AND COVER HOLE. 	89

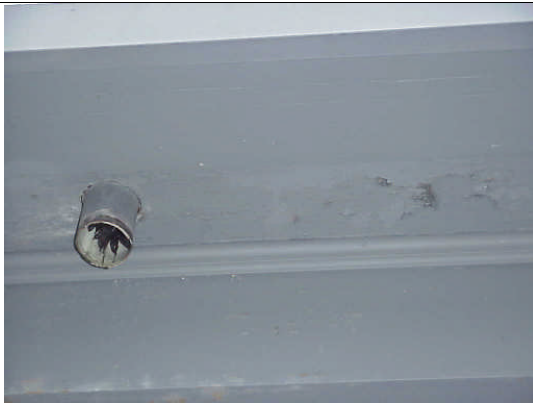
<p>OUTSIDE:</p> <ol style="list-style-type: none"> 1. SEVERAL GUTTER AREAS WHERE IT HAS RUSTED. 	90

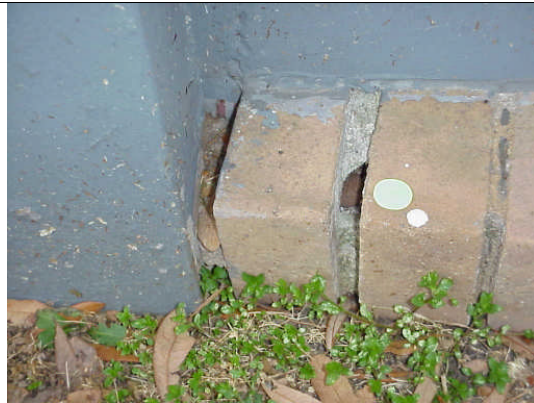
<p>OUTSIDE:</p> <ol style="list-style-type: none"> 1. AREA AT THE WINDOW SILL /WINDOW INTERFACE WHERE THERE'S HOLE IN MORTAR 2. SEAL ALL HOLES IN MORTAR ESPECIALLY AT THE WINDOW/BRICK INTERFACE.

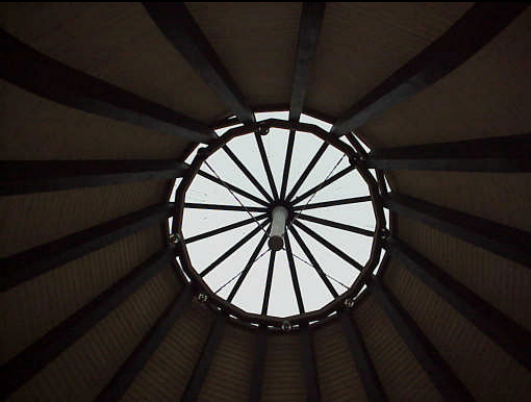
<p><u>VIEW OF TOP OF THE CHURCH FROM INSIDE:</u></p> <ol style="list-style-type: none"> 1. NOTICE SEVERAL SIDE PANELS ARE NOT SEATED PROPERLY. 2. SEE PIC. #30 & PIC#33 TO SEE CLOSE-UP OF SIDE PANEL. IT SEEMS AS IF THEY ARE LOOSE 	92	  <p><u>BOARD ROOM:</u></p> <ol style="list-style-type: none"> 1. PILLAR BOTTOM DAMAGE 2. PAINT/ PLASTER FLAKING OFF 	93	  <p><u>SIDE ENTRANCE AREA:</u></p> <ol style="list-style-type: none"> 1. WINDOW PANE DAMAGE
94

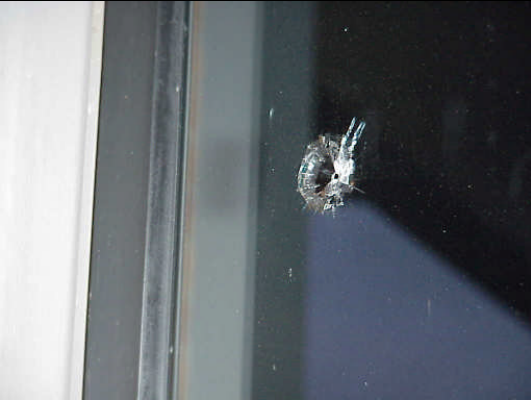
<p><u>SIDE ENTRANCE AREA:</u></p> <ol style="list-style-type: none"> 1. WINDOW PANE DAMAGE 	95

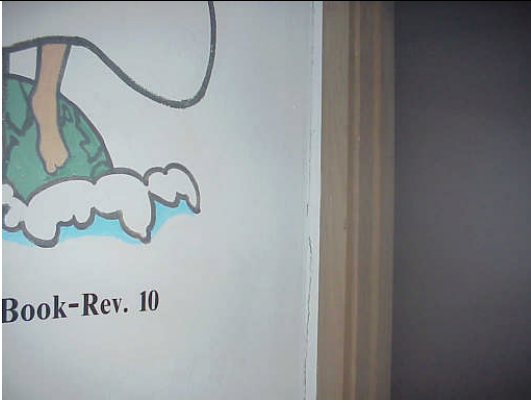
<p><u>SUNDAY SCHOOL ENTRANCE:</u></p> <ol style="list-style-type: none"> 1. VERTICAL CRACK AT THE DOOR FRAME/WALL INTERFACE. 2. SEAL WITH CAULK AND RE-PAINT 	96	  <p><u>ABOVE DOOR AT THE CHECK-IN AREA OF NURSERY</u></p> <ol style="list-style-type: none"> 1. SEAL CRACK AND RE-PAINT IN CORNER AND ABOVER RIGHT CORNER OF DOOR

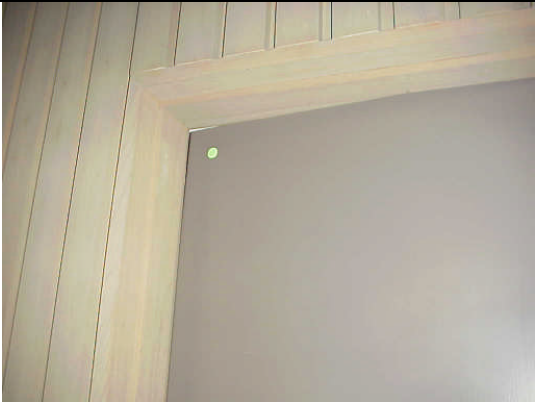
<p><u>BEHIND THE PULPIT:</u> HALLWAY SIDE DOOR IS WARPED ON TOP</p>	98	<p><u>MENS BATHROOM (NEXT TO MAIN ENTRY):</u> 1. BOWL/BASE IS LOOSE</p>	101	<p><u>GIRLS ROOM:</u> 1. WATER LEAKS FROM FAUCET 2. SINK IS NOT SECURED PROPERLY 3. EXHAUST FAN DOES NOT WORK 4. HOLE IN PLASTER ABOVE BLINDS IN CORNER</p>
		99	<p><u>LADIES BATHROOM: (NEXT TO MAIN ENTRY):</u> 1. SINK IS NOT SECURED 2. EXHAUST FAN IS NOISY 3. EXHAUST IS NOT PULLING AIR OUT 4. COLD WATER HANDLE IS VERY LOOSE 5. BOWL/BASE IS LOOSE 6. WATER RUNS IN TANK CONTINUOUSLY</p>	102	<p><u>BEHIND PULPIT STAGE: (LEFT SIDE)</u> 1. EXHAUST FAN IS NOISY 2. ELECTRICAL OUTLET COVER IS LOOSE 3. BOWL/BASE IS LOOSE</p>
		100	<p><u>BOYS ROOM:</u> 1. DRAIN STOPPER PULL ROD ASSY MISSING 2. FLOOR TILE IS LOOSE 3. SINK IS NOT SECURED PROPERLY</p>	103	<p><u>BEHIND PULPIT STAGE: (LEFT SIDE)</u> 1. EXHAUST FAN IS NOT WORKING 2. FAUCET IS LOOSE 3. TANK IS LOOSE</p>
