RSH ENGINEERING, INC.

LIGHT COMMERCIAL INSPECTION REPORT

INSP#: S06110

Address: 12345 Main St, Anywhere, Texas

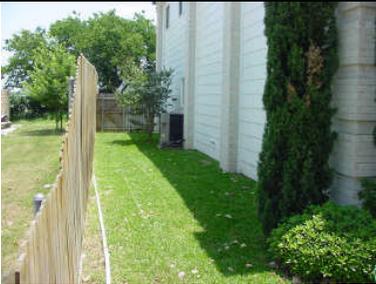
<p>LEFT SIDE OF BUILDING</p> <ol style="list-style-type: none"> LOW SPOT/NEGATIVE SLOPE AREA TOWARDS THE BUILDING WHERE WATER PONDS. GENERAL NOTE: AT ALL FLAT/LOW/NEGATIVE SLOPED AREAS GRADE SURFACE AWAY FROM THE FOUNDATION MINIMUM 6.0-INCHES DROP IN 10- FEET (2000 INTERNATIONAL RESIDENTIAL CODE # 401.3) RECOMMEND A POSITIVE SLOPE (AWAY FROM THE FOUNDATION) OF 1-INCH OF DROP EVERY FOOT FOR THE FIRST FIVE FEET IF POSSIBLE. DO NOT LET WATER POOL/POND AROUND AND WITH-IN 5- FEET OF FOUNDATION. <p>SEE PIC. # 2 TO PIC. # 12 FOR DETAILS.</p>	3

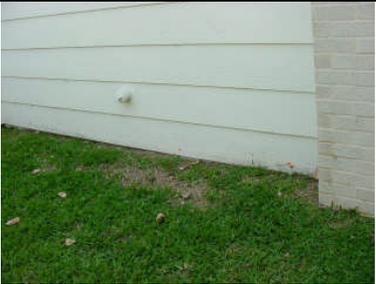
<p>LEFT SIDE OF BUILDING:</p> <ol style="list-style-type: none"> SOIL LEVEL IS TOO HIGH. 2000 IRC # 323.1 REQUIRES THAT THE BOTTOM OF SILL BE 8-INCHES TO EARTH. JAMES HARDIE SPECIFIES 6 INCHES FROM BOTTOM OF PLANK TO SOIL. 	4

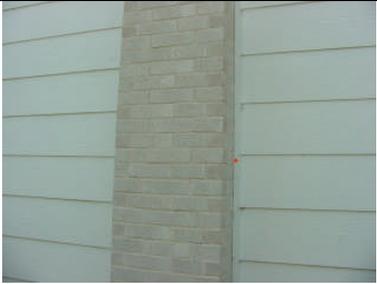
<p>LEFT SIDE OF BUILDING:</p> <p>CAULK TRIM/BRICK INTERFACE TO PREVENT WATER LEAKS (WATER DAMAGE AND MOLD) TO THE INSIDE.</p>	6

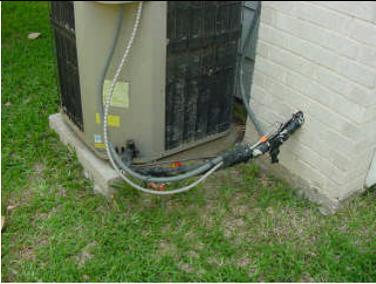
<p>LEFT SIDE OF BUILDING:</p> <ol style="list-style-type: none"> INSULATION MISSING AT FREON LINE – ADD INSULATION SUCH THAT NO COPPER TUBING IS UNINSULATED. WIRING NOT COMPLETELY ENCLOSED IN CONDUIT. 	7

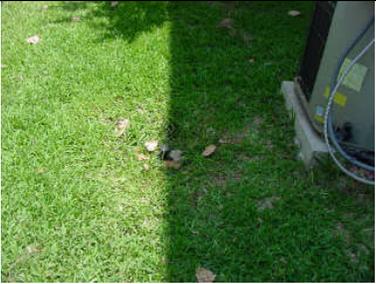
<p>LEFT SIDE OF BUILDING:</p> <p>LOW SPOT AREA WHERE WATER PONDS FOR MORE THAN 24 HOURS – CORRECT DRAINAGE SLOPE.</p>	8

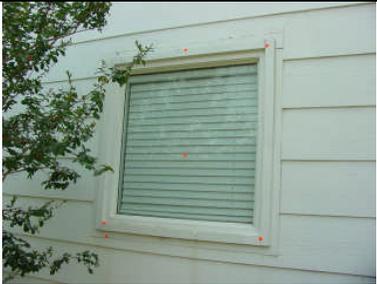
<p>LEFT SIDE OF BUILDING:</p> <ol style="list-style-type: none"> 1. 2000 INTERNATIONAL RESIDENTIAL CODE SECTION R703.8.4. APPROVED CORROSION-RESISTIVE FLASHING SHALL BE PROVIDED IN THE EXTERIOR WALL ENVELOPE IN SUCH A MANNER AS TO PREVENT ENTRY OF WATER INTO THE WALL CAVITY OR PENETRATION OF WATER TO THE BUILDING STRUCTURAL FRAMING COMPONENTS. THE FLASHING SHALL EXTEND TO THE SURFACE OF THE EXTERIOR WALL FINISH AND SHALL BE INSTALLED TO PREVENT WATER FROM REENTERING THE EXTERIOR WALL ENVELOPE. APPROVED CORROSION-RESISTANT FLASHINGS SHALL BE INSTALLED AT ALL OF THE FOLLOWING LOCATIONS: <ol style="list-style-type: none"> 4. ABOVE ALL PROJECTING WOOD TRIMS. 2. CAULK THE WINDOW TRIM/SIDING INTERFACES. 	10

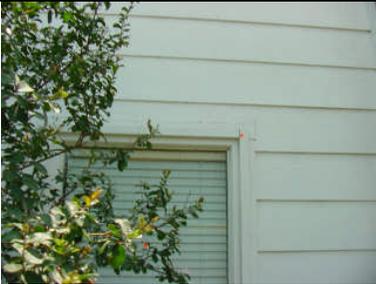
<p>LEFT SIDE OF BUILDING:</p> <p>SIDING PLANK IS CRACKED ABOVE THE WINDOW TRIM AT THE FRONT TOP CORNER.</p>	11

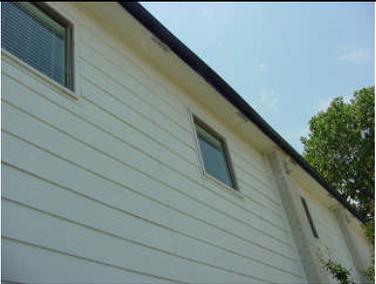
<p>LEFT SIDE OF BUILDING:</p> <p>GENERAL NOTE: SOFFIT VENTS ARE MISSING AND/OR IS INADEQUATE – ADD SOFFIT VENTS. PROVIDE ADEQUATE # OF SOFFIT VENTS TO MEET THE NET FREE VENT OPENINGS OF 1/300 (IF VAPOR BARRIER IS PRESENT) OR 1/150 (IF VAPOR BARRIER IS NOT PRESENT). (UNIFORM BUILDING CODE # 1505.3) (1999 STANDARD BUILDING CODE – 1203.1.3), 2000 INTERNATIONAL RESIDENTIAL CODE # 806.1& # 806. 2.</p>	12

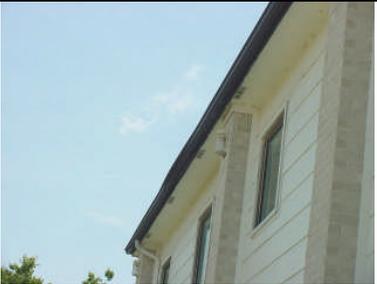
<p>LEFT SIDE OF BUILDING:</p> <p>RAIN GUTTER IS BENT. REPAIR OR REPLACE THE GUTTER.</p>

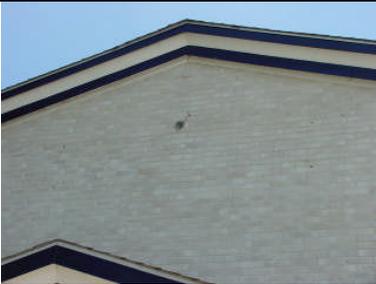
<p>FRONT SIDE OF BUILDING:</p> <ol style="list-style-type: none"> 1. THE LIGHT FIXTURE IS MISSING. INSTALL A LIGHT FIXTURE AND SEAL/CAULK AT THE LIGHT FIXTURE BASE. 2. EXPANSION JOINT IS MISSING IN BRICK VENEER – INSTALL EXPANSION JOINT 3. PROVIDE EXPANSION JOINT THAT IS CLEAR OF ALL MORTAR AND SEAL WITH EXPANSION JOINT SEALANT 	15

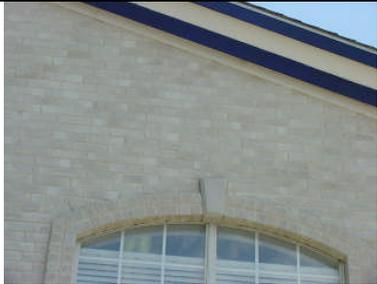
<p>FRONT SIDE OF BUILDING: DIAGONAL STEP CRACK IN THE MORTAR BETWEEN THE BRICKS ABOVE THE WINDOW. SEAL THE MORTAR CRACKS. GENERAL NOTE: CAULK AROUND ALL WINDOWS OF THE BUILDING.</p>	16

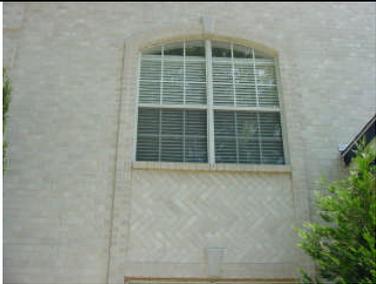
<p>FRONT SIDE OF BUILDING: SEAL THE MORTAR CRACKS BETWEEN THE BRICKS BELOW THE WINDOW TO PREVENT WATER LEAKS TO THE INSIDE AND PREVENT MOLD AND/OR PREVENT MOLD DAMAGE.</p>
17

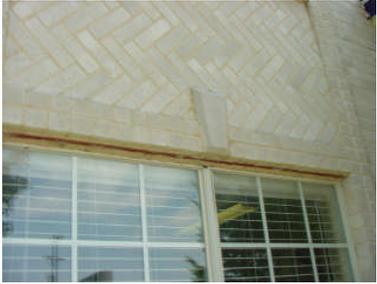
<p>FRONT SIDE OF BUILDING:</p> <ol style="list-style-type: none"> 1. CAULK/SEAL THE WINDOW FRAME AT THE TOP OF THE WINDOW. 2. RUSTING LINTELS – RE-PAINT. 	18

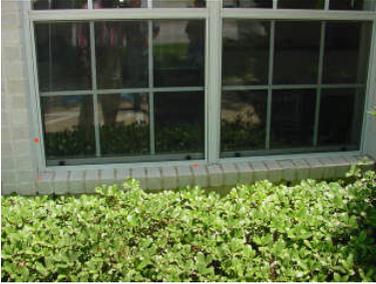
<p>FRONT SIDE OF BUILDING:</p> <ol style="list-style-type: none"> 1. CAULK WINDOW FRAME/BRICK INTERFACE TO PREVENT AIR DRAFT AND WATER LEAKS TO THE INSIDE. 2. SEAL THE MORTAR CRACKS BETWEEN THE BRICKS TO PREVENT WATER LEAKS TO THE INSIDE AND PREVENT MOLD AND/OR PREVENT MOLD DAMAGE. 	19

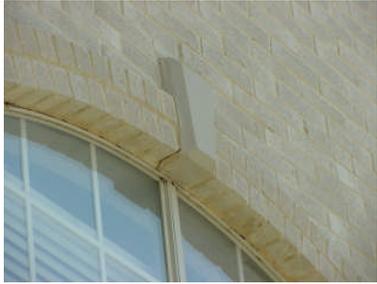
<p>FRONT SIDE OF BUILDING:</p> <ol style="list-style-type: none"> 1. FILL/SEAL THE VOID AT THE CAPSTONE WITH MORTAR. 2. CAULK WINDOW FRAME/BRICK INTERFACE TO PREVENT AIR DRAFT AND WATER LEAKS TO THE INSIDE. 	20

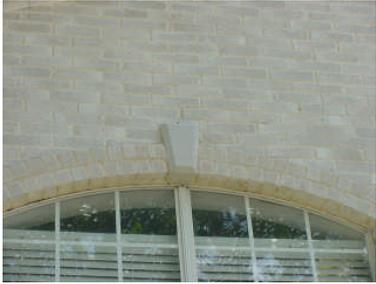
<p>FRONT SIDE OF BUILDING: SEE NOTES AT PIC. # 19. SEAL THE MORTAR CRACKS BETWEEN THE BRICKS TO PREVENT WATER LEAKS TO THE INSIDE AND PREVENT MOLD AND/OR PREVENT MOLD DAMAGE.</p>

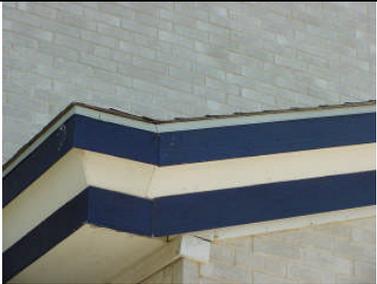
<p>FRONT SIDE OF BUILDING: STARTER COURSE OF SHINGLES MISSING AT BOTTOM ROW OF SHINGLES ALL AROUND THE BUILDING.</p>	22

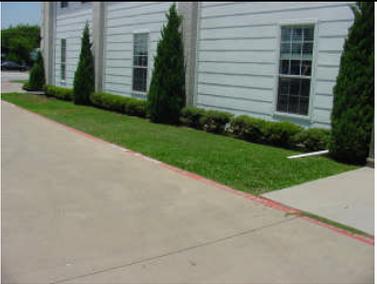
<p>RIGHT SIDE OF BUILDING:</p> <ol style="list-style-type: none"> 1. LOW SPOT/NEGATIVE SLOPE AREA TOWARDS THE BUILDING WHERE WATER PONDS. 2. GENERAL NOTE: AT ALL FLAT/LOW/NEGATIVE SLOPED AREAS GRADE SURFACE AWAY FROM THE FOUNDATION MINIMUM 6.0-INCHES DROP IN 10-FEET (2000 INTERNATIONAL RESIDENTIAL CODE # 401.3) 3. RECOMMEND A POSITIVE SLOPE (AWAY FROM THE FOUNDATION) OF 1-INCH OF DROP EVERY FOOT FOR THE FIRST FIVE FEET IF POSSIBLE. DO NOT LET WATER POOL/POND AROUND AND WITH-IN 5-FEET OF FOUNDATION.
25

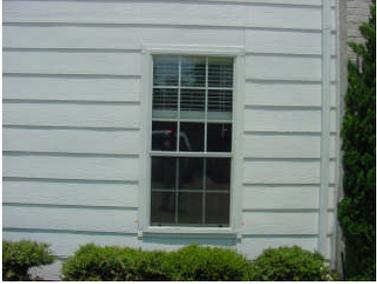
<p>RIGHT SIDE OF BUILDING: 2000 INTERNATIONAL RESIDENTIAL CODE SECTION R703.8.4. APPROVED CORROSION-RESISTIVE FLASHING SHALL BE PROVIDED IN THE EXTERIOR WALL ENVELOPE IN SUCH A MANNER AS TO PREVENT ENTRY OF WATER INTO THE WALL CAVITY OR PENETRATION OF WATER TO THE BUILDING STRUCTURAL FRAMING COMPONENTS. THE FLASHING SHALL EXTEND TO THE SURFACE OF THE EXTERIOR WALL FINISH AND SHALL BE INSTALLED TO PREVENT WATER FROM REENTERING THE EXTERIOR WALL ENVELOPE. APPROVED CORROSION-RESISTANT FLASHINGS SHALL BE INSTALLED AT ALL OF THE FOLLOWING LOCATIONS: 4. ABOVE ALL PROJECTING WOOD TRIMS.</p>	26

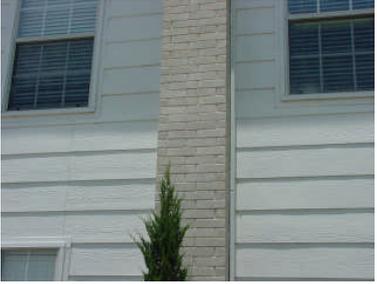
<p>RIGHT SIDE OF BUILDING: CAULK TRIM/BRICK INTERFACE TO PREVENT WATER LEAKS (WATER DAMAGE AND MOLD) TO THE INSIDE.</p>

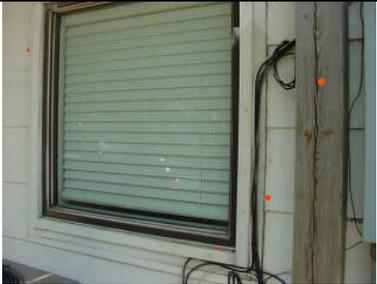
<p>BACK SIDE OF BUILDING:</p> <ol style="list-style-type: none"> 1. CAULK THE TRIM/SIDING INTERFACES. 2. THE POST OF THE STAIRWAY IS SPLITTING. REPLACE OR REPAIR THE POST. 3. THE TRIM AT THE BOTTOM OF THE WINDOW IS PROJECTING. REFER TO NOTES AT NEXT PICTURE. 	42

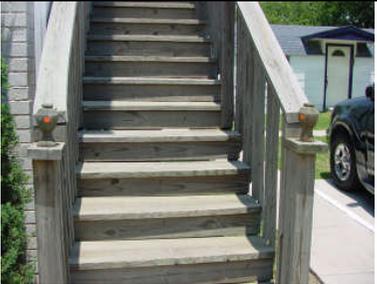
<p>BACK SIDE OF BUILDING: THE ORNAMENTAL KNOBS AT THE TOPS AT THE HAND RAILS AT THE BOTTOM POSTS ARE LOOSE AND DAMAGED. REPLACE THE KNOBS.</p>

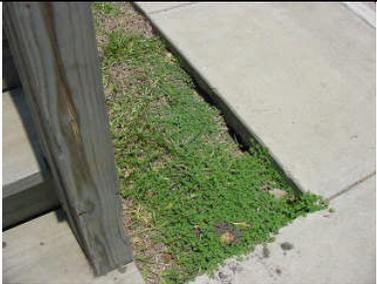
<p>BACK SIDE OF BUILDING: SOIL MISSING BELOW WALKWAY NEAR THE BOTTOM OF THE STAIRS. ADD SOIL.</p>	50

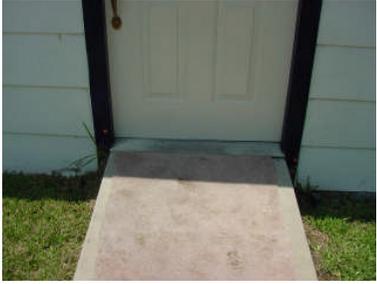
<p>OUTBACK BUILDING OFFICE: THE DOOR FACING AT EACH SIDE OF THE DOOR IS ROTTED OUT. REPLACE THE TRIM AND PAINT THE NEW TRIM TO MATCH EXISTING COLOR.</p>	54

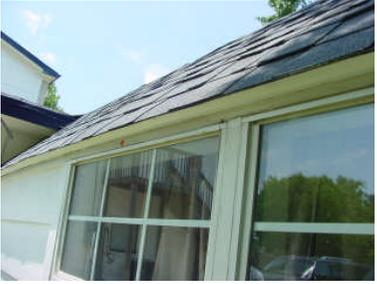
<p>OUTBACK BUILDING OFFICE: CAULK/SEAL THE WINDOW FRAME/SIDING INTERFACES ALL AROUND THE WINDOW(S).</p>

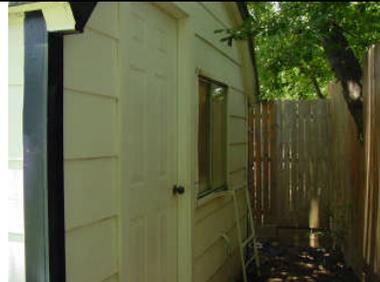
<p>OUTBACK BUILDING OFFICE:</p> <ol style="list-style-type: none"> 1. THE TRIM AROUND THE WINDOW IS ROTTED. REPLACE THE TRIM AND PAINT THE NEW TRIM TO MATCH EXISTING COLOR. 2. INSTALL FLASHING ABOVE ALL PROJECTING WOOD TRIM (REFER TO NOTES AT PIC. # 42). 	58

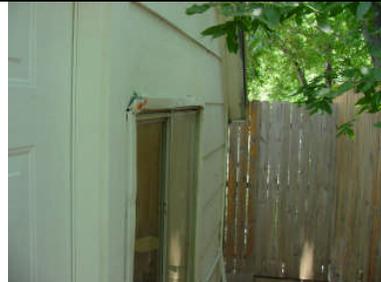
<p>OUTBACK BUILDING OFFICE:</p> <p>SEE NOTES AT PIC. # 57.</p>	59

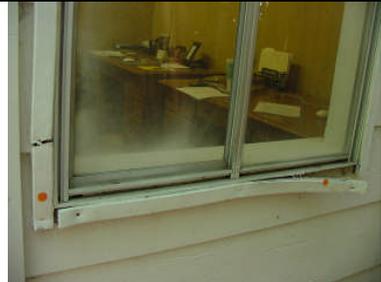
<p>OUTBACK BUILDING OFFICE:</p> <ol style="list-style-type: none"> 1. WINDOW SCREEN IS MISSING. 2. CLEAN PAINT FROM THE GLASS PANES OF THE WINDOW. 3. SEE NOTES AT PIC. # 57 FOR ADDITIONAL DETAILS. 	60

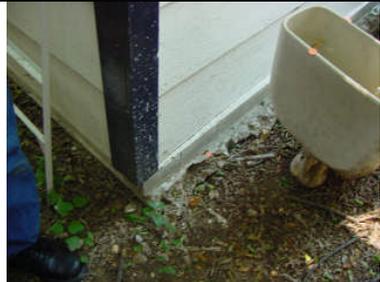
<p>OUTBACK BUILDING OFFICE:</p> <p>THERE APPEARS TO BE NO FOOTING FOR THE SLAB OF THIS BUILDING.</p>
61

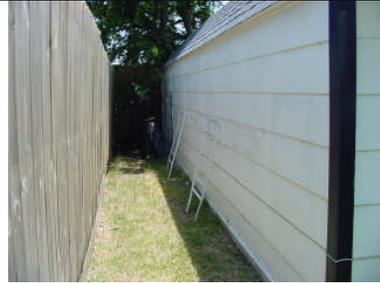
<p>OUTBACK BUILDING OFFICE:</p> <ol style="list-style-type: none"> 1. LOW SPOT/NEGATIVE SLOPE AREA TOWARDS THE BUILDING WHERE WATER PONDS. 2. GENERAL NOTE: AT ALL FLAT/LOW/NEGATIVE SLOPED AREAS GRADE SURFACE AWAY FROM THE FOUNDATION MINIMUM 6.0-INCHES DROP IN 10-FEET (2000 INTERNATIONAL RESIDENTIAL CODE # 401.3) 3. RECOMMEND A POSITIVE SLOPE (AWAY FROM THE FOUNDATION) OF 1-INCH OF DROP EVERY FOOT FOR THE FIRST FIVE FEET IF POSSIBLE. DO NOT LET WATER POOL/POND AROUND AND WITH-IN 5- FEET OF FOUNDATION. 	62

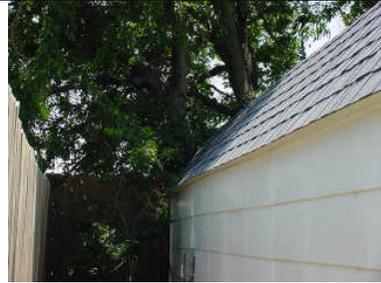
<p>OUTBACK BUILDING OFFICE:</p> <p>CUT THE TREE BRANCHES AWAY FROM THE BUILDING SO THEY ARE UNLIKELY TO CONTACT THE BUILDING IN WINDS OF 20 MPH.</p>	63

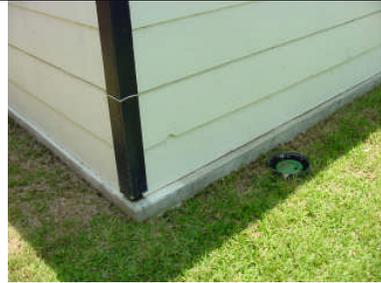
<p>OUTBACK BUILDING OFFICE:</p> <p>PROVIDE FLASHING AT THE FOUNDATION TO PREVENT WATER LEAKS TO THE INSIDE.</p>	64

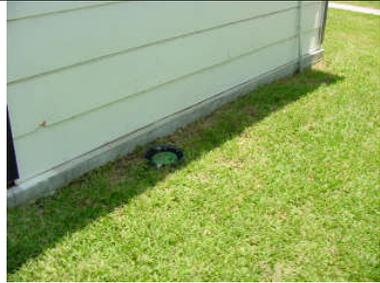
<p>OUTBACK BUILDING OFFICE:</p> <p>REPLACE THE DAMAGED SIDING. SEE NOTES AT PIC. # 63.</p>

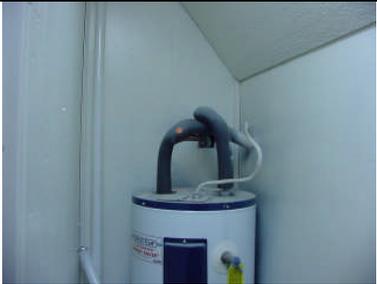
<p>OUTBACK BUILDING OFFICE: 1. INSULATION NOT SECURED AROUND THE WATER PIPES ABOVE THE WATER HEATER. 2. GROUND WIRE FOR THE WATER HEATER SEEMS TO BE MISSING.</p>	74

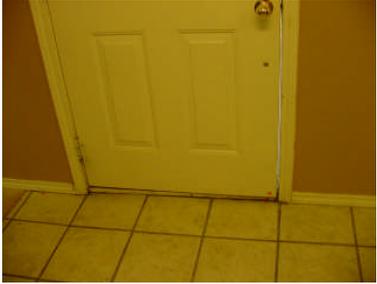
<p>OUTBACK BUILDING OFFICE: AIR GAP AROUND THE DOOR. REPAIR THE WEATHER STRIPPING.</p>	78

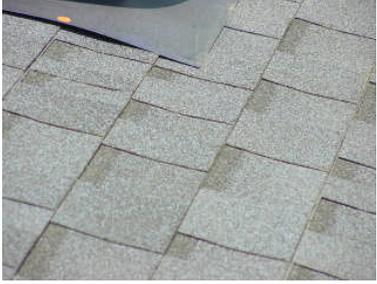
<p>ROOF: CLOSE-UP OF PIC. # 80. THE ROWS OF SHINGLES AT EACH SIDE OF THE VENT SHOULD OVERLAP THE BASE TO PREVENT WATER LEAKS (WATER DAMAGE AND MOLD) TO THE INSIDE.</p>	82

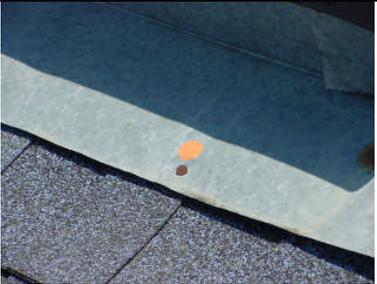
<p>ROOF: CLOSE-UP OF PIC. # 86. GENERAL NOTE: SEAL OVER ALL EXPOSED NAILS AND/OR STAPLES HOLDING DOWN THE FLUE/ATTIC VENTS/SEWER VENT BASES WITH ROOF CEMENT.</p>
89

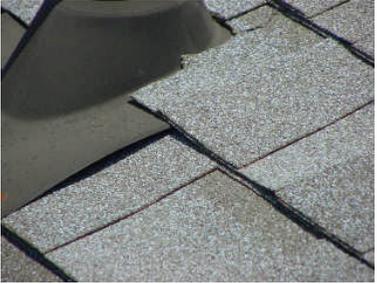
<p>ROOF: CLOSE-UP OF PIC. # 91. THE ROWS OF SHINGLES AT EACH SIDE OF THE VENT SHOULD OVERLAP THE BASE TO PREVENT WATER LEAKS (WATER DAMAGE AND MOLD) TO THE INSIDE.</p>

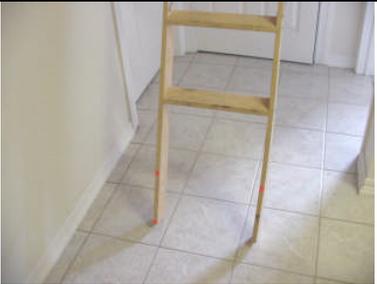
<p>ATTIC:</p> <ol style="list-style-type: none"> THE BOTTOM STEP OF THE PULL-DOWN DOOR IS MISSING. CUT THE LEGS OF THE LADDER SO THEY ARE FLUSH WITH THE FLOORING.
97

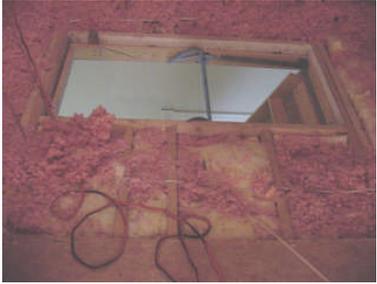
<p>ATTIC:</p> <ol style="list-style-type: none"> PROVIDE DECKING AROUND THE PULL-DOWN DOOR TO PREVENT ACCIDENTS. PROVIDE UNOBSTRUCTED ACCESS PATH 24 INCHES WIDE, NOT MORE THAN 20 FEET IN LENGTH WHEN MEASURED ALONG THE CENTERLINE, FROM THE ACCESS POINT TO THE APPLIANCE. 2000 INTERNATIONAL RESIDENTIAL CODE SECTION M1305.1.3. 	98

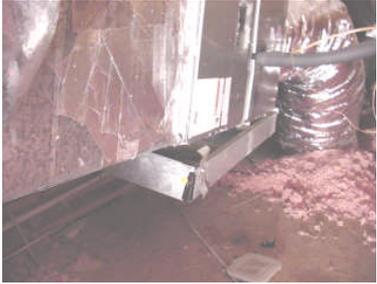
<p>ATTIC: THE EMERGENCY DRAIN PAN IS DAMAGED AND NOT HAVING PROPER SLOPE TOWARDS DRAIN AND WILL NOT PREVENT WATER DAMAGE TO THE INTERIOR OF THE BUILDING DURING TIMES OF EMERGENCY.</p>	106

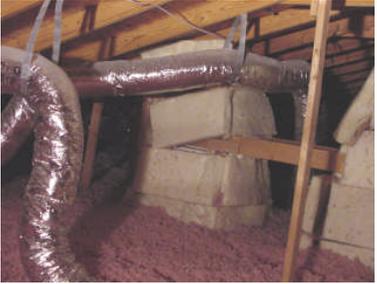
<p>ATTIC: SKYLIGHT WALL AREA IS MISSING INSULATION – SEE PIC. # 109 FOR CLOSE UP</p>

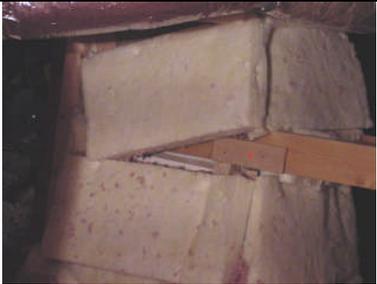
ATTIC: CLOSEUP OF PIC. # 108 WHERE INSULATION COVERAGE IS MISSING. INSTALL INSULATION.	110

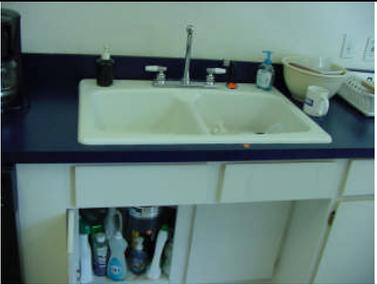
INSIDE KITCHEN: THE SINK IS LOOSE. SECURE THE SINK. CAULK THE SINK RIM/COUNTERTOP INTERFACE. THE SPRAYER ASSEMBLY IS LOOSE. TIGHTEN THE SPRAYER. THE GARBAGE DISPOSAL DOES NOT OPERATE.
113

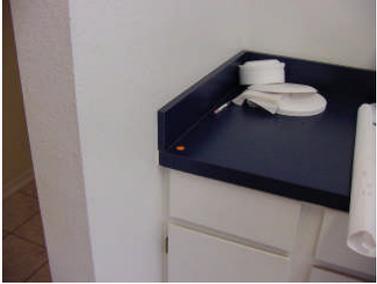
INSIDE KITCHEN: GROUT CRACKS AT THE COUNTERTOP/SPLASH BACK INTERFACE.	114

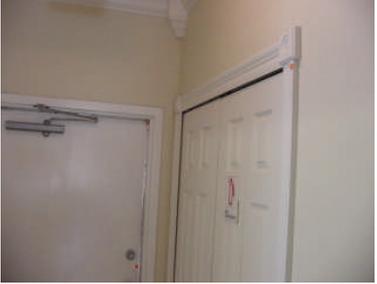
INSIDE DOWNSTAIRS REAR HALLWAY: JOINT CRACKS AT DOOR TRIM CORNERS.

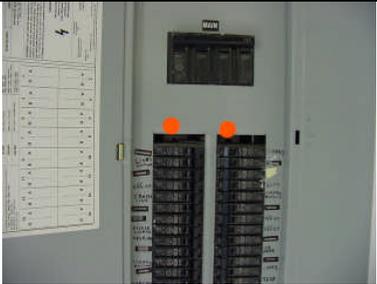
<p>INSIDE ELECTRICAL PANEL CLOSET: SEAL THE OPENINGS WHERE BREAKERS AND TABS ARE MISSING WITH PLASTIC FILLERS THAT CAN BE PURCHASED AT RETAILERS WHO SELL THE BREAKERS FOR THIS MODEL PANE.</p>	118

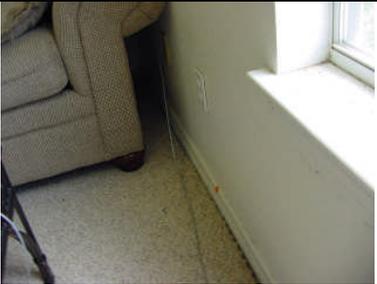
<p>INSIDE ROOM 2 (DOWNSTAIRS RIGHT REAR ROOM): BASEBOARD/DRYWALL SEPARATION CRACKS.</p>
121

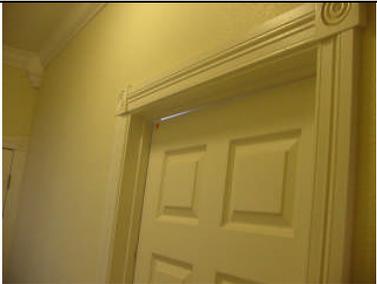
<p>INSIDE RIGHT MIDDLE ROOM DOWNSTAIRS: DOOR IS NOT SQUARE WITH FRAME.</p>	122

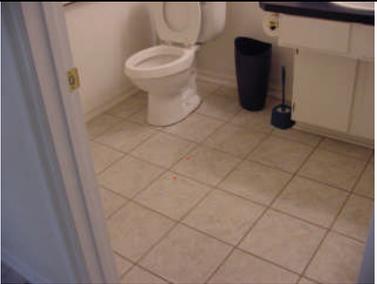
INSIDE DOWNSTAIRS REAR RESTROOM: FLOOR TILES ARE CRACKED.
129

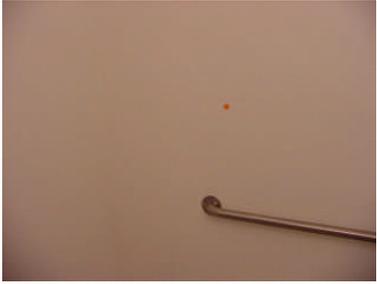
INSIDE DOWNSTAIRS REAR RESTROOM: TEXTURE MISMATCH ON WALL.	130

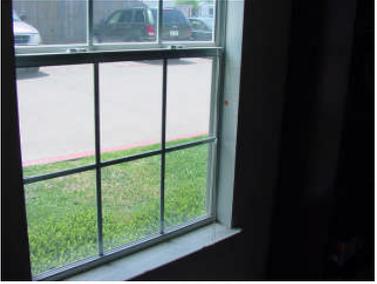
INSIDE DOWNSTAIRS ROOM 1: CAULK AROUND THE WINDOW FRAME.
133

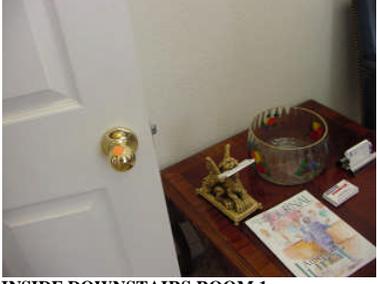
INSIDE DOWNSTAIRS ROOM 1: DOOR KNOB IS LOOSE.	134

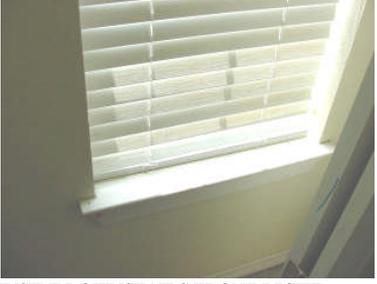
INSIDE DOWNSTAIRS FRONT RIGHT ROOM: THE TRIM BELOW THE WINDOWSILL IS COMING LOOSE.

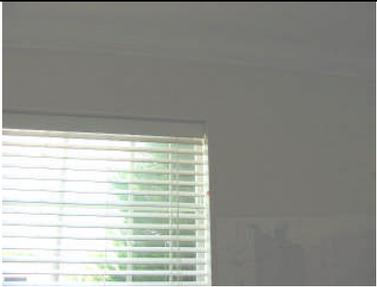
INSIDE DOWNSTAIRS FRONT RIGHT ROOM: CORNER CRACK AT WINDOW.	138

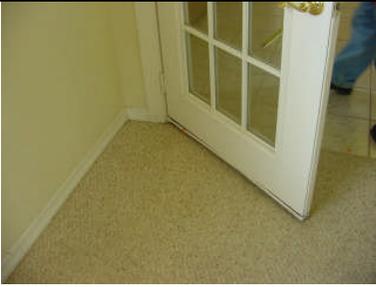
INSIDE DOWNSTAIRS FRONT RIGHT ROOM: GENERAL NOTE: THROUGHOUT THE BUILDING DOOR STOPS ARE MISSING.	139

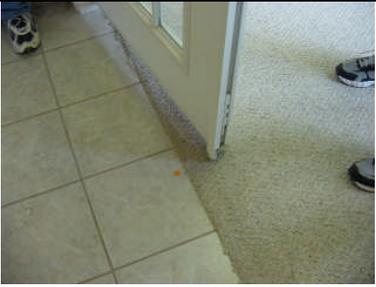
INSIDE DOWNSTAIRS FRONT RIGHT ROOM: NO LATCH PLATE FOR BOTTOM OF DOOR.	140

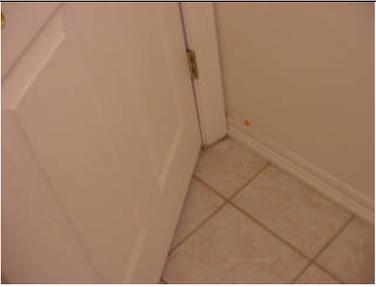
INSIDE DOWNSTAIRS FRONT RESTROOM: DRYWALL DAMAGE BEHIND THE DOOR.	144

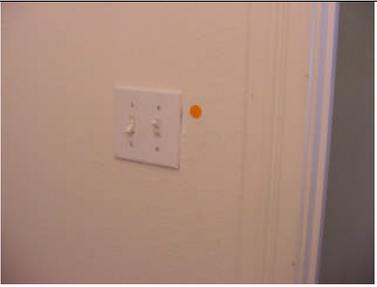
INSIDE DOWNSTAIRS FRONT RESTROOM: GAP AT SWITCH COVER/DRYWALL INTERFACE.
145

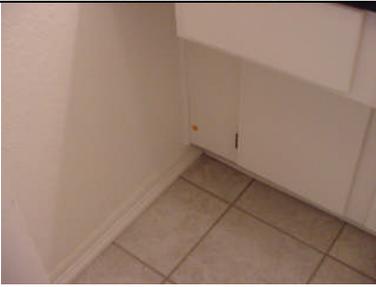
INSIDE DOWNSTAIRS FRONT RESTROOM: SEPARATION CRACK AT THE WALL/CABINET INTERFACE.	147

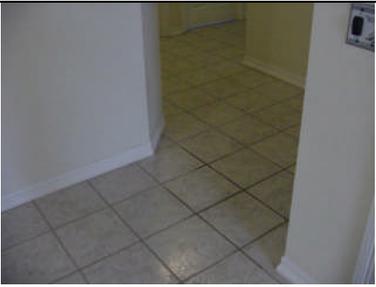
INSIDE UPSTAIRS LANDING AREA: THE FLOOR IS OFF LEVEL BY 3/4-INCH IN 4 FEET TOWARDS THE LEFT WALL.	148

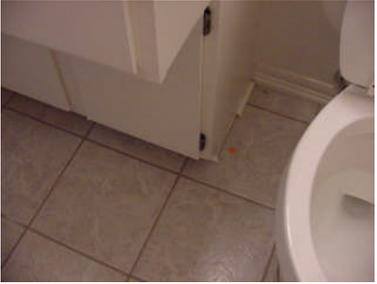
INSIDE UPSTAIRS FRONT RESTROOM: FLOOR TRIM MISSING.
157

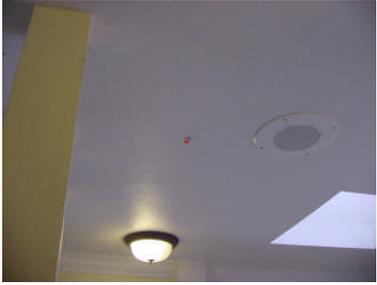
INSIDE: DRYWALL DAMAGED ON CEILING ABOVE STAIRWAY.	158

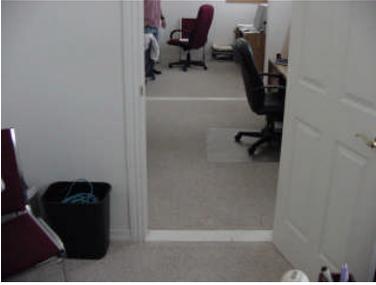
INSIDE UPSTAIRS LEFT REAR OFFICE: 1. FLOOR IS OFF LEVEL FROM REAR TO THE FRONT OF THE MIDDLE LEFT OFFICE BY 1-1/2 INCH. 2. THE FLOOR IS OFF LEVEL FROM THE REAR OF THE REAR OFFICE TO THE FRONT OF THE FRONT OFFICE BY 1 INCH.	159

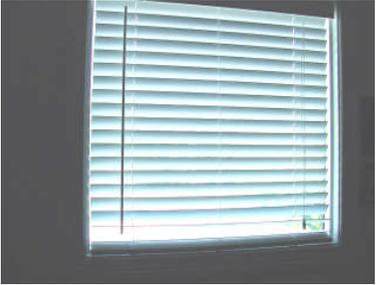
INSIDE UPSTAIRS LEFT REAR OFFICE: THE WINDOWS ARE NOT OPERABLE IN THE UPSTAIRS LEFT THREE OFFICES. CHECK WITH CITY OF THE COLONY REGARDING EGRESS VIOLATIONS, THE OFFICES EACH HAVE A DOOR INTO THE HALLWAY AND HAVE DOORS BETWEEN THE THREE OFFICES.	160

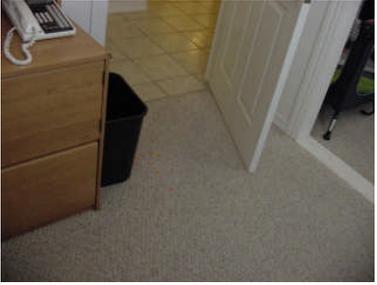
INSIDE UPSTAIRS LEFT REAR OFFICE: THE FLOOR OF THE MIDDLE OFFICE IS OFF LEVEL FROM LEFT TO RIGHT BY 1 INCH.

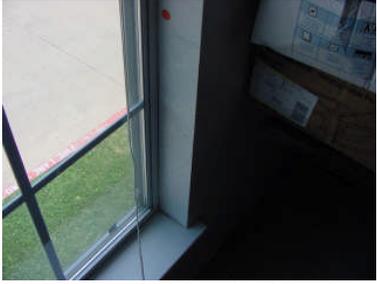
INSIDE UPSTAIRS RIGHT REAR OFFICE: CAULK THE WINDOW FRAME.	174

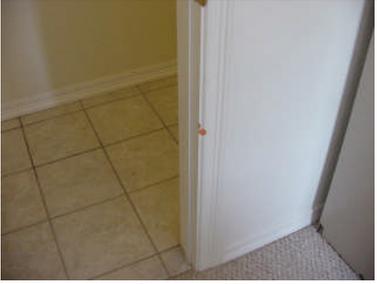
INSIDE UPSTAIRS ROOM 10: DOOR FACING IS DAMAGED.
177

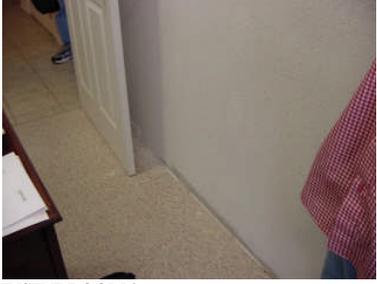
INSIDE ROOM 9: BASEBOARD MISSING AT REAR WALL.	178

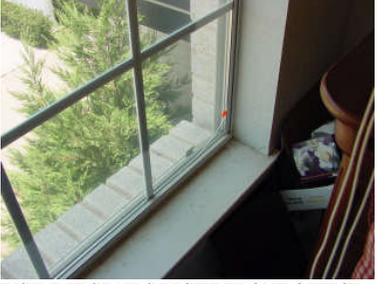
INSIDE UPSTAIRS RIGHT FRONT OFFICE (ROOM 8): CRACKED WINDOW.
