# SOLEDAD MOUNTAIN ROAD LANDSLIDE REMEDIATION PROJECT

EDITED BY KELLY M. PAGE

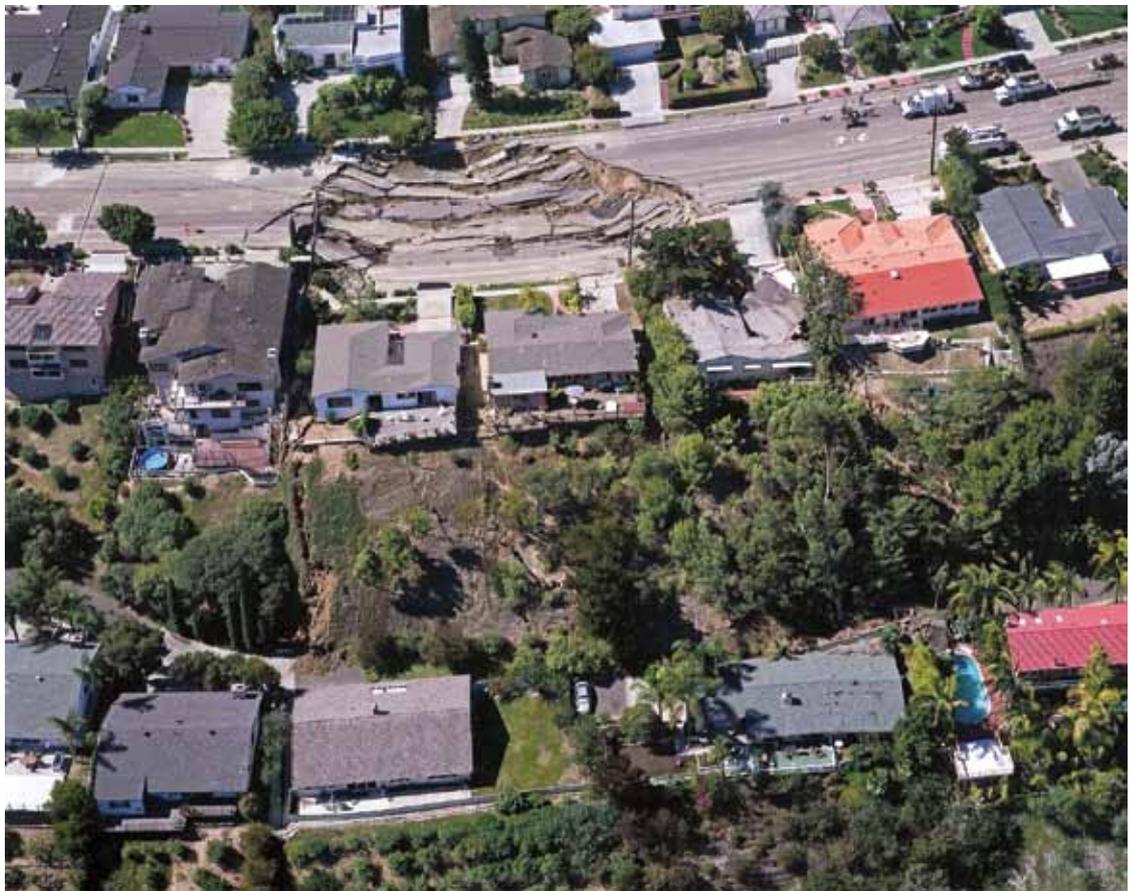
**O**n the morning of October 3, 2007, at approximately 8:50 a.m., a large landslide approximately 250 ft (76.2 m) in width occurred in the 5700 block of Soledad Mountain Road. The failure, which represents a partial reactivation of a larger ancient landslide underlying the Soledad Corona Estates subdivision, lasted 45 minutes and resulted in a total lateral eastward translation of approximately 25 ft (7.6 m). Soledad Mountain Road was rendered impassable in both directions, and Upper Desert View Drive was blocked by debris, cutting off access to eight residences. In addition to affecting traffic flow in the area, four homes were destroyed, and three more adjacent to the landslide margins were damaged to varying degrees and tagged as unsafe for occupancy by the city of San

*Soledad Mountain Road landslide, October 3, 2007*

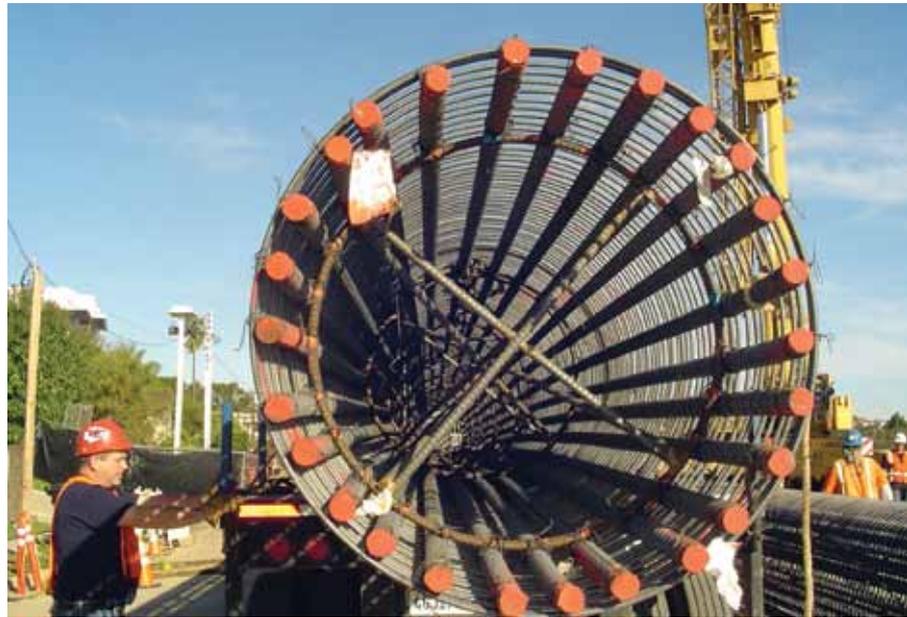
*Closeup of reinforcement cage*

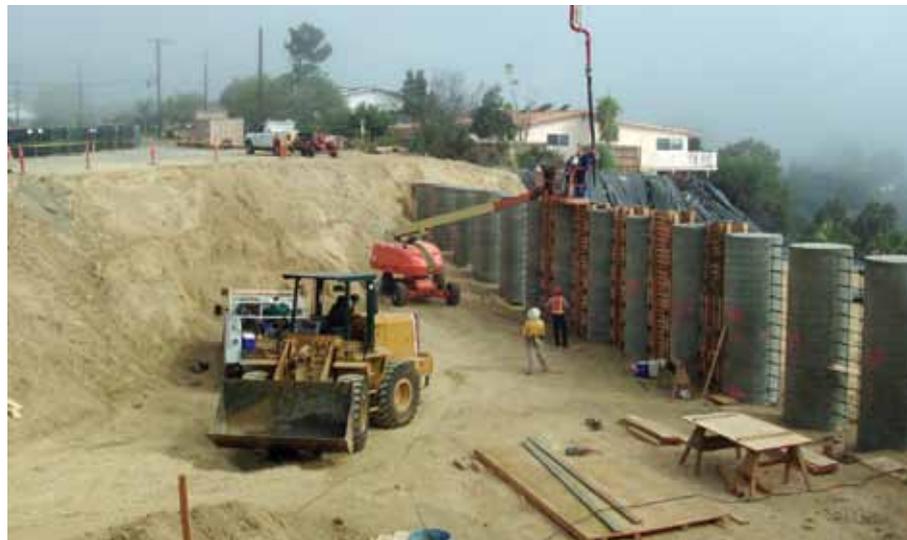
*East-side shoring panel wall construction*

Following installation, shear pin Numbers 49 through 70 were connected by poured-in-place concrete panels. The top of each panel wall was formed to match the flanking piers, whereas the bottom of the panels matched existing grade across the landslide mass at the time of construction to a maximum height of 16 ft (4.9 m). Panels were 12 in. (305 mm) thick, reinforced with No. 5 reinforcing steel bars (vertical) 15 in. (381 mm) on center and No. 5 reinforcing steel bars (horizontal) 12 in. (305 mm) on center. Connections to adjacent pins were made with 3 ft (0.9 m) lengths of No. 5 reinforcing steel bars, vertically spaced 12 in. (305 mm) on center, lap-spliced with the panel wall reinforcement with 18 in. (457 mm) embedment into the adjacent pin. The purpose of the panel wall was to prevent soils from pushing between the shear pins during restoration of the right-of-way and to provide additional lateral support for Soledad Mountain Road until fill could be placed on the east side of the shear pins and eliminate the grade break. Blockouts were formed at predetermined elevations to facilitate the future installation of residential sewer connections for the residences at 5703 and 5715 Soledad Mountain Road.

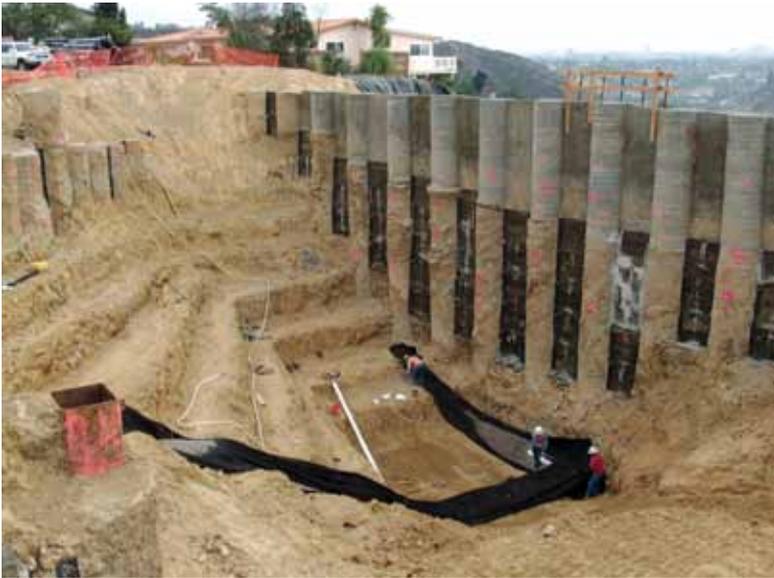
*Temporary and east-side shoring during excavation*

Following completion of the temporary and east-side shoring, slot-cut excavations were undertaken to remove compressible landslide debris and restore the roadway using geogrid reinforced engineered fill. Temporary lagging was placed between adjacent shear pins. Cut lagging ends were angled to match the approximate curvature of adjacent shear pins. Lagging was braced behind angle iron that was anchored to adjacent shear pins using epoxy-anchored bolts. Shoring was grouted at vertical intervals not exceeding 4 ft (1.2 m). Excavation and backfill

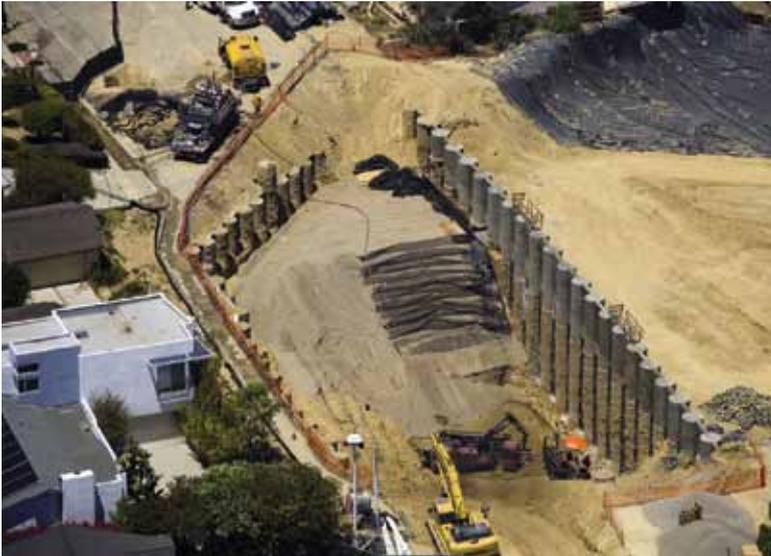
*Geogrid reinforced fill in Slot 1 excavation*

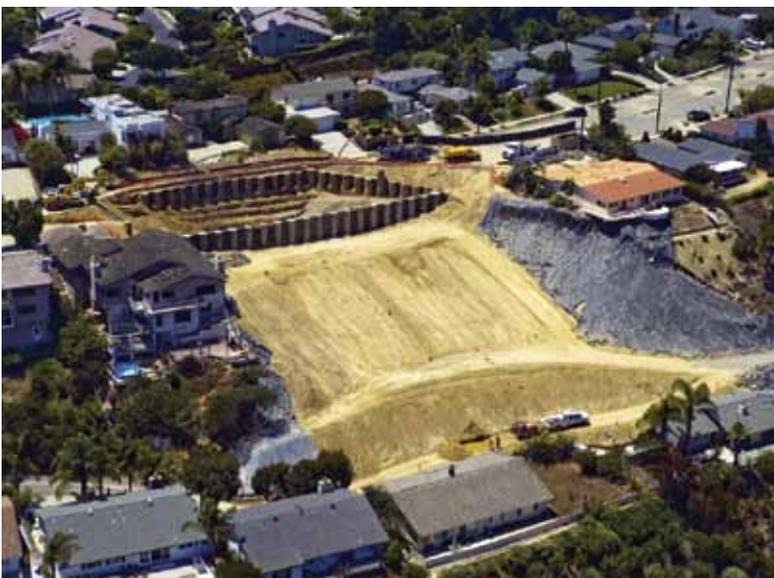
*Aerial view of shoring during repairs*

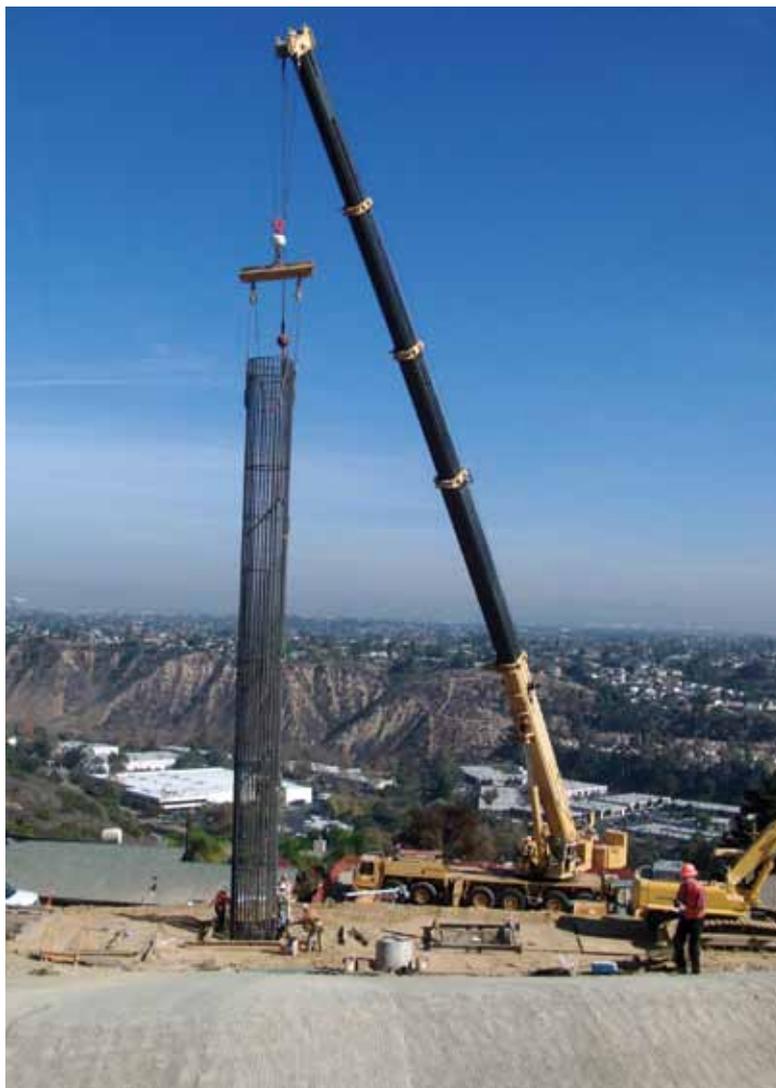
*Setting of reinforcement cage using 500 ton (453.6 metric ton) crane*

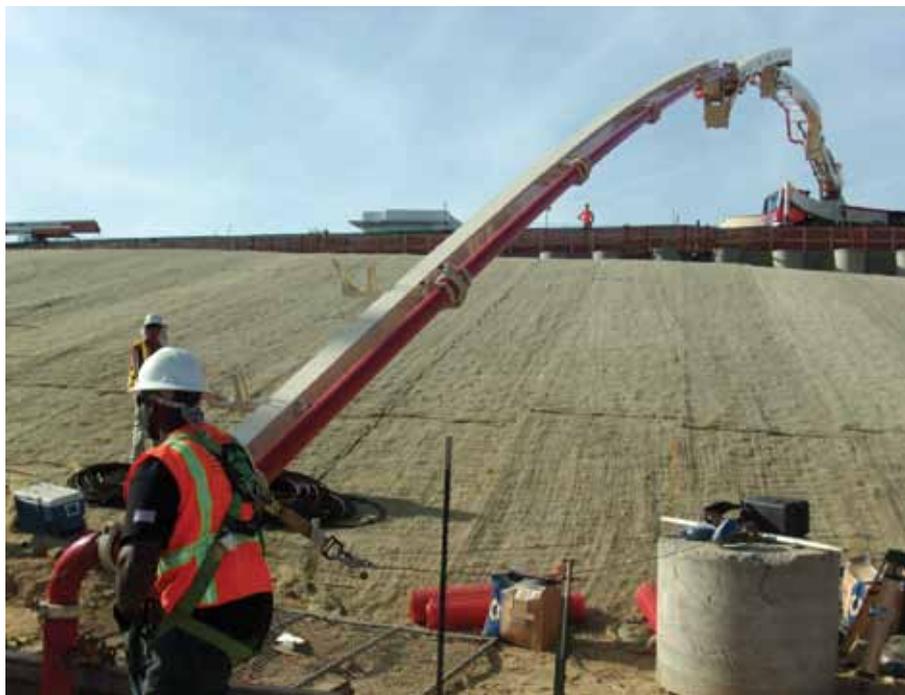
*Pumping concrete using 170.6 ft (52 m) boom truck*

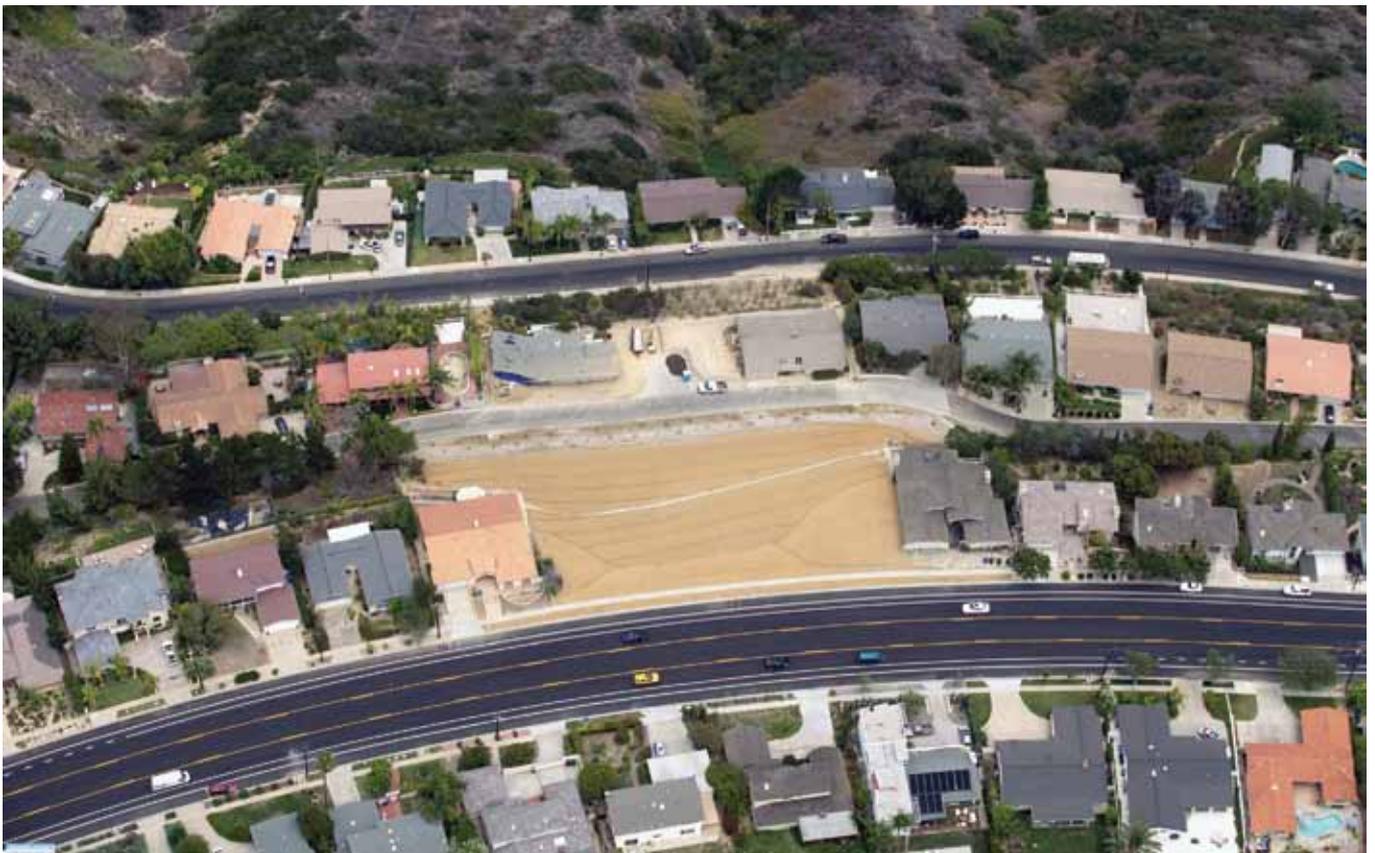
*Completed landslide remediation repair of Soledad Mountain Road and Upper Desert View Drive*
