Characterization and Stabilization of Reactivated Ancient Landslide, Soledad Mountain Road, La Jolla, California

Stanley Helenschmidt¹, G.E., R.C.E; Michael Hart², CEG; Rupert Adams³, CEG

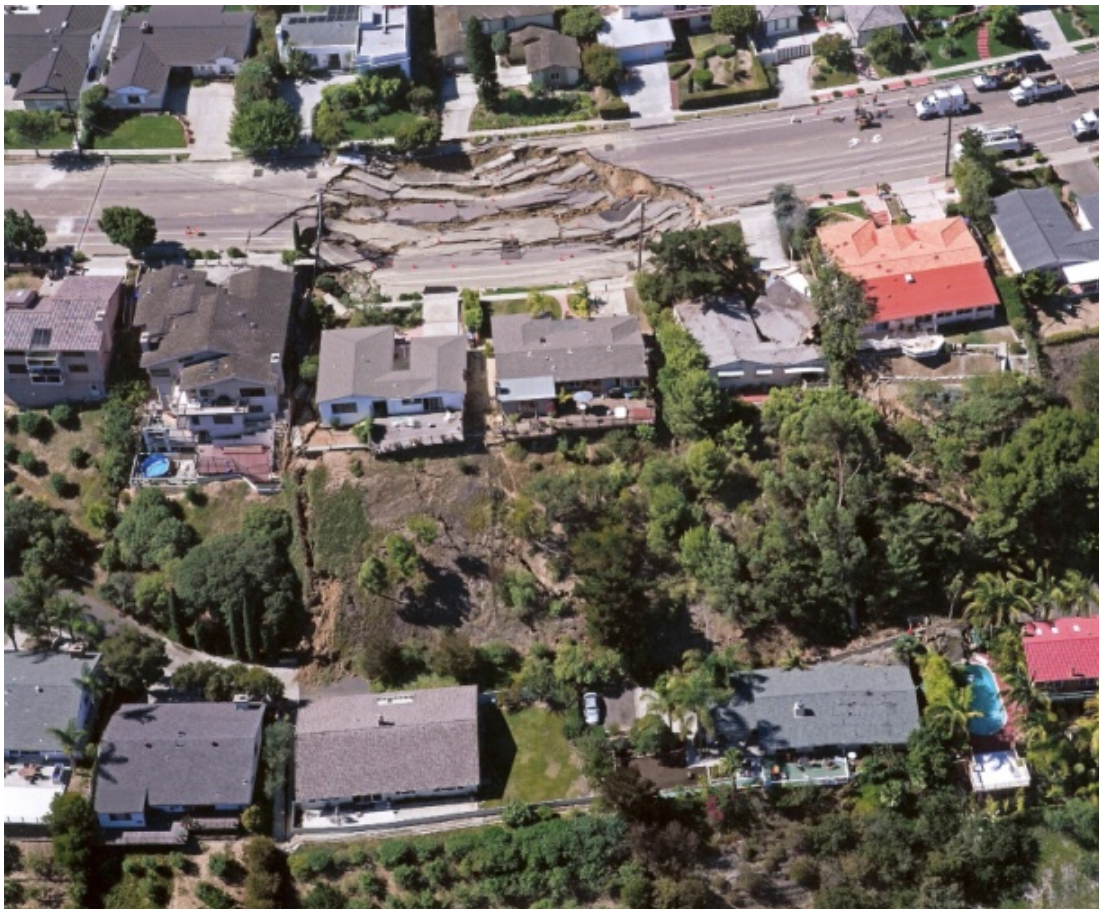
**FIG. 2. Aerial View of October 3, 2007 Landslide
Photo From Geo-Tech Imagery Intl.**

The landslide failed at approximately 8:50 am on October 3, 2007. A sudden drop of the pavement of approximately 15 mm occurred across the head of the landslide at Soledad Mountain Road followed by snapping of power lines. Several minutes elapsed prior to the major episode of displacement that resulted in translation of the residential structures 5703 to 5725 and rear yard slope approximately six meters toward the east and a drop in elevation in the street and building areas (5703 to 5725) of approximately three meters. Run-out at the toe area buried the front of the residence at 5734 Desert View Drive Alley and the alley was covered with up to 4.6 meters of landslide debris from the north end of 5720 to the south end of 5748. A free-standing wall at the east side of the alley at 5748 was also covered with landslide debris. The limits of the landslide are shown on the Geologic Map, Figure 5. A photograph of the landslide after the failure is shown on Figure 2.

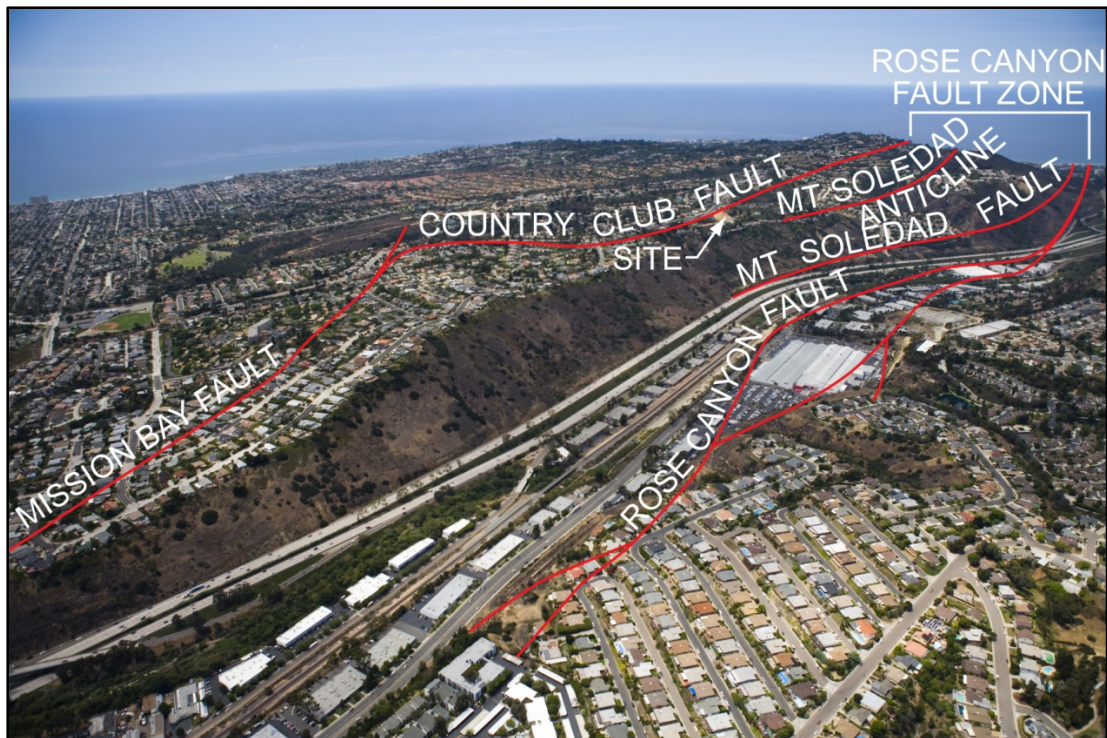
The site lies near the crest of the Mount Soledad anticline, a broad, asymmetrical fold resulting from compressional forces that developed along a bend in the Rose Canyon Fault Zone (Figure 3). Bedding attitudes shown on the geologic map of the La Jolla Quadrangle (Kennedy, 1975) generally indicate low to moderate dips of from 10 to 16 degrees to the east and southeast. These attitudes are in general

FIG. 3. Mount Soledad Faults
Base Photo From Geo-Tech Imagery Intl. (Annotation Added)

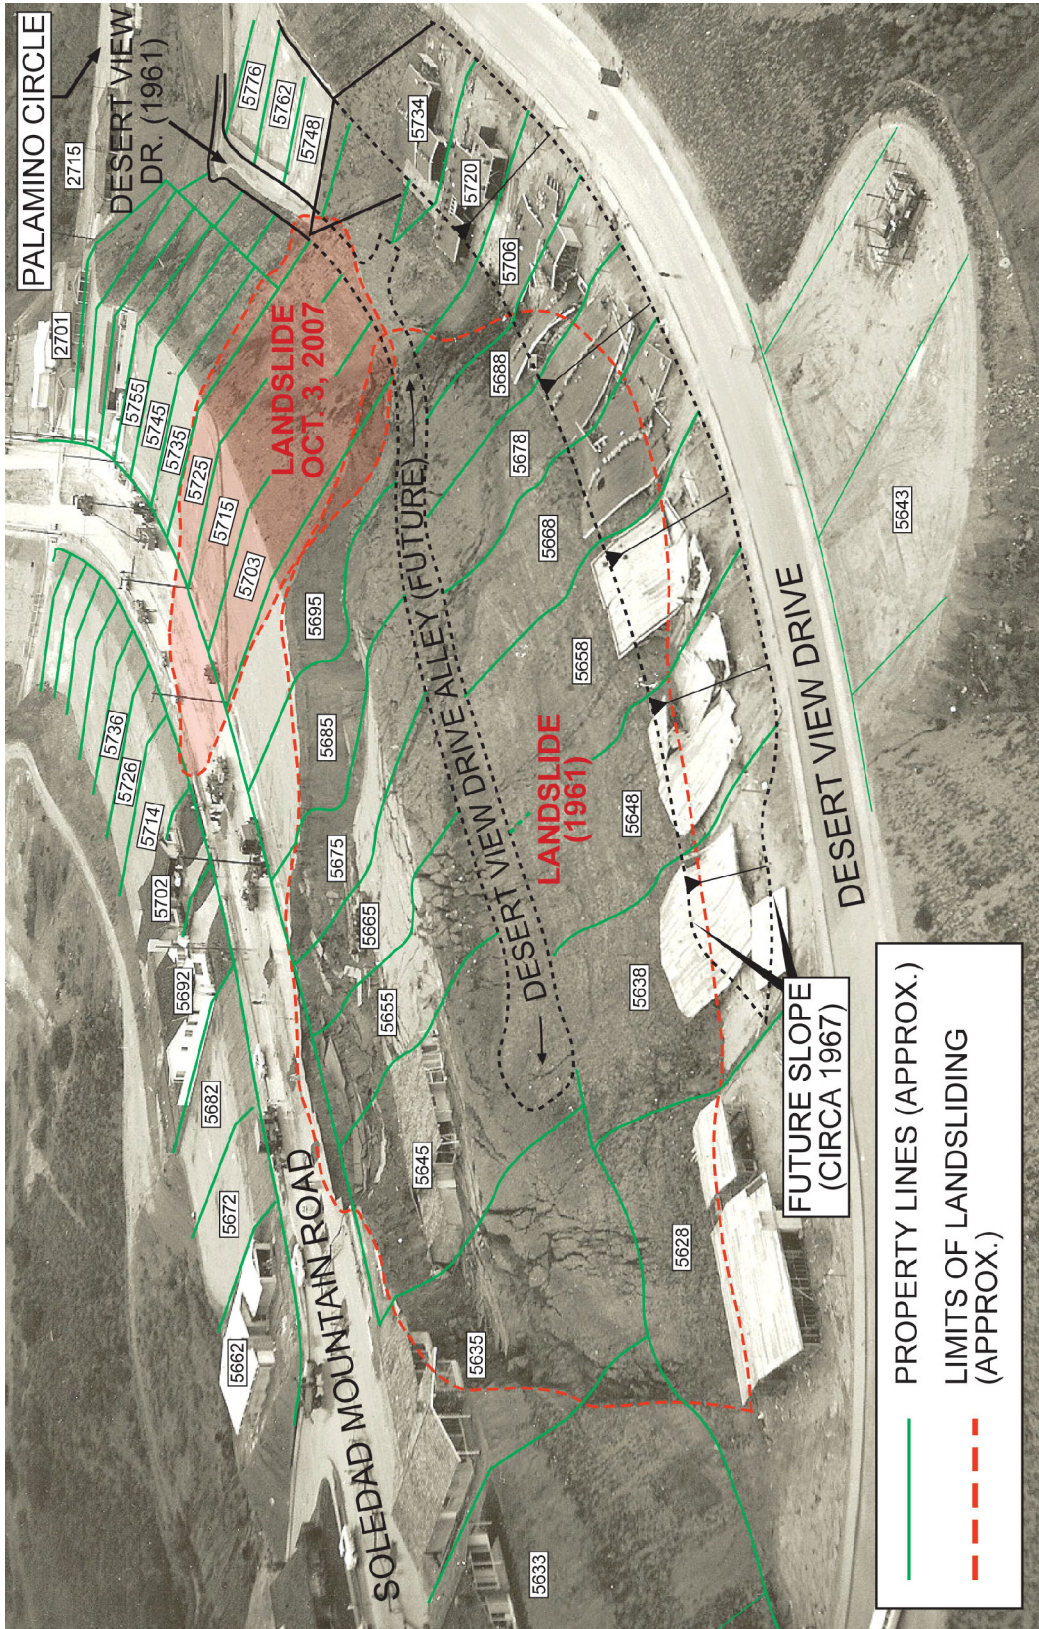
Grading for Soledad Mountain Road occurred between 1953 and 1961. Grading for the adjacent subdivision, Soledad Corona Estates (lots immediately east of Soledad Mountain Road) occurred in 1960-1961. During construction of homes in 1961 along south Desert View Drive and along the east side of Soledad Mountain Road immediately south of the October 3, 2007 slope failure, a larger landslide occurred (December 14, 1961) that extended approximately half way across Soledad Mountain Road and encompassed several building pads and the descending slope area east of Soledad Mountain Road. At least eight homes under construction were destroyed. Based on review of an oblique aerial photo taken in 1961 (San Diego Historical Society), the toe of the landslide extended through the slope to just above Desert View Drive (Figure 4). The toe area of the slide on the northern flank appears to have transected the lower portion of the slope of the property at 5695 Soledad Mountain Road coinciding with the southerly boundary of the 2007 failure.

FIG. 4. 1961 Aerial Photograph
 Base Photo From San Diego Historical Society (Annotation Added)

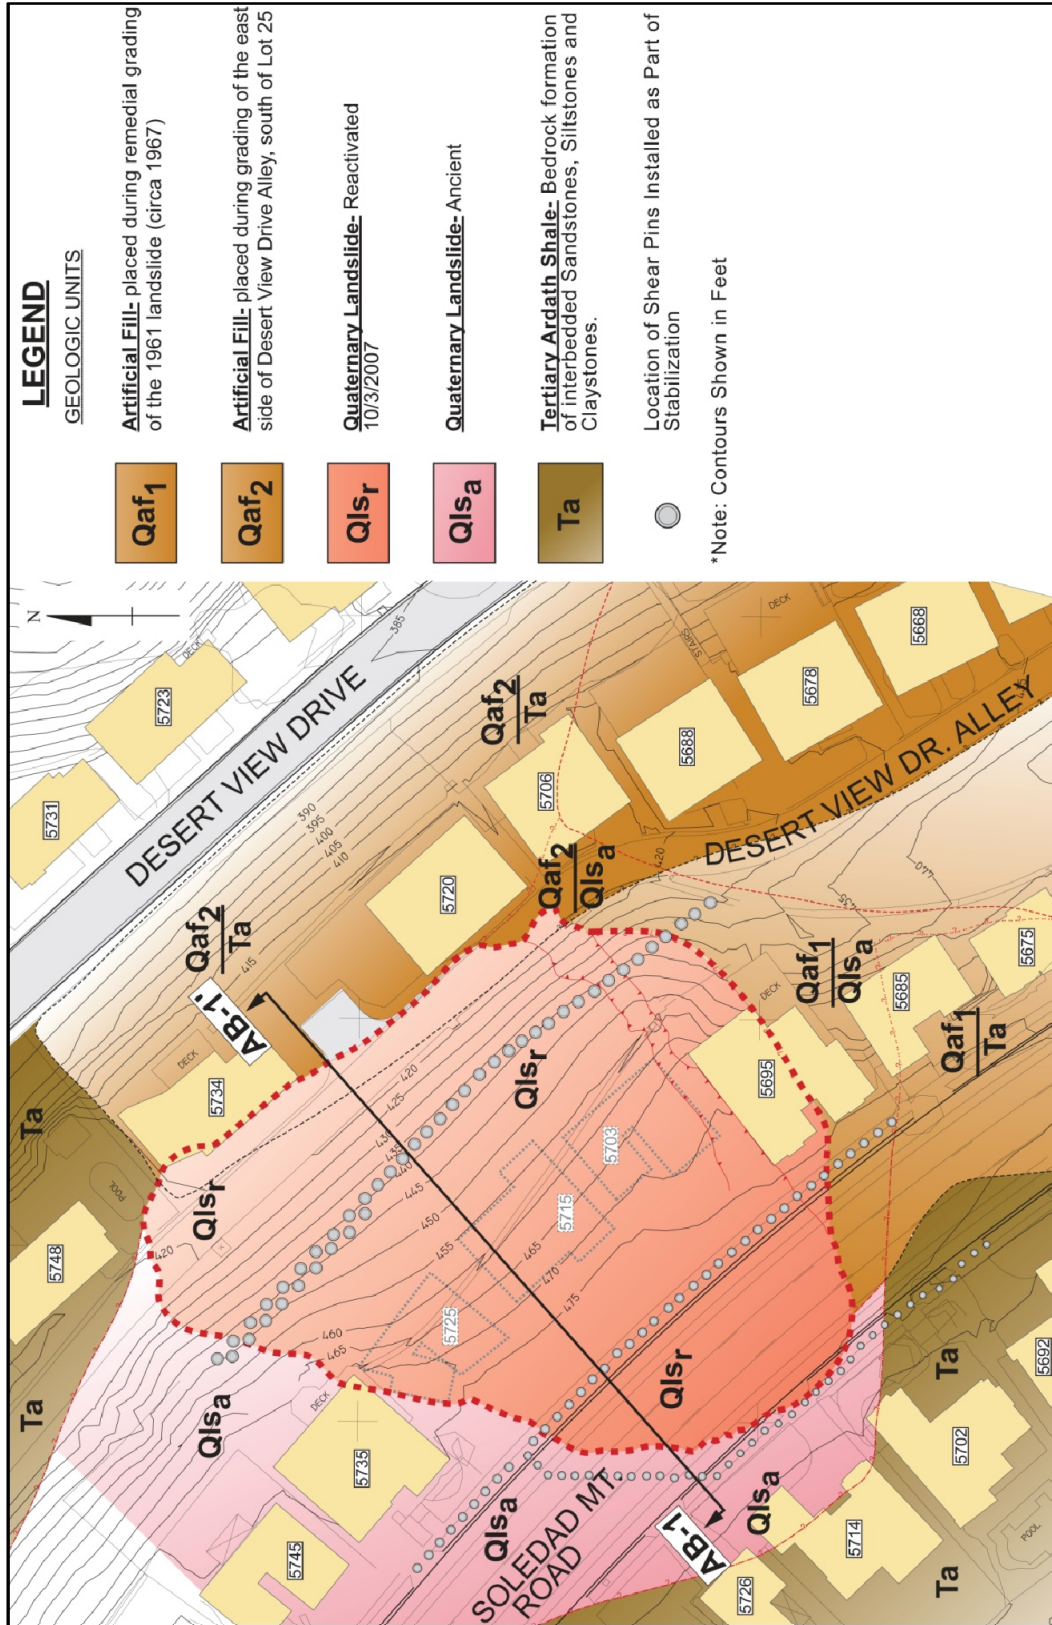
FIG. 5. Geologic Conditions Prior to Repair

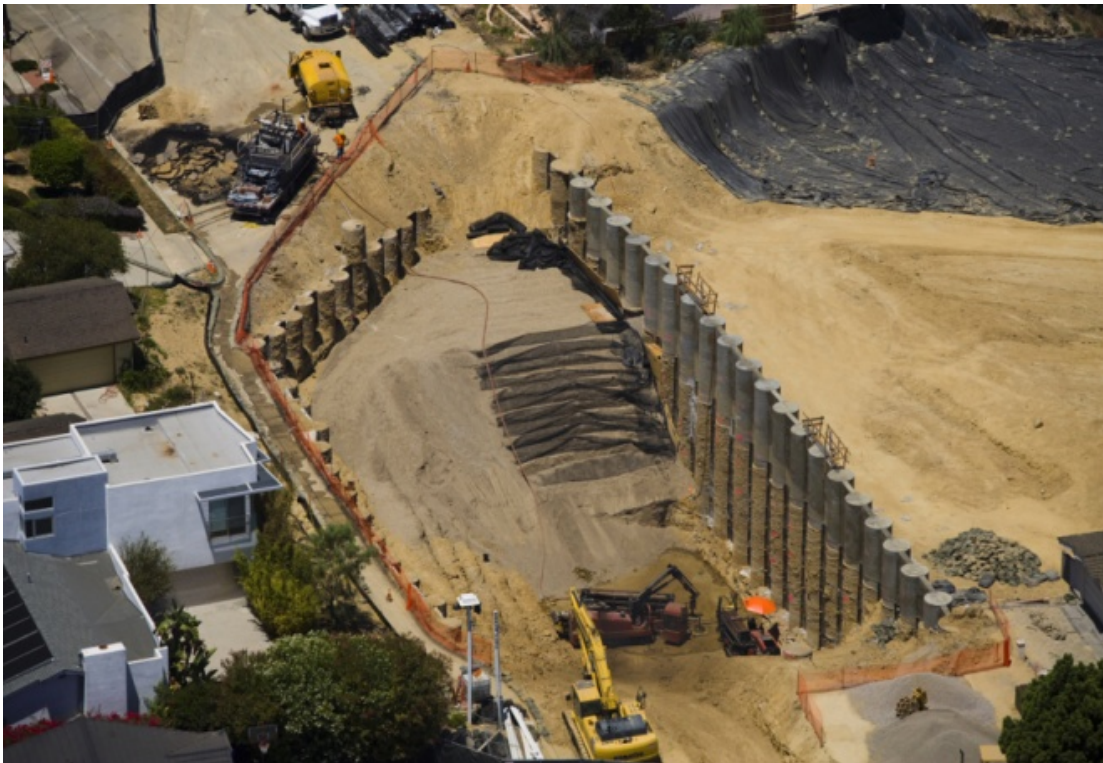
**FIG. 7. Roadway Stabilization (Looking North)
Photo From Geo-Tech Imagery Intl.**

Installation of stabilization features are pictured on Figure 7. Slope stabilization and repair of the Soledad Mountain Road Right-of-Way included installation of 75 CIDH re-bar reinforced concrete shear pins, 1.1, 1.2 and 1.4 meters in diameter, installed in two phases. The initial phase of shoring installation occurred along the west and north sides of the landslide mass, and consisted of 37 CIDH shear pins, 1.1 and 1.2 meters in diameter. This phase of shoring was designed for two primary purposes: to prevent westward expansion of the headscarp and associated damage to private property and to allow safe excavation of landslide debris within the right-of-way which would be hindered by existing shear surfaces. The second phase of shoring was installed along the east side of the Soledad Mountain Road Right-of-Way, and consisted of 38 CIDH shear pins, 1.4 meters in diameter. The purpose of this phase of shoring was to provide long-term slope stability of Soledad Mountain Road, to provide safe working conditions during removal and replacement of landslide debris and to support the temporary grade separation that existed between finished grade on the restored right-of-way and the ungraded private lots to the east which had dropped approximately 4.9 meters during landsliding.
