THURBER ENGINEERING LTD.

December 09, 2014

BAWLF EXISTING SEWAGE TREATMENT PLANT ASSESSMENT OF THE EXISTING LAGOON CONDITIONS

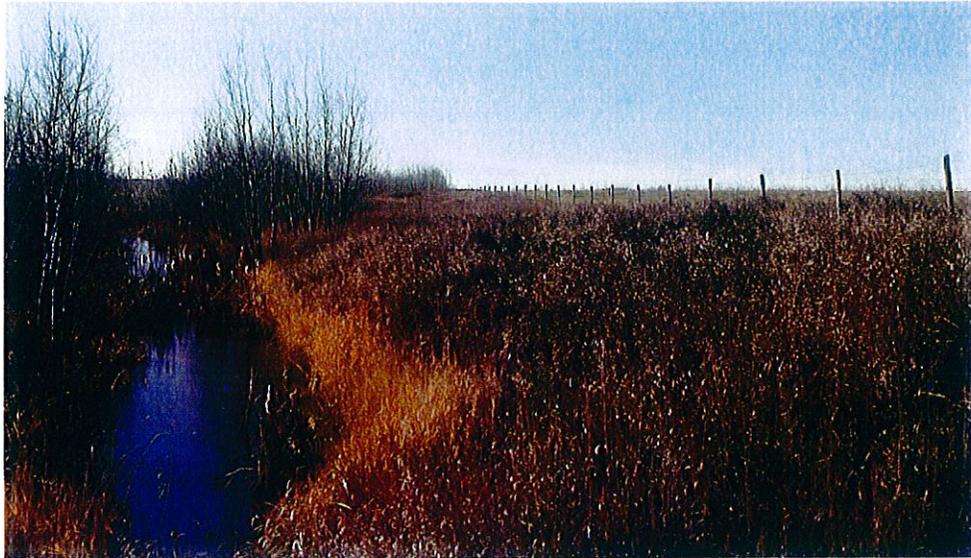
The wastewater lagoon is located on relatively flat land surrounded by farmland. Approximately 20 m north of the north-west corner of the lagoon boundary line was a dug-out pond. At the south side there was an un-named creek that runs parallel to the toe of the south berm (Photo 1). Parallel to the toe of the east berm there was a ditch (Photo 2), the south end of the ditch was bermed and it appeared that the ditch discharged to the north.

Dr. Clementino inspected the entire berm slopes for signs of instability, distress, or seepage. The outside slopes were well vegetated and appeared in good condition, with a side slope of approximately 3H:1V. There were no signs of significant erosion or instability as shown in Photo 1, 2 and 3. Seepage was not visible on the outside slopes, however, the below freezing temperature and high vegetation during the site reconnaissance made it difficult to observe excessive moisture or signs of seepage.

Photo 1 – North berm outside side slope

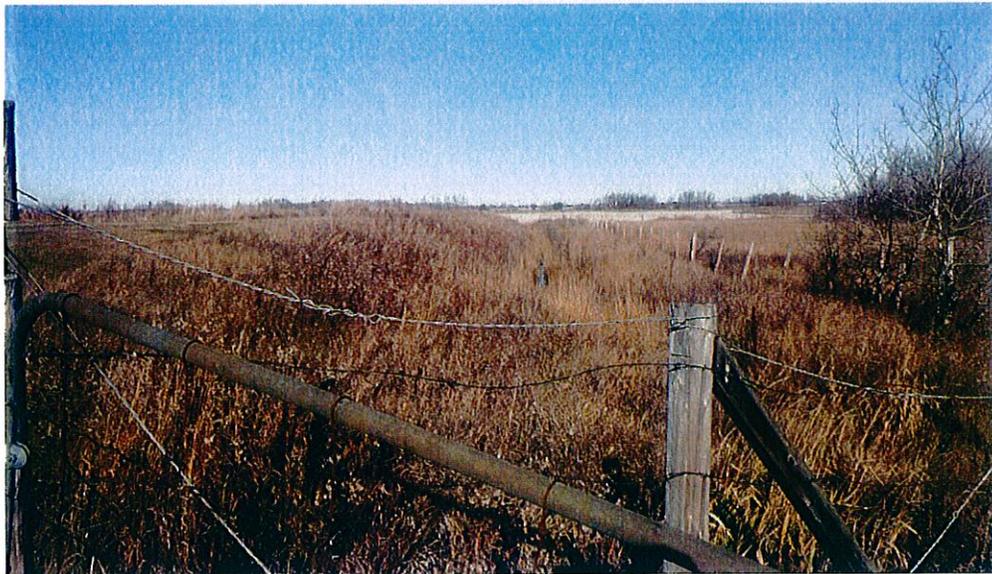
Photo 2 – East berm outside side slope, and ditch.

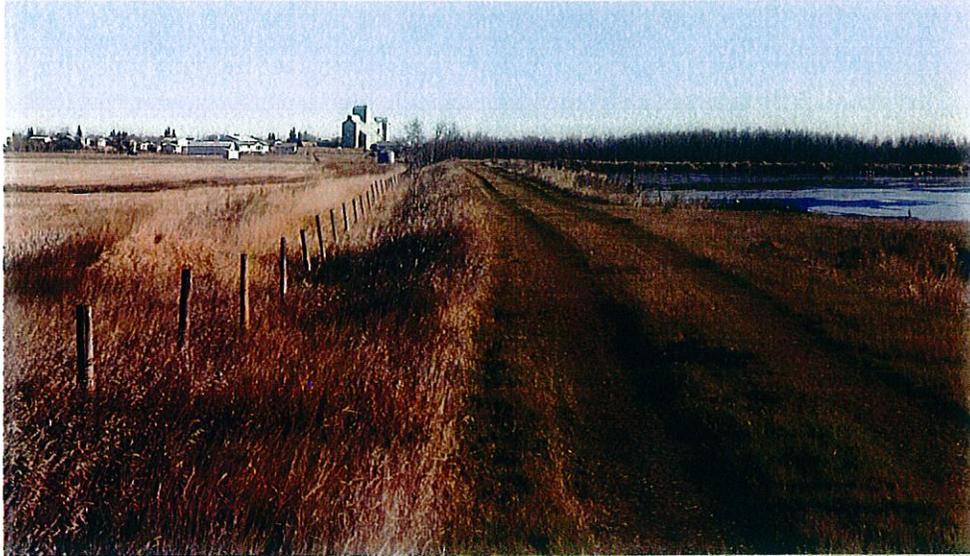
Photo 3 – North berm outside side slope

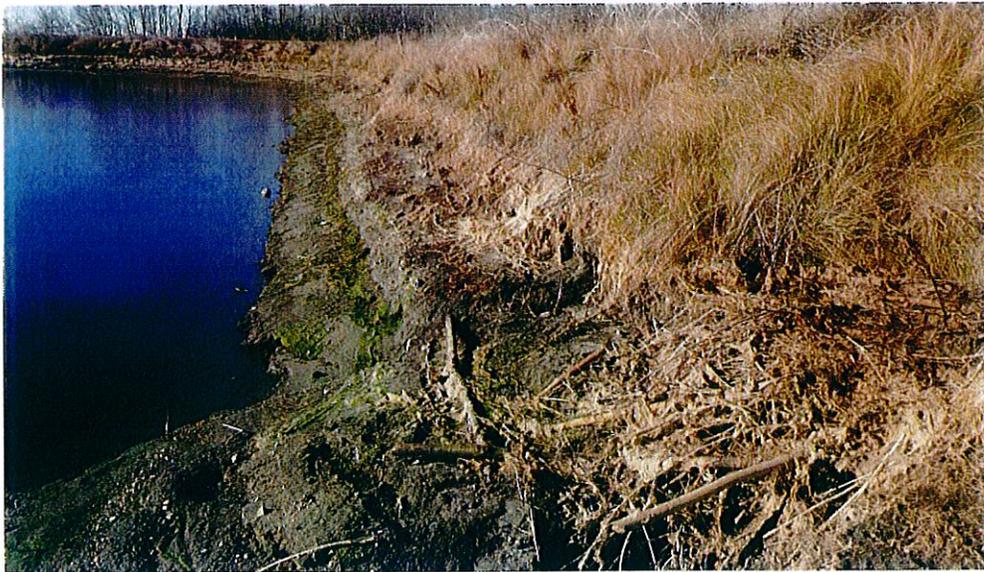
The inner slope of the berms presented signs of subsidence at the bottom third of the slope, which caused an over-steepened of the middle third of the slope as shown in Photo 4.

Despite of the evidence of the deterioration of the inner berm slope, due to cyclic action of the water level over the years and animal activities, the overall stability of the berms appears to remain satisfactory. However, it will likely degrade with time and will require some remediation work to restore it to its original condition.

Photo 4 – View of the inside slope of the lagoon berm.

If the monitoring program confirms that the lagoon is leaking wastewater the recommended remedial option would consist of draining the lagoon and constructing a low permeability compacted clay liner or lining the existing basin and berms with a geosynthetic membrane. For the installation of the liner, the inner slope of the berms will need to be repaired to provide a stable foundation.

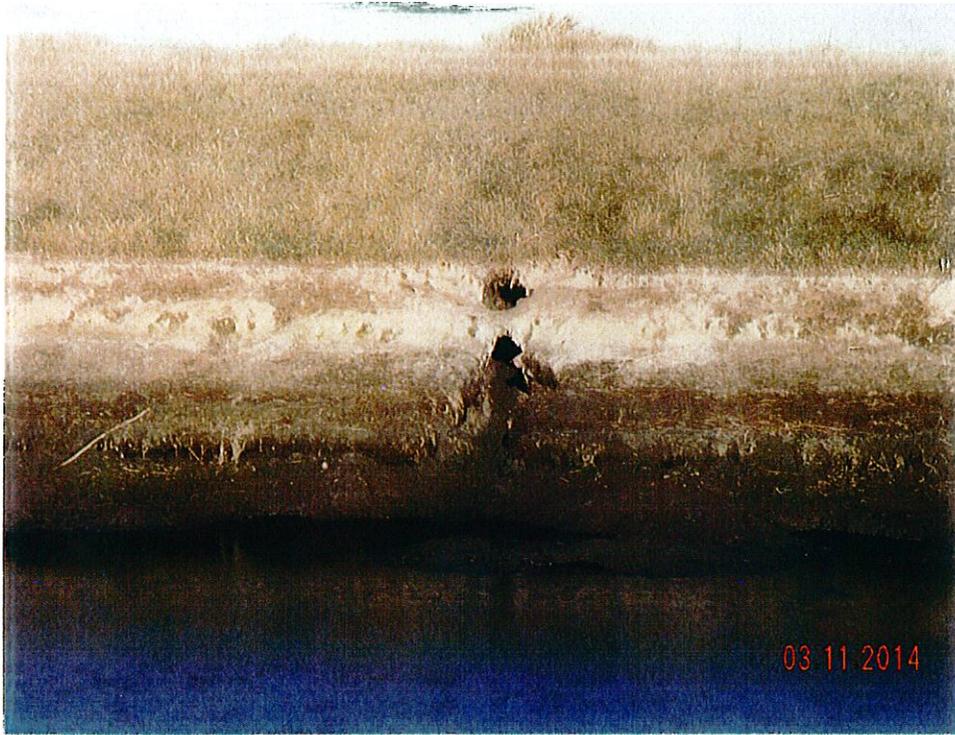
Certain locations of the inner slope presented evidence of a shallow slump, which appeared inactive, but may retrogress and increase with time. There were also several features of animal activity throughout the inner berm slopes, such as boreholes (Photo 5 and 6) and a beaver dam (Photo 7).

Photo 5 – Central berm, south slope, animal activity borehole.

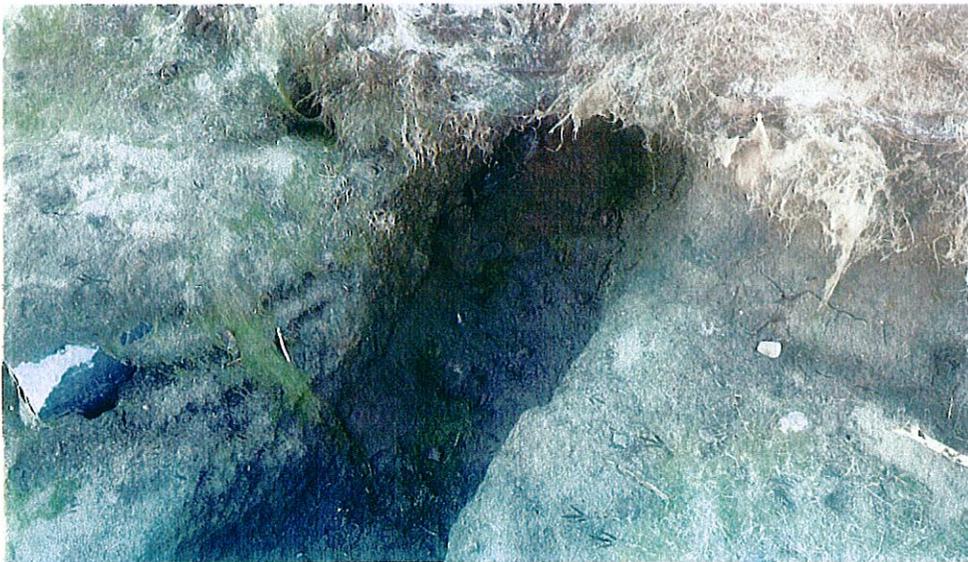
Photo 6 – South berm, inner slope, animal activity borehole.

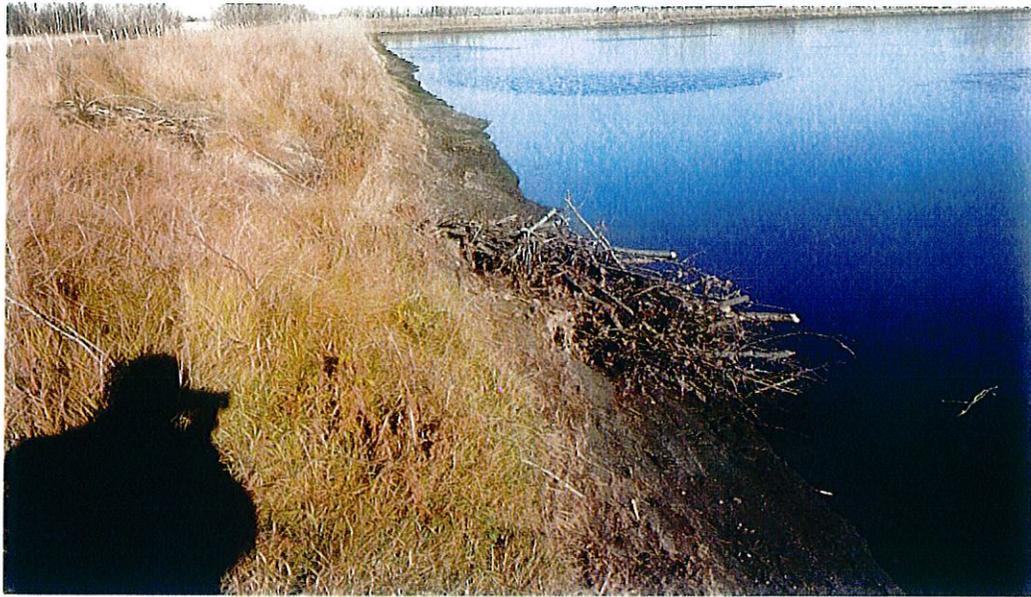
Photo 7 – North berm, inner slope, beaver dam.
