Horsley Home Inspection

Property Inspection Report

1234 Over there lane, Houston, TX 12345

Date of Inspection: 11/14/2017 Time: 10:00 Am

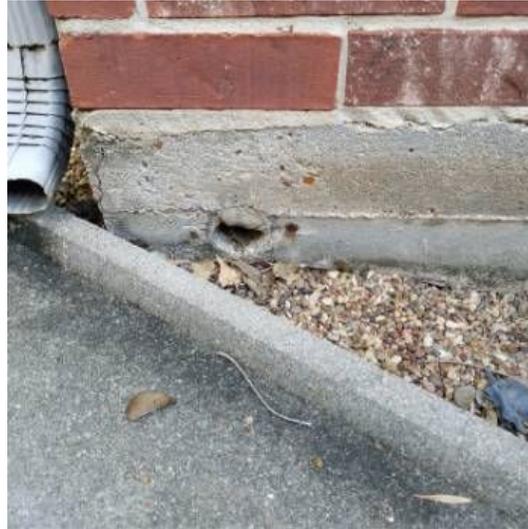
- Cable ports on post tension foundations should be sealed with mortar
- Recommend having post tension pockets sealed by professional contractor
- Dirt was observed to be too high and partially blocking the weep holes for drainage
- At the time of the inspection the foundation appears to be functioning as intended.

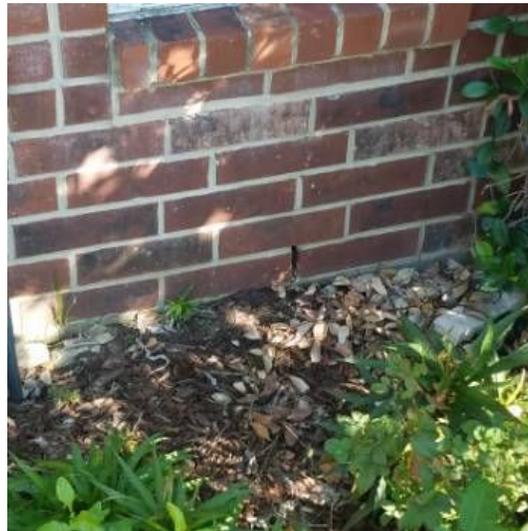
- Over all the grading of the lot appears to be draining away from the foundation as intended.
- Grading to close to siding in several locations. 4 inch minimum clearance for masonry 6 inch clearance for siding.
- Recommend reduction in planter material.

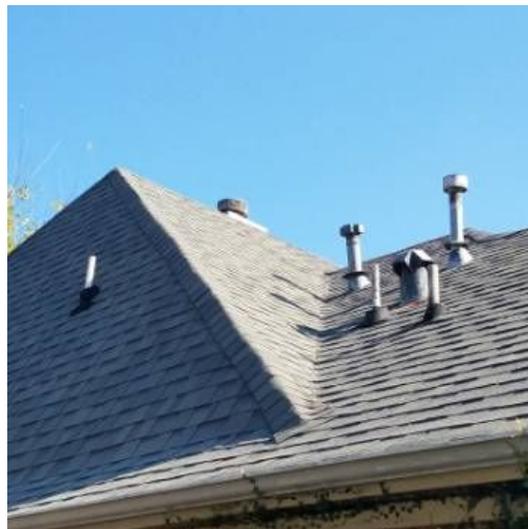
- Inspector could not access the roof due to either roofing material, dangerous slope of roof and/or above the reachable height; therefore, the roof was observed from ground level with optical lenses
- Galvanized steel gutters and downspouts were noted
- The gutter system was observed to have some leakage, corrosion, rust, loose fasteners and/or filled with debris
- Roof details (vent stack pipes) need painting. Recommend professional roofer.
- [Roof details need minor maintenance, over all the roof details are in good condition.](#)

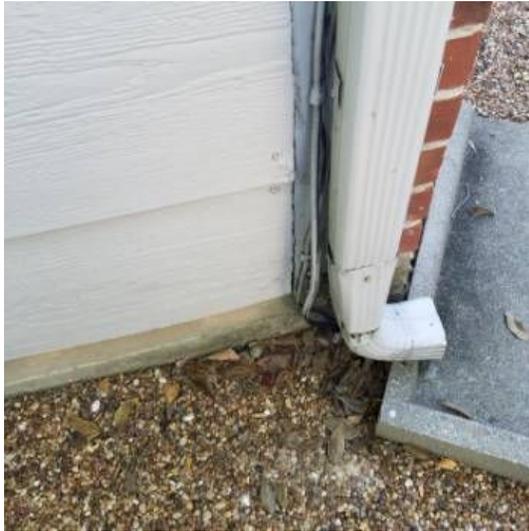
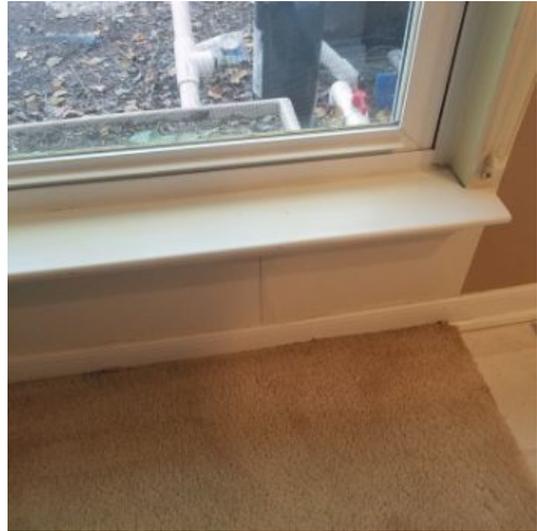
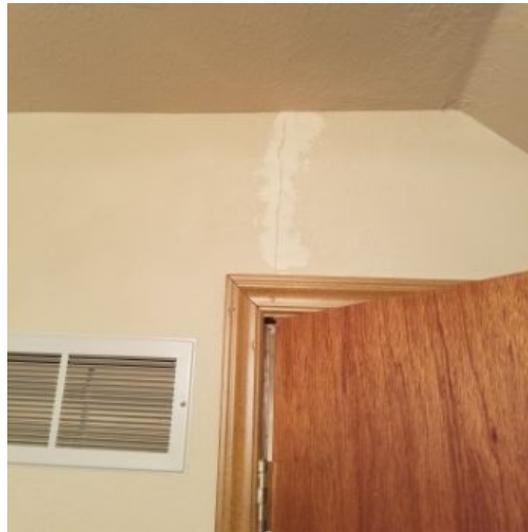
- The exterior veneer / cladding has some deterioration and/or damage
- The wood veneer chimney chase was observed to have some deterioration and/or damage

- The steel lintels above the exterior doors and windows should be painted to prohibit corrosion
- Interior wall stress / joint cracks were observed and the cause and/or remedy should be further evaluated and corrected as necessary

- Evidence of moisture entering structure from interior water stains

- Elastomeric caulking improvements are recommended between the exterior veneer and the window frames
- Elastomeric caulking is recommended for the area between the exterior veneer and the garage door trim boards

- NOTE: The areas between the exterior cladding / veneer and ALL wall penetrations need to be properly sealed such as utility connections, downspouts, hose bibs, lighting fixtures, receptacles, etc with an exterior grade elastomeric sealant

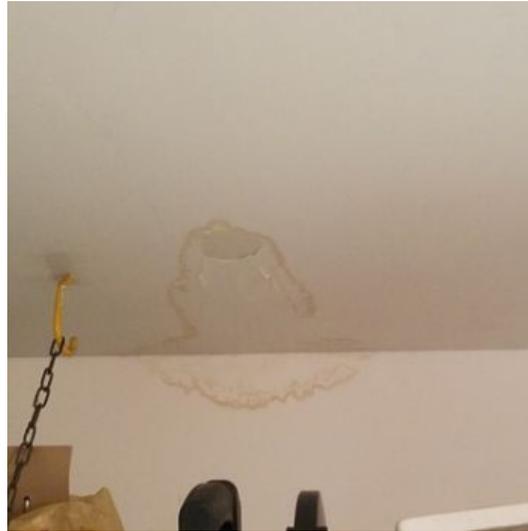
In garage

- Ceiling stress and/or joint cracks were observed
- Water stains were observed on the ceiling. The cause and remedy should be further evaluated and corrected as necessary

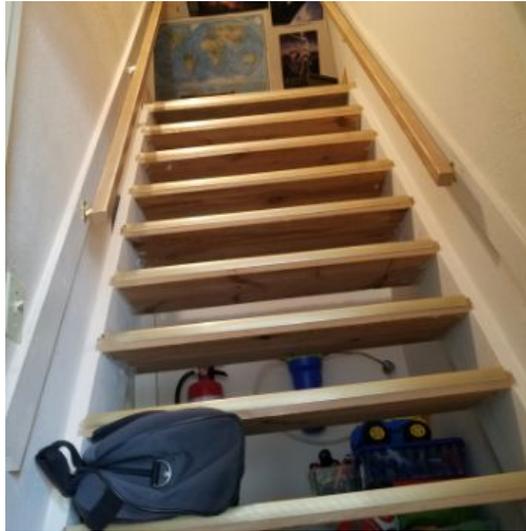
- Stairs do not meet current safety standards.
- Enclosed accessible spaces below the staircase requires a minimum of {5/8"} fire code drywall
- A minimum of {1 1/2"} spacing is required between the sidewall and the handrail. The continuous handrail shall be secured at a height of {34"-38"} above the tread level.

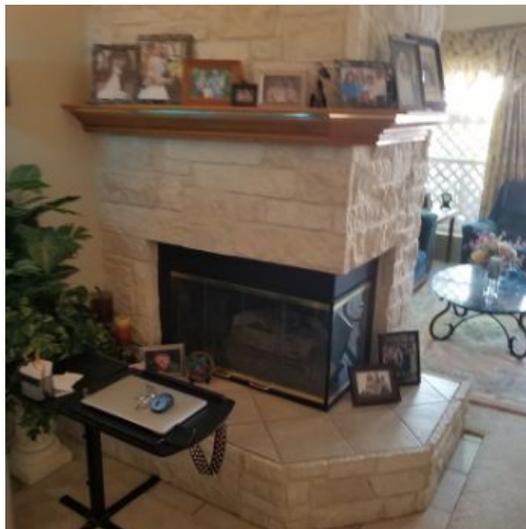
- All components were found to be performing and in satisfactory condition at the time of the inspection
- The damper was tested for operation and appears to be functional
- Fireplace was not operated do to objects in the way.
- Loose insulation resting on top of fire box.

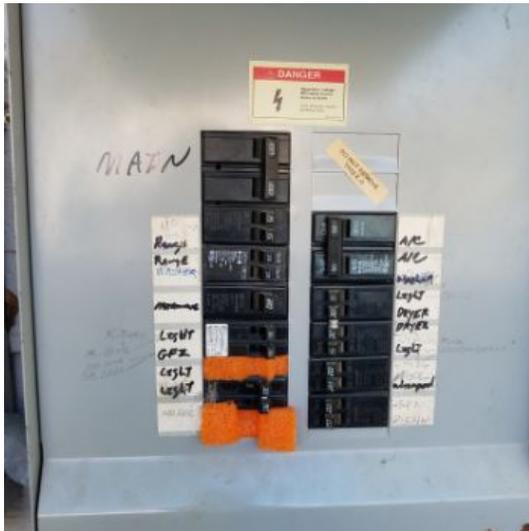
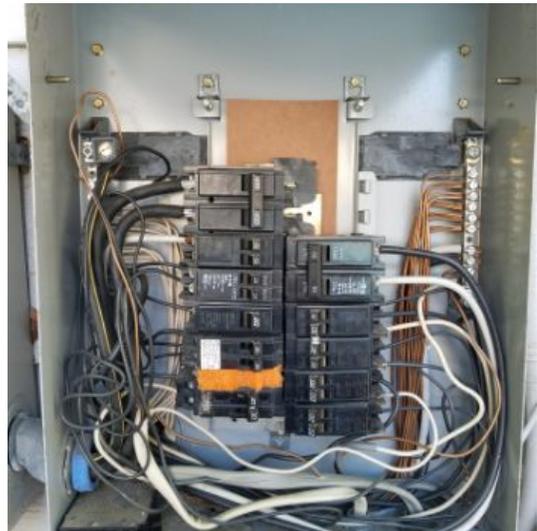
- Panel Locations:
- Electrical panel is located on the east side of the building
- Materials and Amp Rating:
- Copper wiring
 - Aluminum wiring
- Comments:
- The aluminum wiring in the service panel was not treated with anti-oxidant sealant
 - No ARC fault breakers {**AFCI**} were observed at the service panel at the time of the inspection; although this may not have been a requirement when the home was built. Beginning in 2008; AFCI breakers are required in the panel for 15A/20A branch circuits providing power to family rooms, dining rooms, living rooms, libraries, dens, bedrooms, sunrooms, recreation rooms, closets and hallways. ARCI breakers provide fire protection by opening the circuit when an arcing fault is detected
 - Ac breaker undersized for unit.
 - Advise licensed electrician evaluate wiring.
 - **There are open breaker slots in the panel which presents a Safety Hazard**

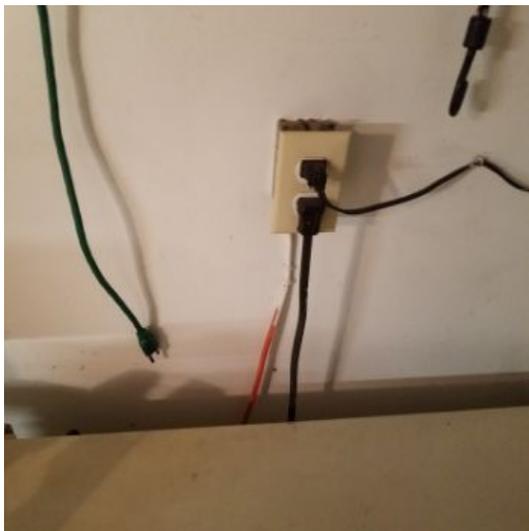
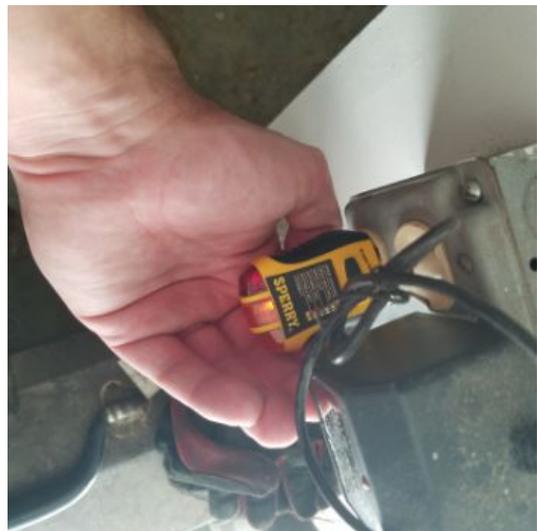
- Under current standards; exterior **GFCI** protected receptacles require a weatherproof bubble type cover
- The doorbell {s} was functional at the time of the inspection
- **The GFCI (ground fault circuit interrupter) breaker is not properly functioning**
- **One or more of the kitchen countertop receptacles appear not to be protected by a GFCI device. Current standards require all countertop outlets have ground fault protection**
- **One or more of the receptacles were noted as an "open ground" and should be corrected**
- **multiple uses of extension cords used as permanent wiring.**
- **Advise licensed electrician evaluate wiring.**

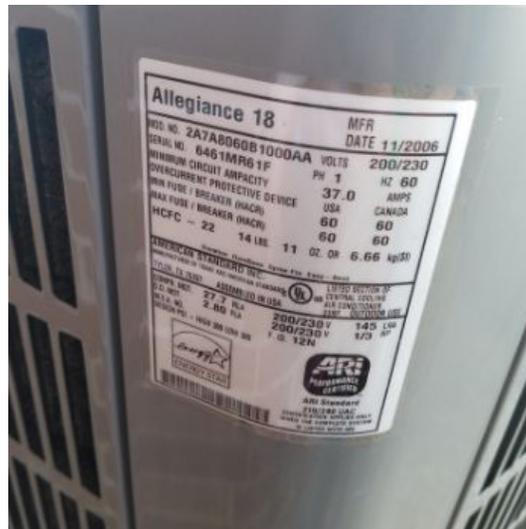
- This unit appears to be functioning as intended at the time of inspection and consistent with accepted industry standards
- No P-Trap was visible on the condensate line and is required under current mechanical standards
- Refrigerant lines could not fully inspected due to personal belongings and/or other obstructions

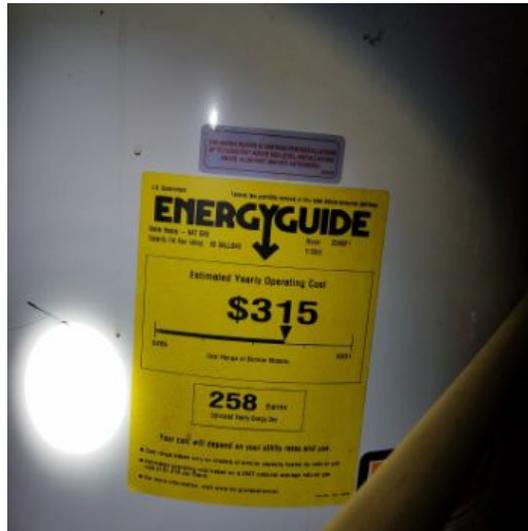
- The water heater and its components were found to be performing and in satisfactory condition at the time of the inspection
- TPR valve was not operated do to being unable verifiable termination of drain line.

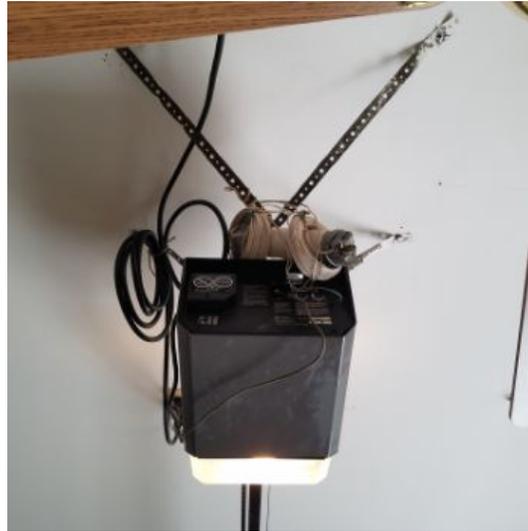
- The manual lock should be removed when an automatic garage door opener is in use
- **The garage door did NOT automatically reverse under reasonable resistance and adjustments are recommended**
- **One garage door is missing reverse sensors.**
