## **HEDDERMAN ENGINEERING, INC.**

REF: CONDITION OF PROPERTY SURVEY

At your request, a visual survey was made of the structural components of the house located at Houston, Texas, by Tim Hedderman.

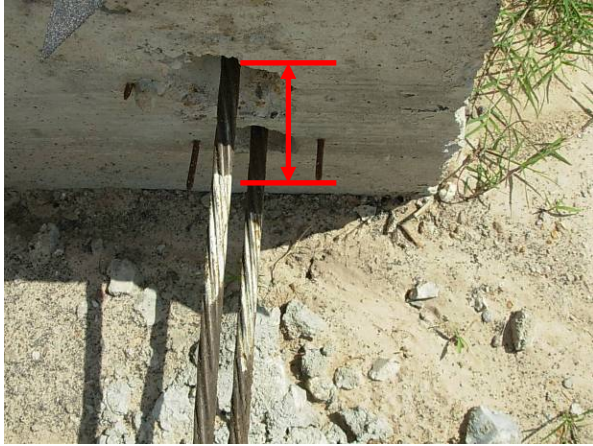
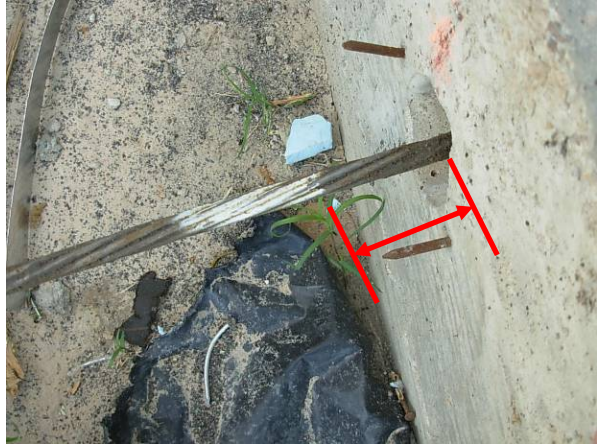
The post tension cables have been tensioned, and the anchor wedges installed. You can see in the photos below from the white paint mark on the cable, that the cables have been elongated approximately 4-5 inches during the tensioning process. When the wedges are set and the pulling force on the cable is released, the residual compression in the cable provides the reinforcement for the concrete slab.

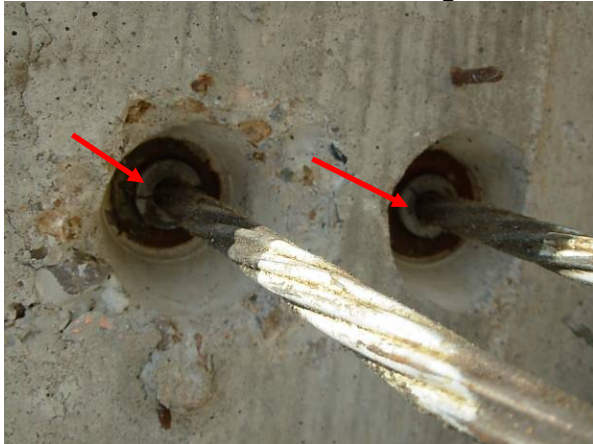
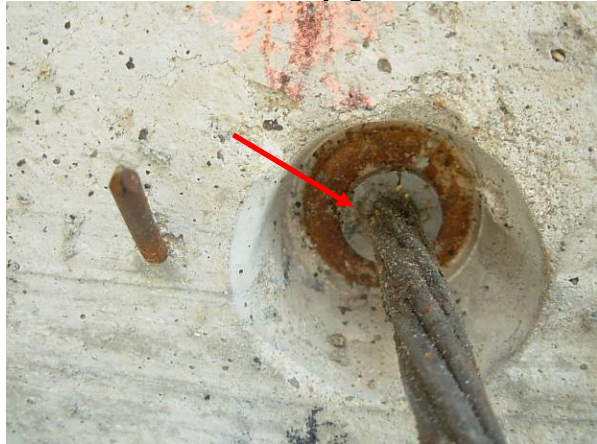
Photos of the anchoring wedges installed in the anchor. The cable ends will be cut off inside the face of the concrete grade beam, and will be covered by grout.

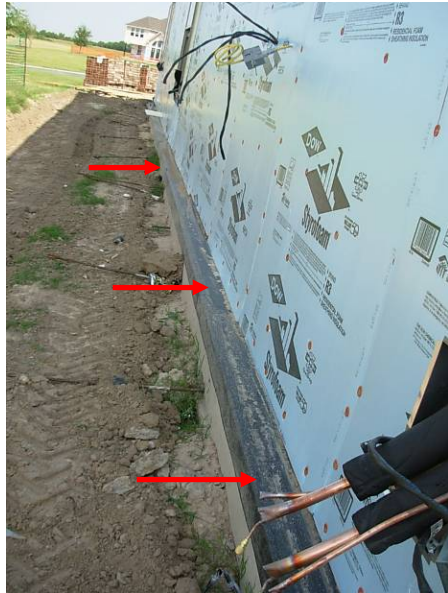
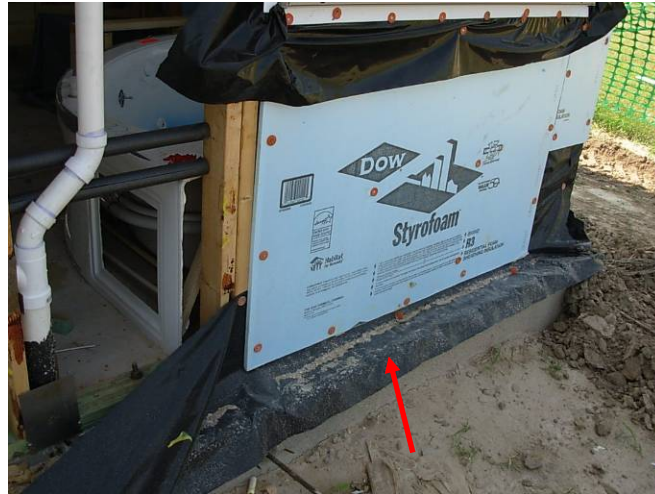
We observed that a piece of black plastic has been installed and is properly covering the brick ledge where the bricks will be installed on the foundation. The plastic is needed as a bond breaker between the brick mortar and the concrete foundation.

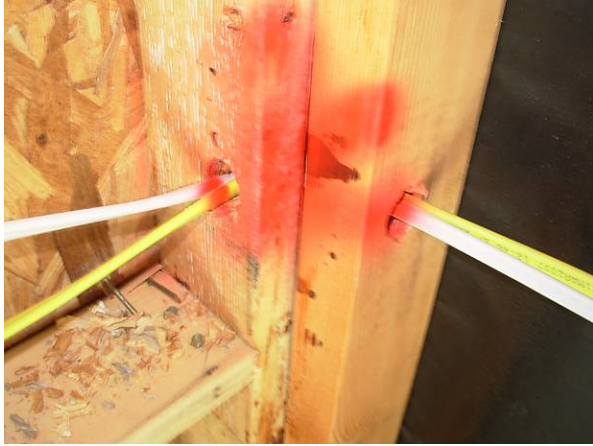
1. We observed that many of the metal nailing plates were missing from the wall studs where the electrical wiring was closer than one inch to the surface of the stud. This can allow a sheetrock screw to penetrate the wiring, and metal plates need to be installed to protect the wiring. The electricians were present at the time of the inspection, and were installing the plates.

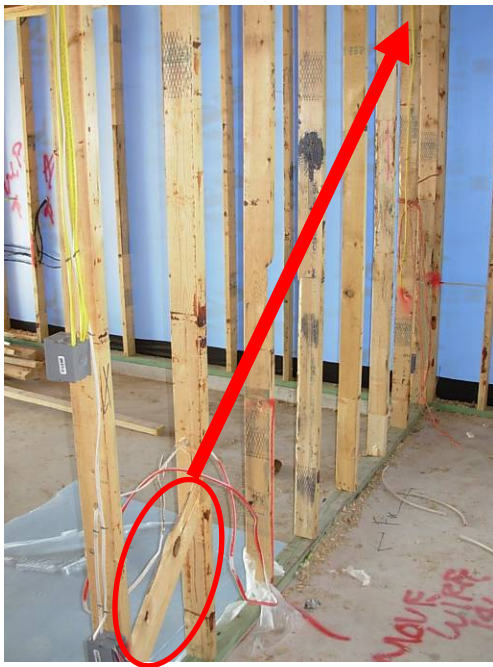
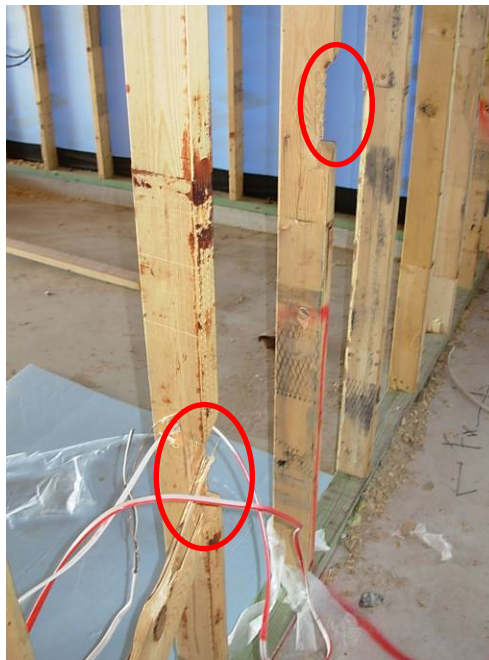
2. We observed in the bedroom between the garage and the master bedroom closet that a diagonal brace has been removed, and some of the studs that were notched out have been replaced. Further investigation with the builder is needed concerning the missing diagonal brace, which is an important framing member, and why it has been removed. (see photos below)

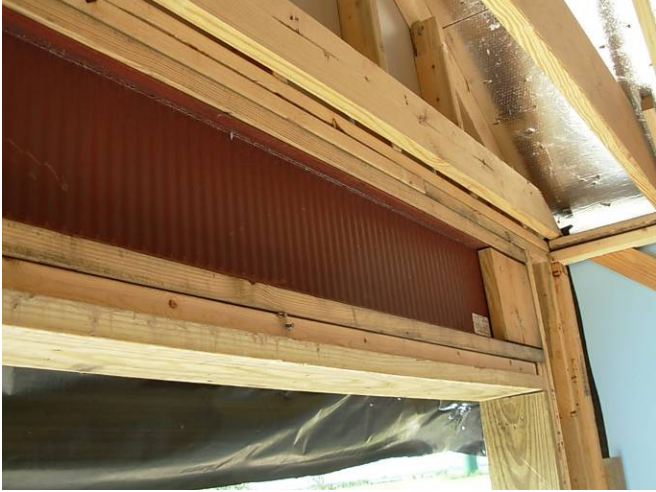
3. We observed a steel beam has been installed in the garage over the garage door, to be used at the header over the garage door. This is better and stronger than the normal beams that are installed over garage doors, and will prevent sagging of the header. (see photo below)

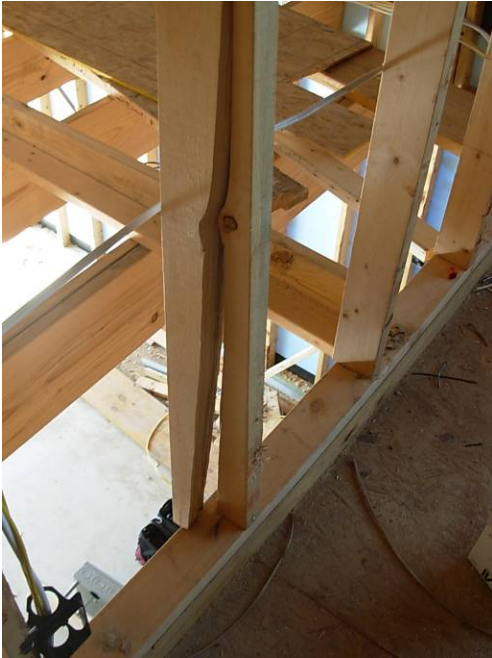
4. One of the wall studs was broken, and needs to be replaced, at the upstairs game room.

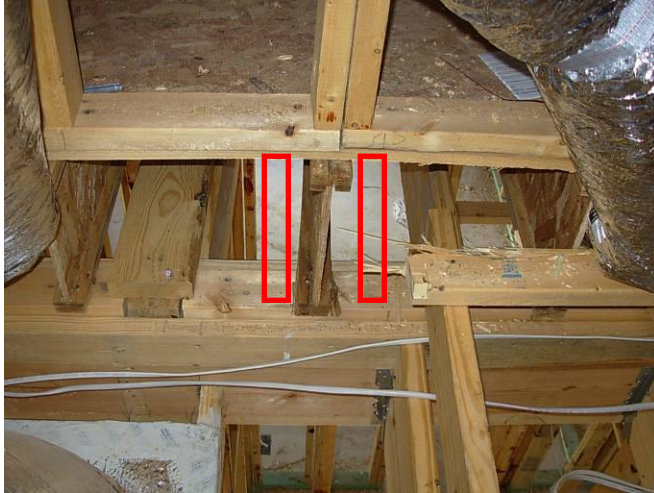
5. The prefabricated truss joists did not have 2 x 4 squash blocks installed on both sides of each truss joist, where there is a load from a wall above. Further investigation with the manufacturer of the truss joists is recommended to determine if their system requires squash blocks at these locations. Squash blocks are pieces of 2 x 4 that are 1/16 inch longer than the height of the truss joist, and are nailed to either side of the truss joist to help carry the load from the wall above, and transfer the load to the framing below.

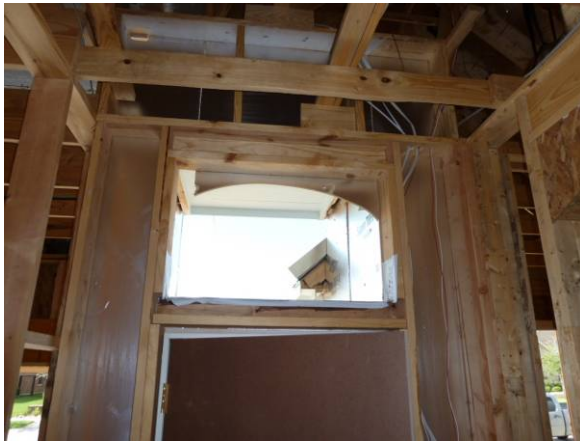
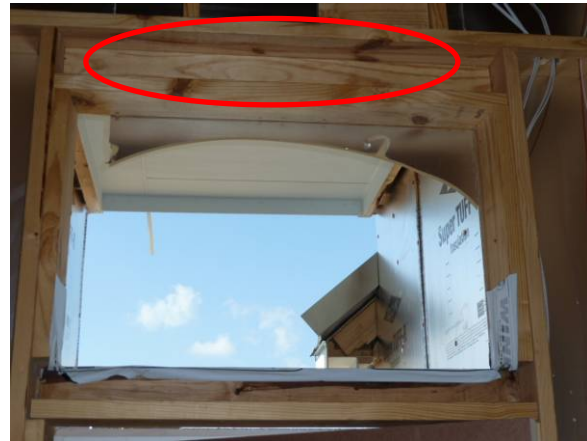
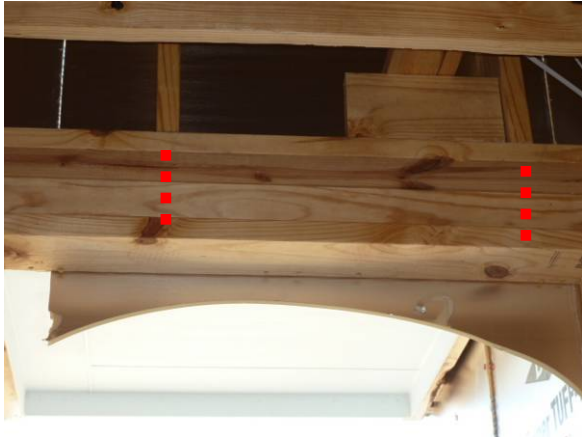
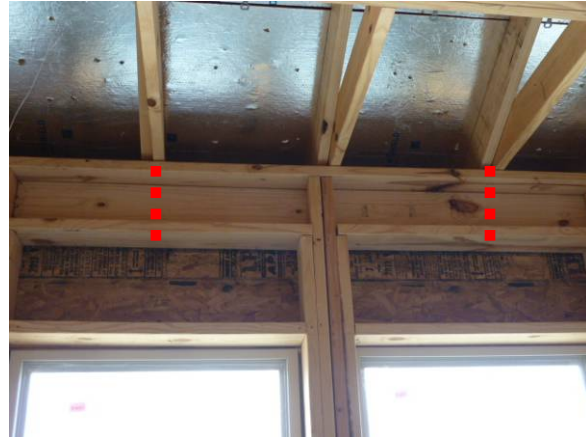
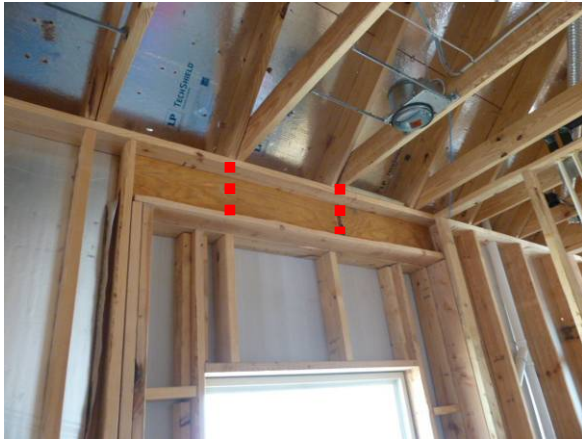
6. We observed that cripple studs were missing above many of the windows and it is recommended that they be installed to provide proper support for the loads above the windows.

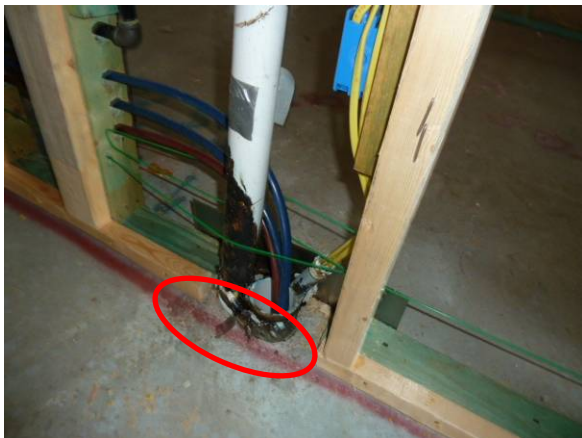
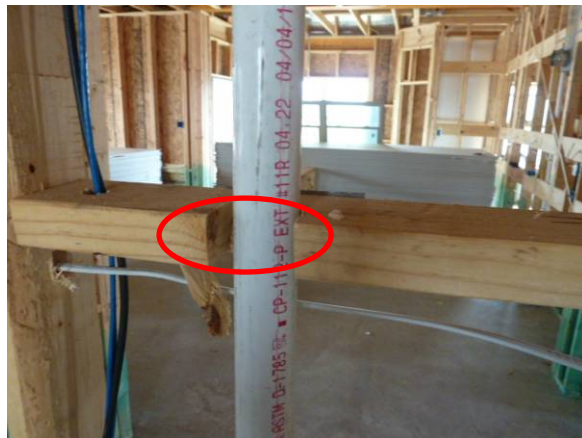
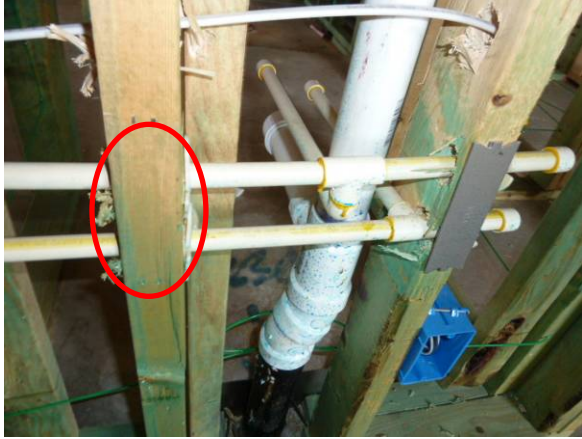
7. We observed missing nailing plates at several locations.

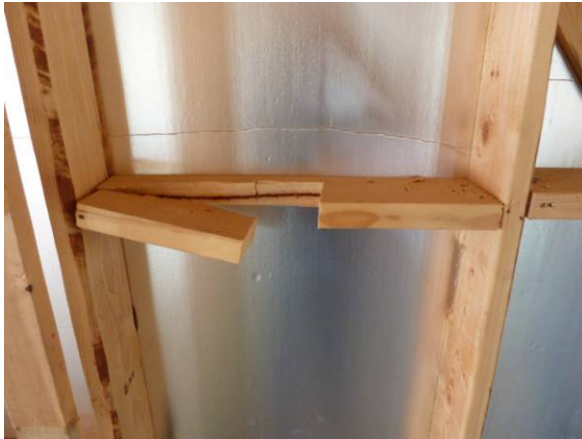
8. We observed a broken brace in the wall at the master suite, where a notch had been cut in the brace for the air conditioning refrigerant lines.

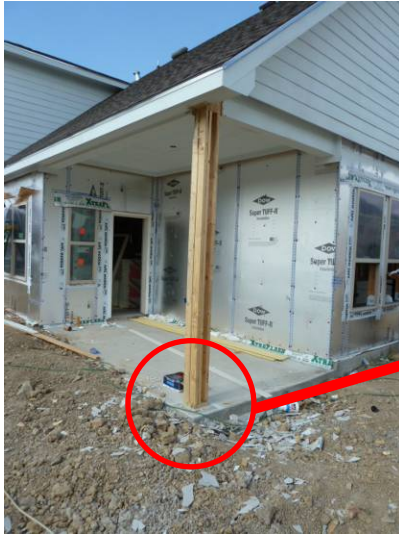
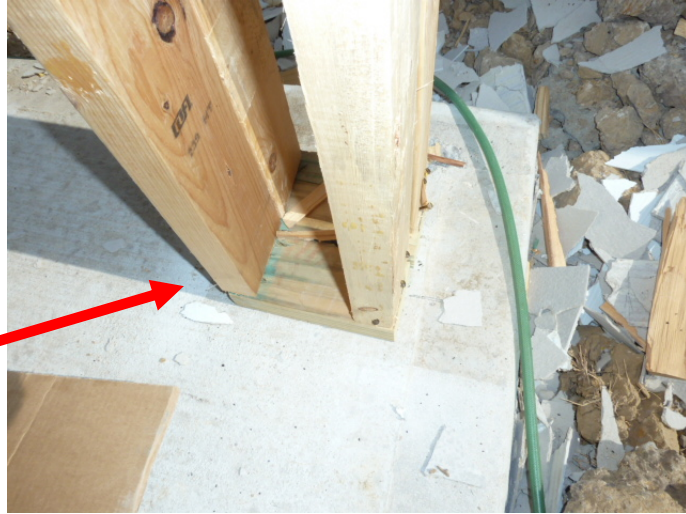
9. The column at the back porch did not show any evidence that it was anchored to the concrete patio area, to prevent uplift from wind forces. Further investigation with the builder is recommended and to make needed repairs.

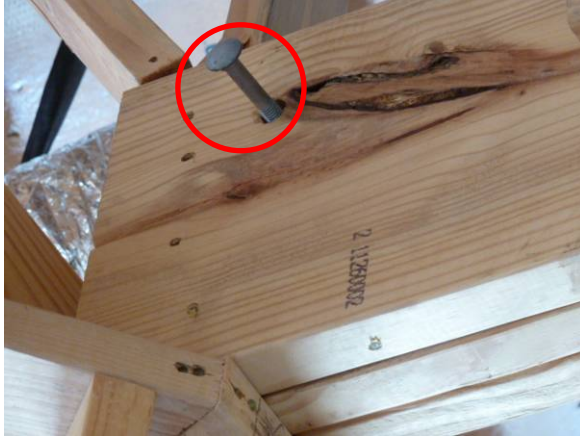
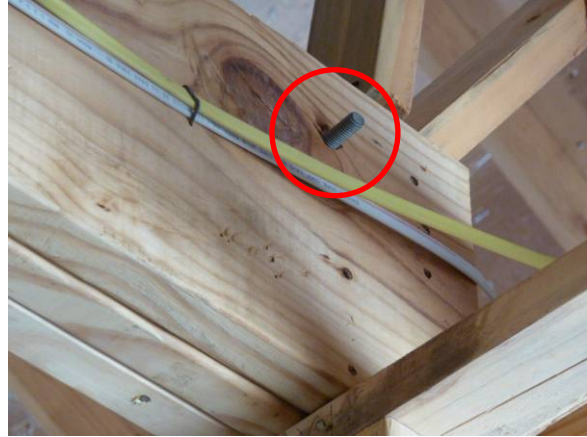
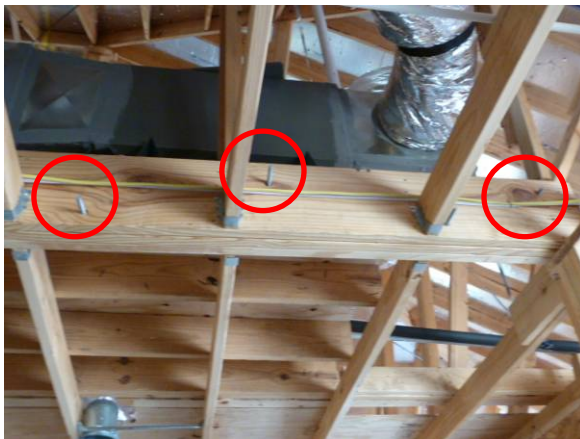
11. We observed major beams in the house which are connected together with bolts. However, many of the nuts were missing from the bolts, and need to be installed.

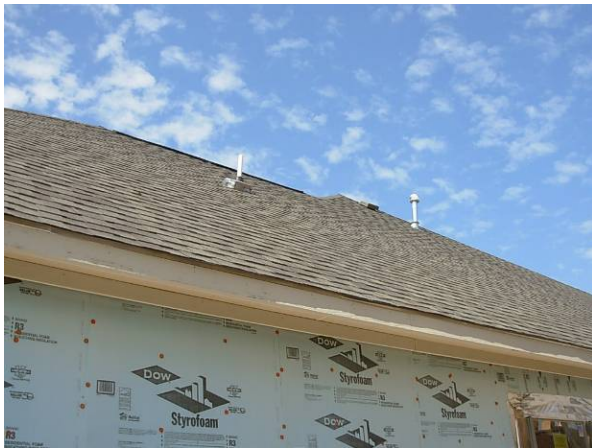
The PVC plumbing vent pipes that protrude through the roof jacks on the roof need to be painted to prevent deterioration of the PVC from the sunlight. Also, the metal vent pipes

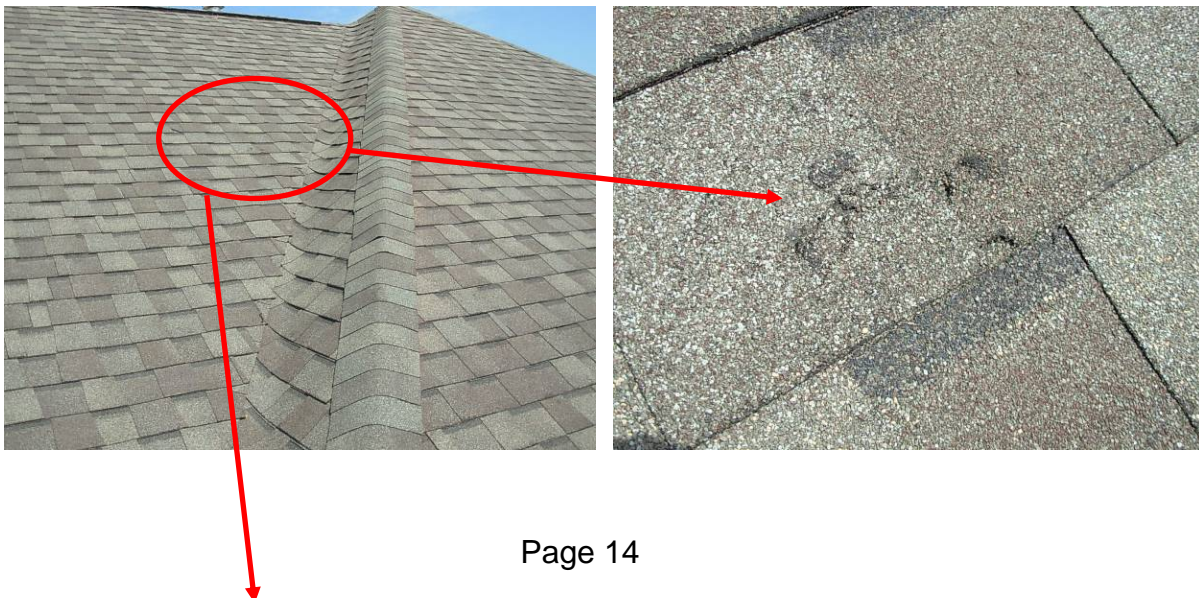
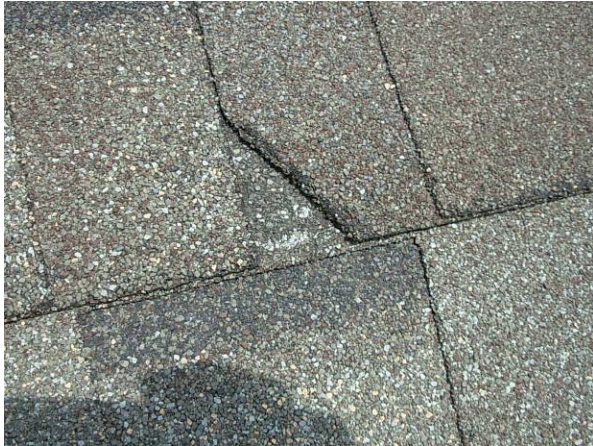
We observed a damaged shingle on the front elevation of the roof, and the damaged shingle needs to be replaced before it causes a roof leak.

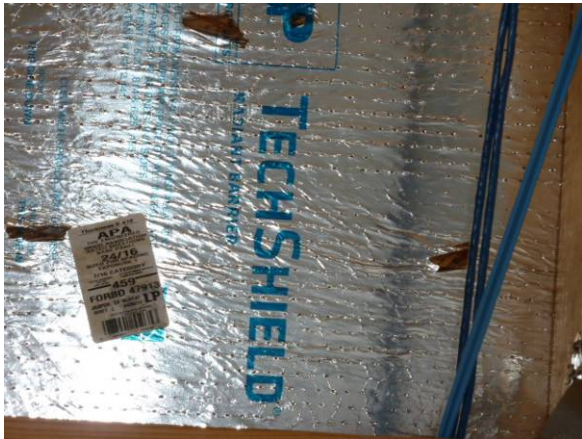
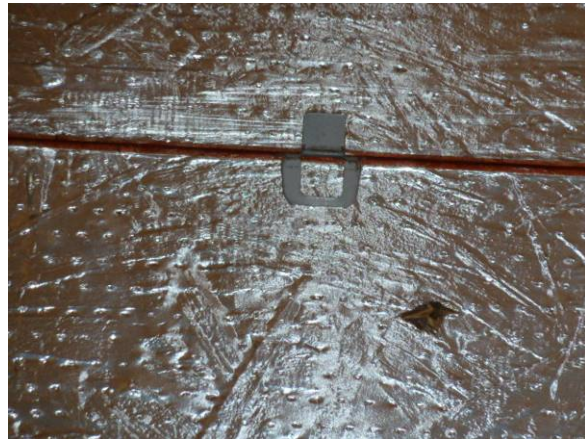
The roof decking was observed to be “Tech-Shield”, which is roof barrier roof decking that has an aluminum foil on the underside of the roof decking. This will help to keep the attic cooler by reflecting radiant heat from the roof.

The roof decking was observed to have spacer clips installed between the adjacent sheets of roof decking to allow for expansion of the roof decking due to heat.

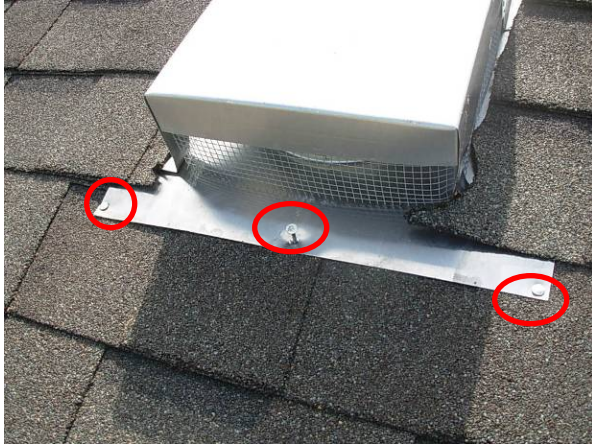
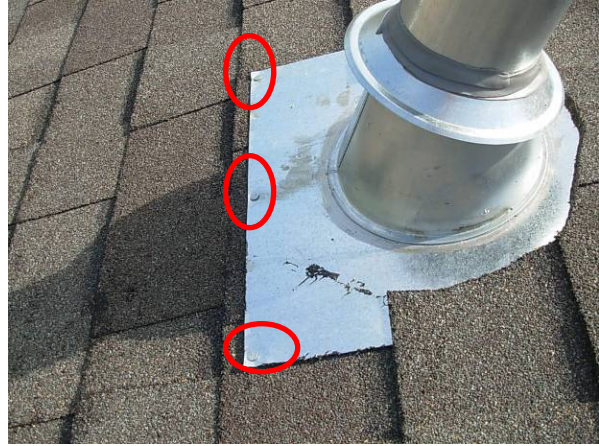
Some of the flashing on the roof jacks were not sealed at the nail heads, and caulking needs to be applied to the nail heads to prevent roof leaks. Most of the nail heads on the other flashings and roof jacks were properly sealed. (see photos below)

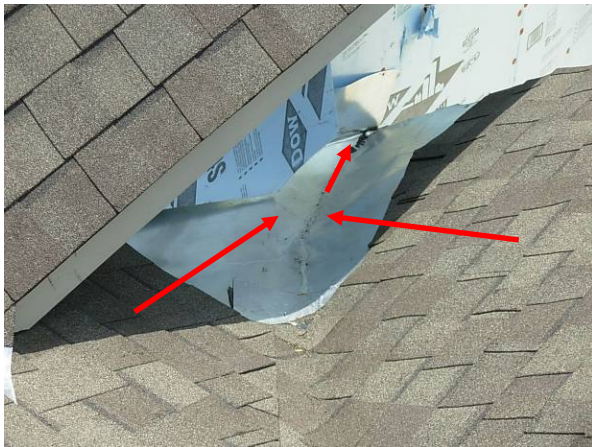
We observed a valley at the front part of the roof that narrows down, and will have a tendency to trap leaves and other debris. The area needs to be maintained to prevent a build up of debris. The area was flashed with metal flashing, which will help to prevent leaks in the area.

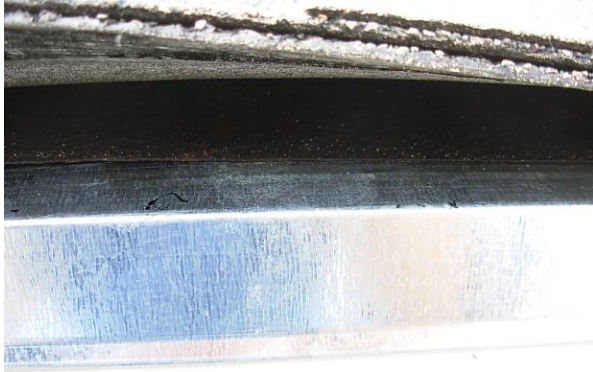
We lifted the edge of the shingles to verify that the tar paper underlayment was properly lapped on top of the drip edge flashing, and it was. No repairs are needed.

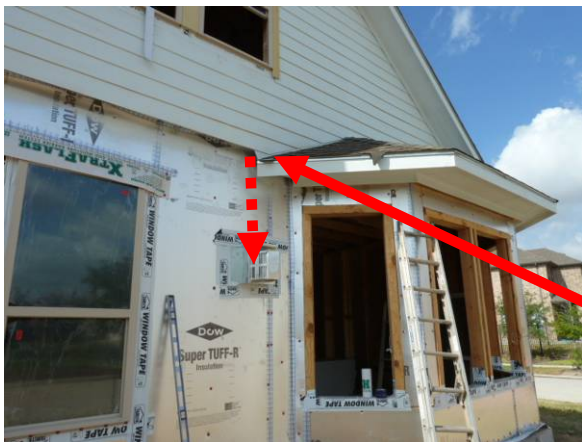
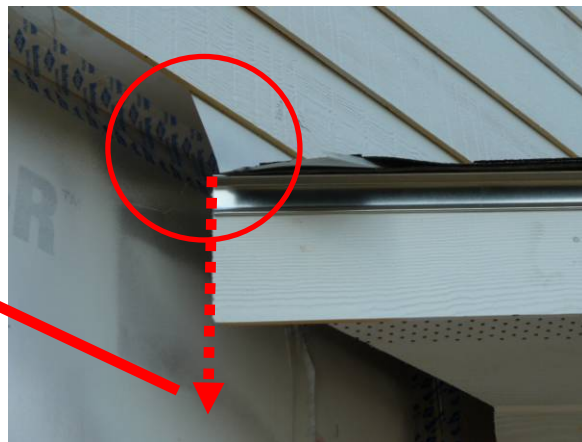
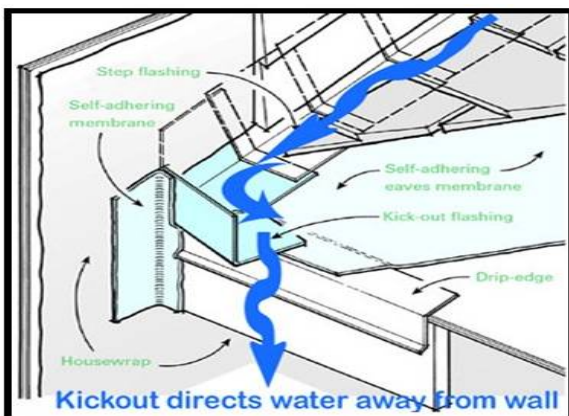
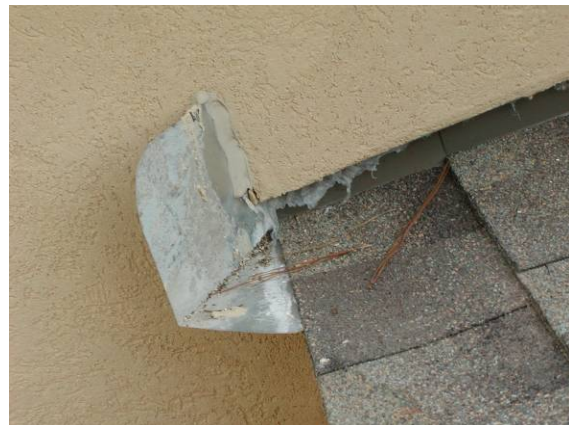
We observed that the lower roof at the rear of the house empties onto the vent pipe for the fireplace. It is recommended that a piece of kickout flashing be installed to route water away from the vent pipe to prevent water penetration.

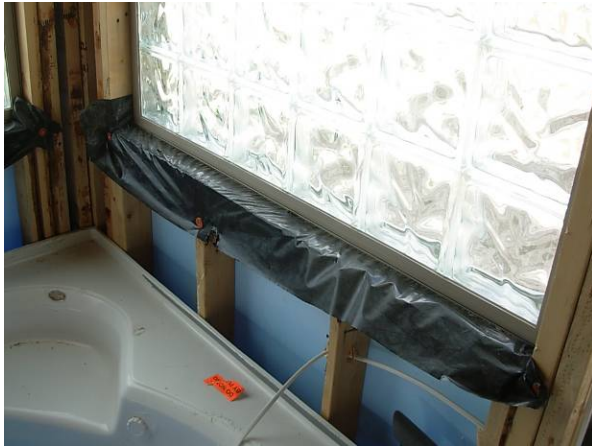
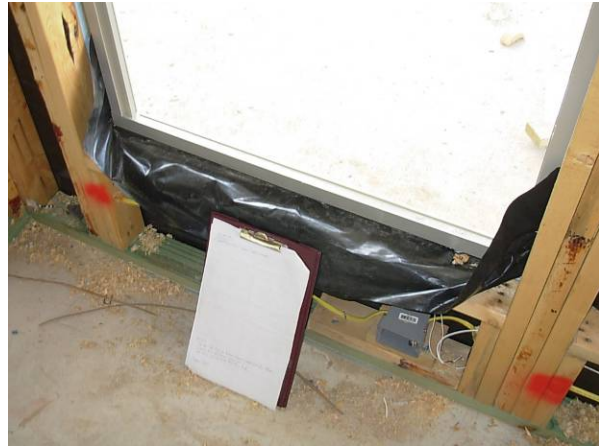
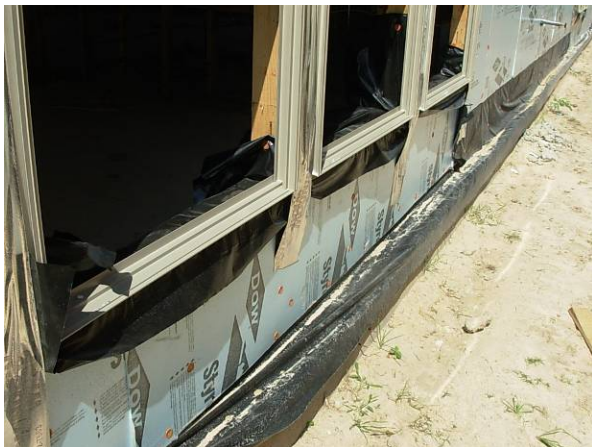
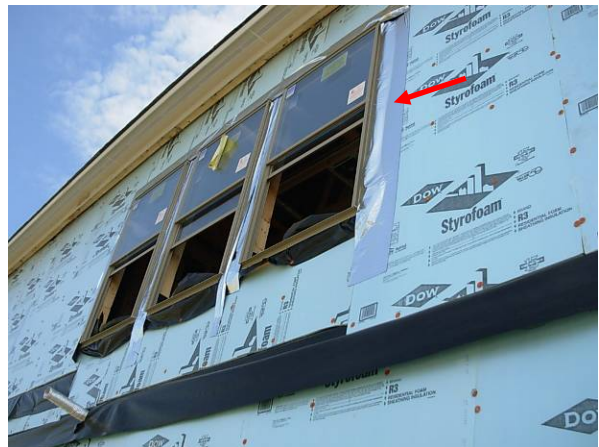
Most of the windows in the house have had a piece of plastic installed under the window, and wrapping over the window sill. This is to prevent any water that leaks through or around the window from going to the inside wall cavity, but rather routes the water to the outside of the wall. The plastic laps over the outside of the window sills, and the windows were sealed with Window Wrap tape.

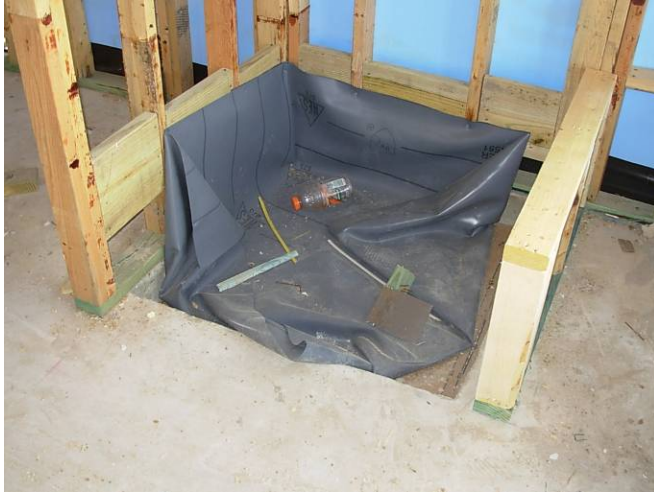
The shower stall at the master bathroom has not been constructed at the time of the inspection, so we could not determine if the shower will have a seat built into the shower. The reason we mention this at this time is because it has been our experience that these seats are not typically built with a watertight detail, where the shower pan material extends across the bottom of the shower, and up over the seat detail. Without the shower pan material covering the seat, water will get under the tile or synthetic marble covering when the grout or caulking deteriorates, and will cause a leak. It is recommended that you check with your builder to determine if a seat will be installed in the shower, and to verify that he intends to extend the shower pan material up over the seat to make a watertight detail. (see photo below)

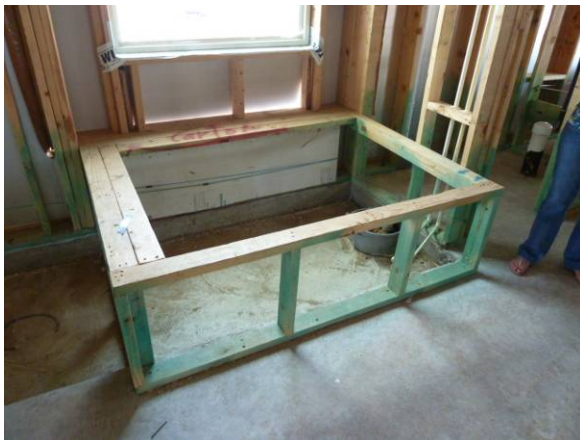
Another typical detail that we see repeatedly on new houses, is a lack of proper and adequate access under the whirlpool tub at the master bathroom for access to the water piping and drain. It is recommended that you check with your builder concerning the tub so that proper access can be built into the tub here at the framing stage of construction.

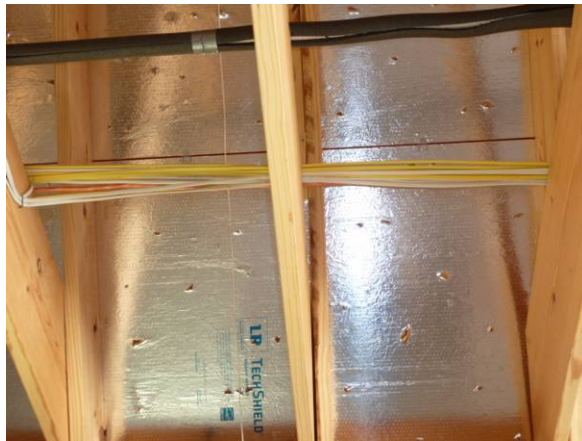
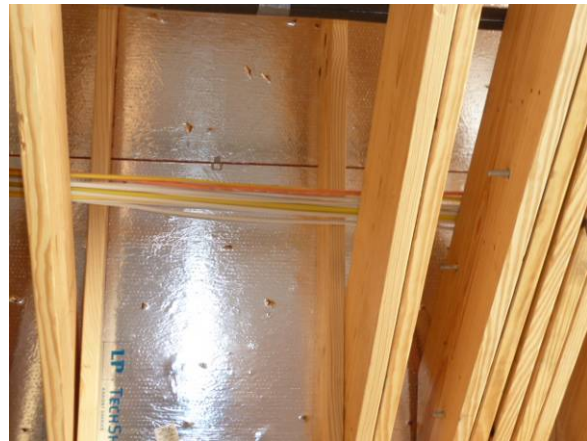
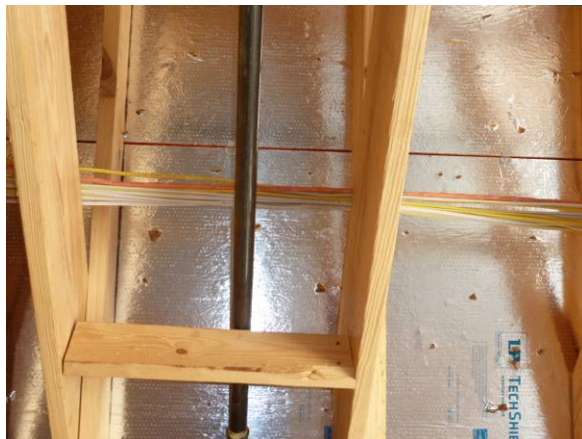
The electrical wiring from the breaker panel in the garage was observed to be bundled together in the wall and also in the ceiling. Electrical wires are not allowed to be bundled for a distance of more than two feet, before having to apply a derating factor to the capacity of the wiring. Further investigation with your builder is recommended to separate the wiring. Following is the section of the International Residential Code that relates to bundling of wires.

International Residential Code - E3605.3 Adjustment factor for conductor proximity.

Where the number of current-carrying conductors in a raceway or cable exceeds three, or where single conductors or **multiconductor cables are stacked or bundled for distances greater than 24 inches**

(610 mm) **without maintaining spacing** and are not installed in raceways, the allowable ampacity of each conductor shall be reduced as shown in Table E3605.3. **(NOTE: Emphasis by HEI)**

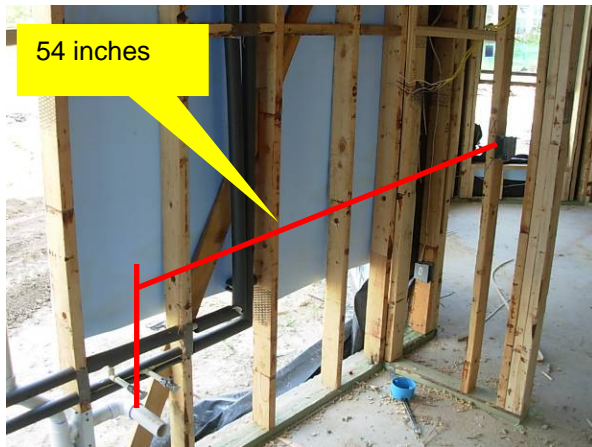
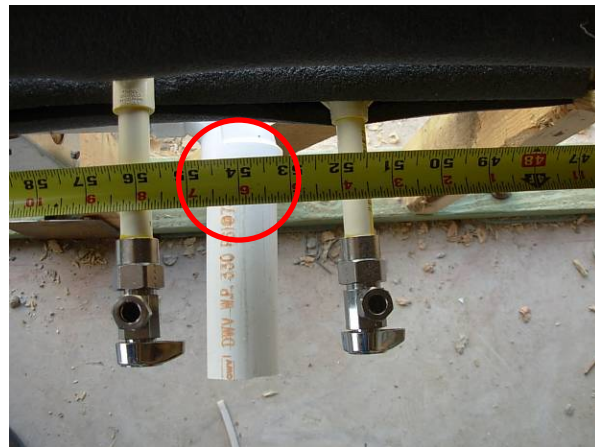
The outlet in the master bathroom was located 54 inches from the centerline of the sink on the adjacent wall. Bathroom outlets are required to be no farther than 36 inches from the outside edge of the sink. Further investigation with your builder is recommended.

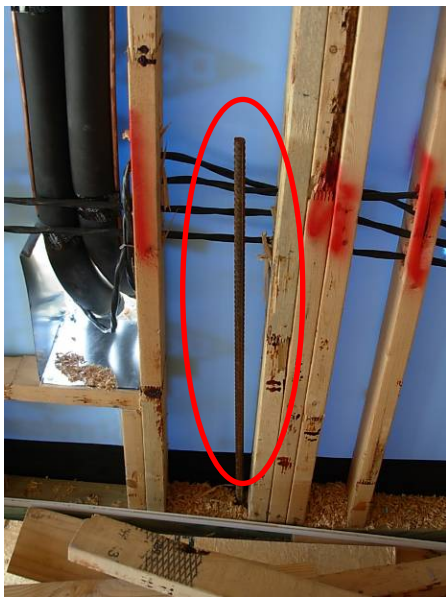
The required reinforcing steel stub up was observed in the garage, where a piece of rebar from the foundation is extended up into the garage wall. However, the bonding wire from the breaker panel to the rebar was not installed at the time of the inspection.

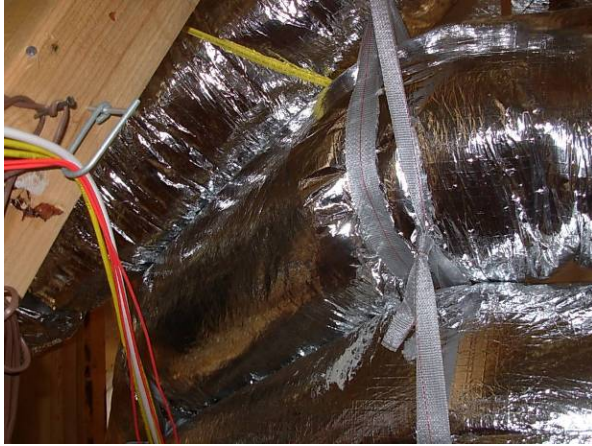
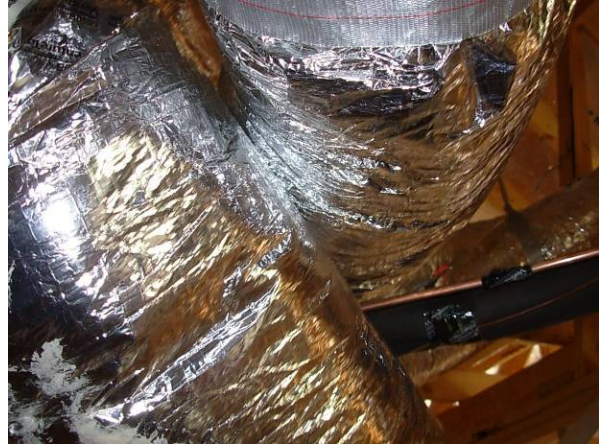
The air conditioning ductwork was in contact with each other in several places. This condition can cause condensation at the contact points and it is recommended that the ducts be separated.

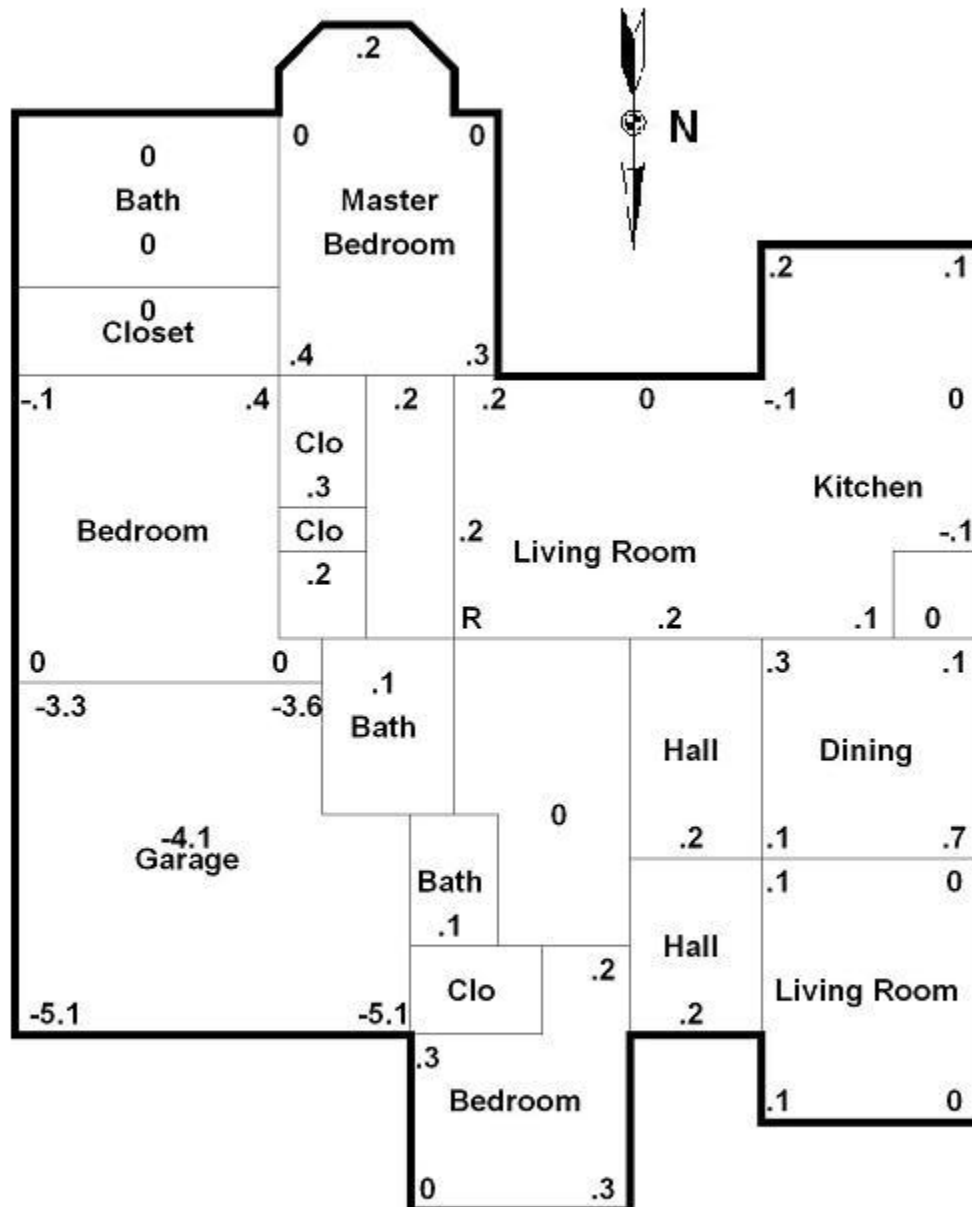
## ELEVATION READINGS

Normally horizontal surfaces, such as floors, door tops, counters, window sills, etc., were observed to be acceptably level throughout the house. The floors were checked with an electronic level, and the difference in elevation between the high point and low point was 0.8 inch. The high point was located at the west side of the house at the dining room, and the low point was located on the east side of the house at the center bedroom.

See our field sketch showing the elevation readings at the end of this report. Note that the "R" on the sketch is our randomly chosen starting reference point, where the elevation is 0, and all other elevation readings are taken relative to the reference point, and are measured in inches to the nearest 1/10 inch. Note also that elevation readings taken at the garage area are relatively large numbers relative to the reference point due to the step down into the garage area.
