HEDDERMAN ENGINEERING, INC.

REF: CONDITION OF PROPERTY SURVEY - Roof Inspection.

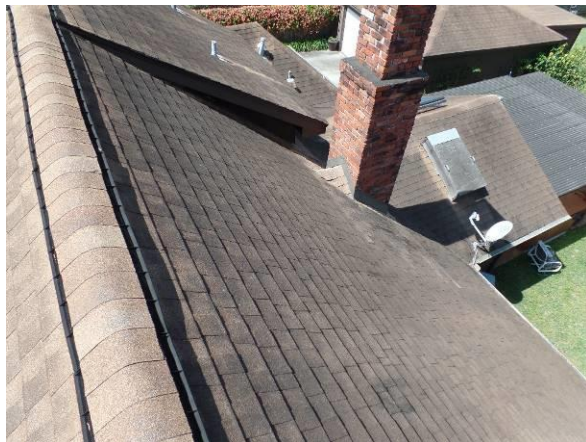
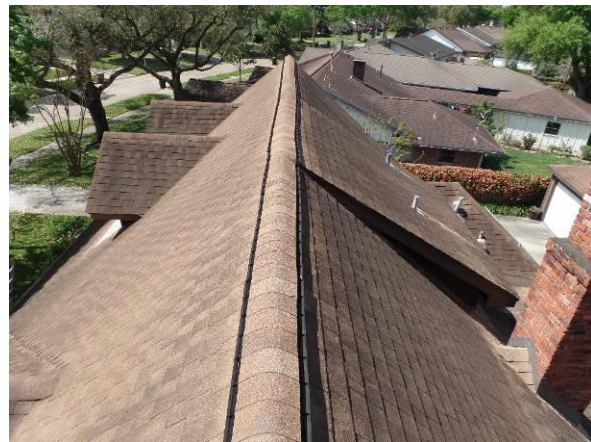
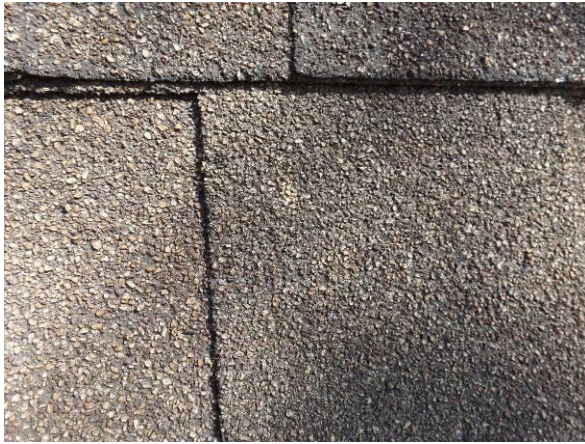
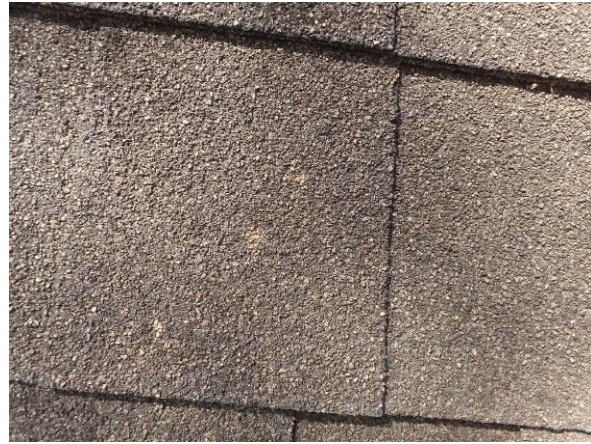
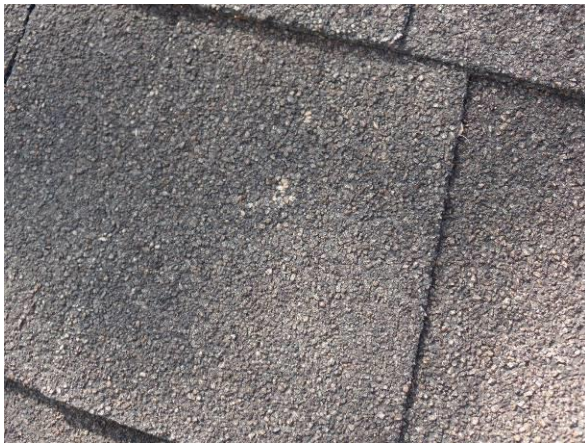
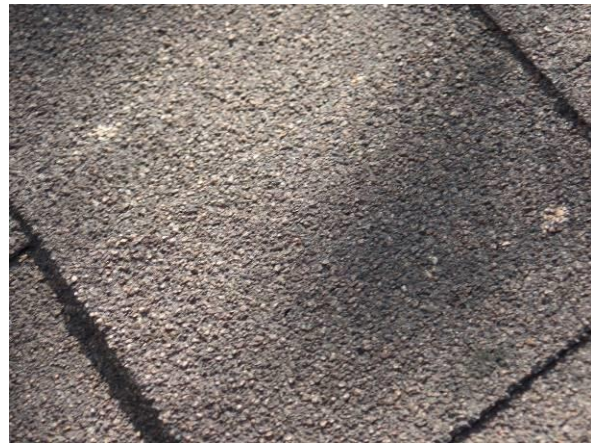
The composition roof has obviously been struck by hail, as evidenced by the numerous locations where the black discoloration on the surface of the shingles has been removed. Most of the damage from hail is principally an impact damage effect and takes place on the bottom side of the shingle, where the force of the hail strike causes microcracks in the base shingle material while loosening the aggregate where the hailstone strikes. These small cracks are not visible without plying and lifting the shingles to see the bottom side. Since this process can damage the shingles, we do not attempt to lift any shingles to see the bottom side.

It was very apparent when viewing the roof from its surface that the entire roof showed evidence of having been struck by hail.

This roof has clearly been struck and damaged by hail, and it is our opinion that the roofs on both the house and garage are in need of replacement, as well as the patio cover over the rear patio area.

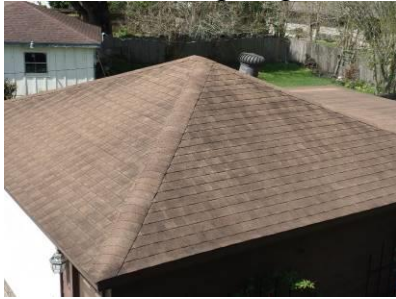
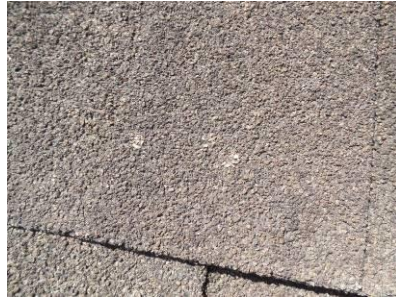
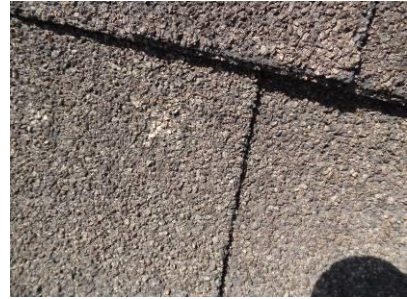
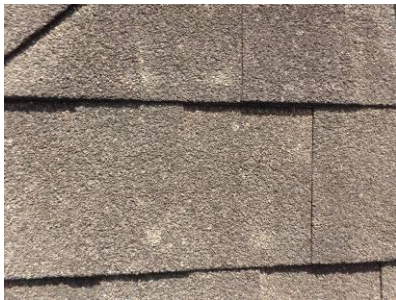
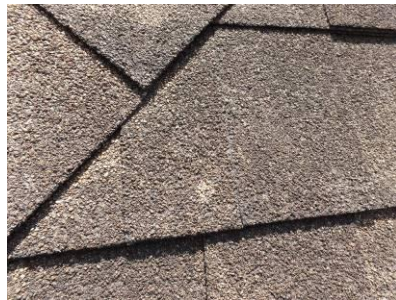
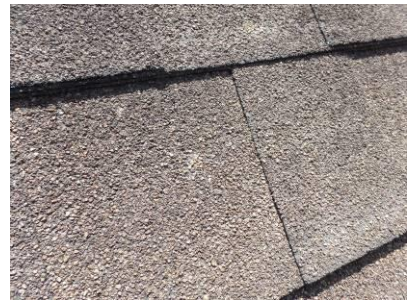
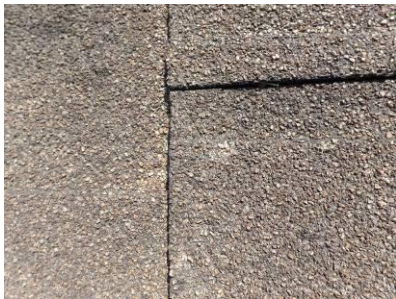
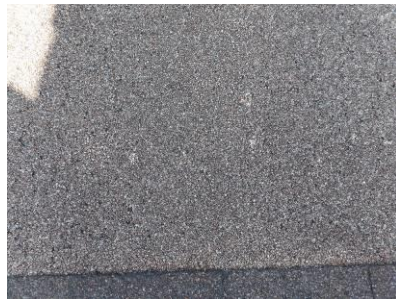
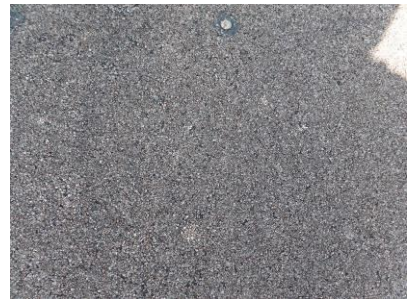
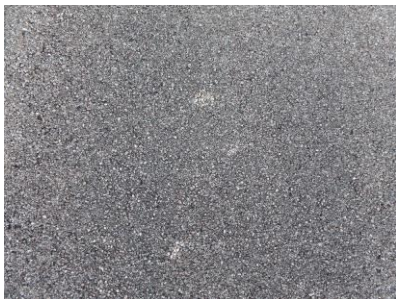
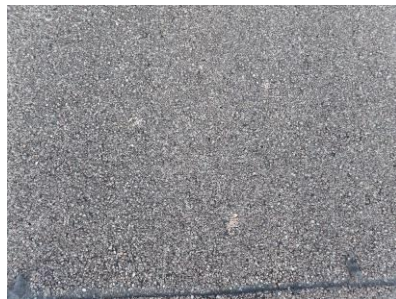
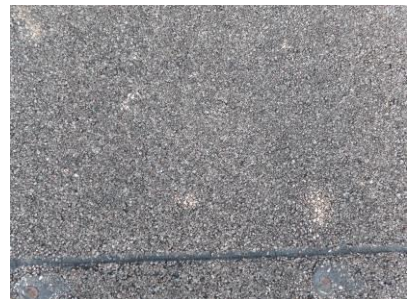
The roofs on the garage were also damaged by hail, as evidenced by the many strike points observed on the shingles and also on the modified bitumen low sloped surface at the rear of the garage.

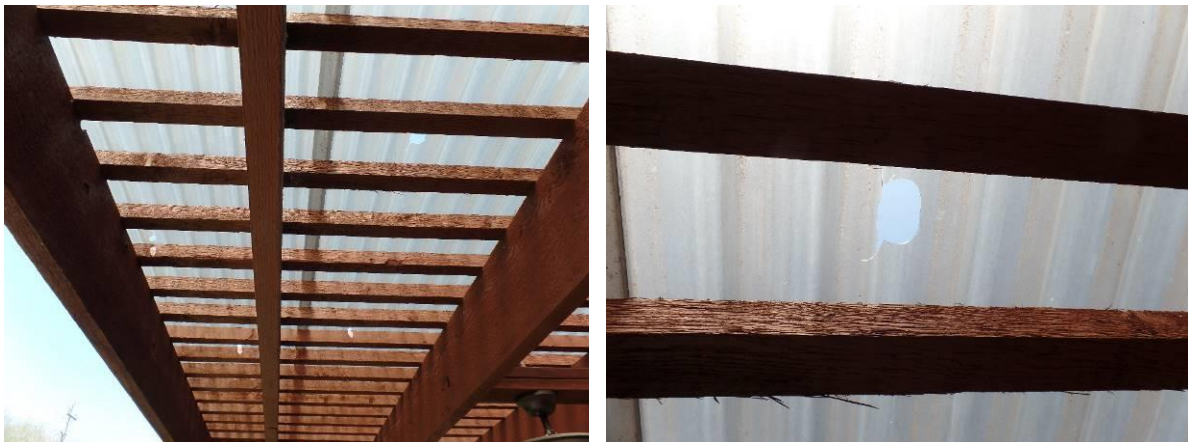
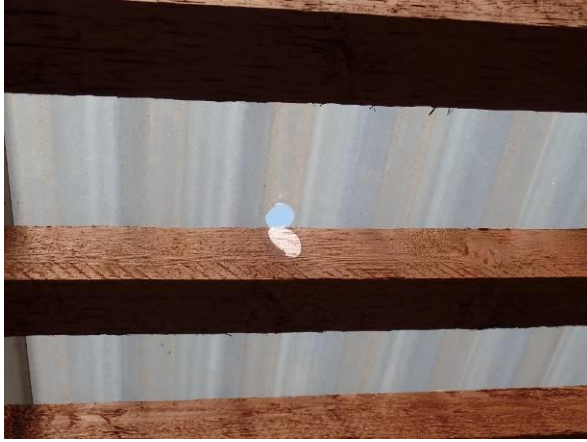
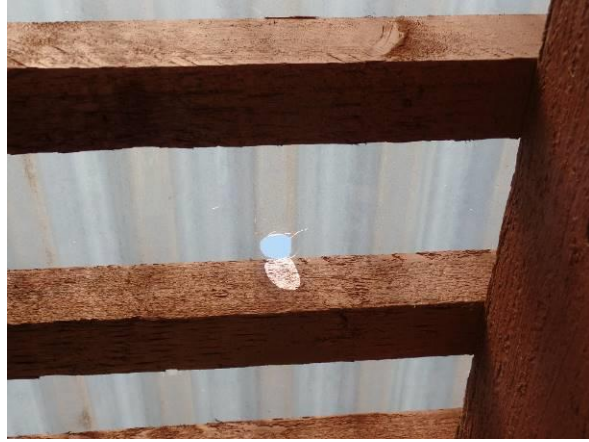
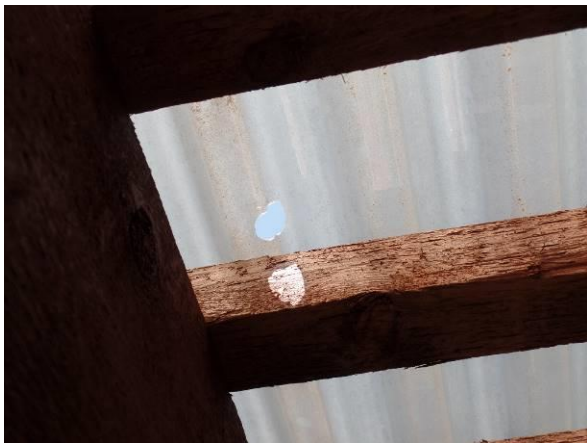
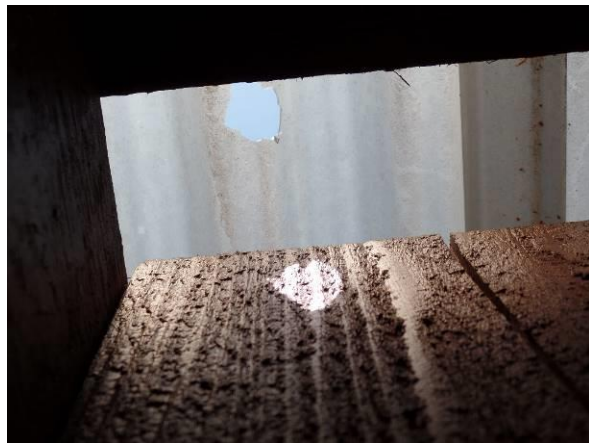
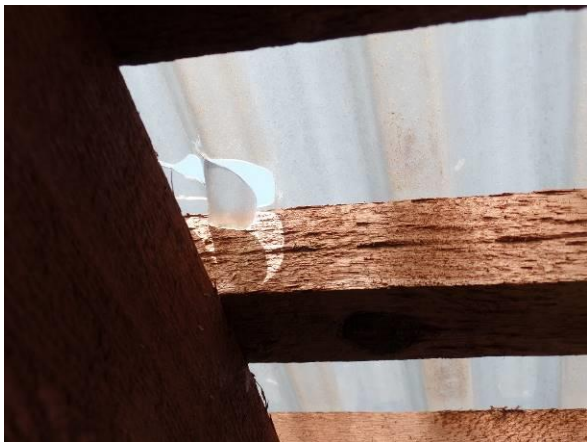
We also observed hail damage to the plastic roof covering over the patio area at the rear of the house where hail stones broke through the thin plastic roof covering.

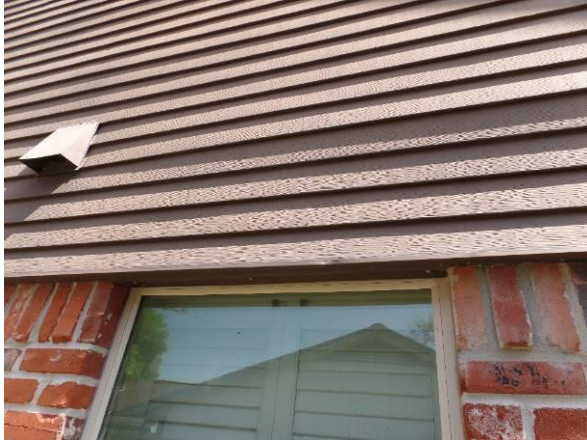
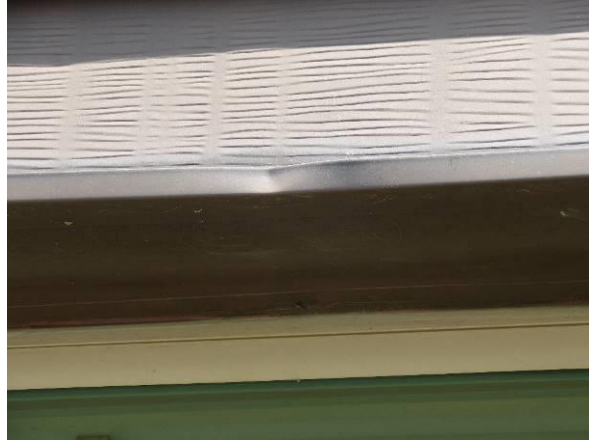
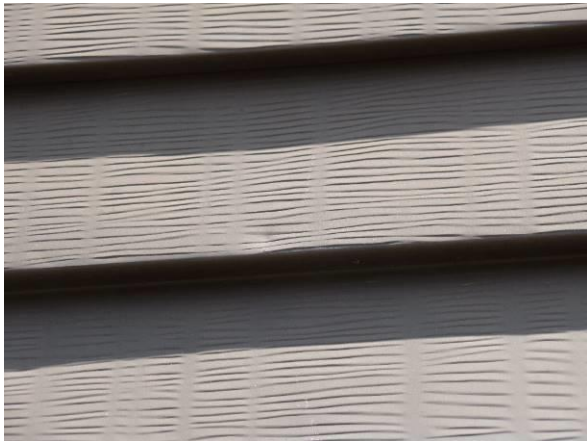
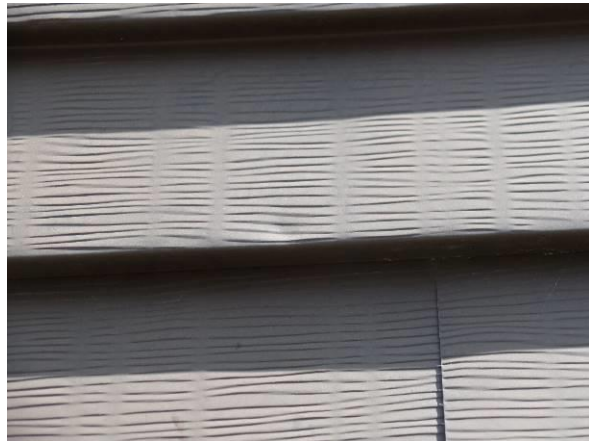
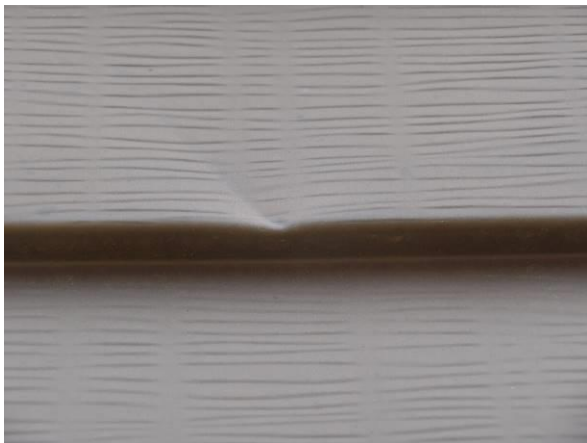
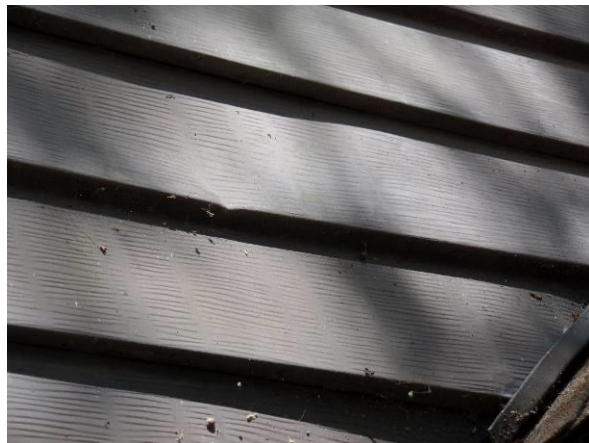
We also observed several dents in the siding material at the front and sides of the house which may be related to the hail storm.
