HEDDERMAN ENGINEERING, INC.

REF: CONDITION OF PROPERTY SURVEY

Address

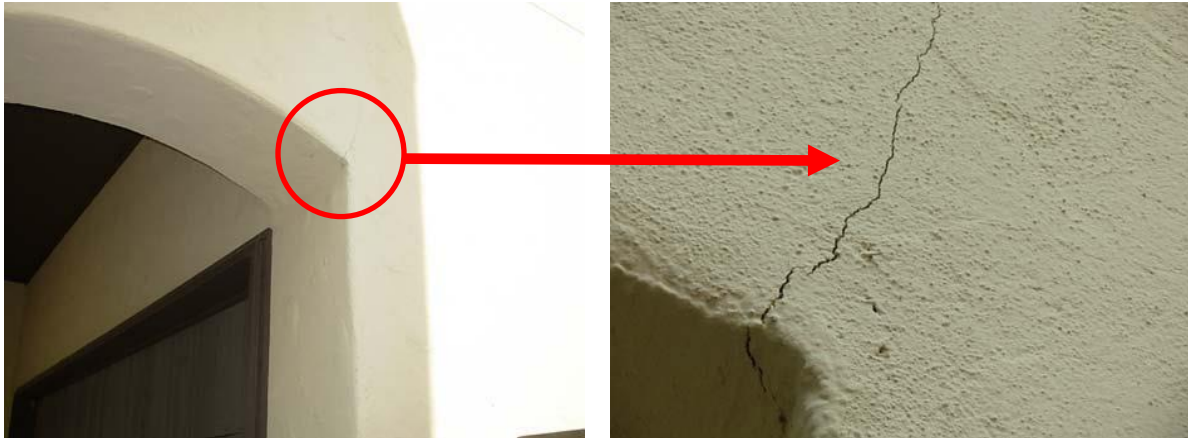
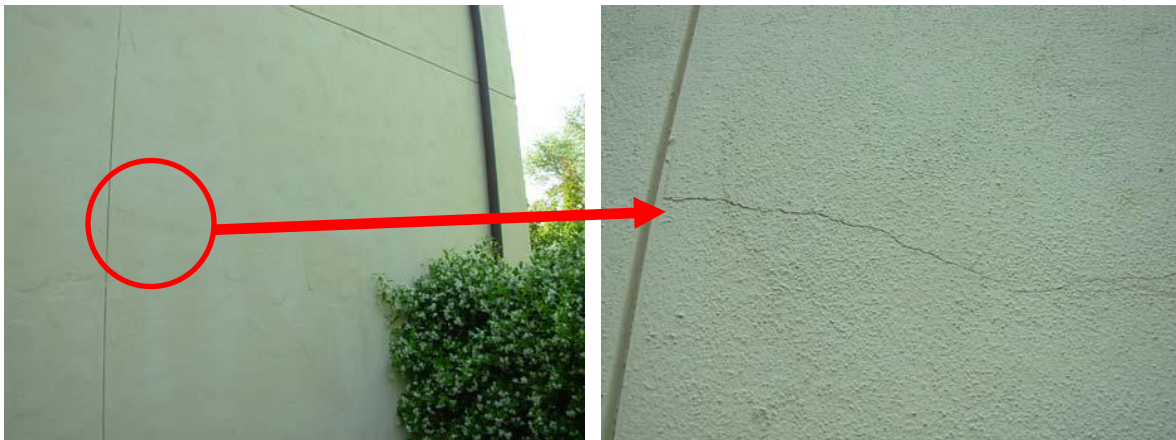
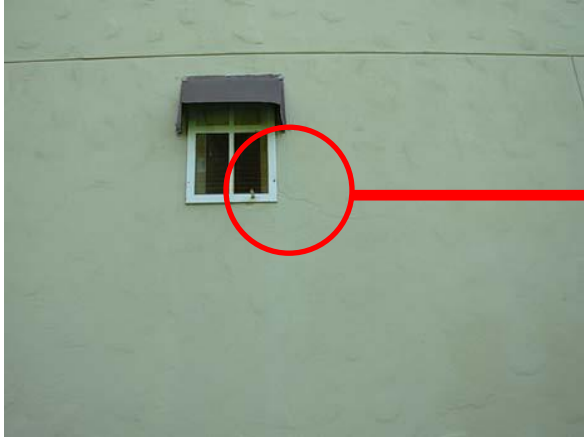
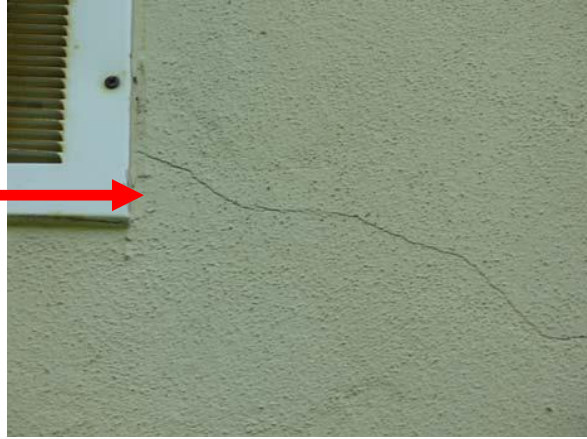
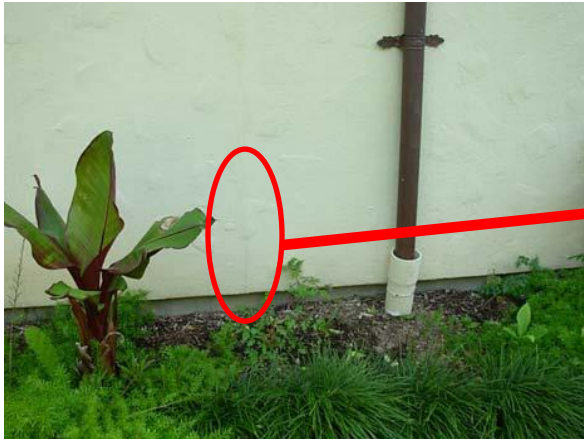
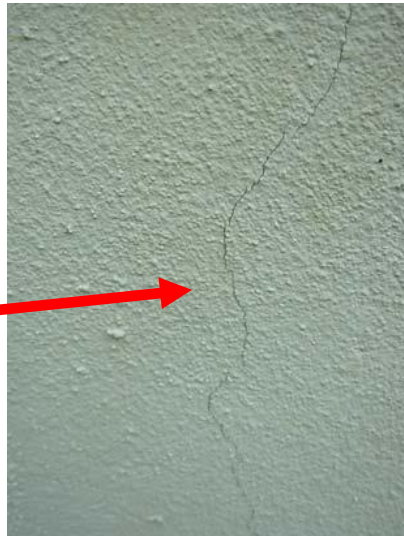
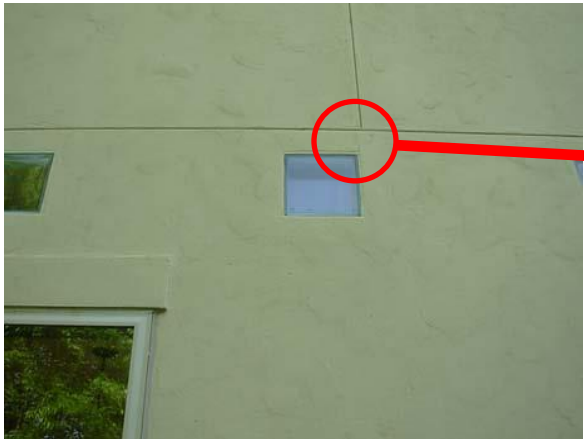
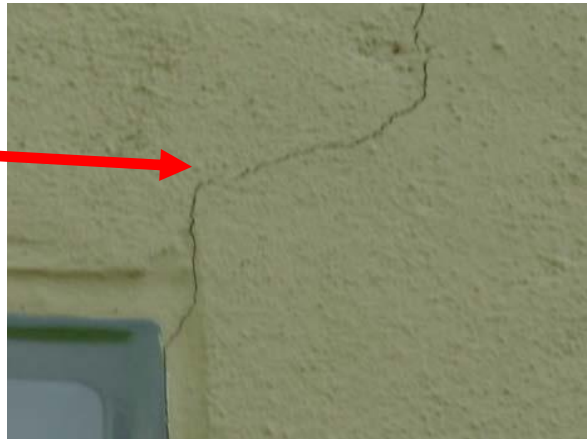
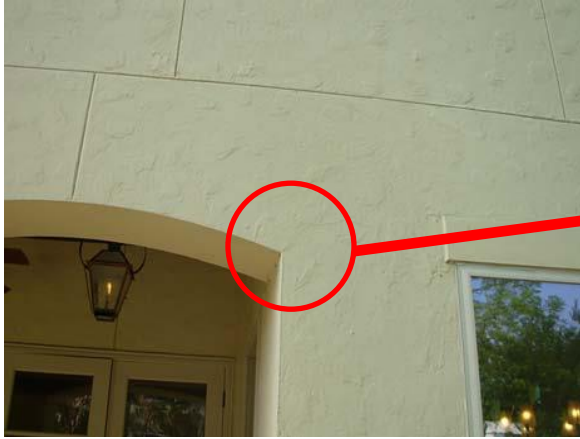
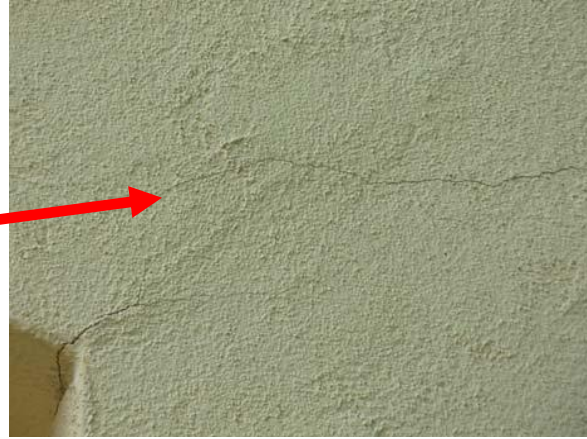
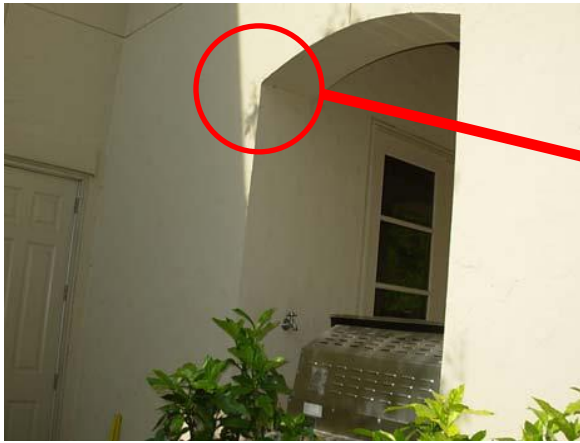
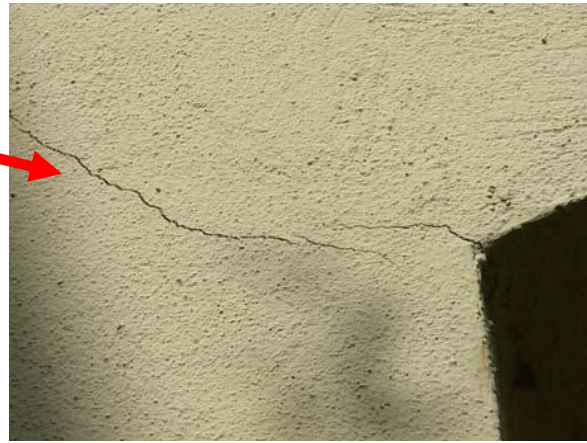
Veneer Cracks

Cracks and/or patches were observed in the exterior stucco veneer at all four sides of the house, as seen in the photos below. The cracks in the stucco were in accordance with movement of the foundation as seen in the elevation survey at the end of the report.

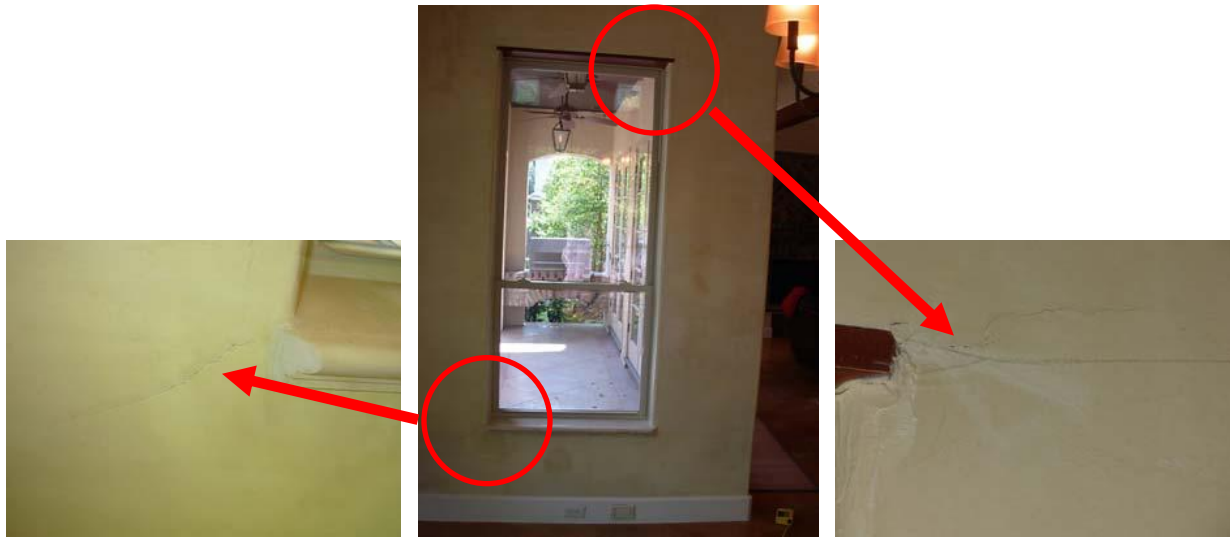
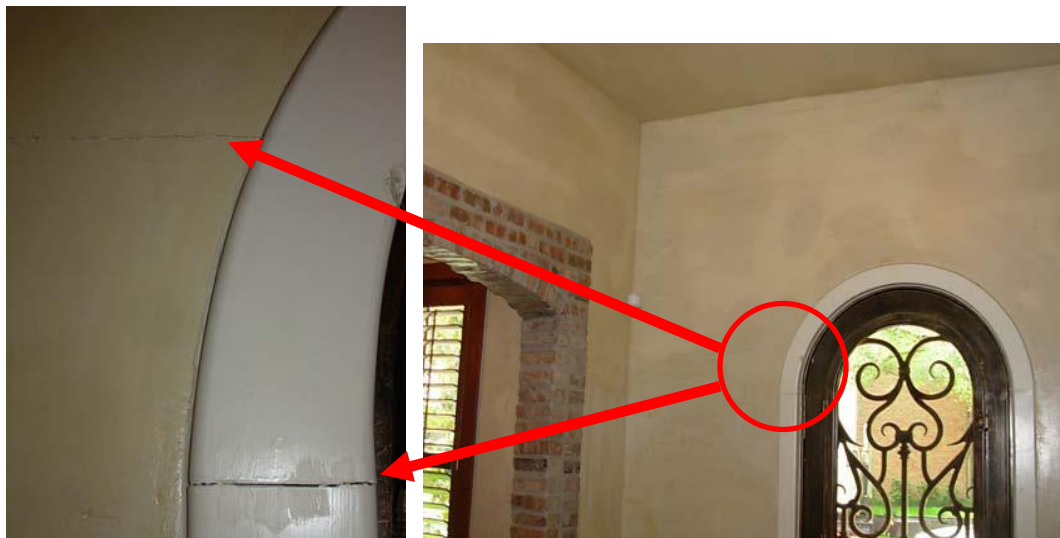
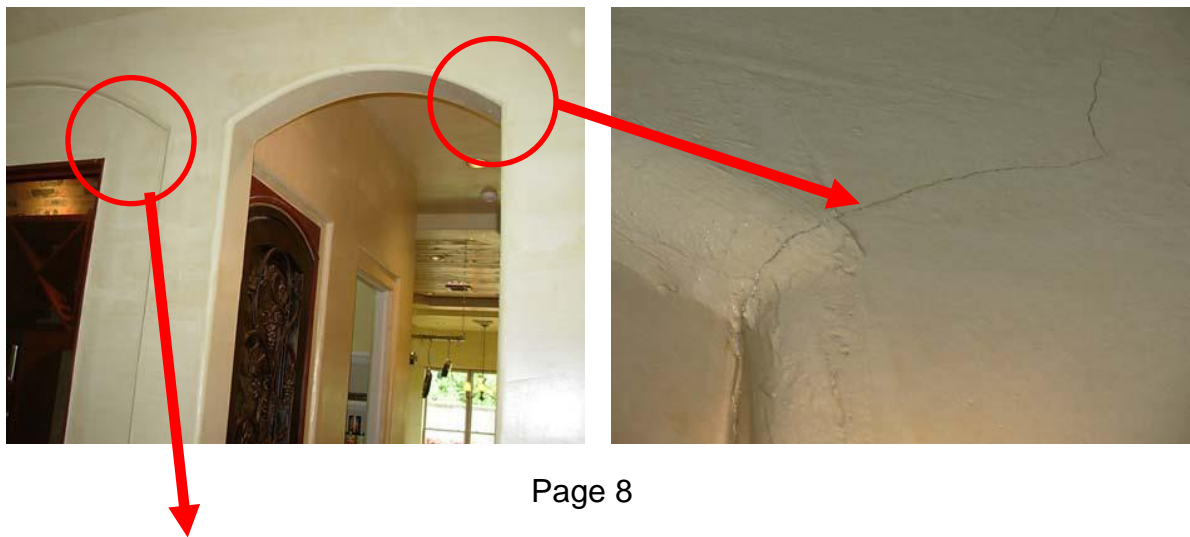
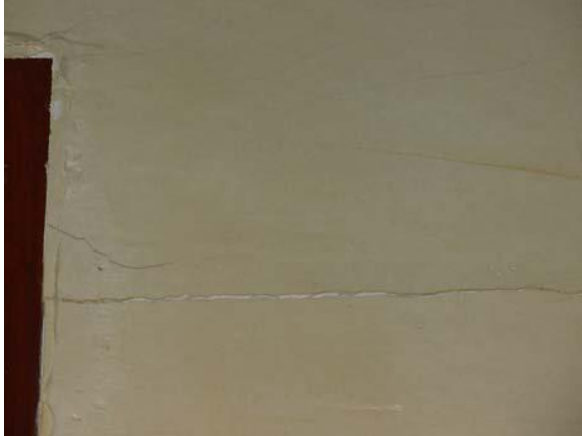
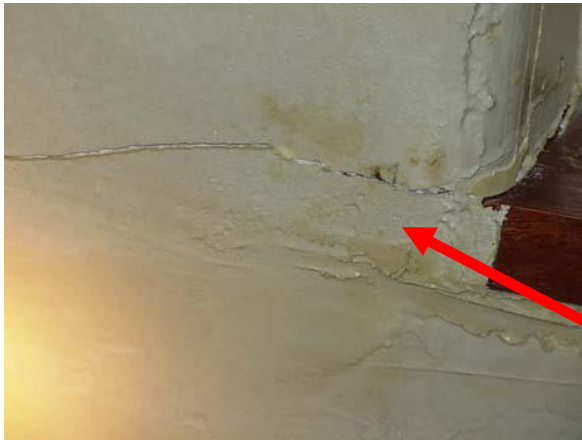
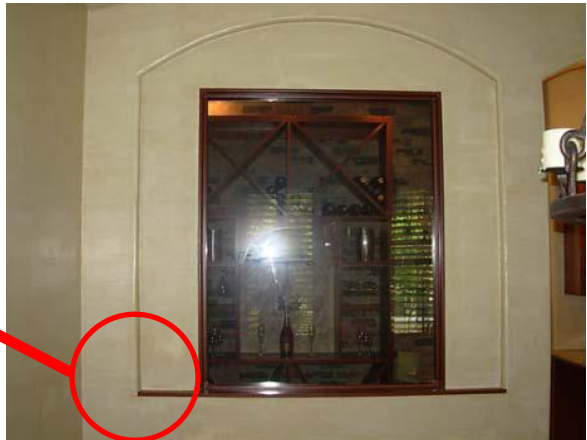
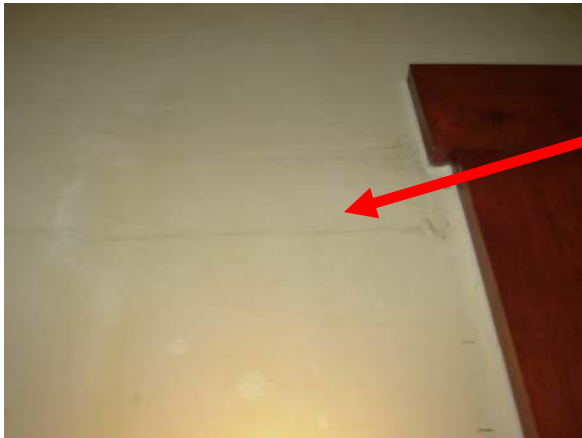
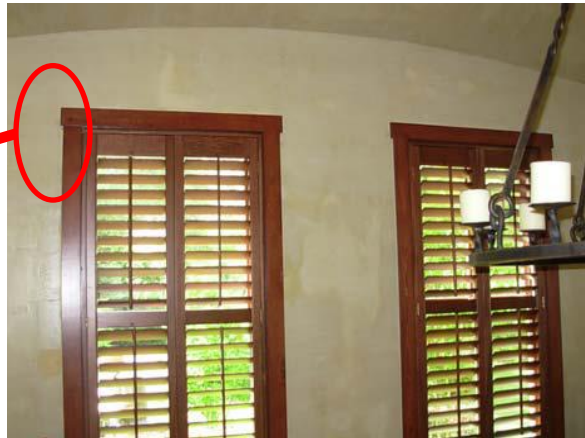
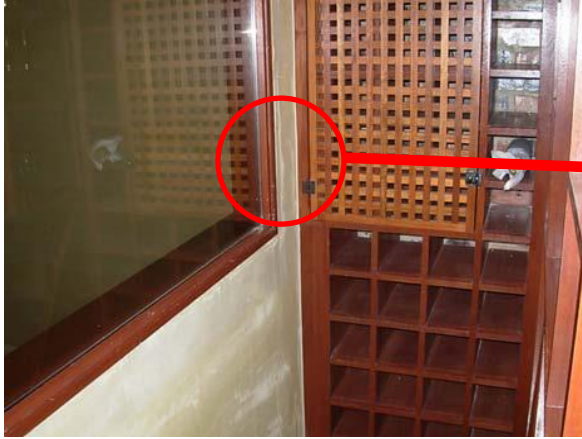
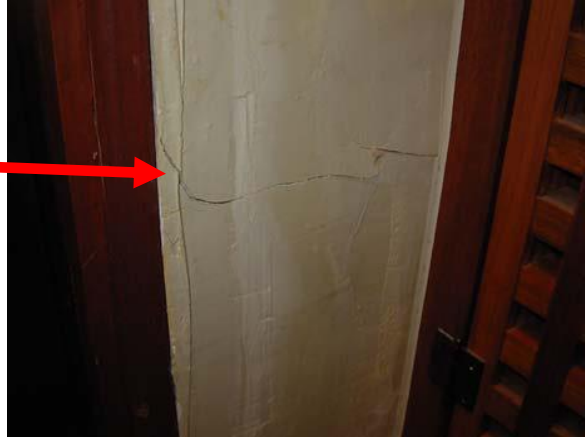
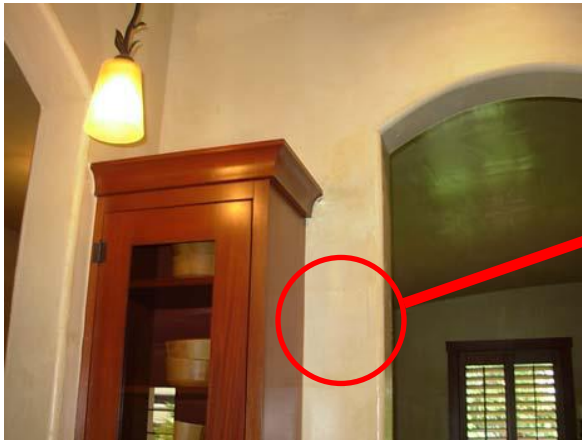
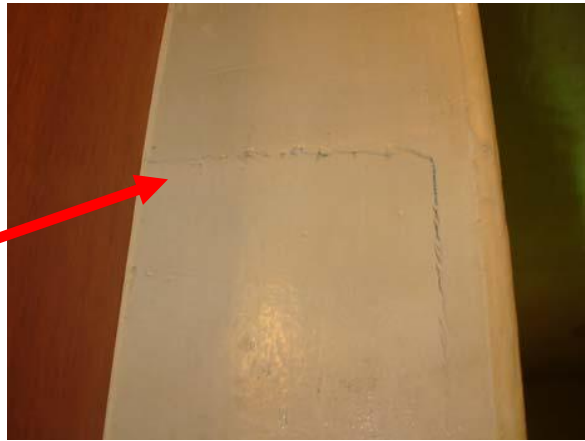
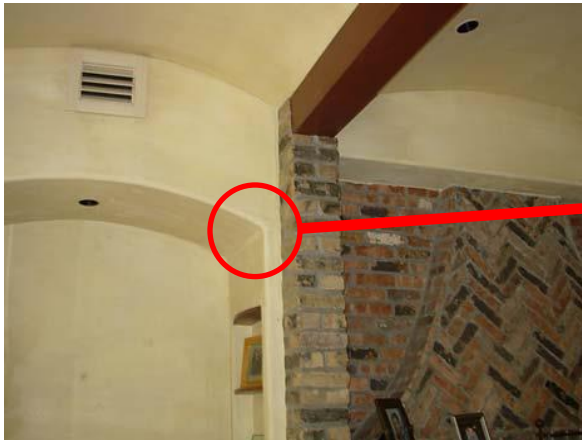
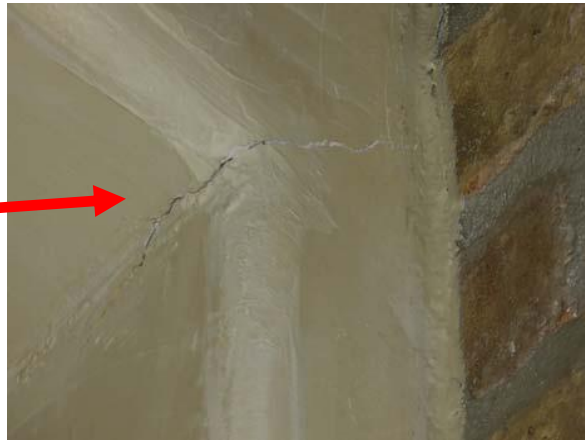
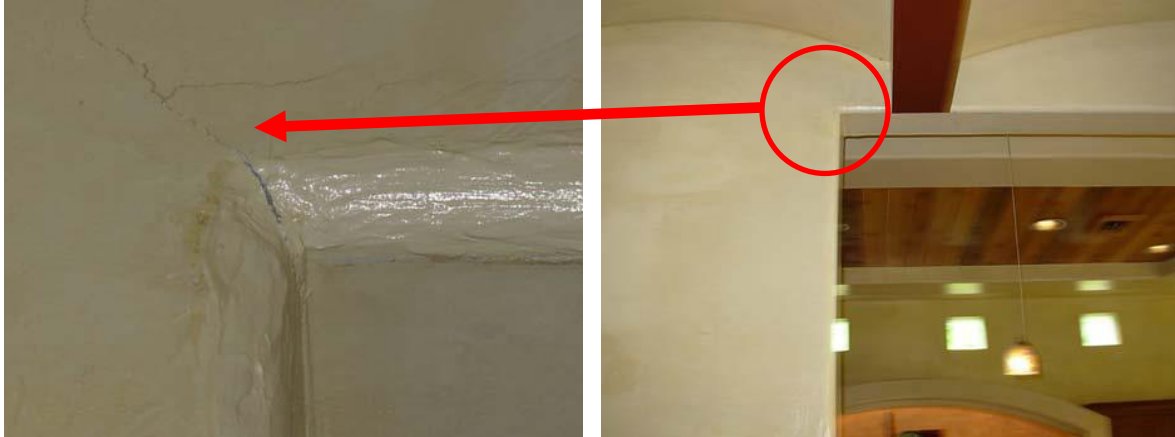
Sheetrock Cracks

Sheetrock cracks, patches, or compression ridges were observed several locations as seen in the photos below. The location and direction of the cracking is in agreement with the sloping of the floors to indicate settlement of the foundation towards the low area of the house at the front wall of the study. Note that the following is only some, not all, of the cracks observed in the house.

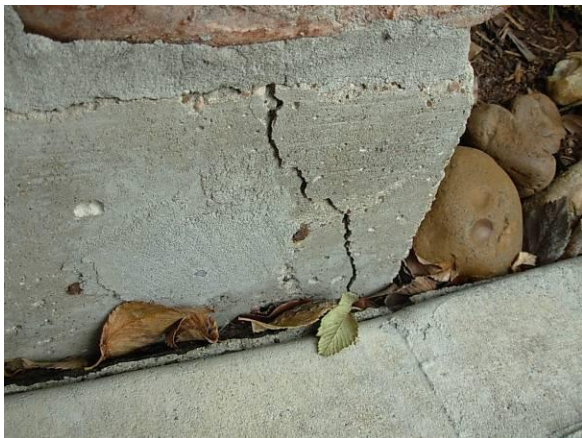
The corner of the foundation was observed to be chipped. This is condition that is caused by differences in thermal expansion between the brick veneer, and the concrete foundation. Also, this condition can be caused by a lack of reinforcement in the corner of the foundation during original construction. In our opinion, this condition does not affect the structural integrity of the foundation.

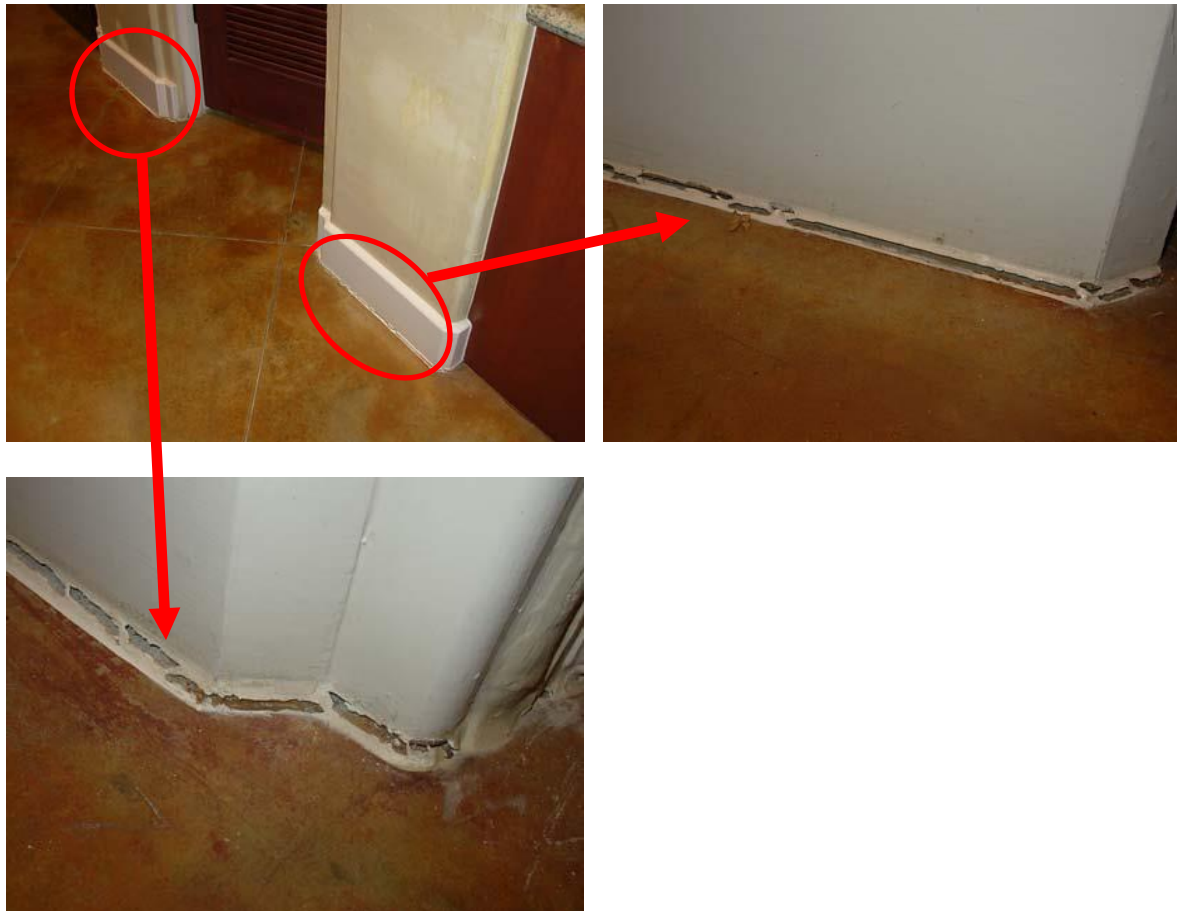
- A separation was visible at the bottom of the door trim at the kitchen pantry and wine room area.

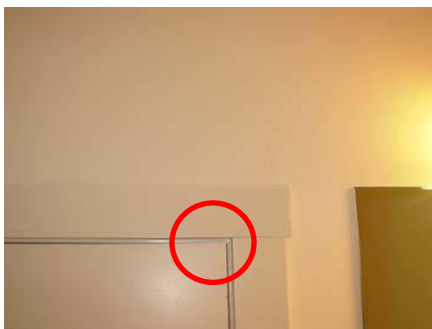
- A door was sticking at the upstairs west center bathroom.

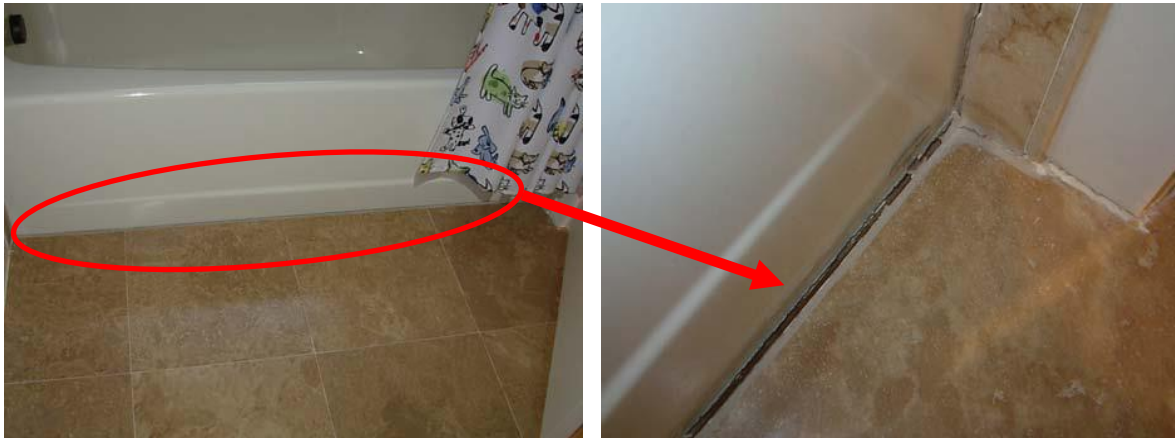
- The floor tiles at the upstairs west center bathroom were separated from the edge of the tub.

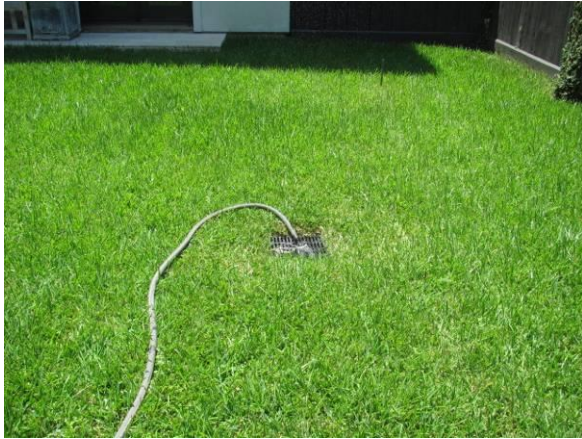
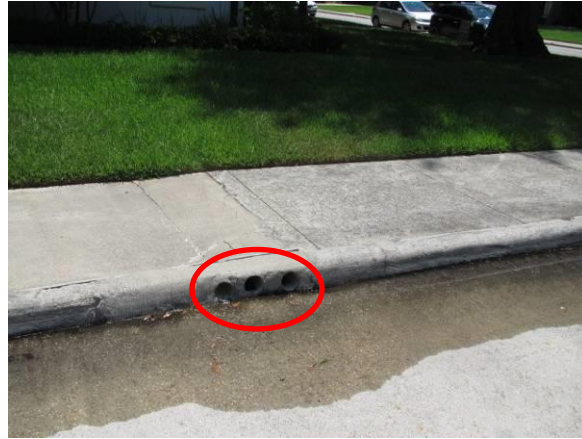
UNDERGROUND DRAIN

The underground drainage system at the rear of the house was checked by running water into the drain for approximately 15 minutes, and the system was observed to be draining properly to the street.

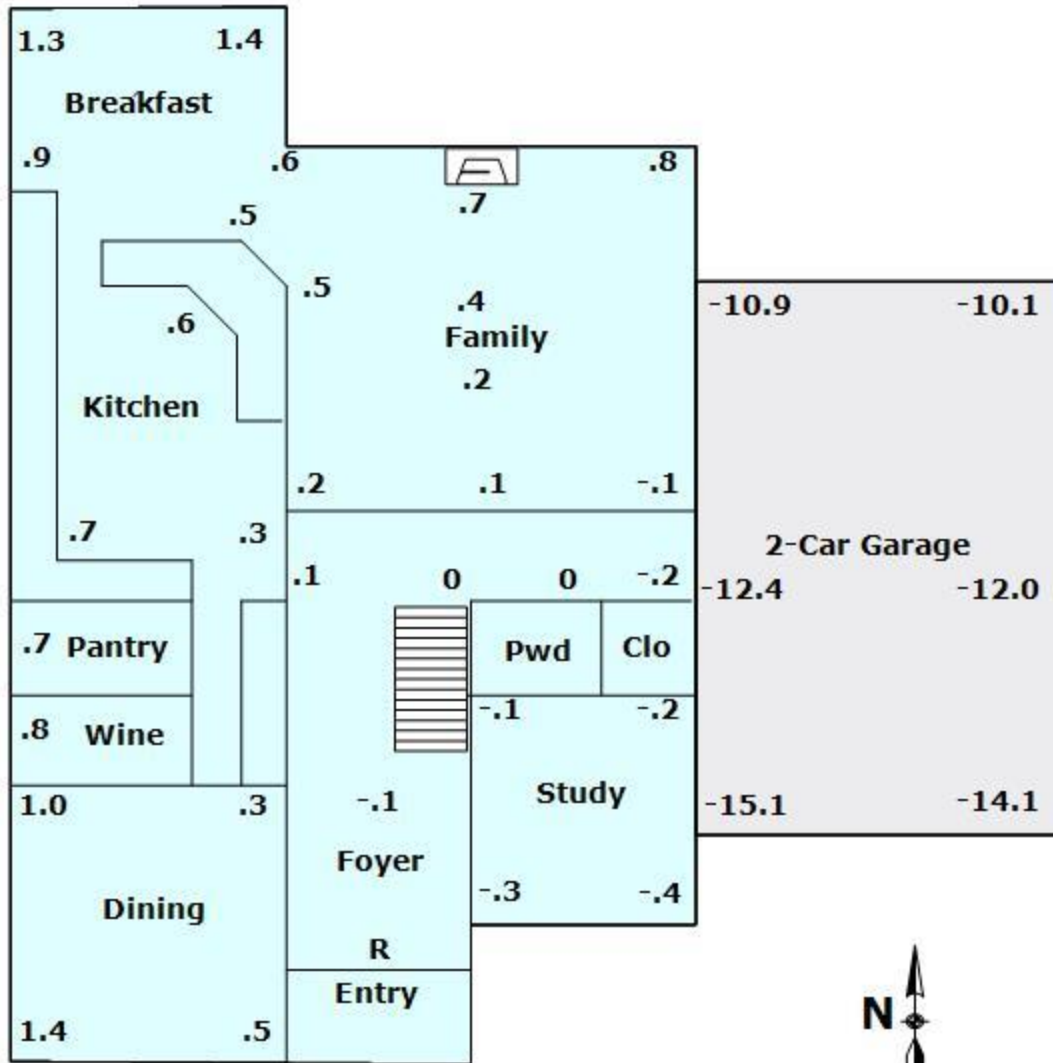
**Elevation Readings
ADDRESS**

Normally horizontal surfaces, such as floors, door tops, counters, window sills, etc., were observed to be sloping generally from the rear of the house towards a low area at the front wall of the house at the study. The floors were checked with an electronic level, and the difference in elevation between the high point and low point was 1.8 inches on the first floor and 2.2 inches on the second floor.

See our field sketch showing the elevation readings at the end of this report. Note that the "R" on the sketch is our randomly chosen starting reference point, where the elevation is 0, and all other elevation readings are taken relative to the reference point, and are measured in inches to the nearest 1/10 inch. Note also that elevation readings taken at the garage area are relatively large numbers relative to the reference point due to the step down into the garage area.

Due to the more than acceptable amount of movement of the foundation of this structure, it is our opinion that releveling of the foundation is needed at this time. It is recommended that at least three foundation repair contractors be contacted in order that they may make their own assessment of the scope and cost of the work needed to bring this foundation back to an acceptable degree of levelness.
