PROPERTY INSPECTION REPORT

Prepared For: **CLIENTS NAME**

Concerning: **PROPERTY ADDRESS**

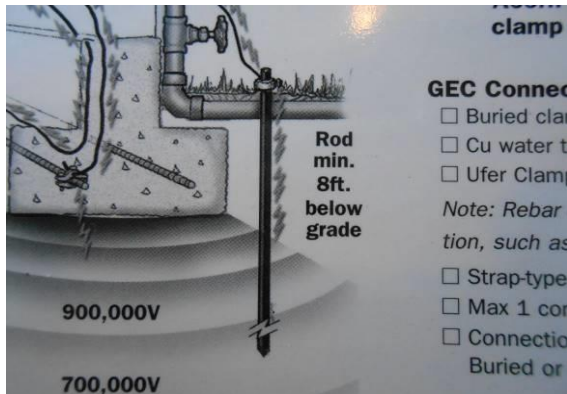
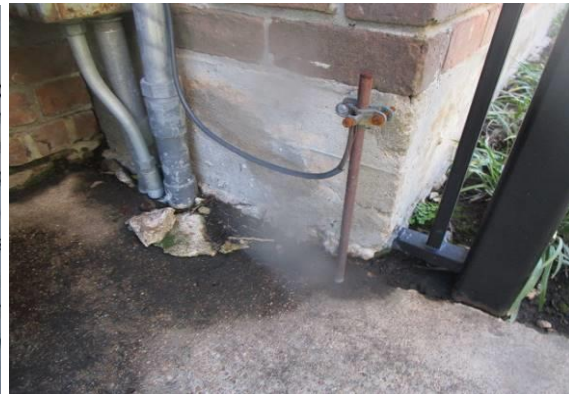
The ground rod was sticking out of the ground a few inches, and, since ground rods are typically 8 feet long and all 8 feet of the rod are required to be in the ground, it is recommended that the ground rod be pounded down flush with the top of the ground.

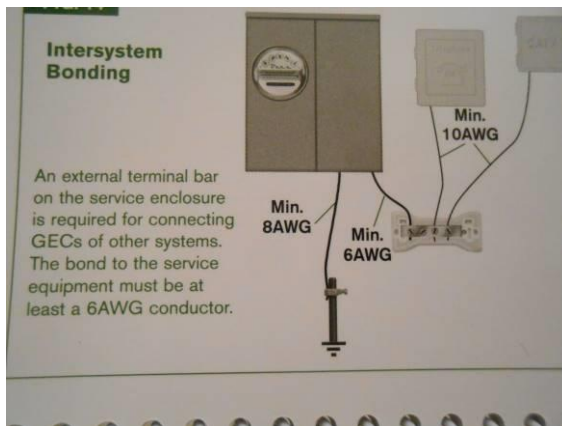
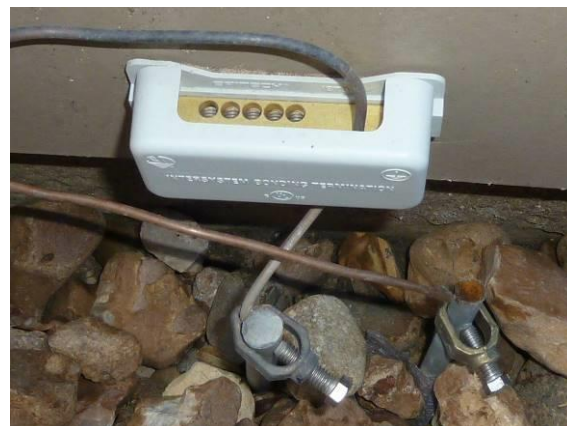
The grounding conductor to the ground rod was not equipped with the grounding block for the low voltage service.

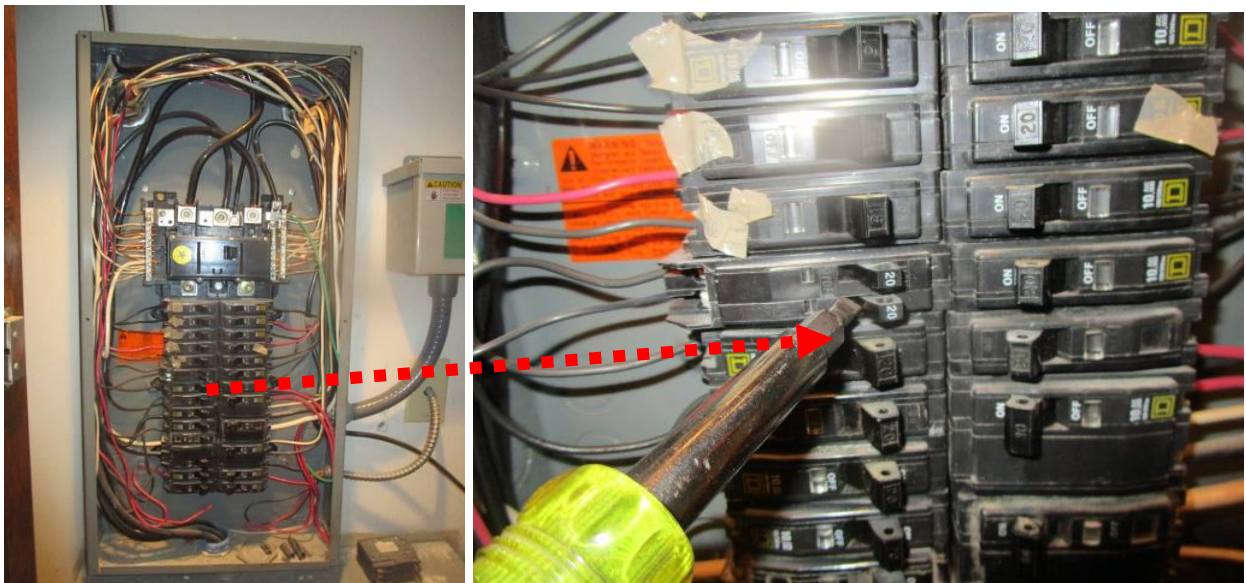
One 20-ampere circuit breaker was observed that was rated higher than the wire that it was protecting. This condition can be a fire hazard, and the oversized breaker should be replaced with a breaker that is sized in accordance with the allowable ampacity of the wire.

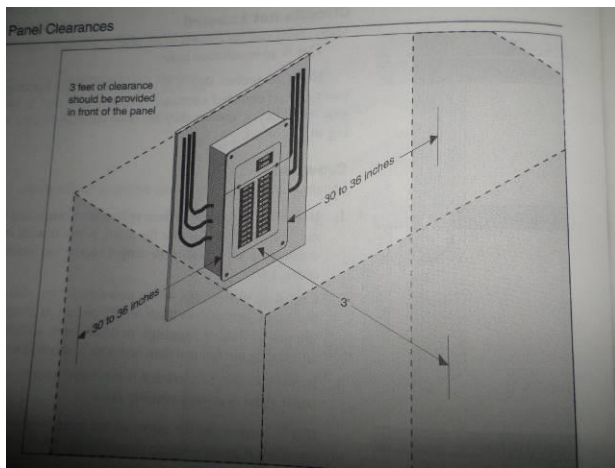
The breaker panel was not located in a readily accessible area, and did not allow proper access to the equipment. A three foot working space needs to be provided and maintained about the equipment.

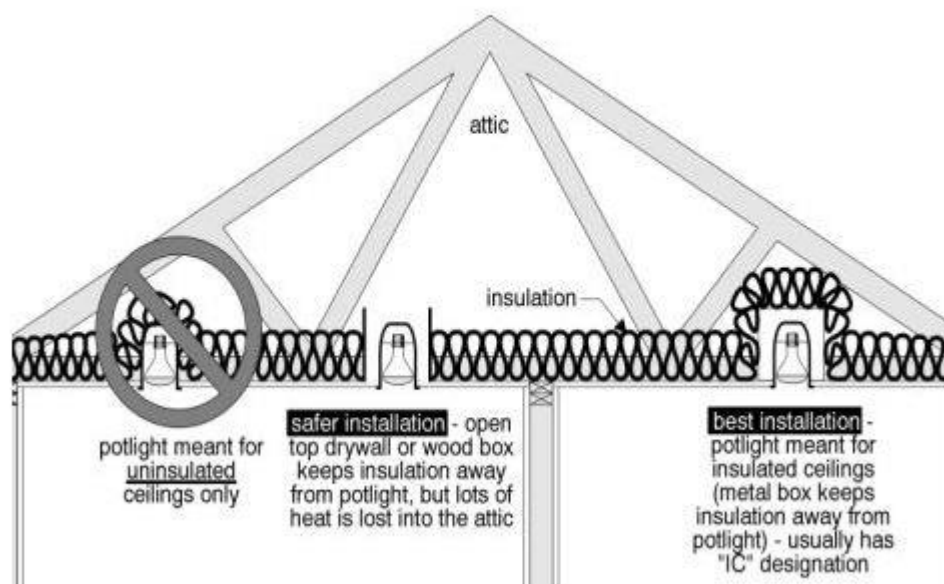
Potlights in insulated ceilings

The insulation was in contact with the recessed lights, which can be a fire hazard and shorten the life of the light bulbs. The recessed cans were specifically marked with a warning of a risk of fire if the recessed light was in contact with insulation. It is recommended that the insulation be pulled back to provide a three inch air space.

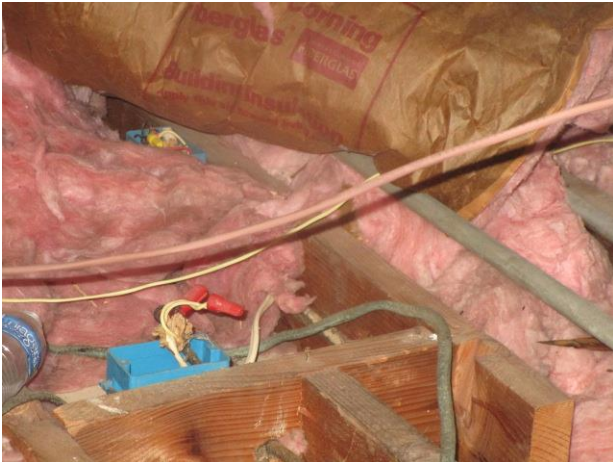
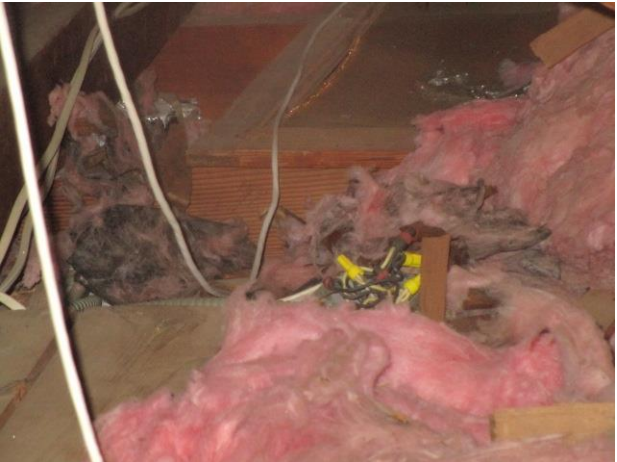
An open junction box(es) was observed.

Locations included: attic

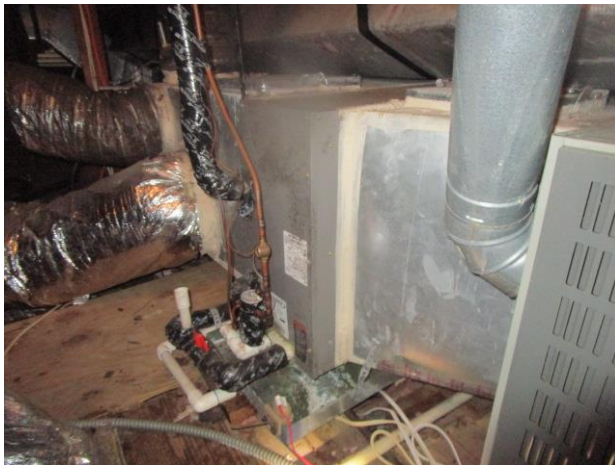
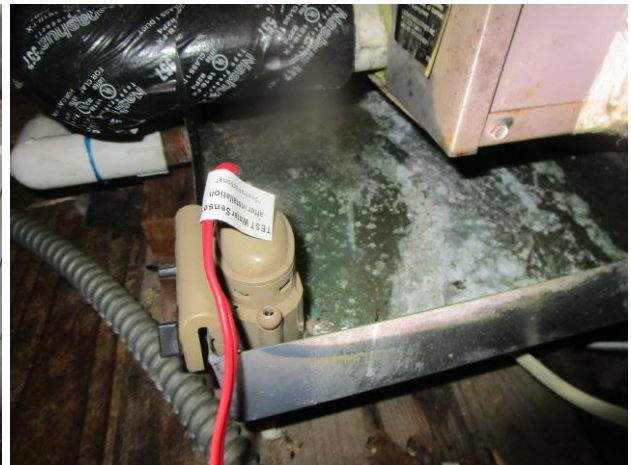
Standing water was observed in the auxiliary drain pan under the evaporator coil for the 5-ton unit. This can indicate a clogged primary drain line, or some other problem with the evaporator coil. Have a service company find the source of the water in the pan, and make any necessary repairs.

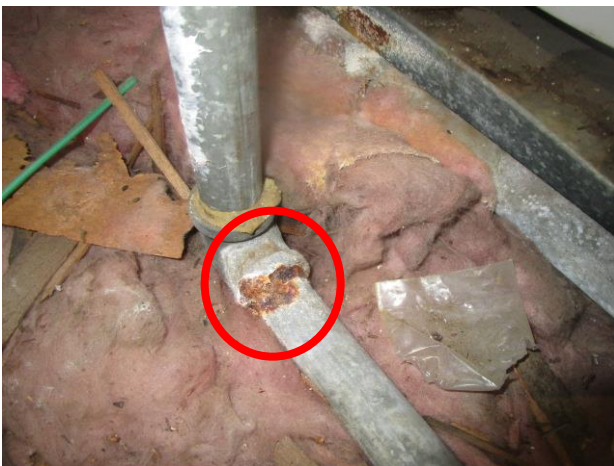
The galvanized piping at the attic was observed to be rusted. No leaks in the piping were visible at the time of the inspection.

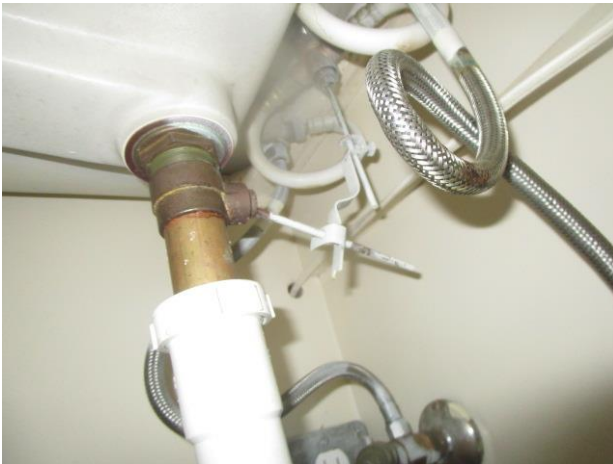
The drain line was leaking under the sink when the sink was filled with water and allowed to drain.

Locations included: hall bathroom

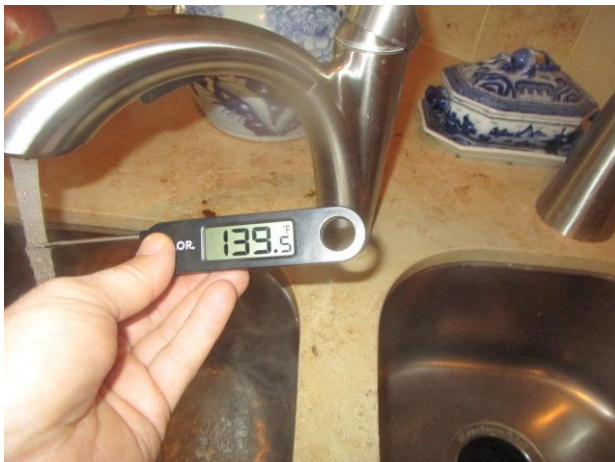
The temperature of the hot water was measured to be **139** degrees at the kitchen sink at the time of the inspection. Normally, 120 degrees is the recommended maximum temperature of hot water to prevent accidental scalding. It takes approximately 1/2 second of exposure to 160 degree water to cause a second or third degree burn. See the link below for more information about hot water burns and a scalding graph.
http://www.accuratebuilding.com/services/legal/charts/hot_water_burn_scalding_graph.html

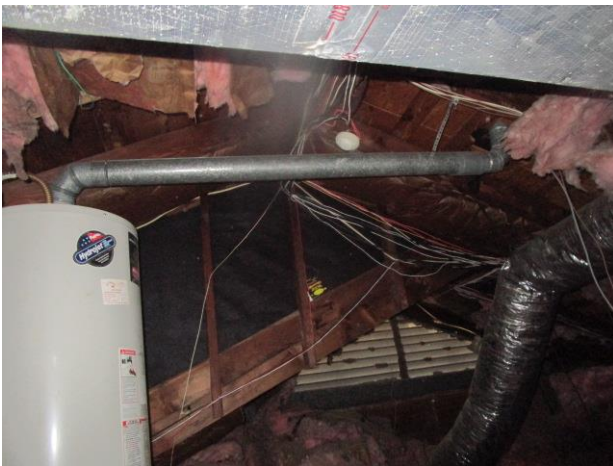
Water Heater Vent Pipe

The vent pipe had a long horizontal run (approximately seven feet), and very little vertical rise (approximately two foot). The vent pipe is not installed properly, and can allow hazardous combustion gases to vent into the attic. Have a service company provide a cost estimate to replace the vent pipe.

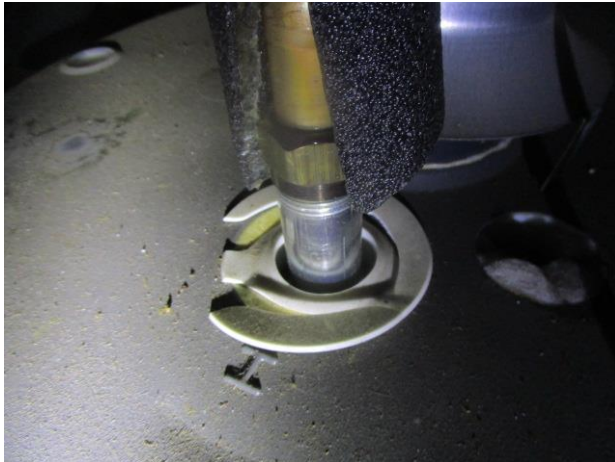
The hot water discharge line had a seepage leak.

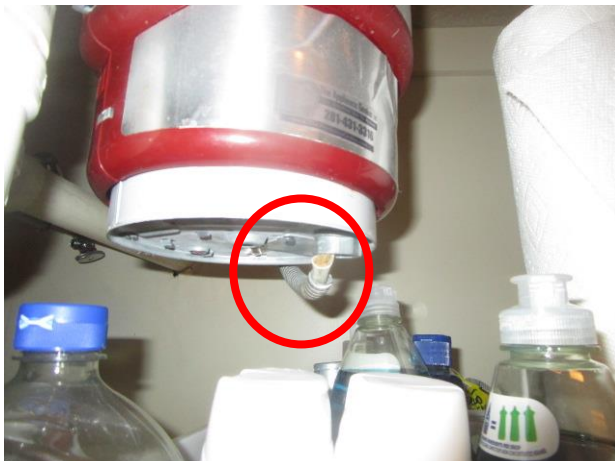
The electrical wiring for the disposal was not properly connected at the bottom of the unit.

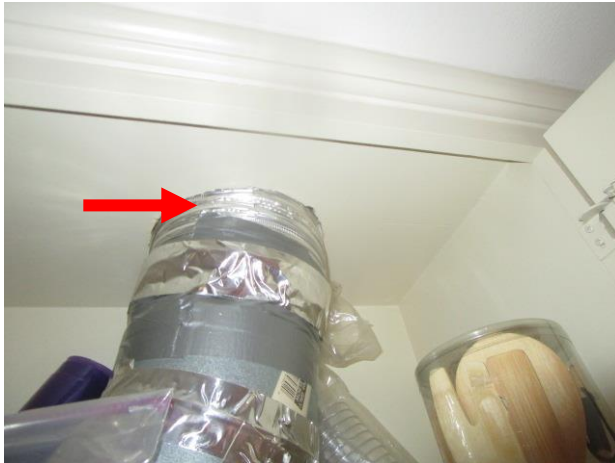
A portion of the vent pipe was flex duct, rather than solid ducting. The flex duct is not an approved material, and it is recommended that it be replaced.

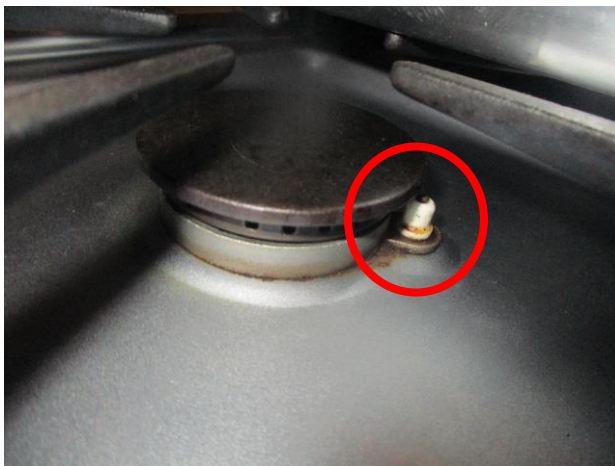
The electronic igniter for the right front burner was non-functional and needs to be repaired/replaced.

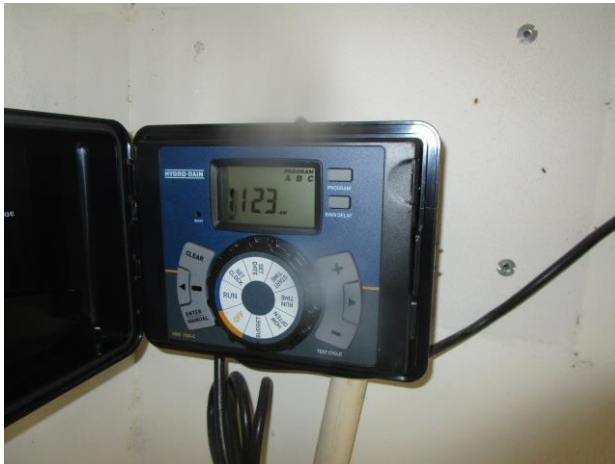
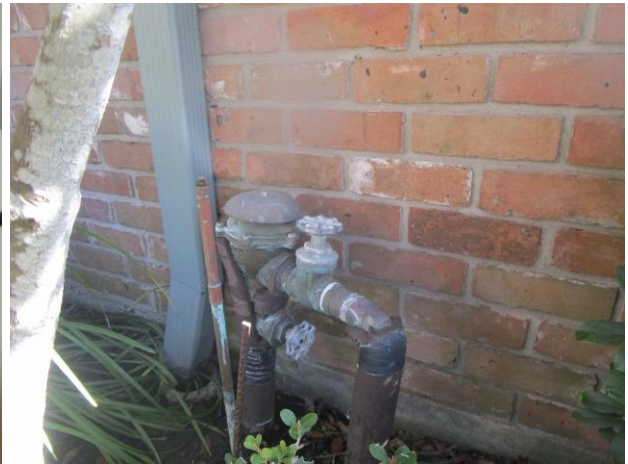
Zone 7 of the system was non-functional at the time of the inspection and water was coming up through the ground at the east side of the house. Have a service company find the source of the problem, and make any necessary repairs.
