SWIMMING POOL

The swimming pool was an in-ground salt water pool covered by a plaster finish. The pool equipment was located at the side of the house.

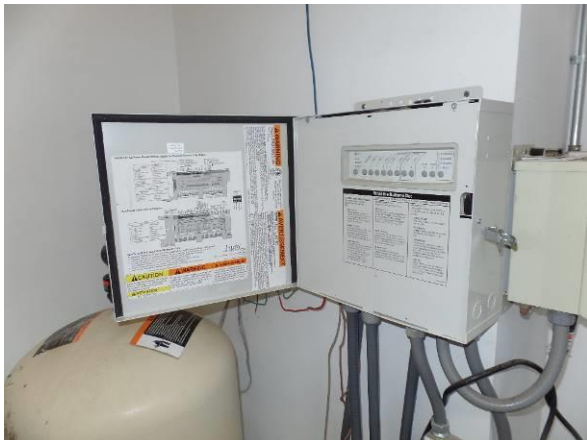
Control Panel

The control panel was functional at the time of the inspection. We operated the controls in the “Service” mode to turn on the various pumps, filter, heater, water feature, lights, etc. and the panel was functional.

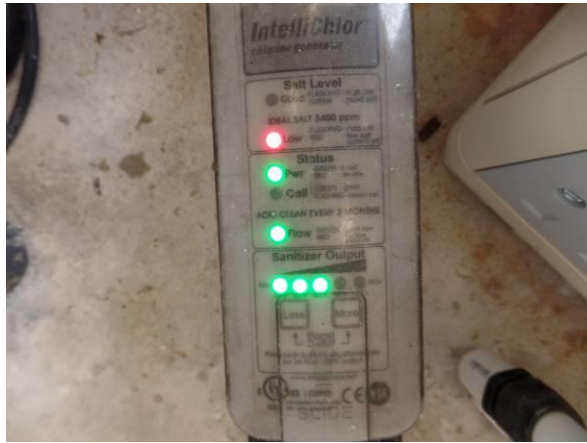
Salt Cell

The pool was equipped with a salt cell that produces chlorine from the salt that is added to the pool. The salt cell is connected to the control panel, which monitors the amount of salt in the pool water. The control panel showed the concentration of salt to be low, and further investigation by a pool service company who should make any needed repairs.

Obtain Cost Estimate

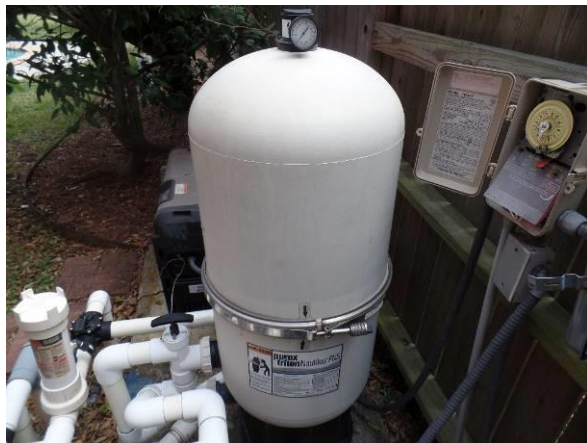
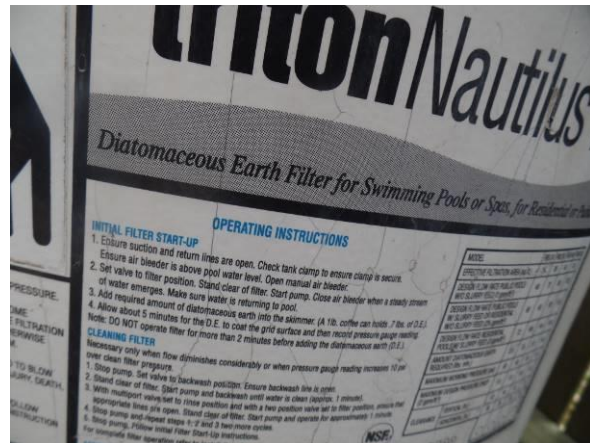
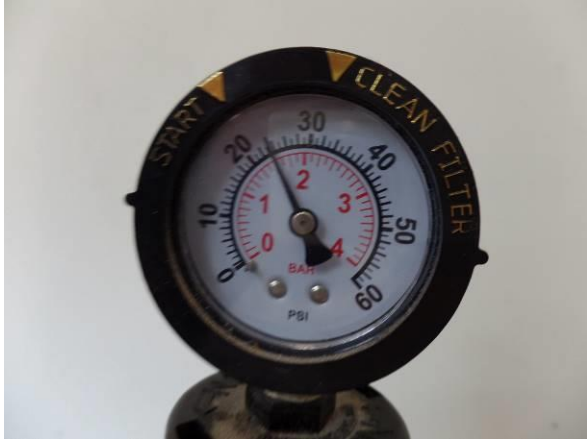
Pool Filter

The pool filter was a diatomaceous earth filter that was functional at the time of the inspection, and showed an operating pressure of 23 psi. This is within a normal range of operation, and no repairs are recommended.

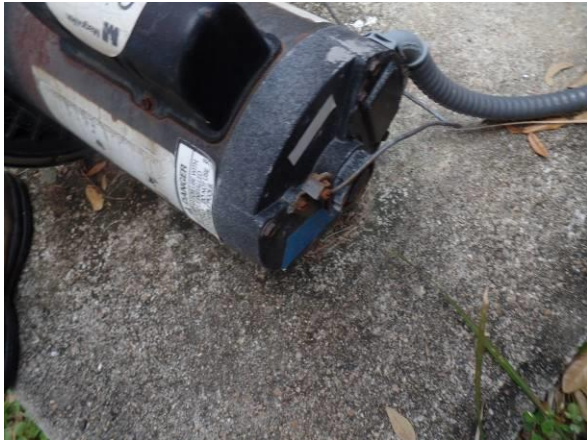
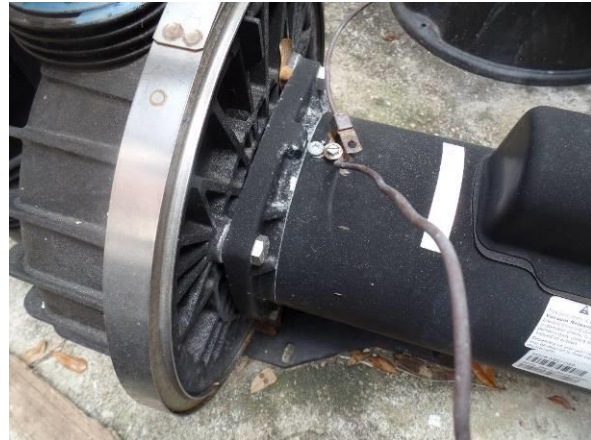
Pumps/Motors

The exterior metal casings on the pump motors were bonded to a grounding wire(s), which ran underground. We could not determine where the wire(s) was terminated.

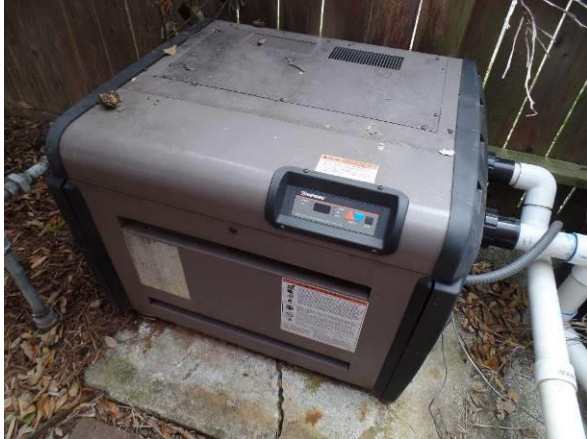
Heater

The furnace was operationally checked at the time of the inspection, and the burners did come on, and were operated for approximately 5 minutes. The furnace was manufactured by Hayward, and no repairs were observed to be needed.

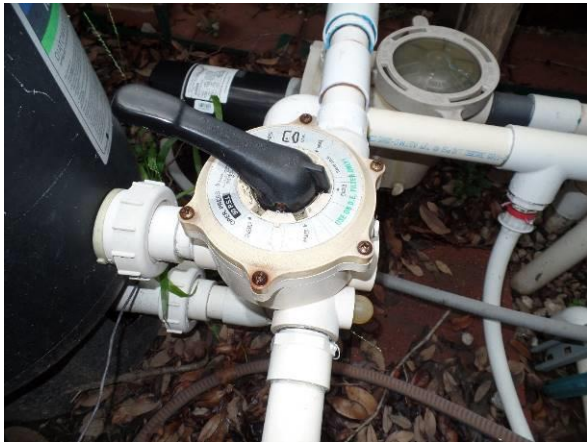
Backflush Valves

The backflush valve was not operated at the time of the inspection. We not operate the valve due to the possibility of damaging the valve during changing the position of the valve.

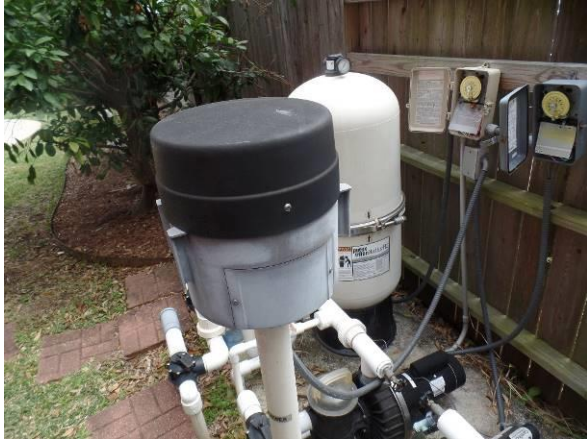
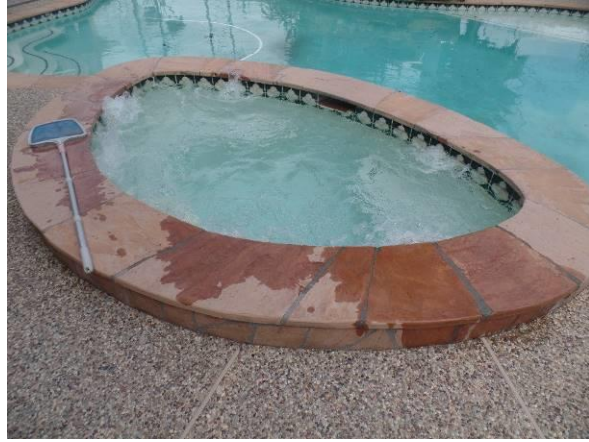
Blower

The spa blower was functional at the time of the inspection.

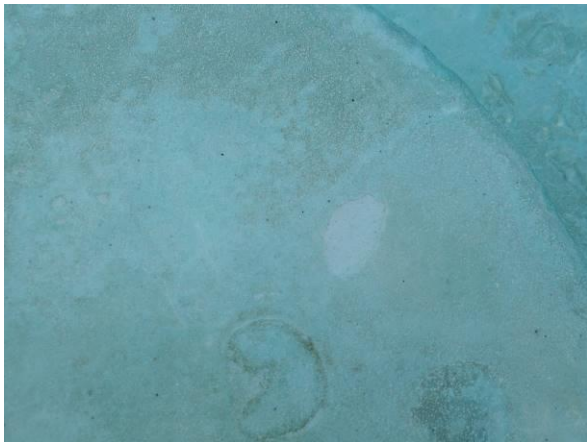
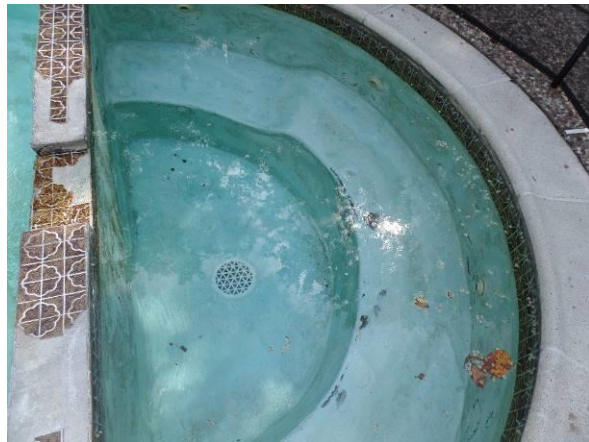
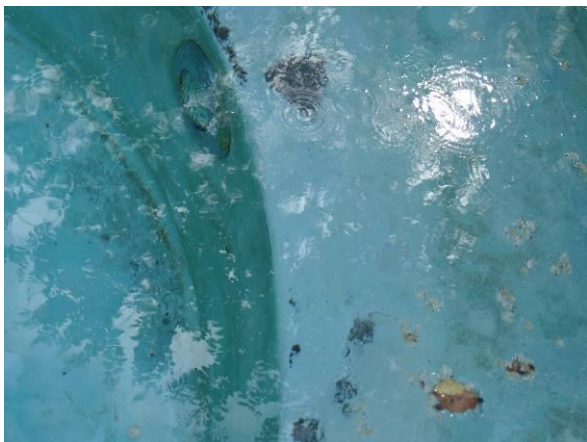
Pool Surface

The surface of the pool was beginning to spall, and the plaster finish has only a limited amount of remaining life. It can be anticipated that the pool will need to be replastered in the next few years.

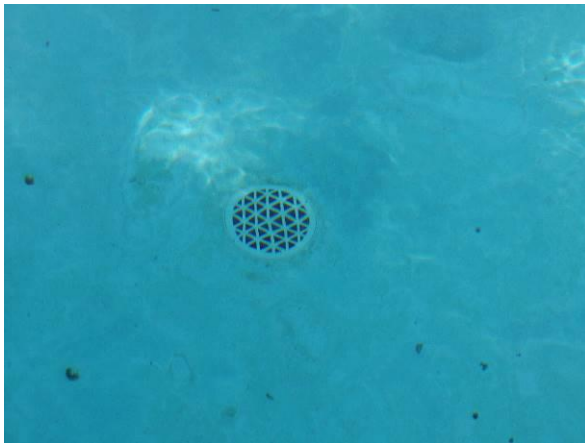
Bottom Cover

The bottom drain for the pool only contained one inlet, which can be a potential hazard for entrapment. We observed that the bottom drain was equipped with a flat type of cover that has a potential for entrapment. It is recommended that the flat cover be replaced with an approved raised cover to reduce the potential for entrapment.

Obtain Cost Estimate

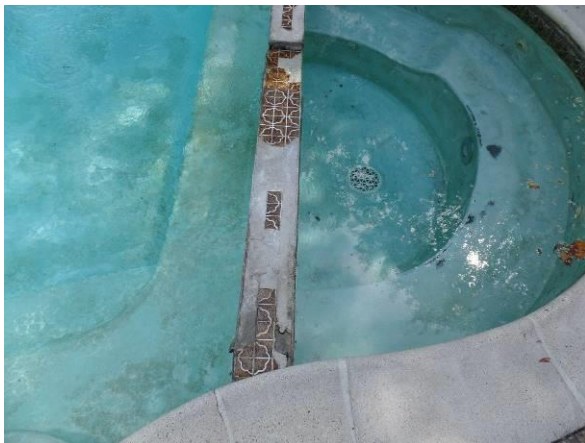
Waterline Tiles

The waterline tiles were cracked or damaged, and need to be repaired or replaced.

Obtain Cost Estimate

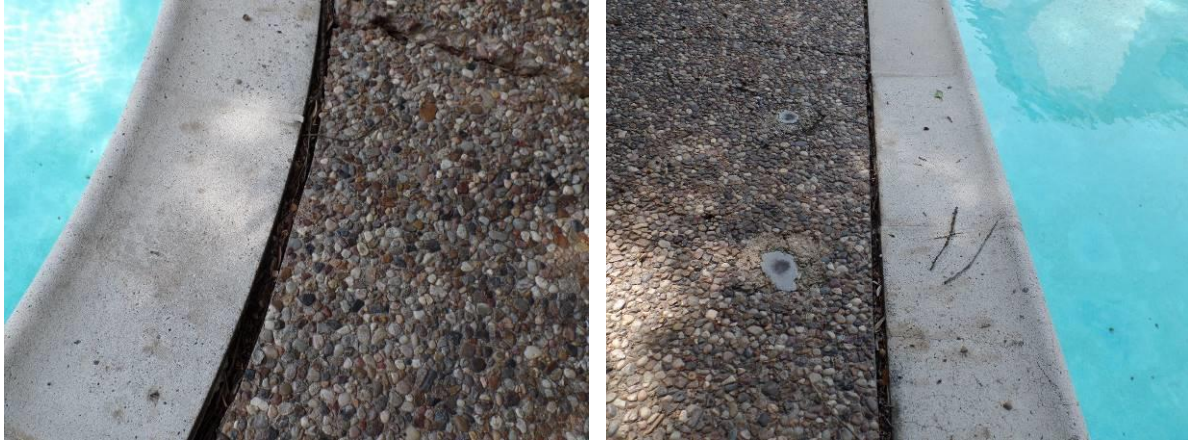
Pool Deck

The joint between the concrete deck and the coping tiles needs to be sealed.

Obtain Cost Estimate

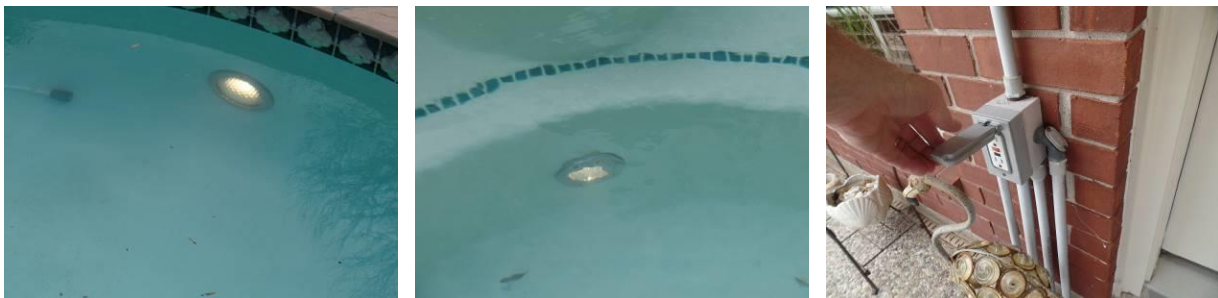
Pool/Spa Light

Both the pool and spa lights were functional at the time of the inspection, and were protected by a Ground Fault Circuit Interrupt device, which was also functional at the time of the inspection.

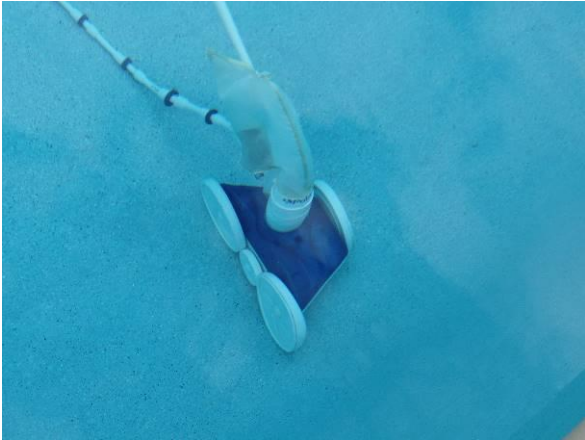
Polaris Pool Sweep

The Polaris pool sweep was functional at the time of the inspection, was observed to be moving across the pool in a normal fashion.

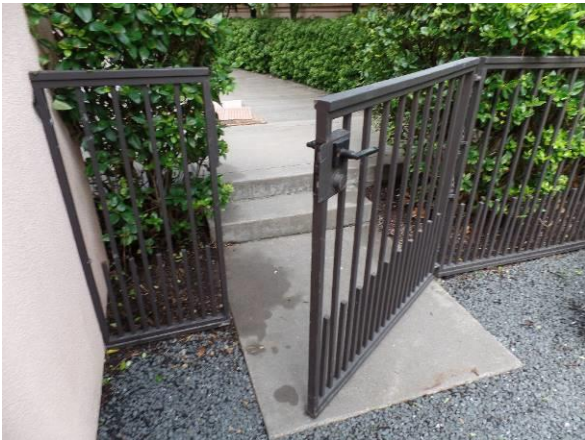
Fence/Gate

The gate to the back yard was not equipped with a self-closing, self-latching mechanism.

Obtain Cost Estimate

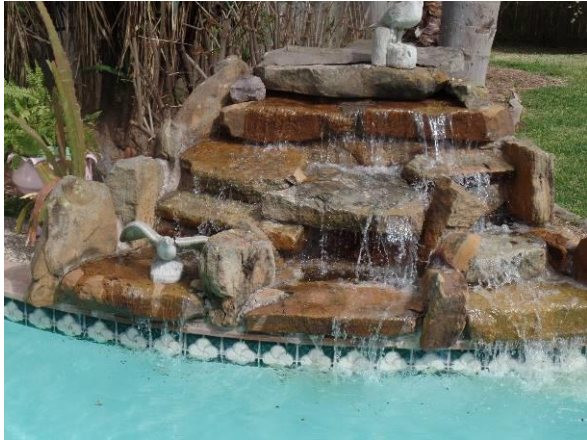
Water Feature

The water feature was functional at the time of the inspection.

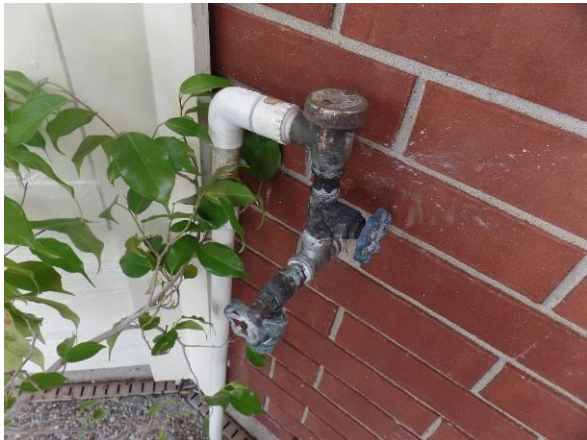
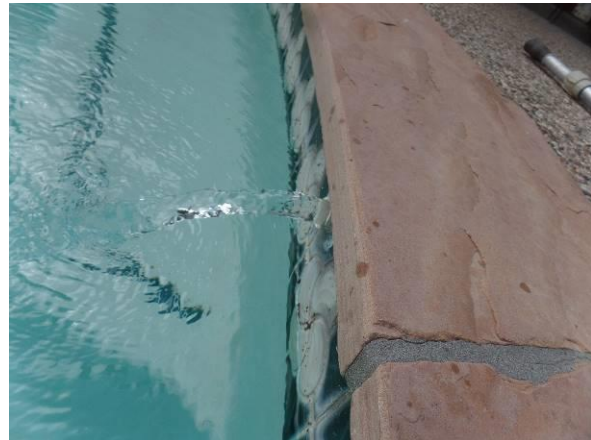
Pool Fill Line

The pool fill line was functional at the time of the inspection, and was equipped with a backflow preventer device. No leaks were present at the time of the inspection.
