HEDDERMAN ENGINEERING, INC.

REF: CONDITION OF PROPERTY SURVEY

ADDRESS OF HOUSE

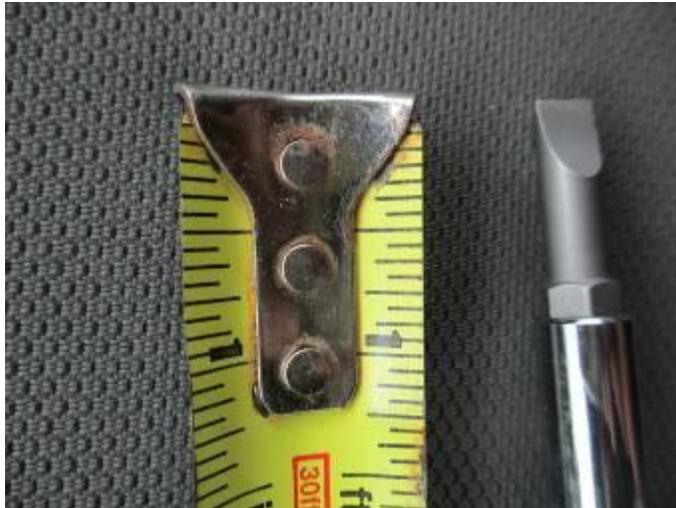
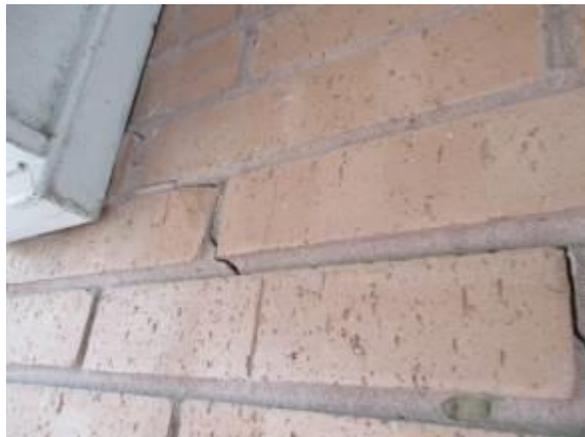
Cracks and/or patches were observed throughout the exterior veneer.

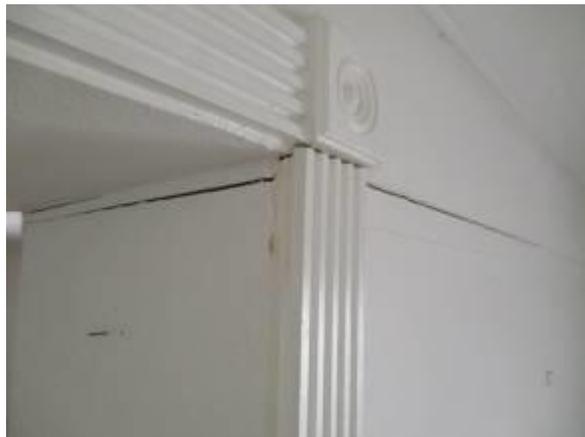
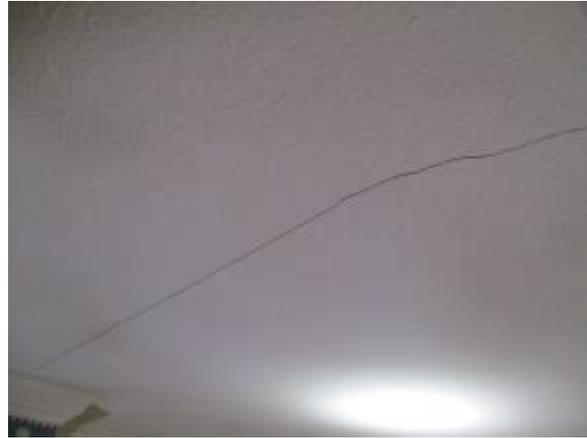
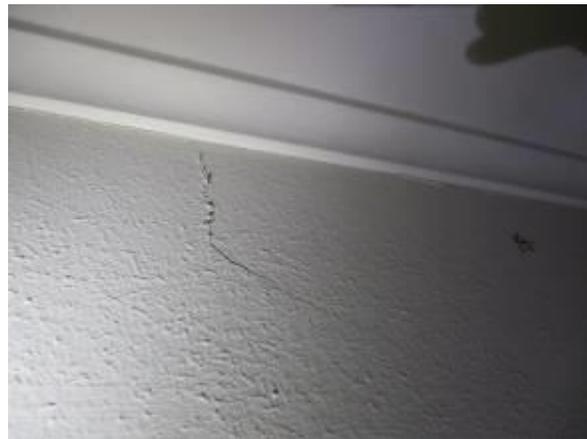
Sheetrock cracks, patches, and/or compression ridges were observed throughout the house.

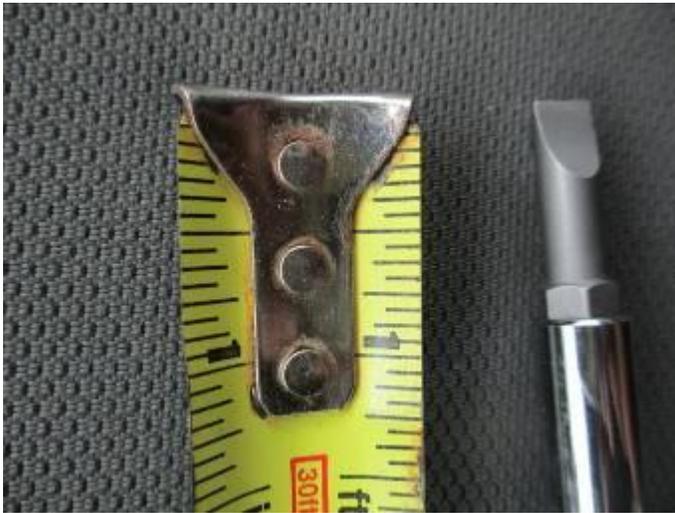
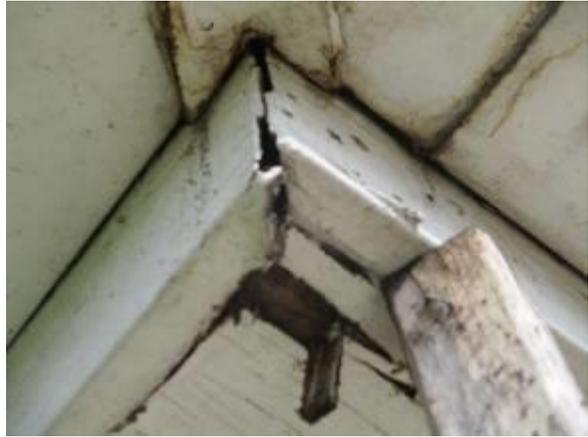
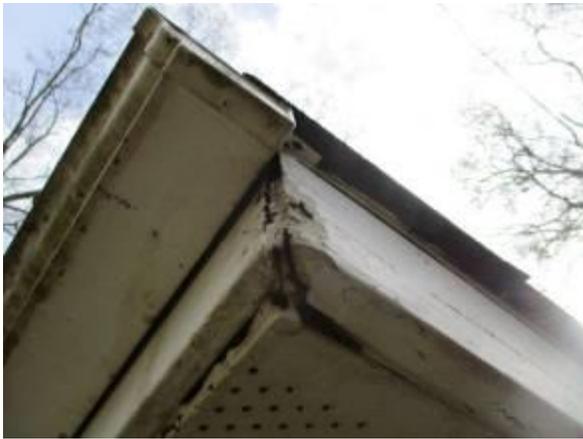
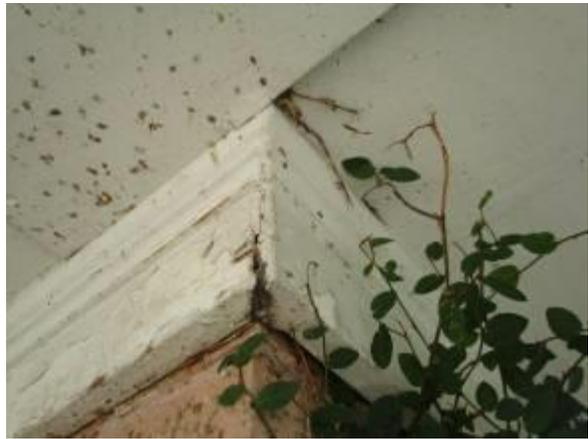
- Window frames were separated from the exterior brick veneer approximately 1/8 inch.
- The frieze board was separated at the roof soffit approximately 1/8-3/8 inch.
- Doors that were sticking were observed at multiple locations.
- Door frames that were out of square, leaving a triangular separation between the door and the door frame at the top of the door were observed at multiple locations, where a separation of approximately 1/2 inch was visible at the top of the door.
- Doors that were trimmed at the top and/or bottom were observed at multiple locations.
- The floor tile was cracked at the foyer area.
- The wall tile was cracked at the guest quarters bathroom and south bathroom.
- The countertop was separated from the wall at the kitchen sink.

Separated frieze board molding

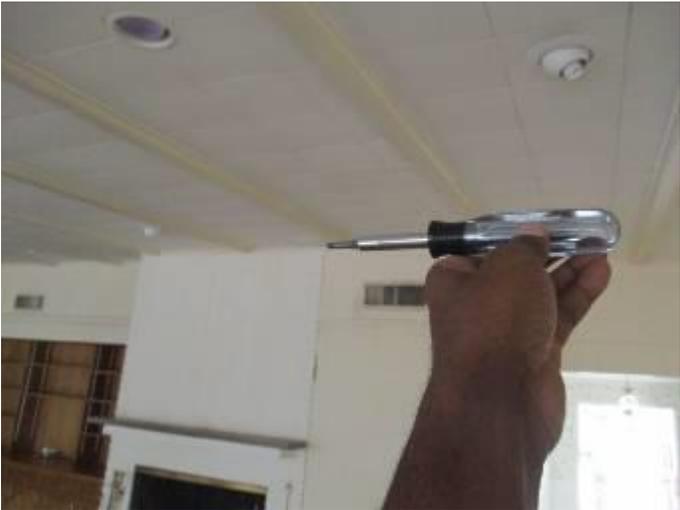
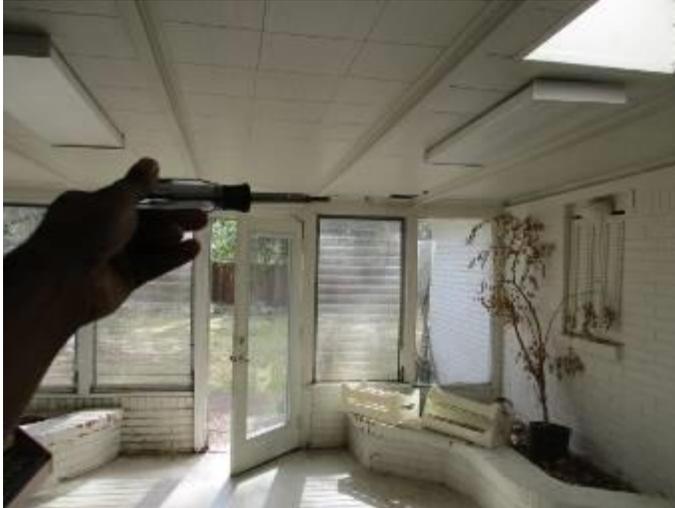
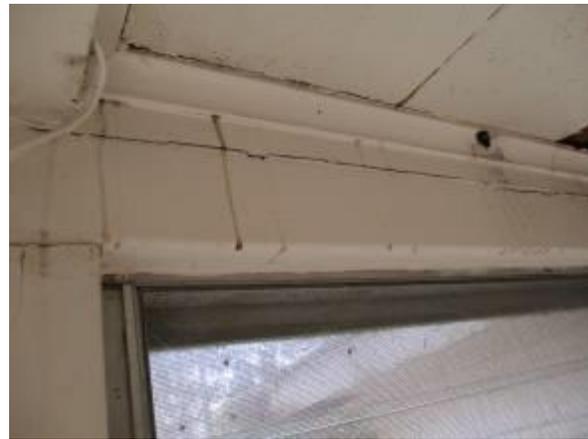
After observing the interior of the structure, evidences of roof leaks were visible, where the ceiling was water stained. It is recommended that a roofing contractor be contacted to find the source of the leaks, and to make any needed repairs.

Locations included: Chimney chase, sun room skylight, sun room south roof edge

Obtain Cost Estimate

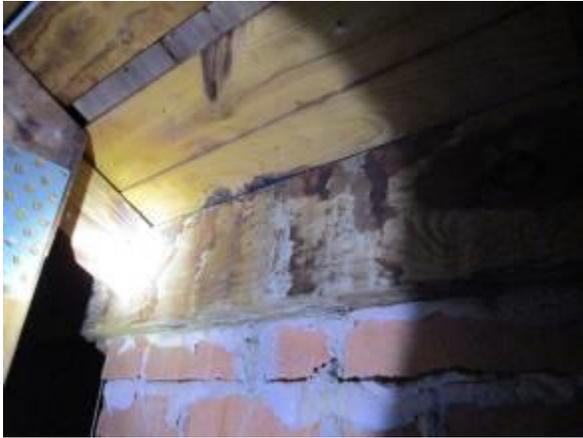
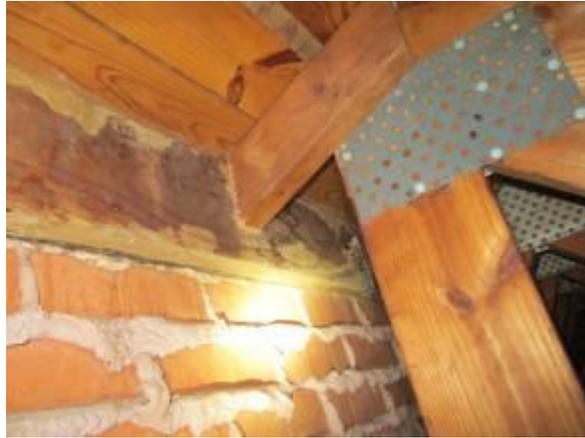
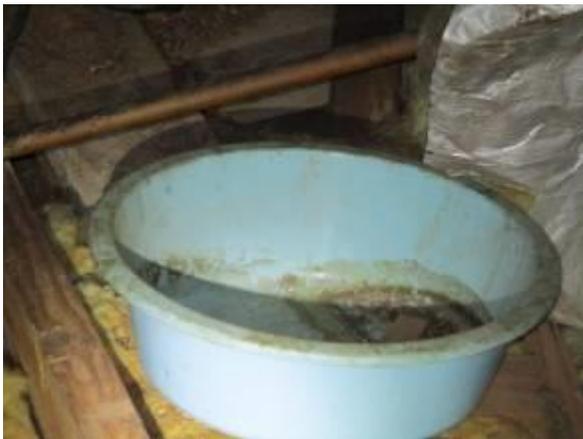
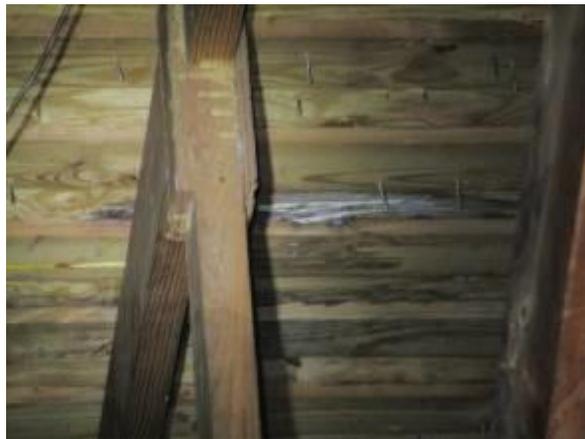
After observing the interior of the structure, evidences of roof leaks were visible in the attic, where the roof decking and/or roof framing members were water stained. It is recommended that a roofing contractor be contacted to find the source of the leaks, and to make any needed repairs.

Locations included: Chimney chase, roof decking near the chimney, Catch bowl above ht east bedroom area

Obtain Cost Estimate

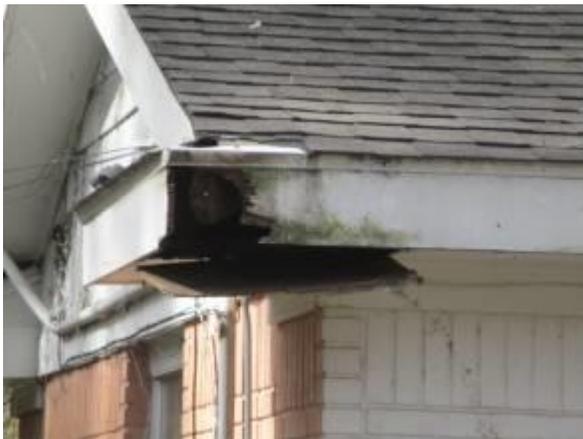
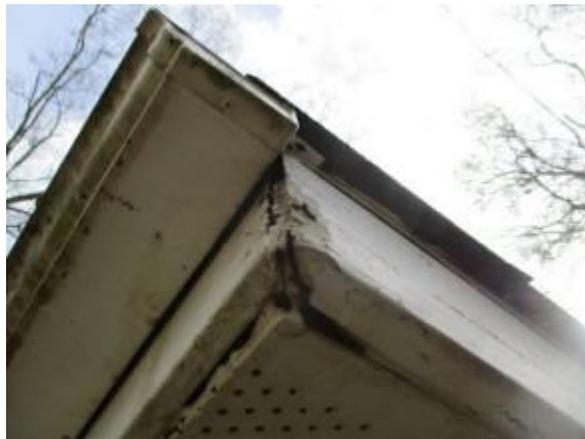
After observing the interior of the structure, evidences of roof leaks were visible in the eaves at multiple areas around the house. It is recommended that a roofing contractor be contacted to find the source of the leaks, and to make any needed repairs.

Obtain Cost Estimate

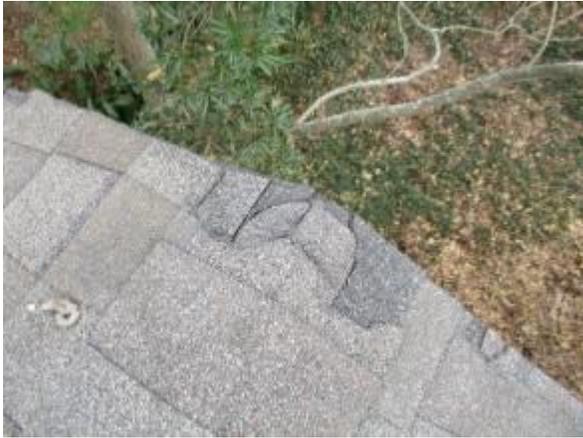
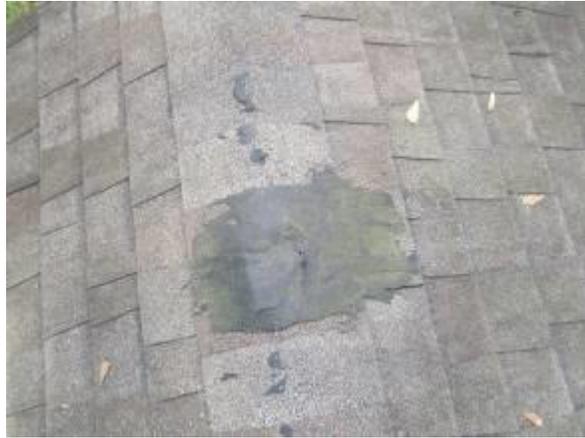
Ivy damaged shingles above the garage

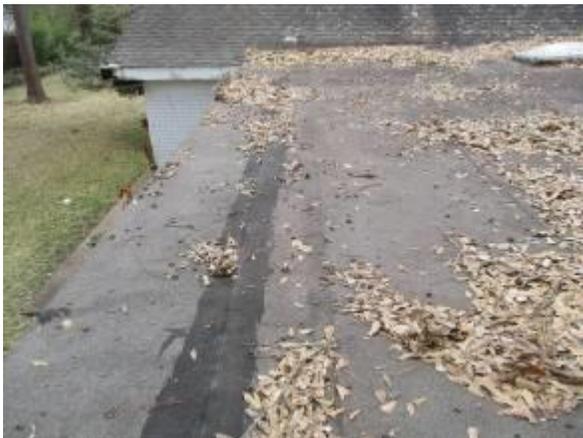
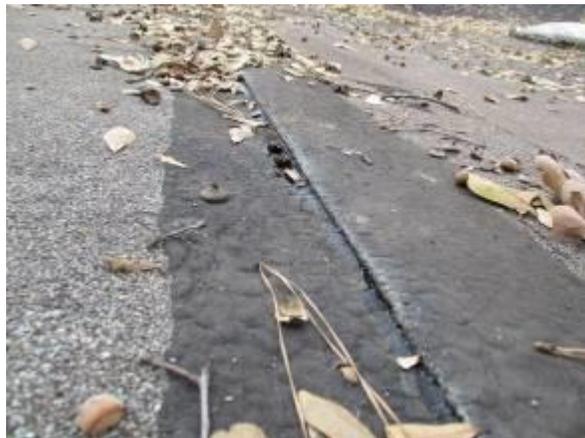
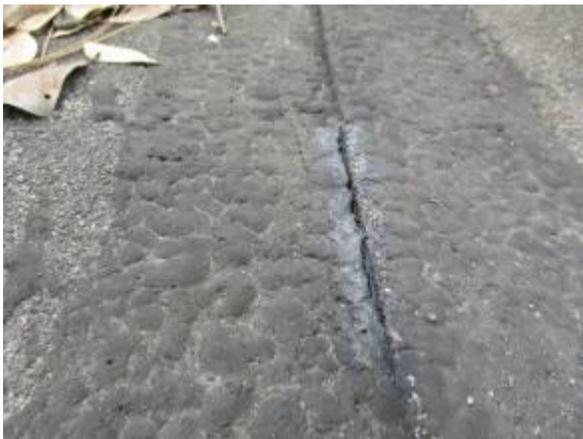
The modified bitumen roof surface was showing a moderate amount of deterioration, including discoloration of the surface, granular loss, cracks in the asphalt at the edges of the sheets, and excessive mastic application in areas.

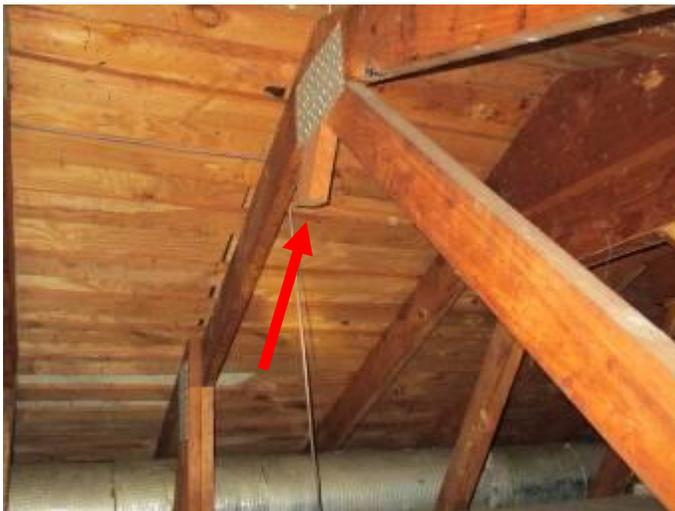
One or more of trusses has had structural members cut and/or removed. The damaged truss needs to be repaired, and it is recommended that the manufacturer of the trusses be contacted if possible to design a repair, or that a structural engineer be contacted to design the repair.

Location included: Attic space just west of the chimney

Obtain Cost Estimate

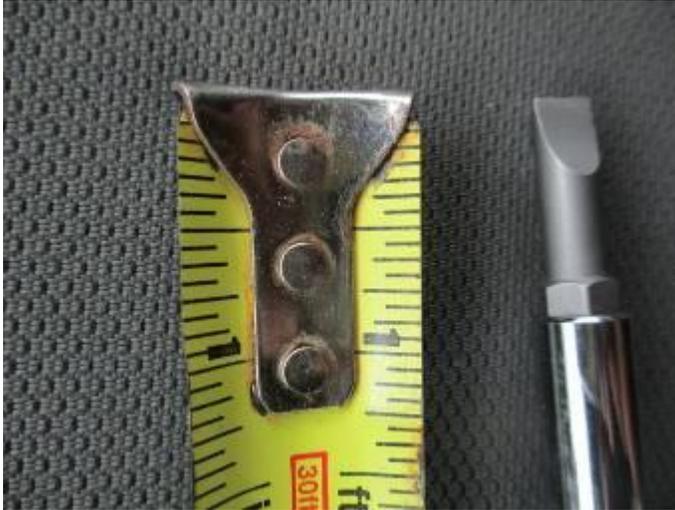
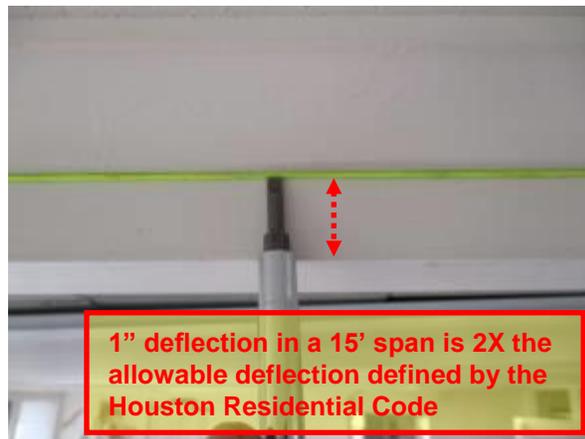
The ceiling framing had a more than normal amount of unlevelness. The allowable deflection in ceiling framing members is one inch deflection in a 30-foot horizontal distance ($L/\Delta = 360$ per the building code). Therefore, further investigation is recommended to determine the cause of the deflection, and the extent of any repairs that may be needed.

Locations included: Sun Room and Garage

1" deflection in a 15' span is 2X the allowable deflection defined by the Houston Residential Code

Obtain Cost Estimate

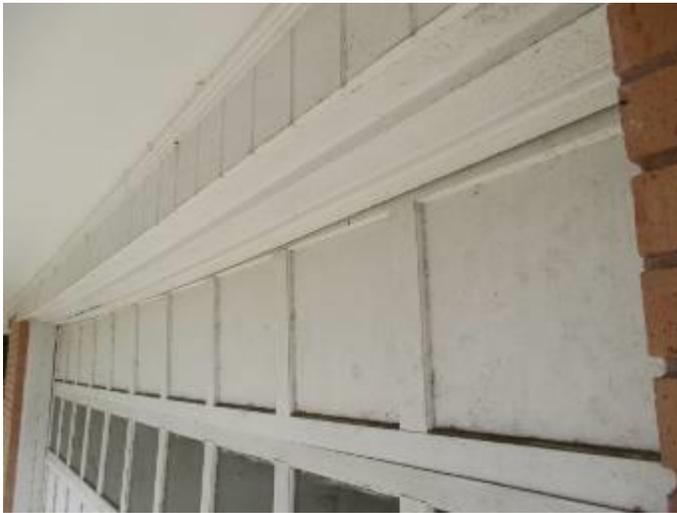
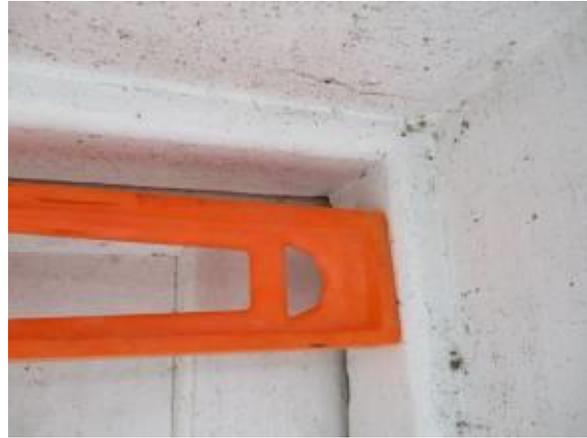
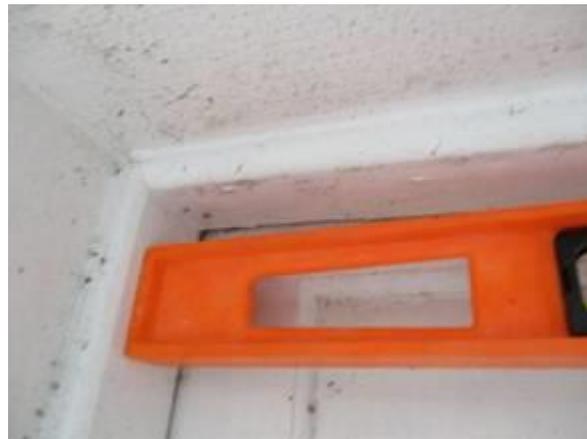
The header over the garage door was visibly deflected, and has deflected beyond an acceptable degree (allowable deflection = one inch deflection in a 30-foot horizontal distance ($L/\Delta = 360$ per the building code)). Therefore, the header was not performing its intended function and repairs are recommended at this time.

Obtain Cost Estimate

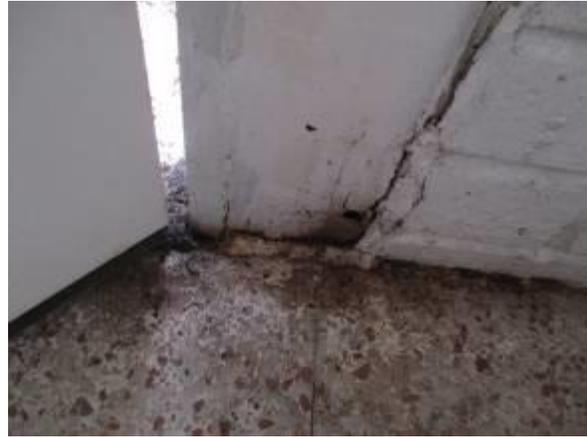
The source of the water penetration appears to be a lack of gutters which allows the water from the roof runoff to splash against the structure. It is recommended that gutters be installed to eliminate the source of the water, and that repairs be made to seal the door and threshold and correct any secondary damages.

Lack of gutters

Obtain Cost Estimate

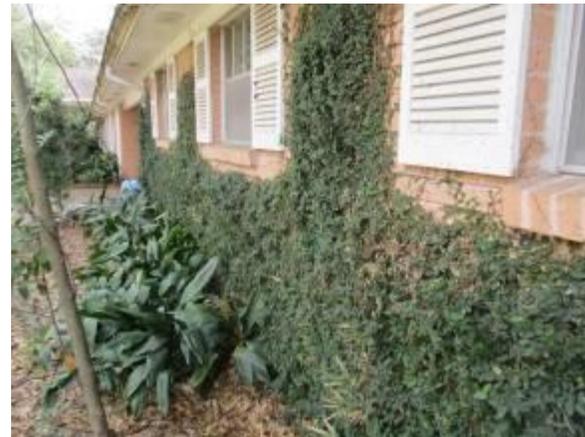
Wood rot/ivy growth

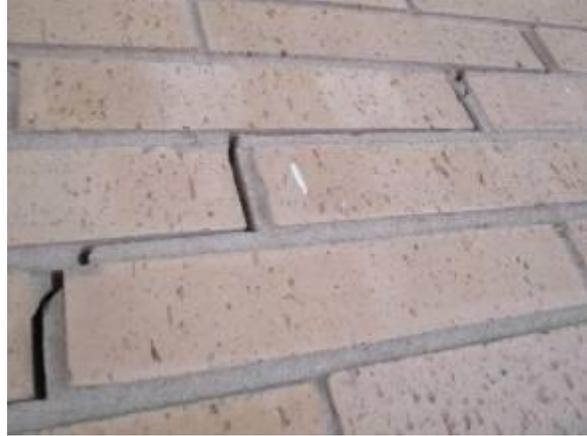
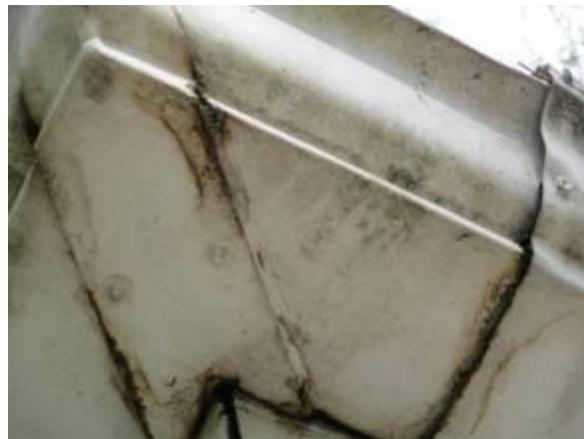
Damaged gutters/Cracked brick veneer

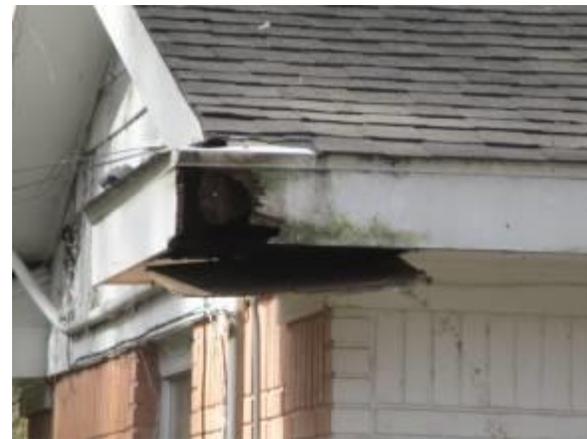
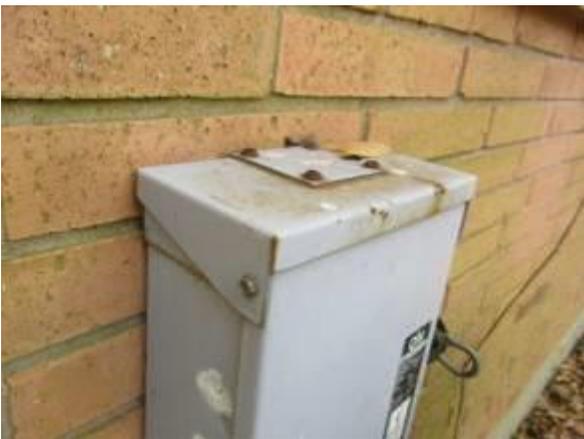
Leaking gutters/Damaged eaves

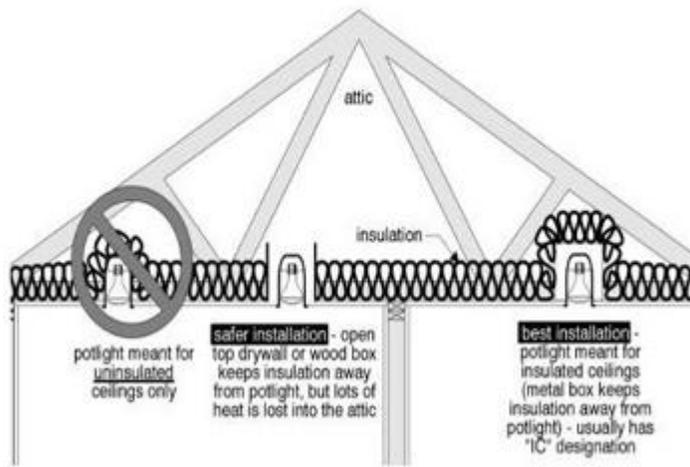
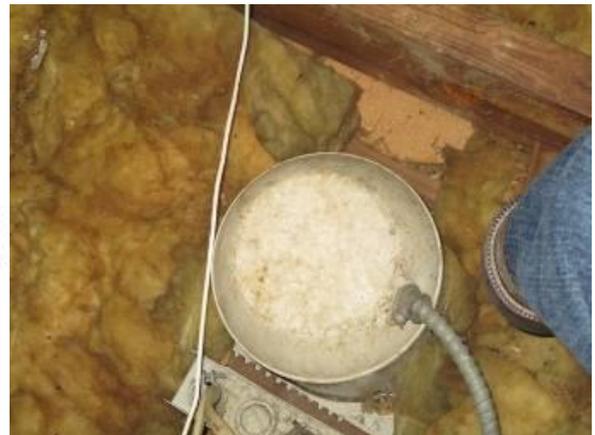
The insulation was in contact with the recessed lights, which can be a fire hazard and shorten the life of the light bulbs. It is recommended that the insulation be pulled back to provide a three inch air space.

Potlights in insulated ceilings

Obtain Cost Estimate

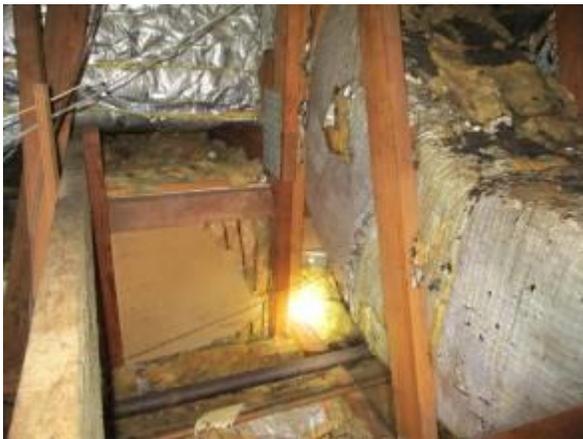
The insulation in the attic was missing from between some of the joists.

Obtain Cost Estimate

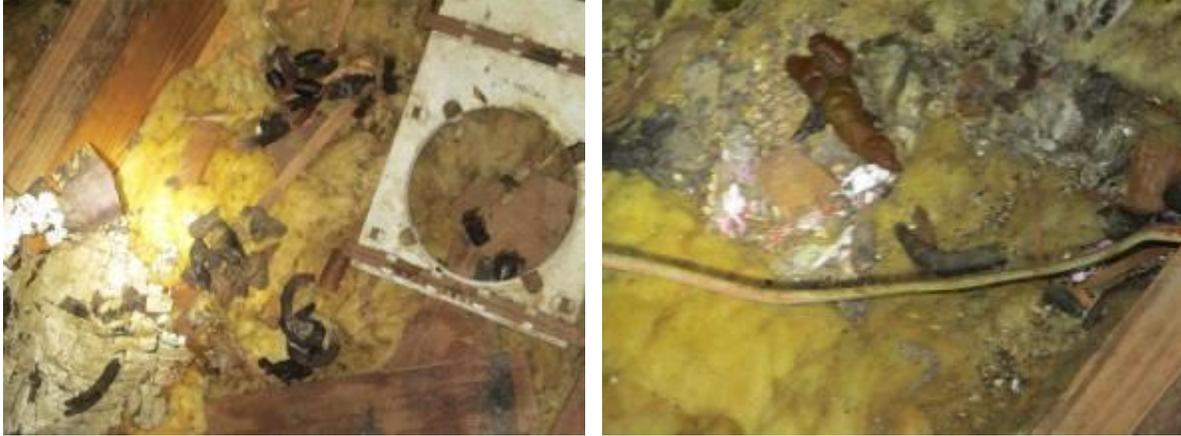
We observed extensive evidence of rodent infestation in the attic, including rodent droppings, discoloration of the insulation possibly from rodent urine, trails through the insulation, etc. Although HEI disclaims inspections for rodents, it is recommended that further investigation be done to find the source of entry of the rodents into the attic, and to make all needed repairs to clean and sanitize the attic from the fecal and urine material. It is recommended that you contact a pest control company concerning this condition.

Fresh rodent droppings and a pungent odor were present at the time of inspection

Obtain Cost Estimate

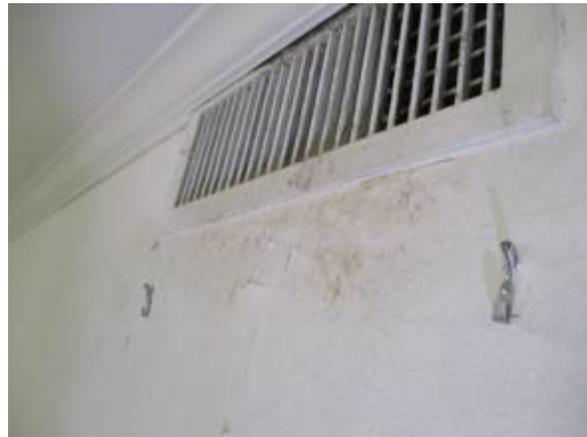
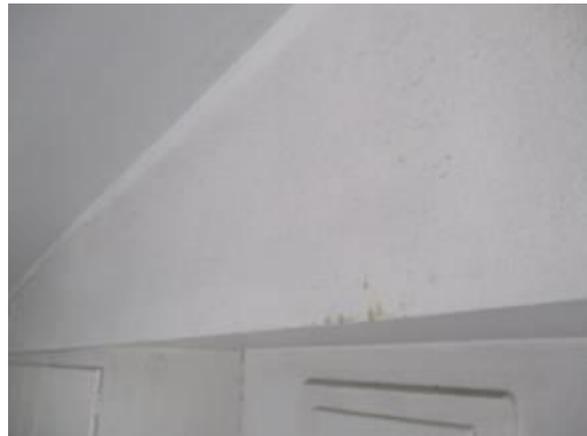
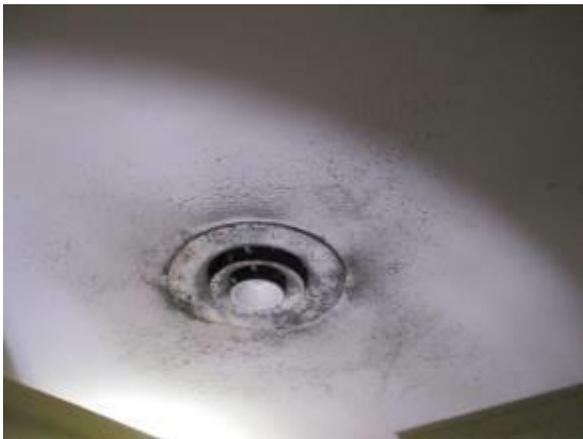
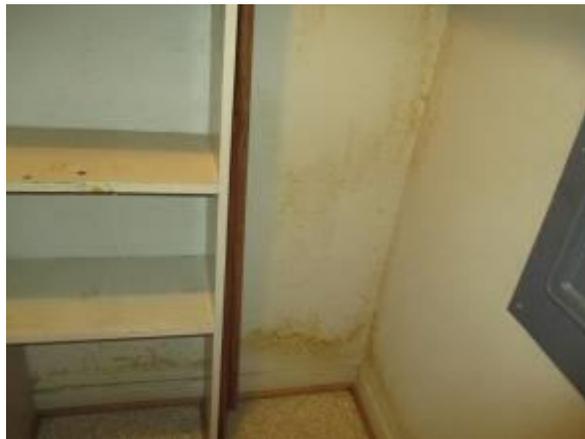
Mold/Mildew was observed at multiple locations in the house. It is recommended that a mold inspector be contacted to make an assessment of this condition and recommend any necessary repair.

Locations included: North bathroom, living room air register, utility room ceiling, utility room duct, master closet air register, guest quarters closet wall base

Obtain Cost Estimate

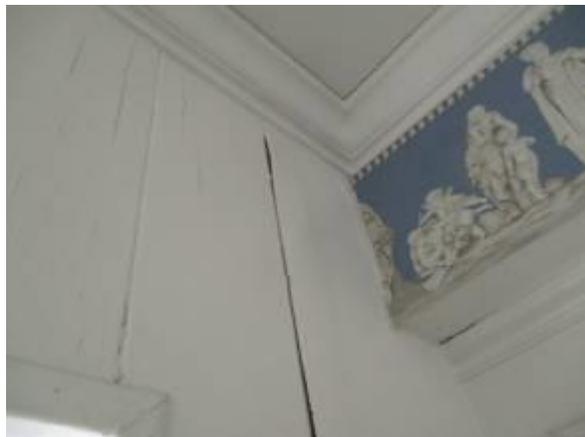
Water stains were observed at the dining room, living room, north bathroom, south bedroom and bathroom, and master suite ceilings. The source of the water stains could not be determined at the time of the inspection, but possible sources include roof leaks, plumbing leaks in the bathrooms located above the stained areas, or possibly some other source. Have a service company determine the source of the water stains, and provide a cost estimate for any necessary repairs.

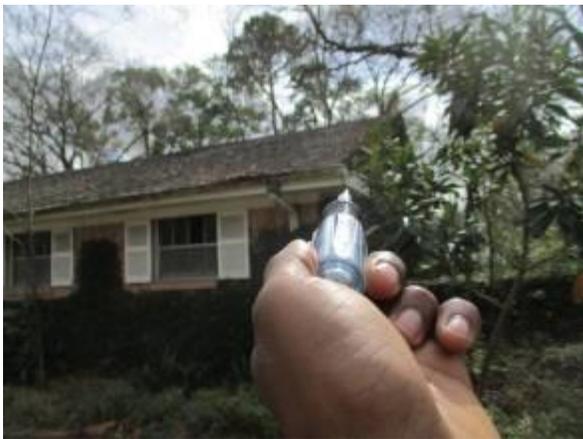
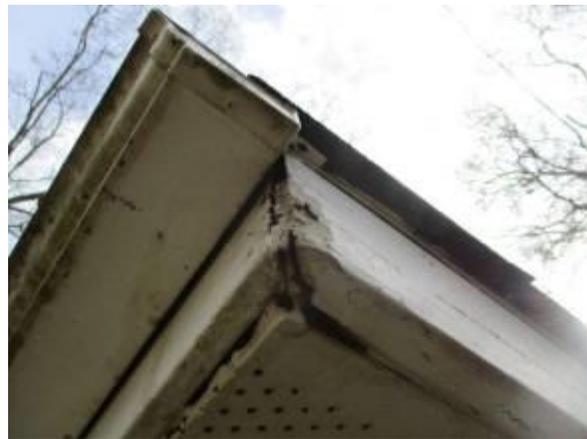
Wood rot was observed and it is recommended that the damaged wood be replaced. It is pointed out that additional damage could be present under the rotted material that will not be visible until the outer rotted materials are removed. Have a service company determine the entire scope of wood rot throughout the house, and provide a cost estimate to replace all rotted wood.

Obtain Cost Estimate

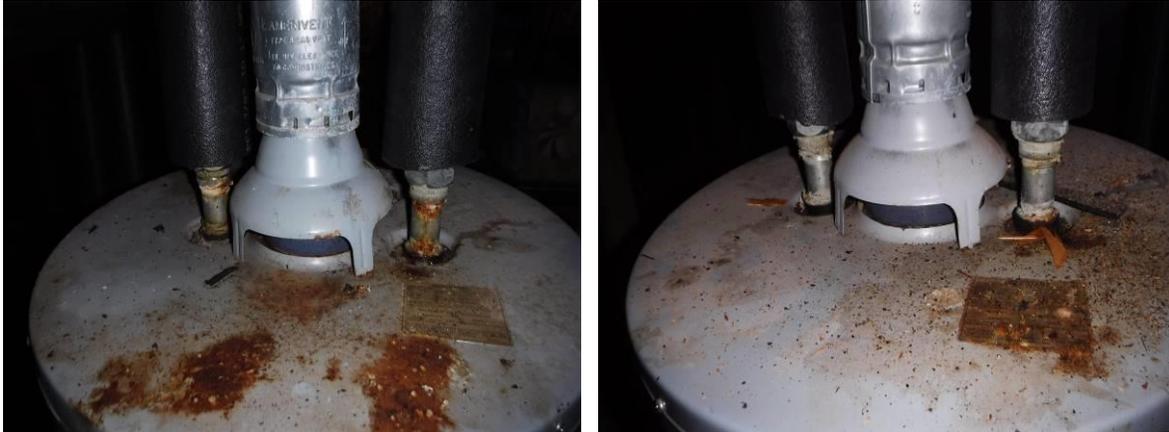
The piping at the top of both water heaters was severely corroded at the fittings, and is in need of repair.

Obtain Cost Estimate

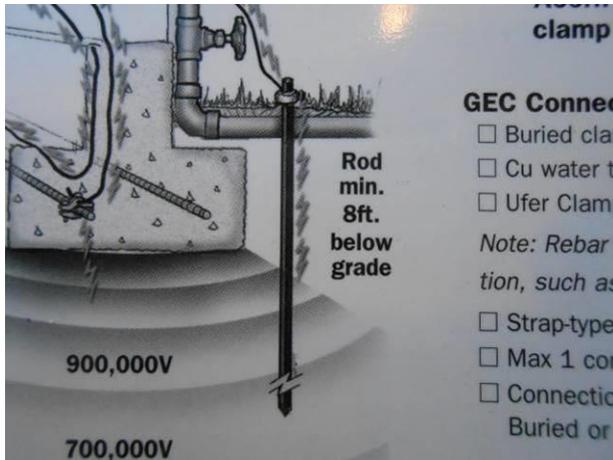
The ground rod was sticking out of the ground a few inches, and, since ground rods are typically 8 feet long and all 8 feet of the rod are required to be in the ground, it is recommended that the ground rod be pounded down flush with the top of the ground. The clamp on the rod should be an acorn clamp that is approved for direct burial in the ground.

Obtain Cost Estimate
