HEDDERMAN ENGINEERING, INC.

REF: CONDITION OF PROPERTY SURVEY

ADDRESS

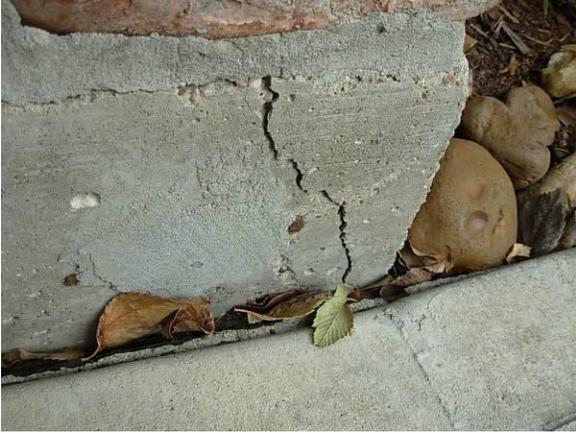
The corner of the foundation was observed to be chipped. This is condition that is caused by differences in thermal expansion between the brick veneer, and the concrete foundation. Also, this condition can be caused by a lack of reinforcement in the corner of the foundation during original construction. In our opinion, this condition does not affect the structural integrity of the foundation.

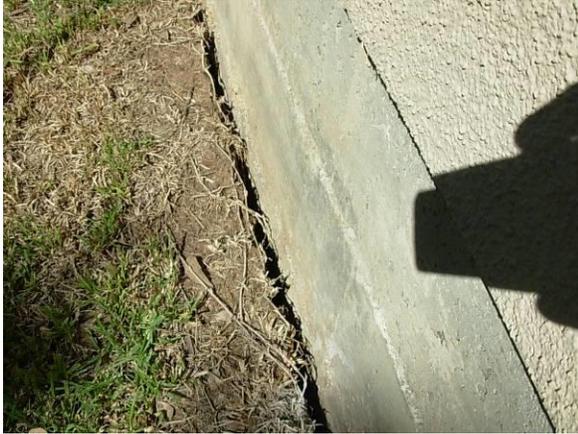
The soil at the perimeter of the foundation was very dry, and has pulled away from the foundation approximately one inch. This excessive dryness of the soil has caused the soil to shrink, which can cause settlement of the foundation. It is recommended that a regular watering program be initiated around the house to keep the soil adjacent to the foundation moist.

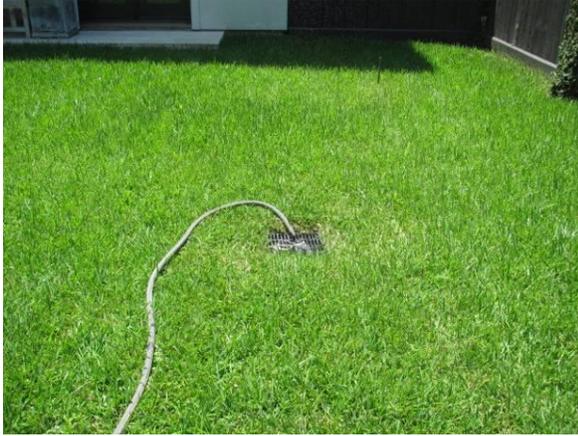
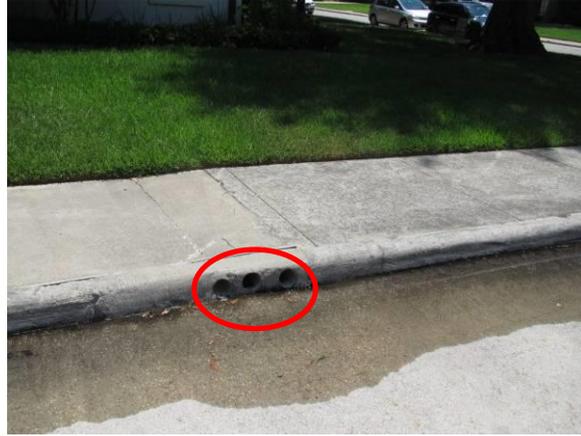
The underground drainage system at the rear of the house was checked by running water into the drain for approximately 15 minutes, and the system was observed to be draining properly to the street.

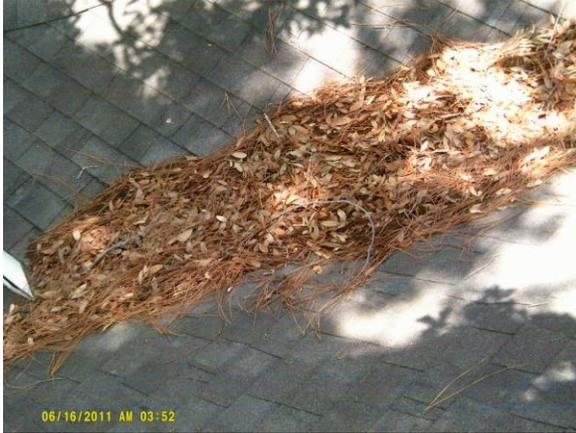
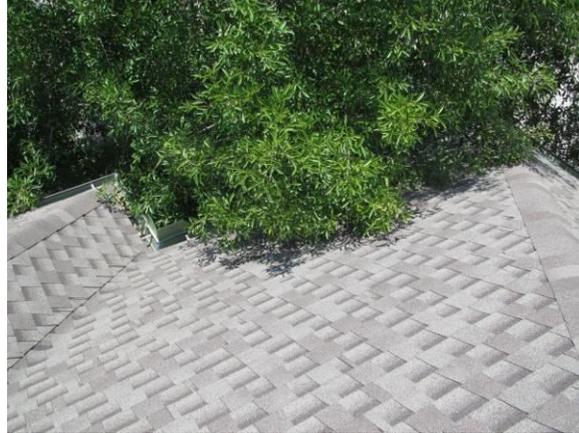
- * Debris was observed on the roof, and the debris should be removed to prevent premature deterioration of the roof surface.

- * Tree limbs were observed to be touching the roof, and need to be trimmed back to prevent them from rubbing across the roof surface.
Estimated cost: \$100

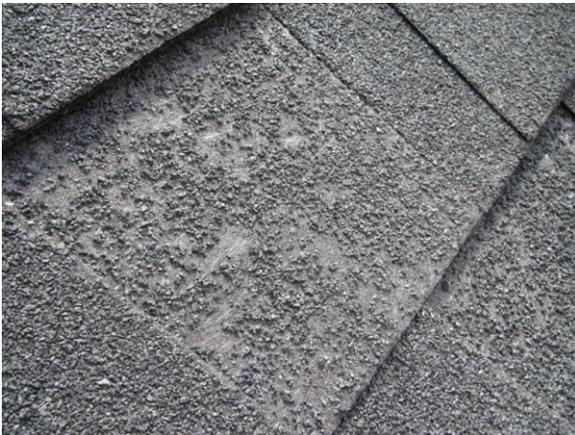
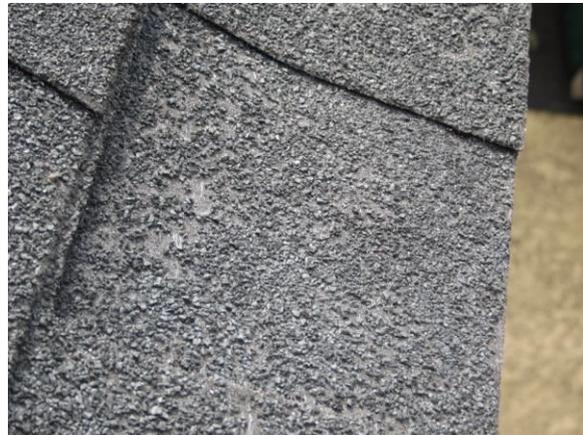
- * The shingles had excessive granular loss, exposing the base material of the shingles to the ultraviolet rays of the sun. It can be anticipated that the deterioration of the roof will accelerate in the next few years, with replacement of the roof anticipated in the next 2-4 years.

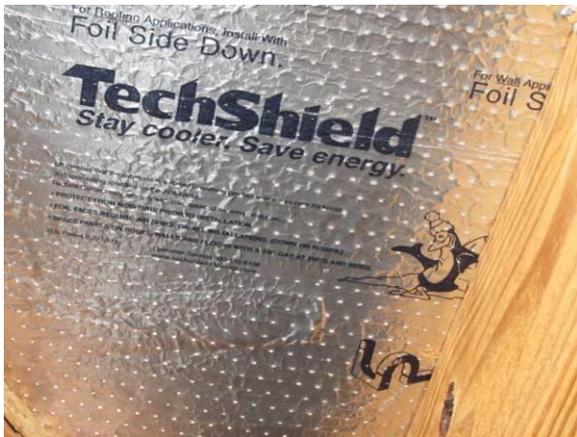
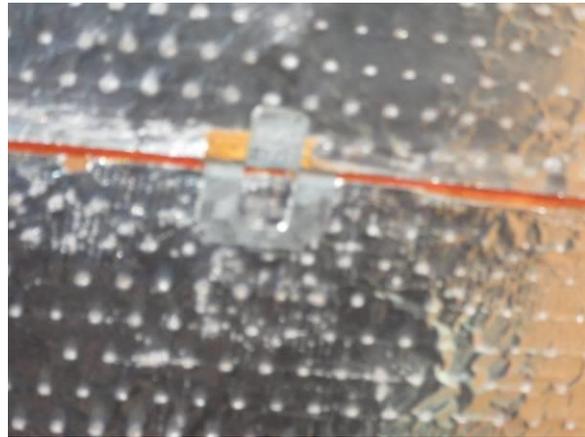
- * The roof decking was observed to be “Tech-Shield” which is an OSB decking that has aluminum foil on the underside, which helps to prevent radiated heat from entering the attic. This will, in turn, keep the attic cooler.
- * It was observed that spacer clips were installed at the joints between the roof decking to allow for expansion of the roof deck.

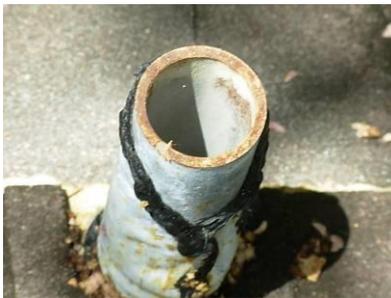
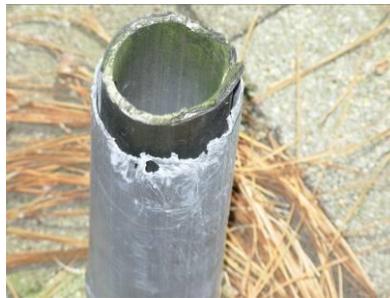
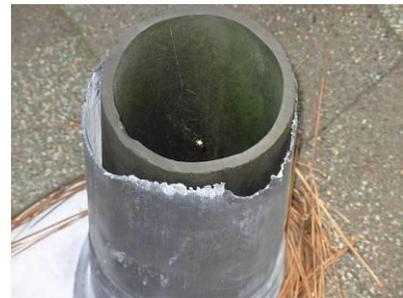
- * Several of the lead roof jacks at the roof penetrations have been damaged, apparently by squirrels eating the lead jacks. The jacks can now allow water to enter the attic space as a roof leak, and the roof jacks need to be repaired as necessary to ensure that all the roof jacks are watertight.

Estimated cost: \$150

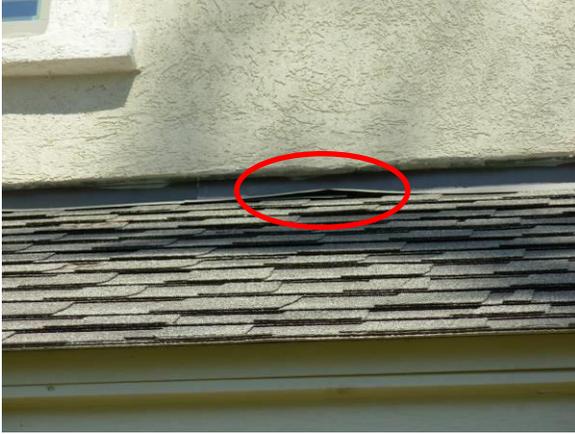
- * The metal flashing at the junction of the low roof and a vertical wall was not secured properly, and can allow wind-blown water to enter the living space. The flashing needs to be resecured to the roof.

Estimated cost: \$75

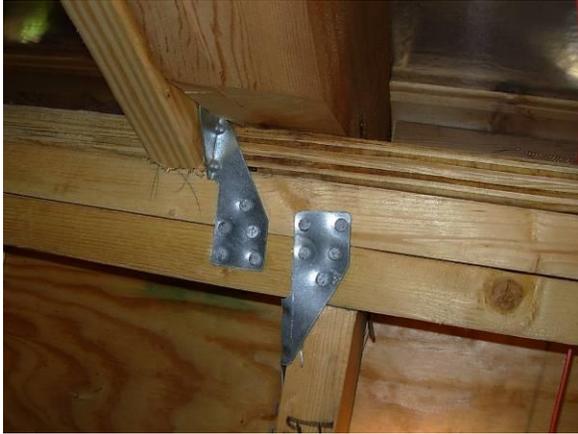
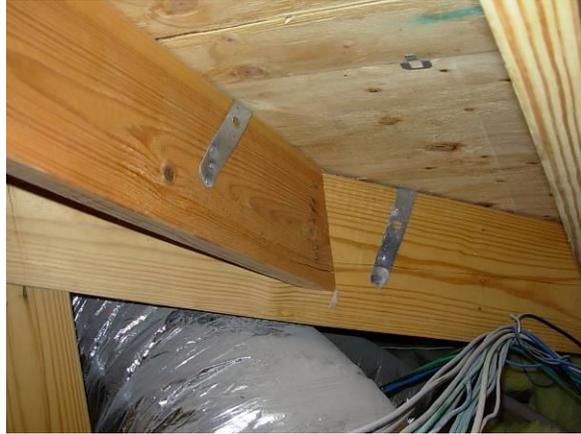
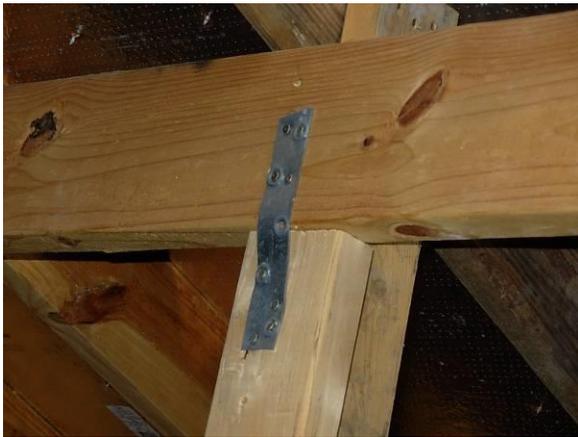
- * Wind uplift or hurricane clips were observed to be installed at the bottom of the roof framing, connecting the roof rafters to the top of the wall framing. Also, we observed metal straps installed over the ridge beam to rafters on both sides of the ridge beam, and also at hip rafters. This provides a stronger structure and will be more resistant to wind uplift from hurricane and tornadoes.

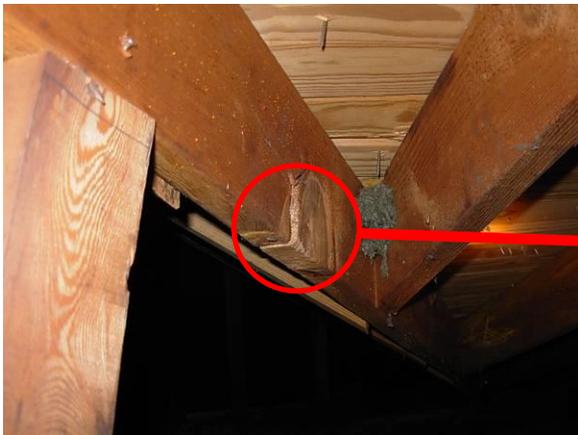
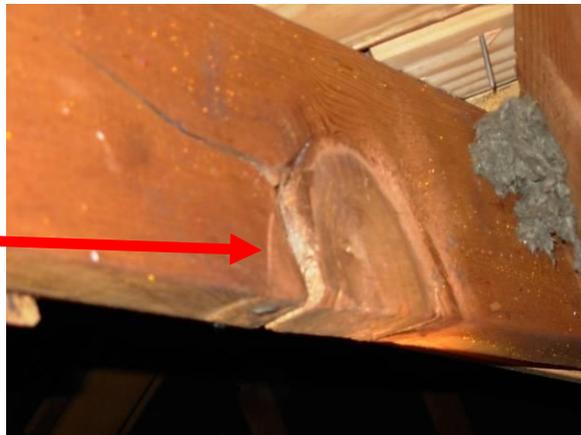
- * One of the rafters in the attic was observed to be split, and needs to be repaired. The damaged rafter was located at the front elevation of the roof over the dining room.

Estimated cost: \$100

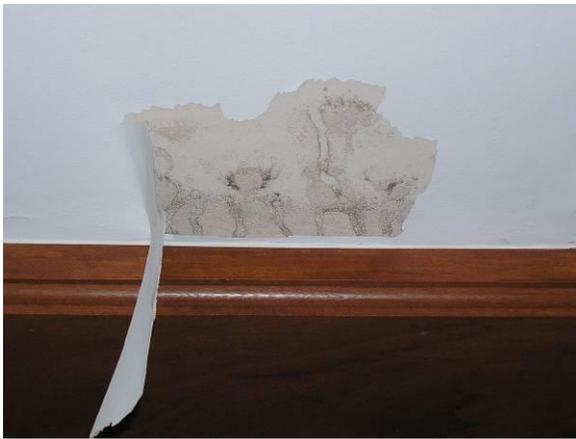
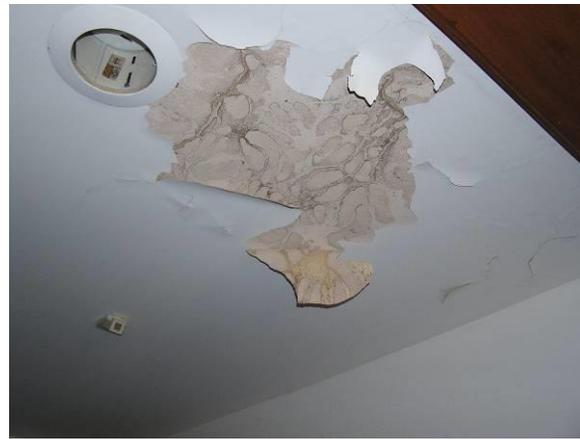
- * Damage was observed on sheetrock at the family room where the exterior paper of the sheetrock was damaged and dirt was visible under the outer layer of paper. This is an evidence of infestation and/or damage by wood destroying insects behind the sheetrock. If the structural framing members are damaged, they will not be visible without removal of the sheetrock. Therefore, it is recommended that the damaged sheetrock be removed along with all other necessary materials in order to view the structural framing members in that area for damage. Have a contractor provide a cost estimate for any repairs that are necessary.

Obtain Cost Estimate

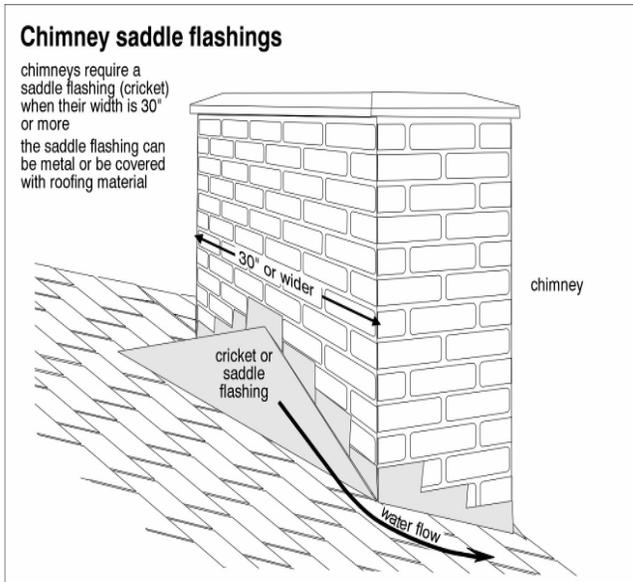
- * No cricket has been installed behind the chimney to divert the roof runoff around the chimney. Since the chimney is more than 30 inches wide, it is recommended that a cricket be installed.

Obtain Cost Estimate

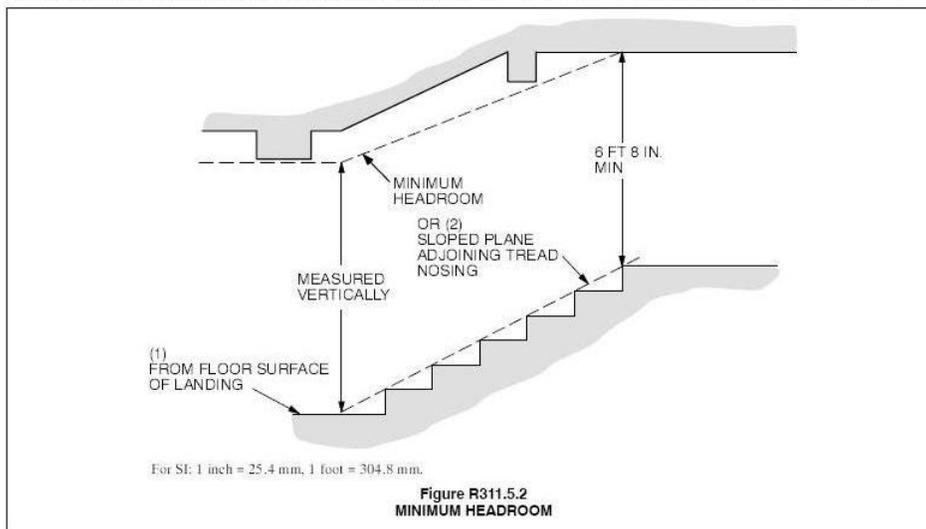
- * The headroom at the stairwell was less than the required six feet, eight inches, which can be hazardous to people using the stairs. Major structural modifications would be needed to provide the minimal head clearance at the stairwell. If the condition is of concern to you, then it is recommended that you contact a contractor to provide a cost estimate to make the structural modifications.

R311.5.2 Headroom. The minimum headroom in all parts of the stairway shall not be less than 6 feet 8 inches (2036 mm) measured vertically from the sloped plane adjoining the tread nosing or from the floor surface of the landing or platform.

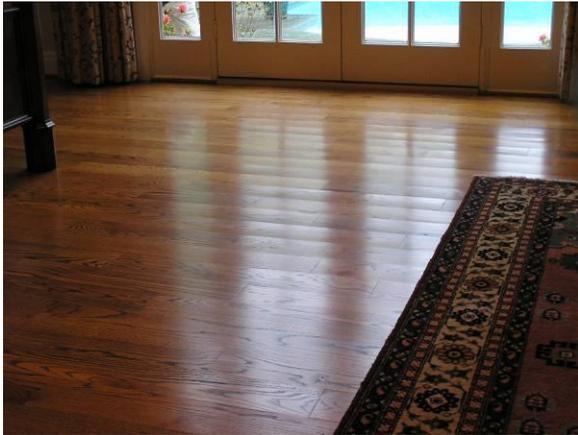
1. The family room, where the wood floors were warped. The source of the water penetration appears to be related to the french doors at the rear of the room, and further investigation with a contractor is recommended to determine the source of the water penetration, and to make any needed repairs.

Obtain Cost Estimate

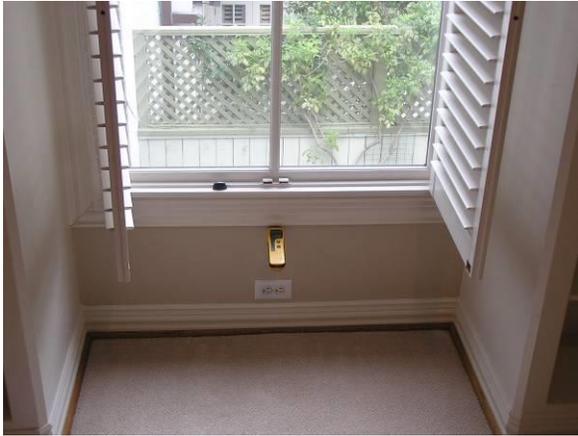
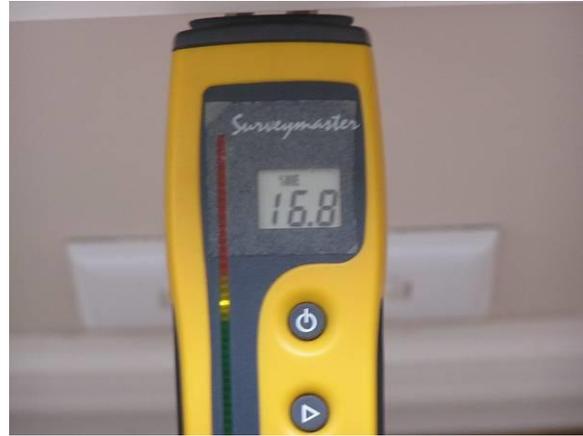
2. The upstairs southeast bedroom, where a high moisture content was found in the sheetrock under the window with our moisture meter. Further investigation with a service company is recommended to determine the source of the water penetration, and to make any needed repairs.

Obtain Cost Estimate

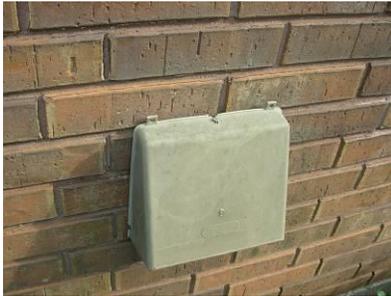
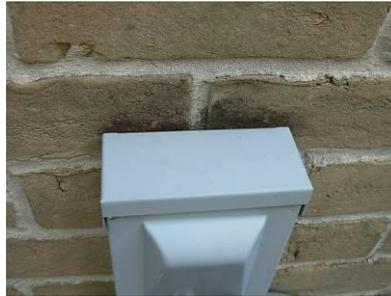
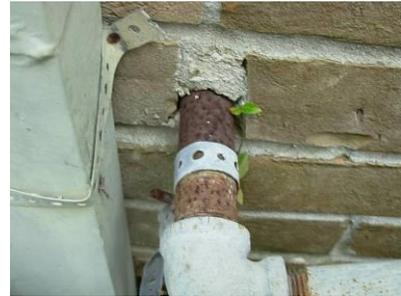
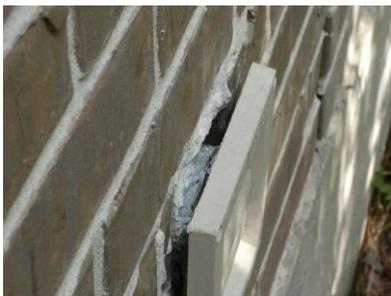
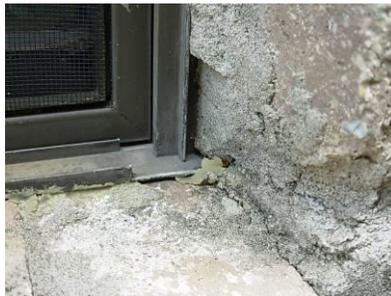
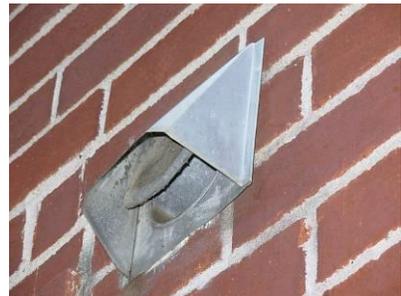
A vulnerability of water penetration was observed at penetrations/openings through the exterior building envelope, and it is recommended that all penetrations/openings be sealed against water penetration. Below is a representative sample of locations and/or photographs showing some, but not necessarily all, locations where there is a vulnerability to water penetration. Have a contractor provide a cost estimate to seal all vulnerable areas against water penetrations.

Obtain Cost Estimate

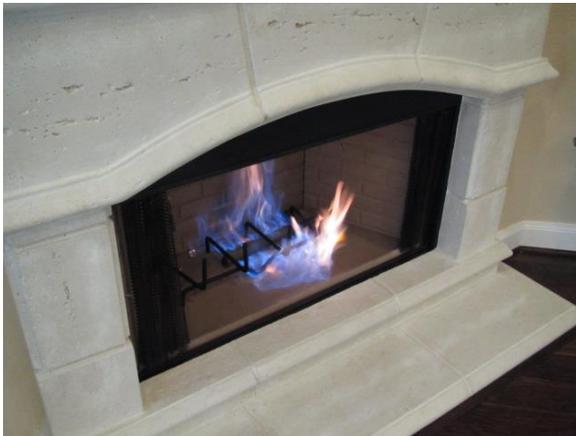
The fireplace at the living room was a prefabricated metal fireplace with a metal flue pipe that extended through the roof. The firebox was equipped with a gas log lighter, with a manually operated gas valve. It was observed that the flames from the log lighter extended out of the firebox, and are a potential fire hazard. Have a service company repair/replace the log lighter to prevent this condition.

Obtain Cost Estimate

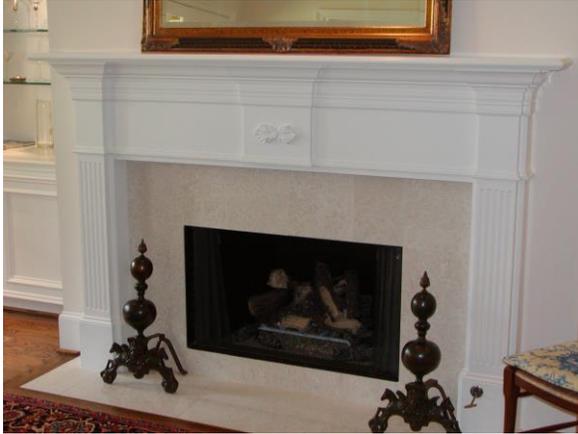
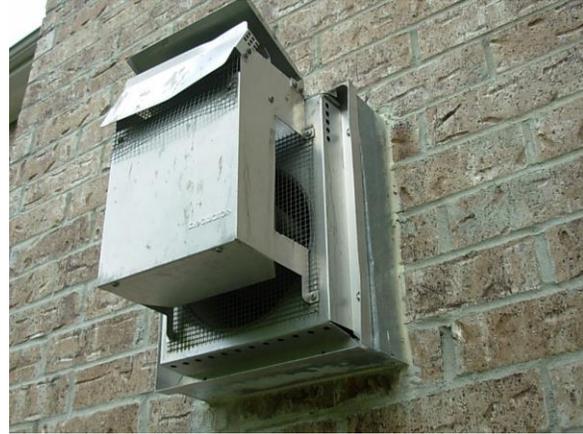
The fireplace at the family room was a sealed, direct vent fireplace that vented to the rear of the house. The fireplace was equipped with a ceramic gas log that was controlled by a remote control device. The fireplace was operationally checked at the time of the inspection, and was functional.

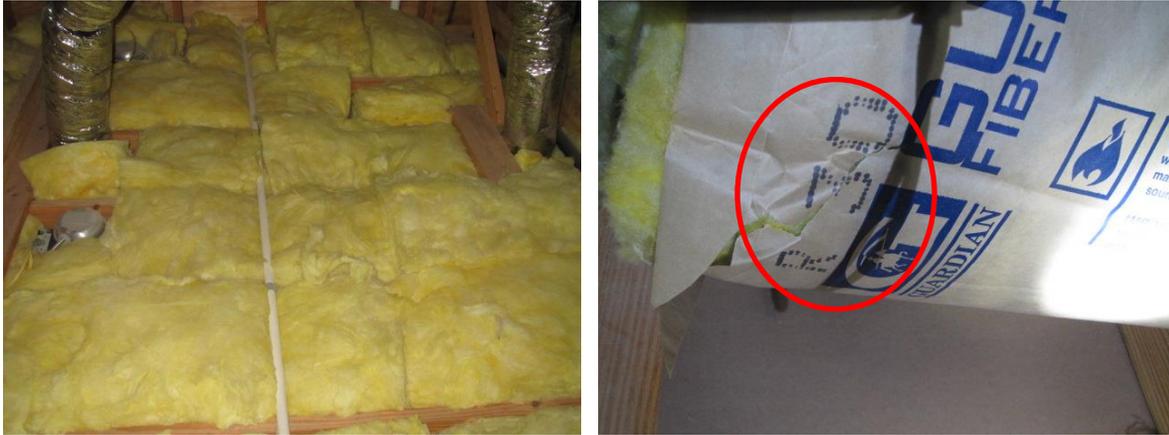
The insulation in the attic was average by today's standards. The normal amount of

insulation for attics in this area is an R30 energy rating. This attic had 9-1/2 inches of fiberglass batt insulation in the ceiling, which was marked as being an R30.

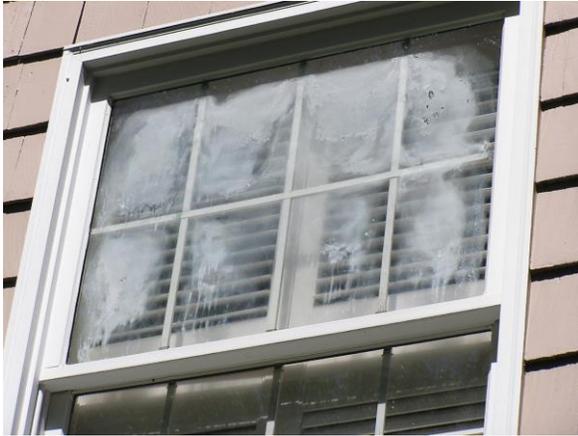
Double pane windows were observed where the seal has broken and allowed moisture between the two panes.

Locations included: the upstairs southeast bedroom

Obtain Cost Estimate

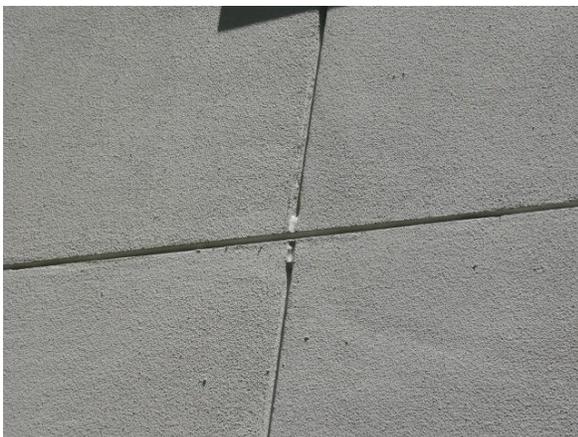
The stucco siding was a traditional hardcoat stucco that was approximately $\frac{3}{4}$ -1 inch thick, and appeared to have been installed in a workmanlike manner. Expansion joints were observed in the stucco at regular intervals, and the flashing at the bottom of the stucco walls was observed to be weepscreed flashing, which is the proper flashing to allow for water to drain out of the stucco wall. We also observed kickout flashing at the roof/wall intersections and metal head flashing at the tops of the windows.

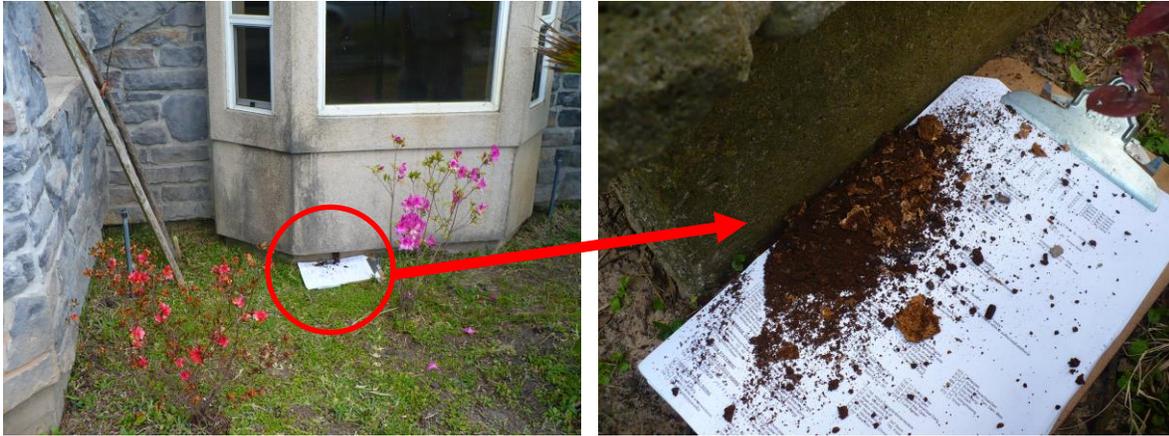
We observed damage to the structural sheathing behind the stucco, where water has apparently penetrated past the stucco to the structural sheathing. The entire scope of any damage that exists is not discernable with a visual inspection, and it is recommended that a stucco specialist be contacted to perform invasive inspections by drilling holes at appropriate locations to determine the scope of the damage. Have a contractor provide a cost estimate for any needed repairs.

Obtain Cost Estimate

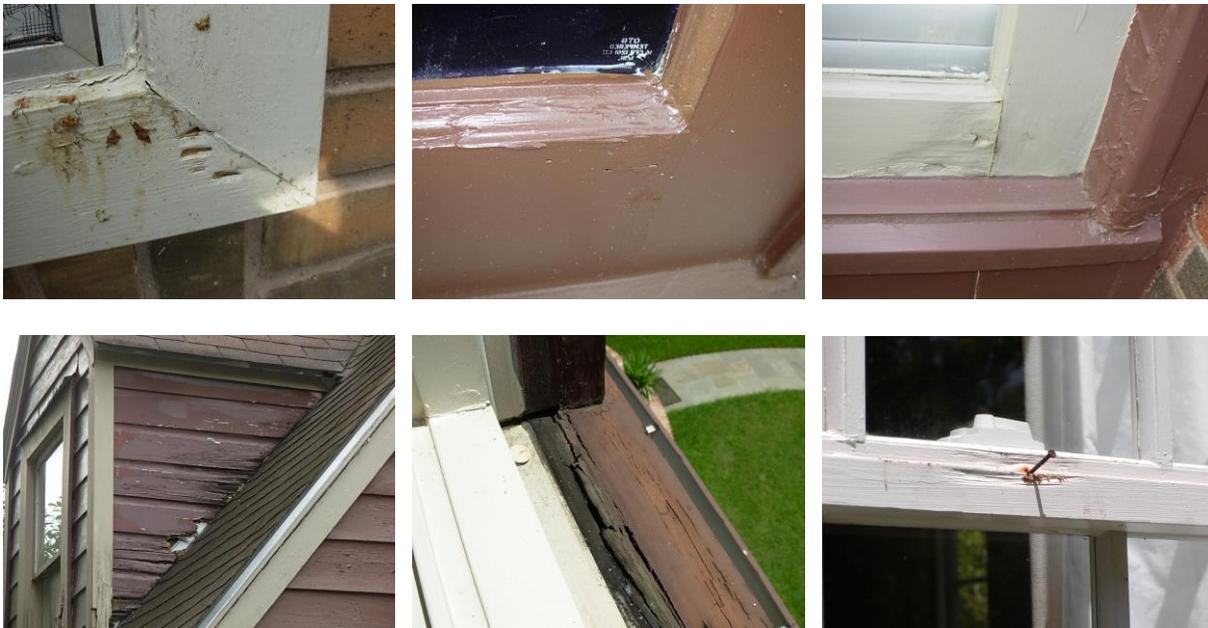
Wood rot was observed and it is recommended that the damaged wood be replaced. It is pointed out that additional damage could be present under the rotted materials, that will not be visible until the outer rotted materials are removed. Have a service company determine the entire scope of wood rot throughout the house, and provide a cost estimate to replace all rotted wood.

Obtain Cost Estimate

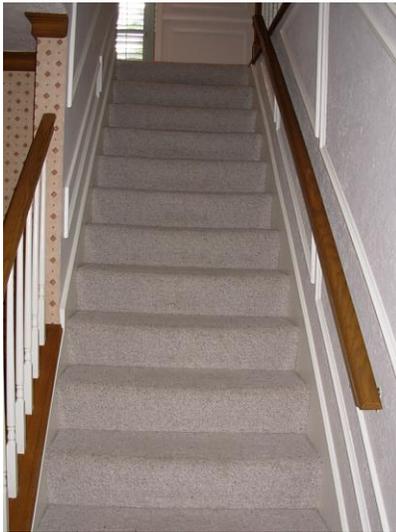
The handrails for the stairway were not constructed according to the current building code standards, which is expected given the age of the house. Therefore, the ends of the handrails do not terminate into the wall, which could allow loose clothing or a purse or bag to catch on the open end, causing tripping and/or falling down the stairs.

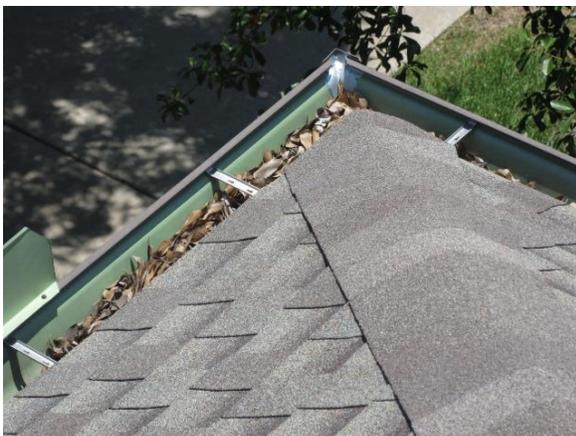
The gutters were observed to have debris in them and are in need of cleaning.

Estimated cost: \$75

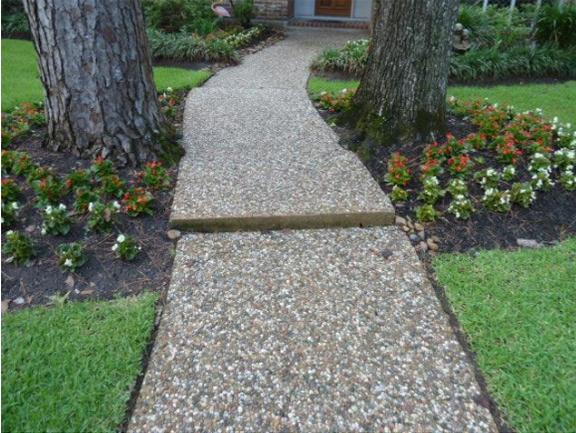
The sidewalk was cracked and uneven at the front of the house, and presents a tripping hazard.

Obtain Cost Estimate

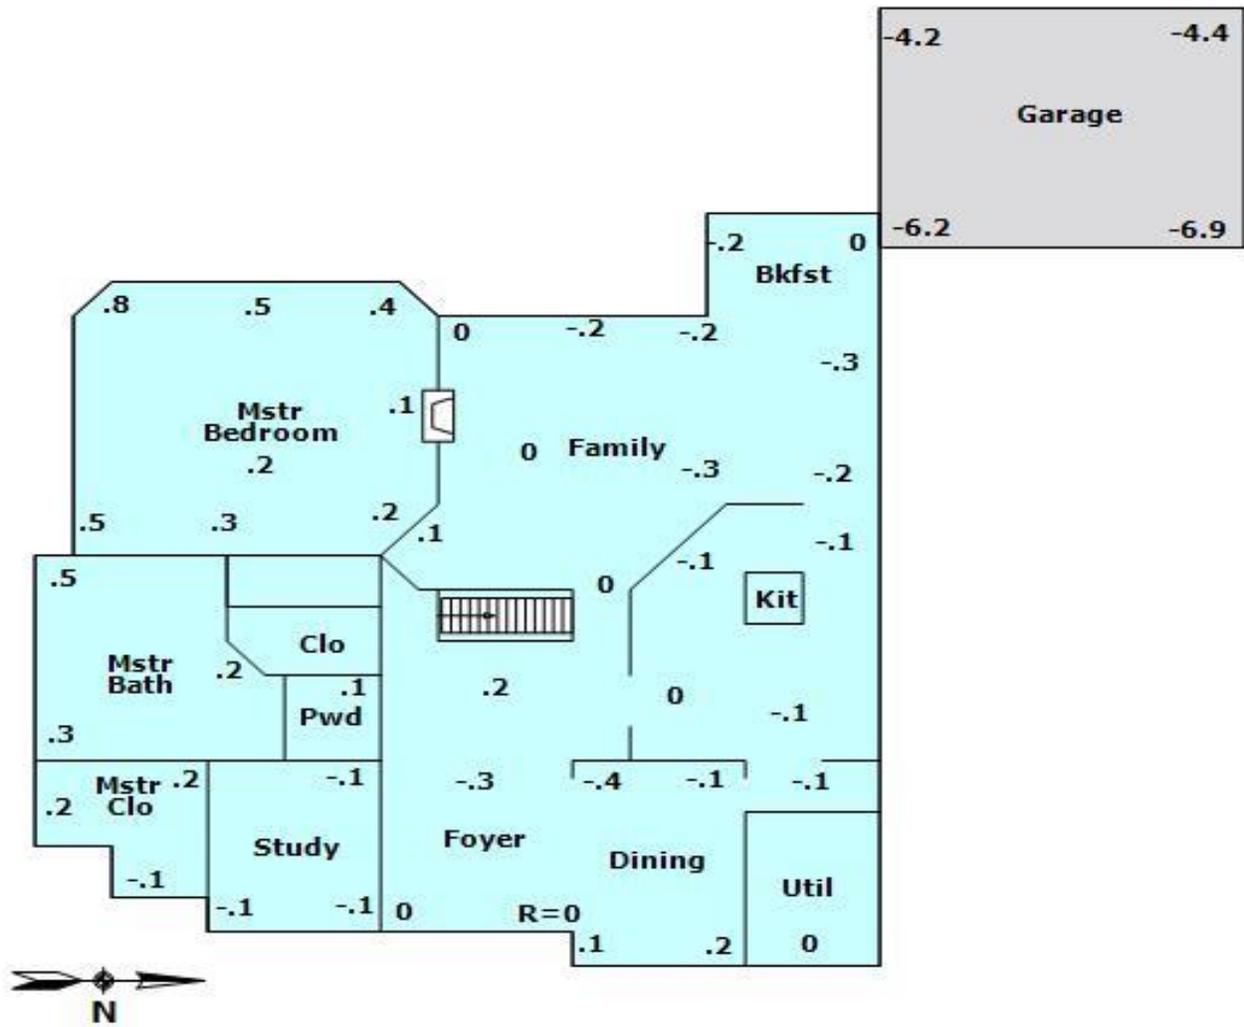
ADDRESS
Elevation Readings

Normally horizontal surfaces, such as floors, door tops, counters, window sills, etc., were observed to be acceptably level throughout the house. The floors were checked with an electronic level, and the difference in elevation between the high point and low point was 1.7 inches. The high point was located at the front corner of the house at the

dining room, and the low point was located diagonally across the house at the master bedroom. The unlevelness takes place over a horizontal distance of approximately 50-60 feet.

See our field sketch showing the elevation readings at the end of this report. Note that the "R" on the sketch is our randomly chosen starting reference point, where the elevation is 0, and all other elevation readings are taken relative to the reference point, and are measured in inches to the nearest 1/10 inch.

Note also that elevation readings taken at the garage area are relatively large numbers relative to the reference point due to the step down into the garage area.
