# Hedderman Stucco

At your request, a visual and probing moisture stucco inspection of the house located at ADDRESS, was made by INSPECTOR.

## **INTRODUCTION**

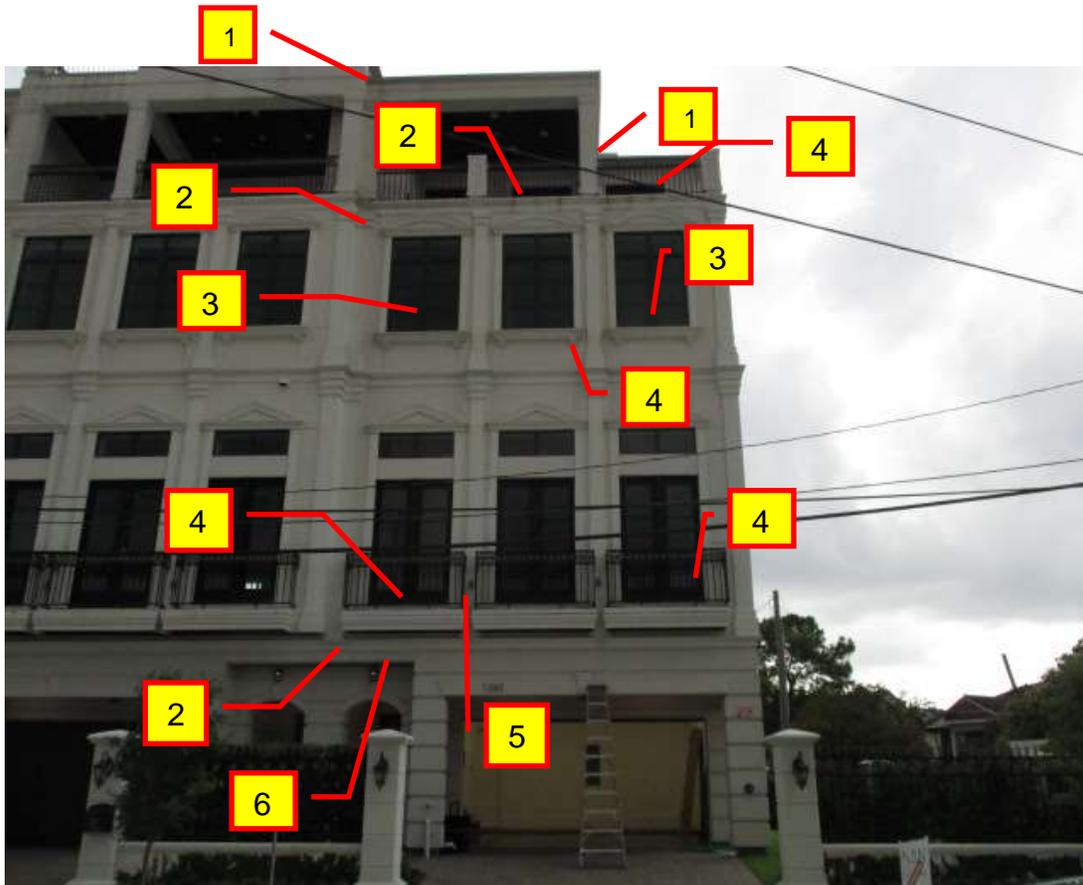
**North Elevation (front)**

#	Description of Visual Observations
1	Kickout flashings present
2	Staining of the stucco finish due to balcony and roof run off
3	EIFS window accent trim surface was flat and did not have a slope and the bottom sealant joint was not done in a professional manner. Recommend coating EIFS trim with Elastomeric paint and re-caulking bottoms of windows. These window have high moisture readings when probed (see below)
4	Sealant missing, separated and/or inadequately applied
5	Balcony Flashings present
6	Drainage plane improperly caulked and does not allow for water to exit wall as intended

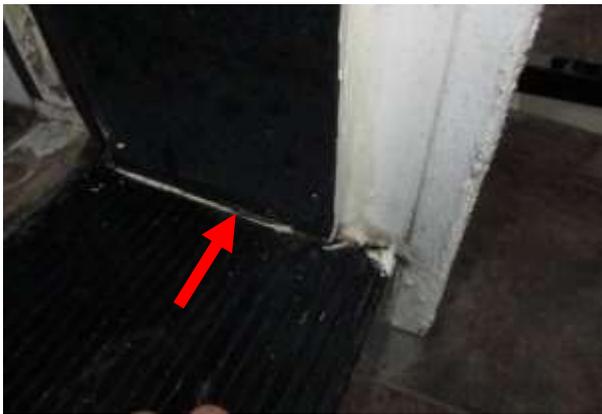
#4 Balcony doors need sealants

Penetration sealants are missing in several areas including the balcony door thresholds, balcony flashing, and balcony railings. The inspector recommends that you consult a qualified stucco waterproofing contractor to seal these areas to prevent moisture penetration.

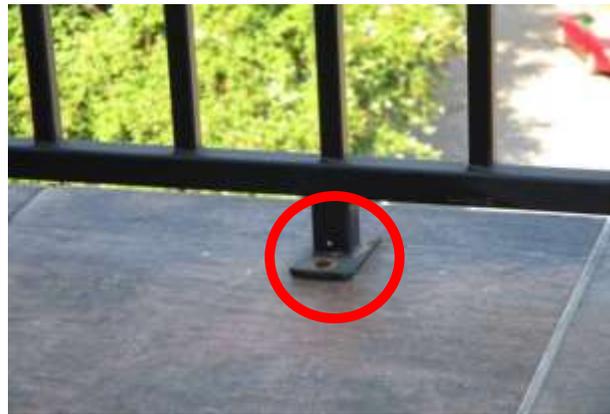
#4 Railing attachments need Sealant

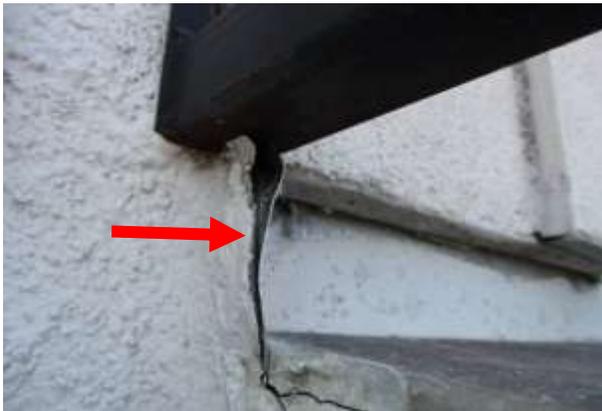
#4 Balcony Flashing needs sealant

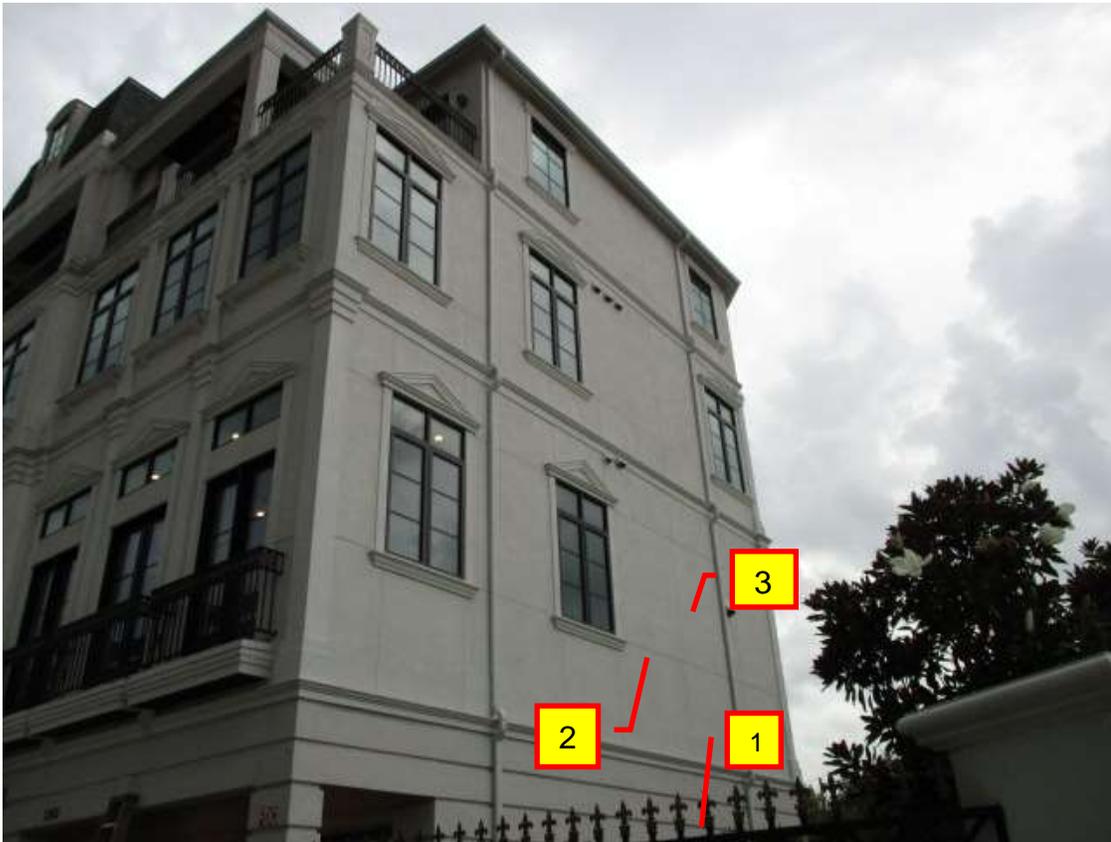
**West Elevation**

#	Description of Visual Observations
1	Stucco does not have proper clearance to grade
2	Crack in stucco at control joint
3	Patches in stucco wall

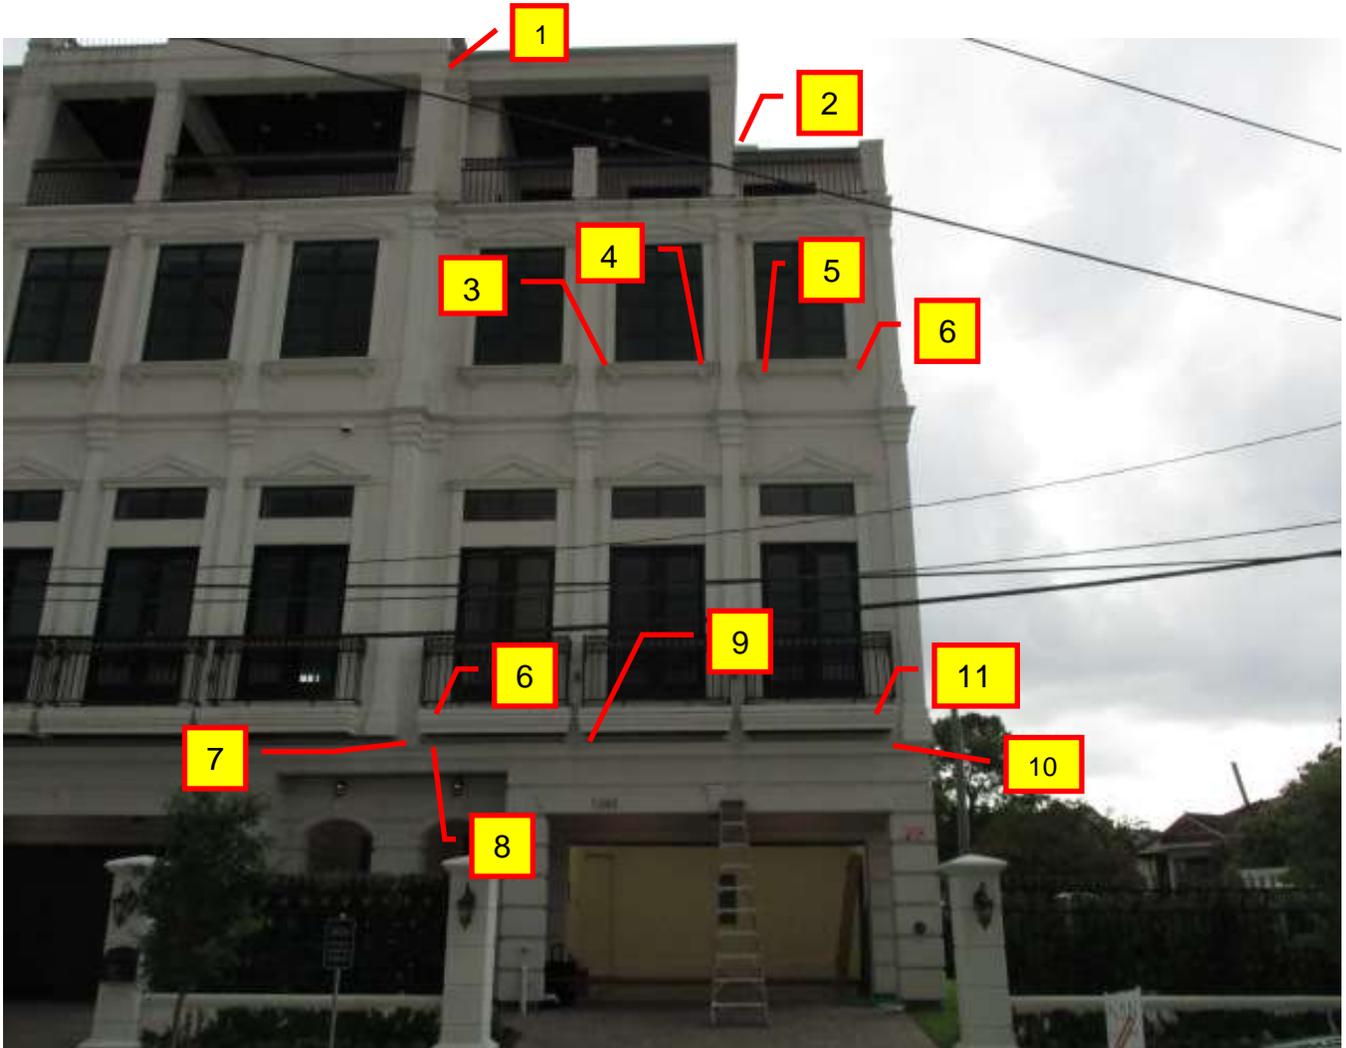
**North Elevation (Front)**

Probing area #	Moisture Reading Percentage	Substrate Integrity
#1	15% Elevated	Firm
#2	40% High	Semi Soft (see conclusions for more detail)
#3	23% High	Firm (See conclusion)
#4	19% High	Firm (See conclusion)
#5	20% High	Firm (See conclusion)
#6	23% High	Firm (See conclusion)
#7	9% Low	Firm

#8	17% Elevated	Firm (See conclusion)
#9	12% Low	Firm
#10	12% Low	Firm
#11	10% Low	Firm

Substrate damage was found on this house and further framing damage may be present beyond the substrate. It is recommended that all areas noted not to have **“Firm” substrate (Including Semi-soft, Soft, or Deteriorated)** be opened up to verify the extent of any damage. It is also recommended that the condition be repaired accordingly to prevent further water entry to the sheathing. It is noted that core sampling to evaluate damage at the areas noted in the report is recommended prior to removal of any large sections of stucco. Consult a qualified waterproofing contractor and/or builder to perform a core sample and/or to repair the damage where applicable. Refer to elevation photos for locations.

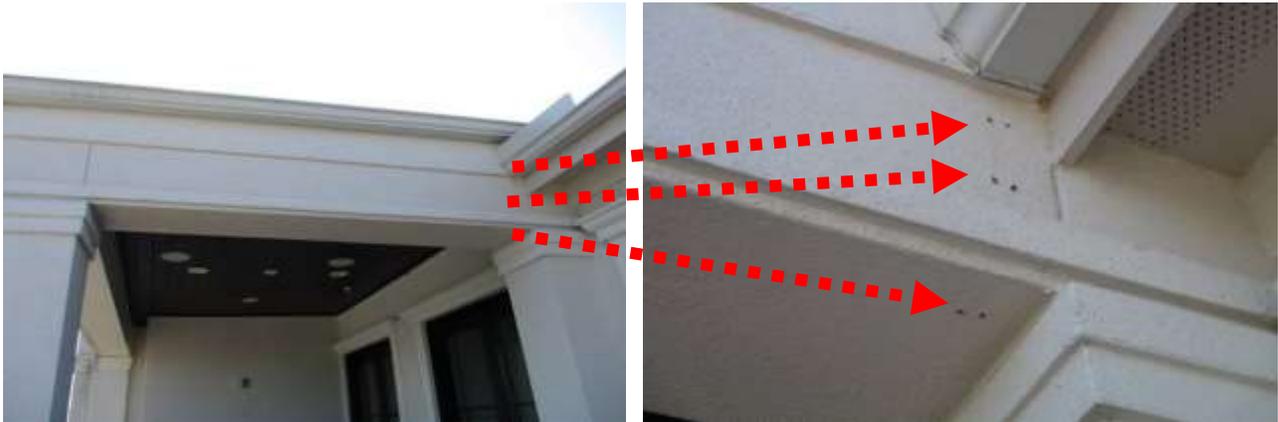
#2 Probing area – All three probes made here were High Moisture content and soft

Kickout flashing has been installed at the roof/wall intersections. However there was high moisture readings under one of the kick out flashings with soft sheathing/substrate (see below at substrate section).

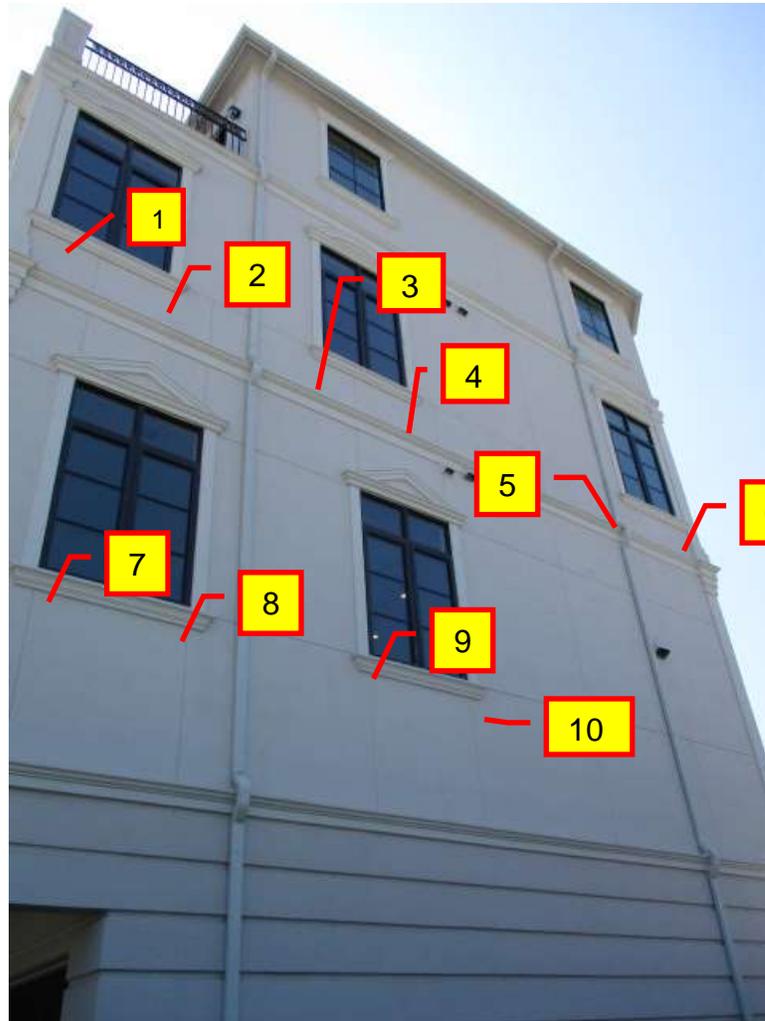
**West Elevation**

Probing area #	Moisture Reading Percentage	Substrate Integrity
#1	10% Low	Firm
#2	11% Low	Firm
#3	9% Low	Firm
#4	13% Low	Firm
#5	12% Low	Firm
#6	11% Low	Firm
#7	11% Low	Firm
#8	9% Low	Firm
#9	12% Low	Firm
#10	11% Low	Firm

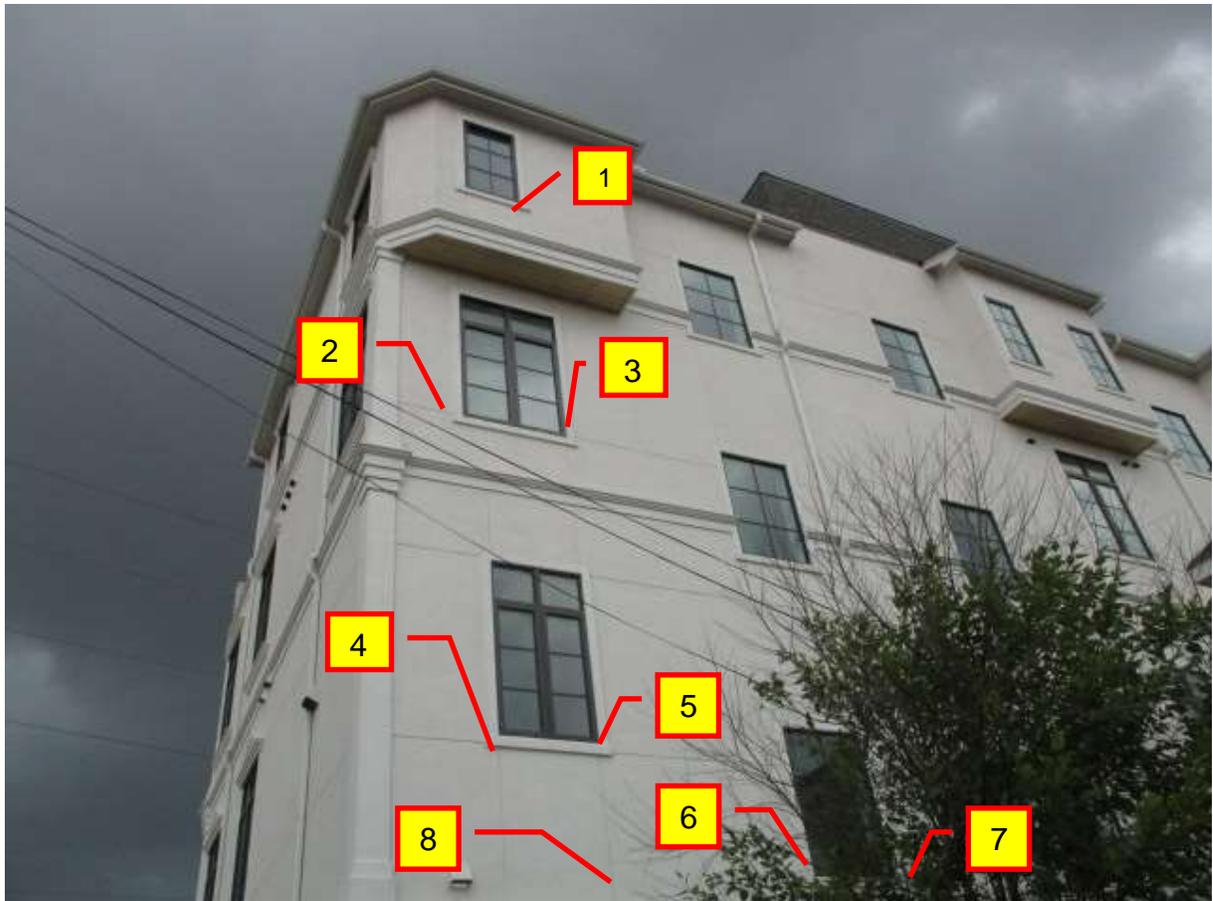
South Elevation

Probing area #	Moisture Reading Percentage	Substrate Integrity
#1	12 Low	Firm
#2	13 Low	Firm
#3	11 Low	Firm
#4	13 Low	Firm
#5	12 Low	Firm
#6	13 Low	Firm
#7	12 Low	Firm
#8	13 Low (Low rood kick out)	Firm

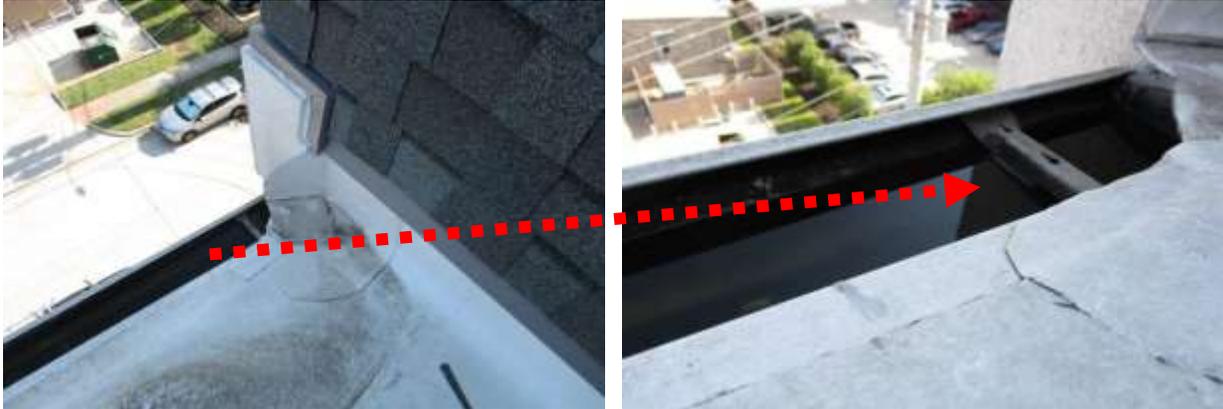
It is noted that the heavy staining at the east corner of the house was determined to be mainly from the gutter overflowing and running down the wall as the gutter slopes the wrong way. The inspector noted that the gutter was full of water at the time of the inspection at the east end and dry at the west end which is its termination point for this section of gutter. Have the builder make the necessary repairs.
