HEDDERMAN ENGINEERING, INC.

REF: CONDITION OF PROPERTY SURVEY

ADDRESS

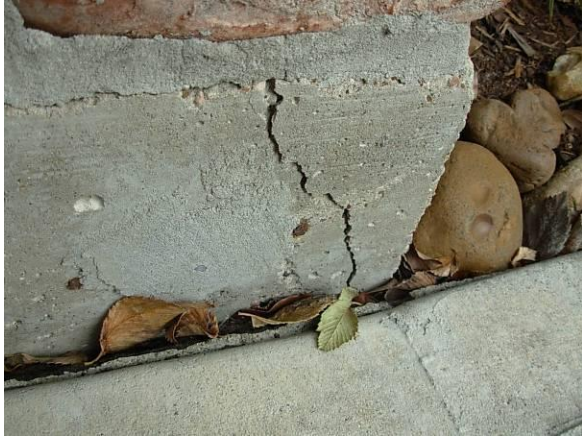
The corner of the foundation was observed to be chipped. This is condition that is caused by differences in thermal expansion between the brick veneer, and the concrete foundation. Also, this condition can be caused by a lack of reinforcement in the corner of the foundation during original construction. In our opinion, this condition does not affect the structural integrity of the foundation.

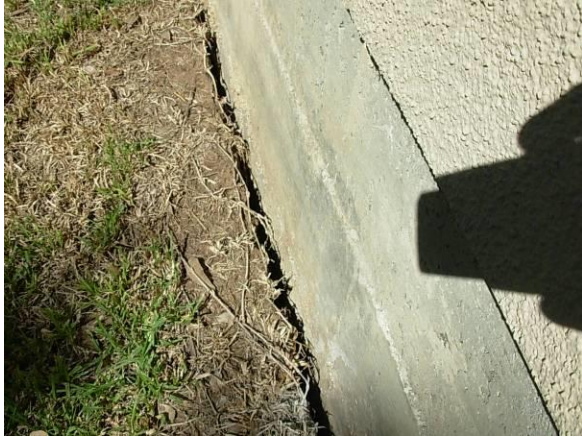
The soil at the perimeter of the foundation was very dry, and has pulled away from the foundation approximately one inch. This excessive dryness of the soil has caused the soil to shrink, which can cause settlement of the foundation. It is recommended that a regular watering program be initiated around the house to keep the soil adjacent to the foundation moist.

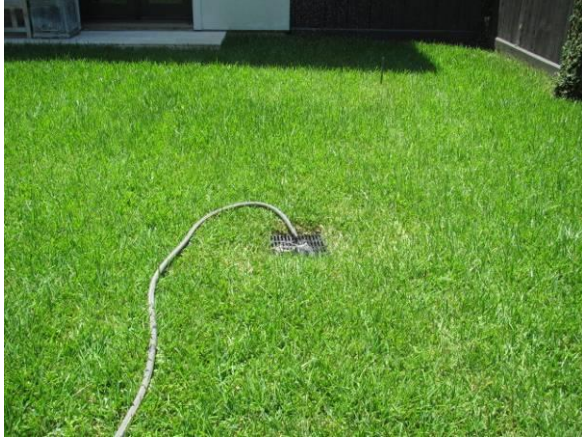
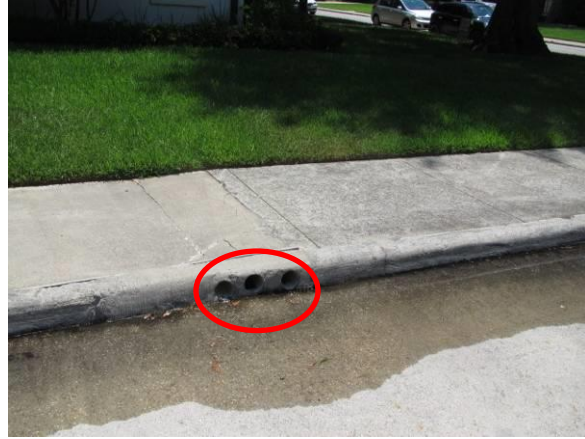
The underground drainage system at the rear of the house was checked by running water into the drain for approximately 15 minutes, and the system was observed to be draining properly to the street.

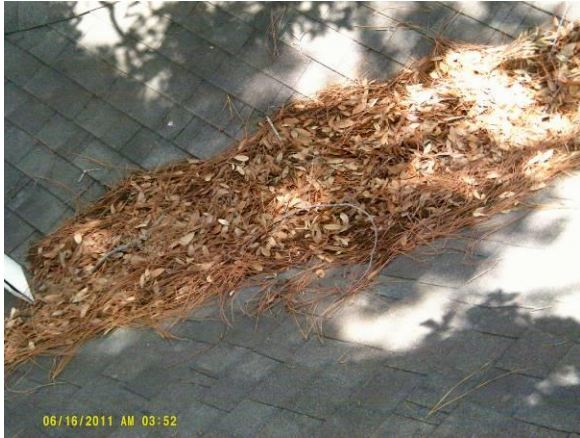
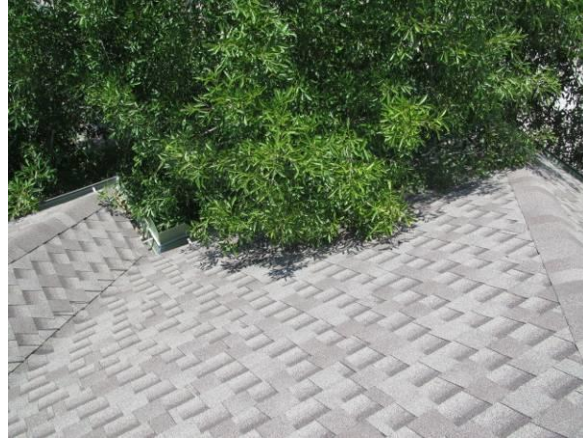
- * Debris was observed on the roof, and the debris should be removed to prevent premature deterioration of the roof surface.

- * Tree limbs were observed to be touching the roof, and need to be trimmed back to prevent them from rubbing across the roof surface.
Obtain Cost Estimate

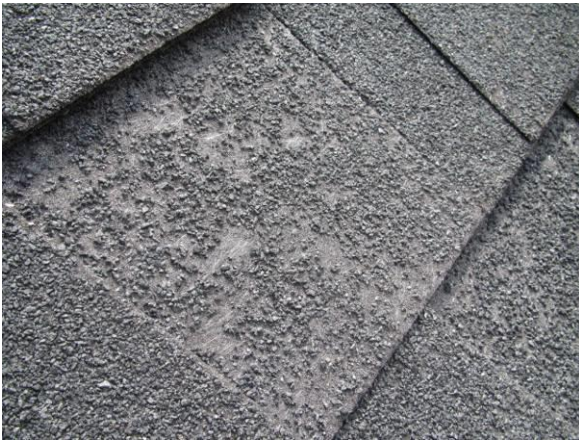
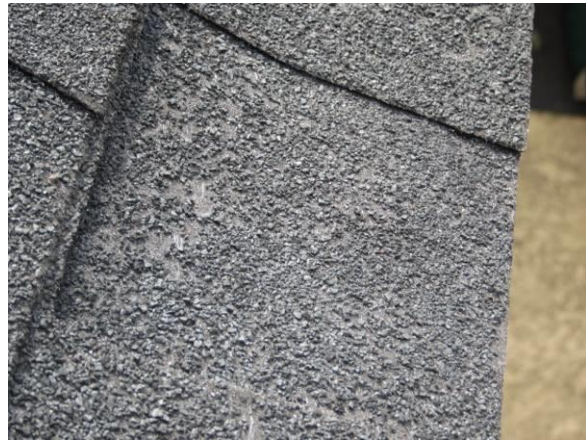
- * The shingles had excessive granular loss, exposing the base material of the shingles to the ultraviolet rays of the sun. It can be anticipated that the deterioration of the roof will accelerate in the next few years, with replacement of the roof anticipated in the next 2-4 years.

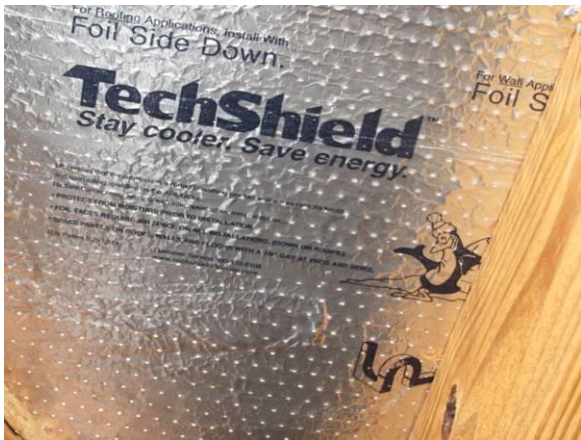
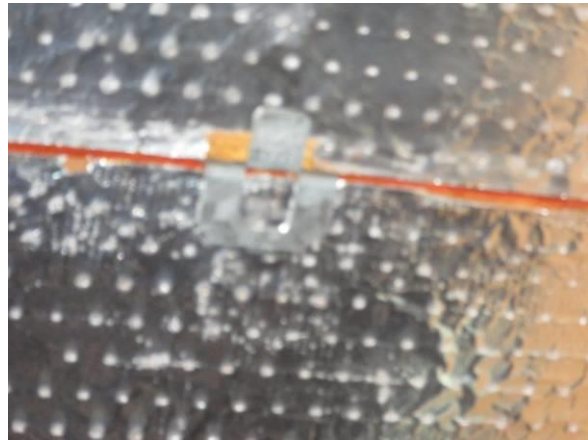
- * The roof decking was observed to be “Tech-Shield” which is an OSB decking that has aluminum foil on the underside, which helps to prevent radiated heat from entering the attic. This will, in turn, keep the attic cooler.
- * It was observed that spacer clips were installed at the joints between the roof decking to allow for expansion of the roof deck.

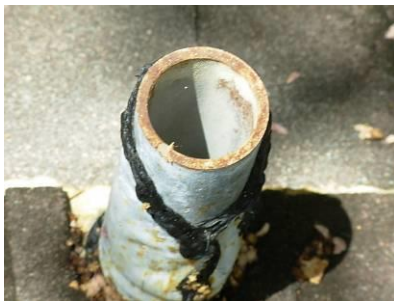
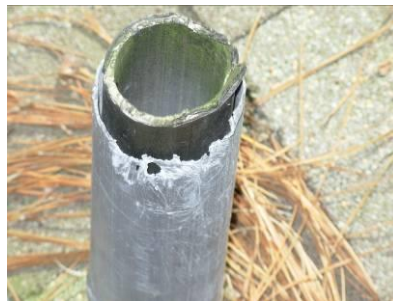
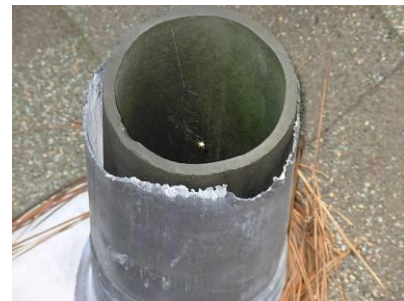
- * Several of the lead roof jacks at the roof penetrations have been damaged, apparently by squirrels eating the lead jacks. The jacks can now allow water to enter the attic space as a roof leak, and the roof jacks need to be repaired as necessary to ensure that all the roof jacks are watertight.

Obtain Cost Estimate

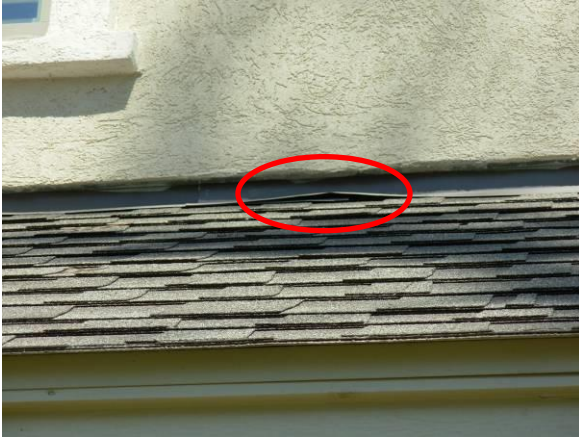
- * The metal flashing at the junction of the low roof and a vertical wall was not secured properly, and can allow wind-blown water to enter the living space. The flashing needs to be resecured to the roof.

Obtain Cost Estimate

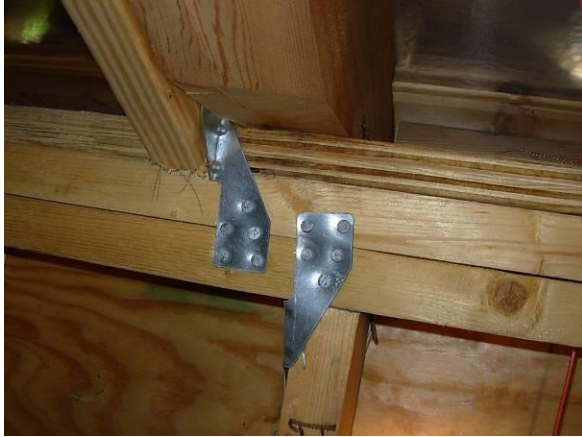
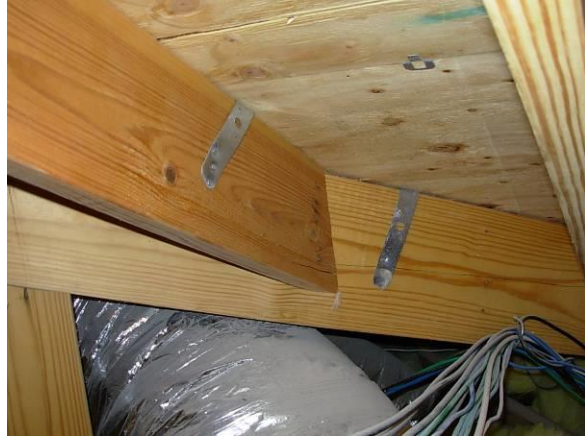
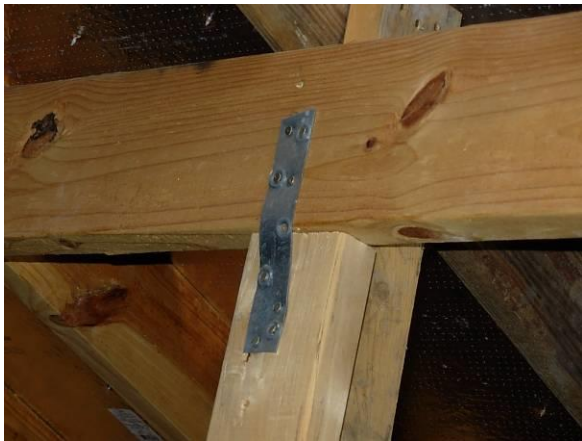
- * Wind uplift or hurricane clips were observed to be installed at the bottom of the roof framing, connecting the roof rafters to the top of the wall framing. Also, we observed metal straps installed over the ridge beam to rafters on both sides of the ridge beam, and also at hip rafters. This provides a stronger structure and will be more resistant to wind uplift from hurricane and tornadoes.

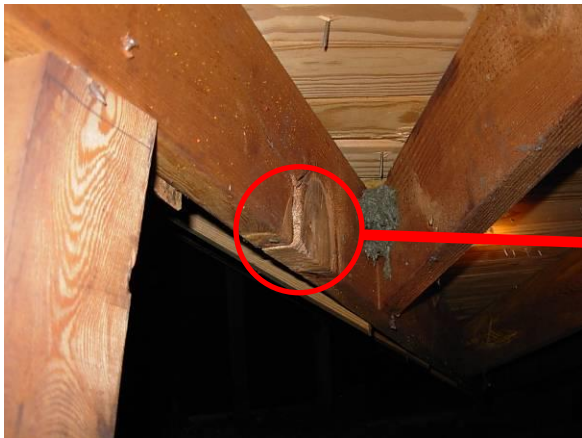
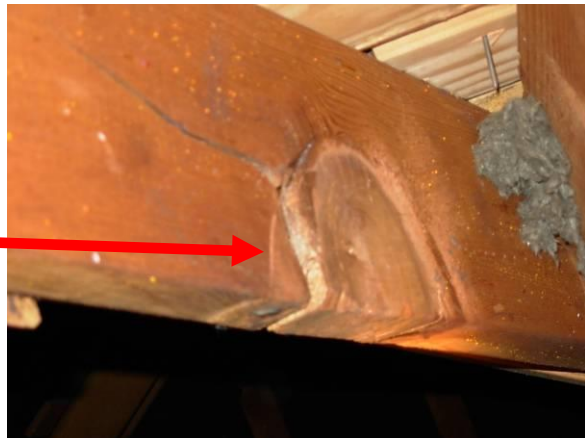
- * One of the rafters in the attic was observed to be split, and needs to be repaired. The damaged rafter was located at the front elevation of the roof over the dining room.

Obtain Cost Estimate

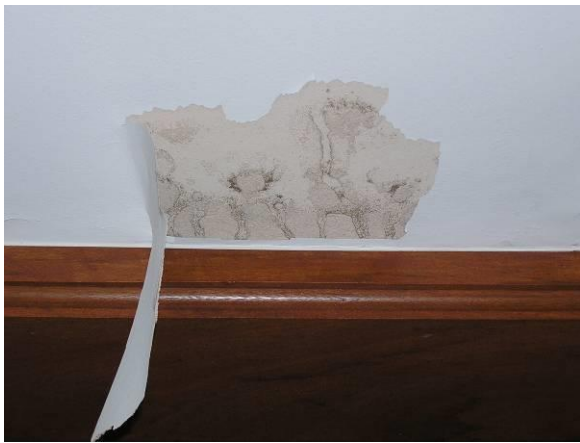
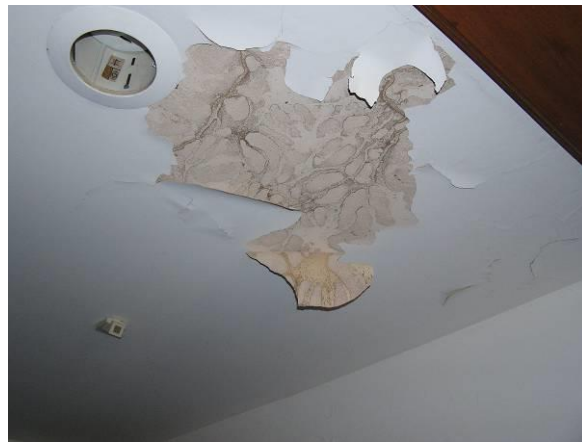
- * Damage was observed on sheetrock at the family room where the exterior paper of the sheetrock was damaged and dirt was visible under the outer layer of paper. This is an evidence of infestation and/or damage by wood destroying insects behind the sheetrock. If the structural framing members are damaged, they will not be visible without removal of the sheetrock. Therefore, it is recommended that the damaged sheetrock be removed along with all other necessary materials in order to view the structural framing members in that area for damage. Have a contractor provide a cost estimate for any repairs that are necessary.

Obtain Cost Estimate

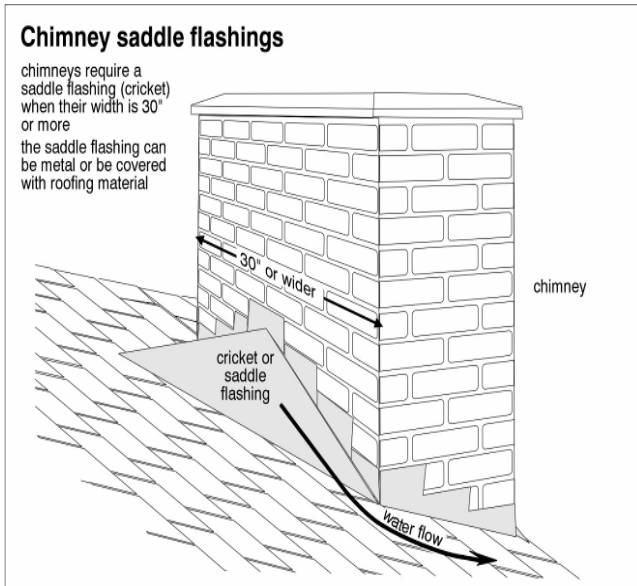
- * No cricket has been installed behind the chimney to divert the roof runoff around the chimney. Since the chimney is more than 30 inches wide, it is recommended that a cricket be installed.

Obtain Cost Estimate

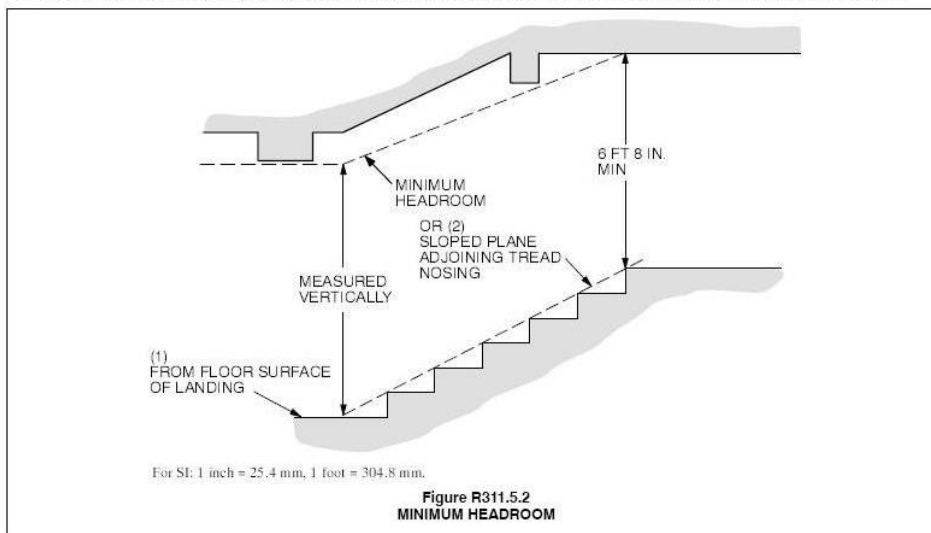
- * The headroom at the stairwell was less than the required six feet, eight inches, which can be hazardous to people using the stairs. Major structural modifications would be needed to provide the minimal head clearance at the stairwell. If the condition is of concern to you, then it is recommended that you contact a contractor to provide a cost estimate to make the structural modifications.

R311.5.2 Headroom. The minimum headroom in all parts of the stairway shall not be less than 6 feet 8 inches (2036 mm) measured vertically from the sloped plane adjoining the tread nosing or from the floor surface of the landing or platform.

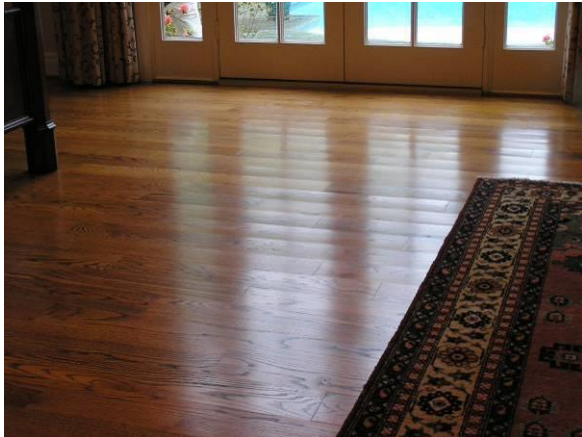
1. The family room, where the wood floors were warped. The source of the water penetration appears to be related to the french doors at the rear of the room, and further investigation with a contractor is recommended to determine the source of the water penetration, and to make any needed repairs.

Obtain Cost Estimate

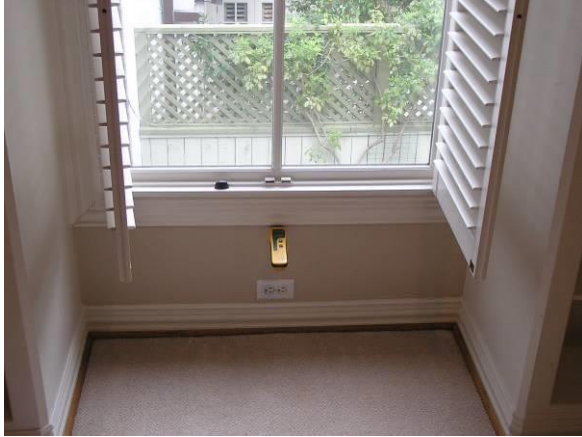
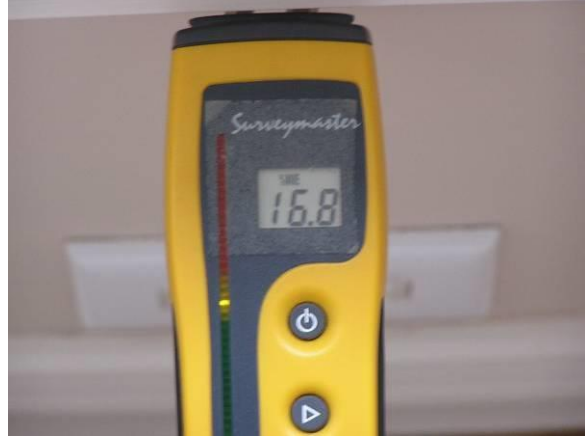
2. The upstairs southeast bedroom, where a high moisture content was found in the sheetrock under the window with our moisture meter. Further investigation with a service company is recommended to determine the source of the water penetration, and to make any needed repairs.

Obtain Cost Estimate

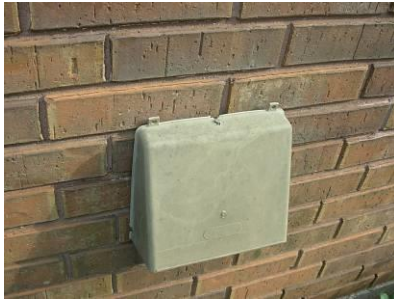
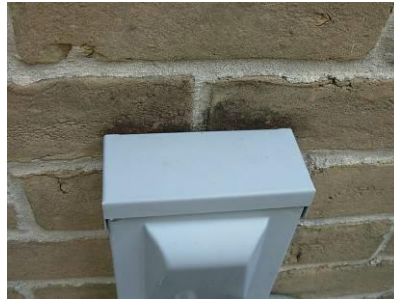
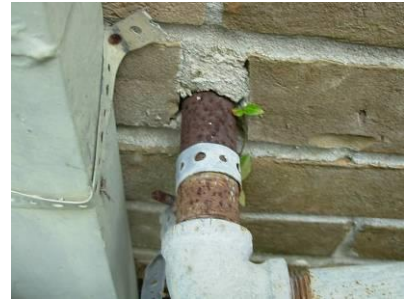
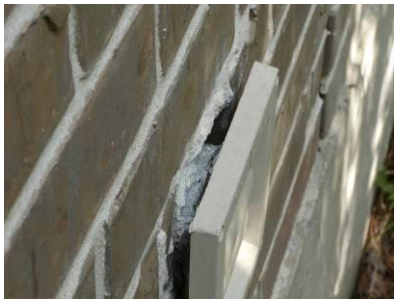
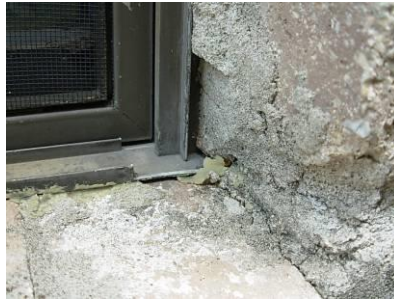
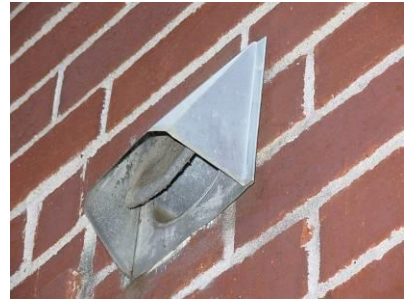
A vulnerability of water penetration was observed at penetrations/openings through the exterior building envelope, and it is recommended that all penetrations/openings be sealed against water penetration. Below is a representative sample of locations and/or photographs showing some, but not necessarily all, locations where there is a vulnerability to water penetration. Have a contractor provide a cost estimate to seal all vulnerable areas against water penetrations.

Obtain Cost Estimate

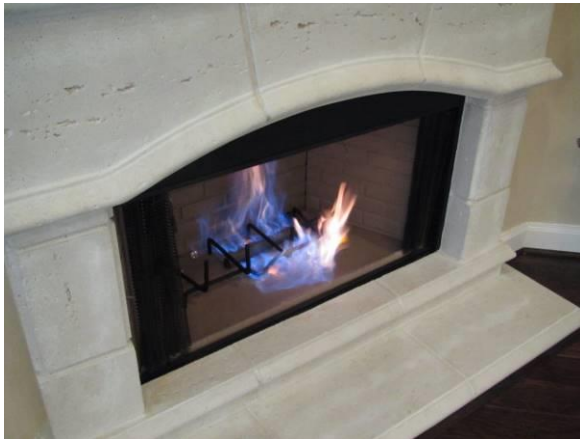
The fireplace at the living room was a prefabricated metal fireplace with a metal flue pipe that extended through the roof. The firebox was equipped with a gas log lighter, with a manually operated gas valve. It was observed that the flames from the log lighter extended out of the firebox, and are a potential fire hazard. Have a service company repair/replace the log lighter to prevent this condition.

Obtain Cost Estimate

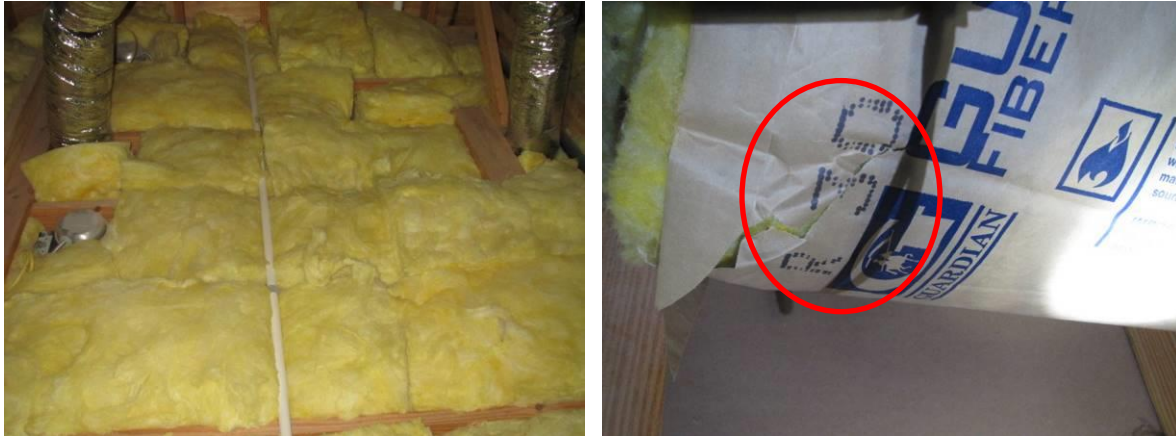
The insulation in the attic was average by today's standards. The normal amount of

insulation for attics in this area is an R30 energy rating. This attic had 9-1/2 inches of fiberglass batt insulation in the ceiling, which was marked as being an R30.

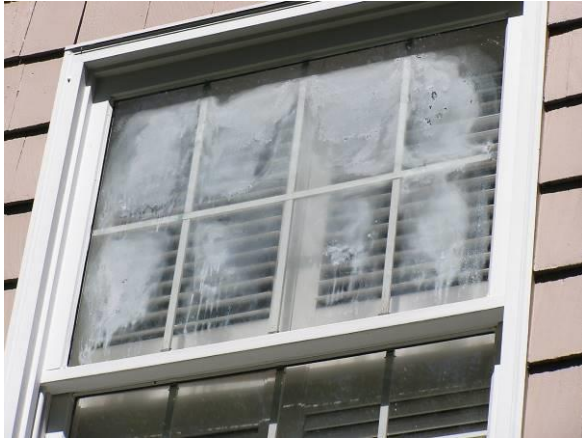
Double pane windows were observed where the seal has broken and allowed moisture between the two panes.

Locations included: the upstairs southeast bedroom

Obtain Cost Estimate

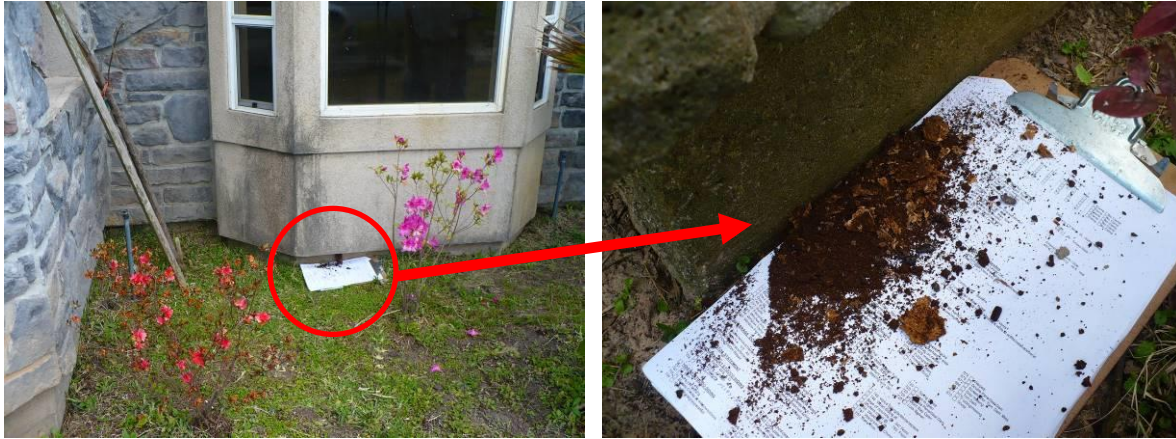
We observed damage to the structural sheathing behind the stucco, where water has apparently penetrated past the stucco to the structural sheathing. The entire scope of any damage that exists is not discernable with a visual inspection, and it is recommended that a stucco specialist be contacted to perform invasive inspections by drilling holes at appropriate locations to determine the scope of the damage. Have a contractor provide a cost estimate for any needed repairs.

Obtain Cost Estimate

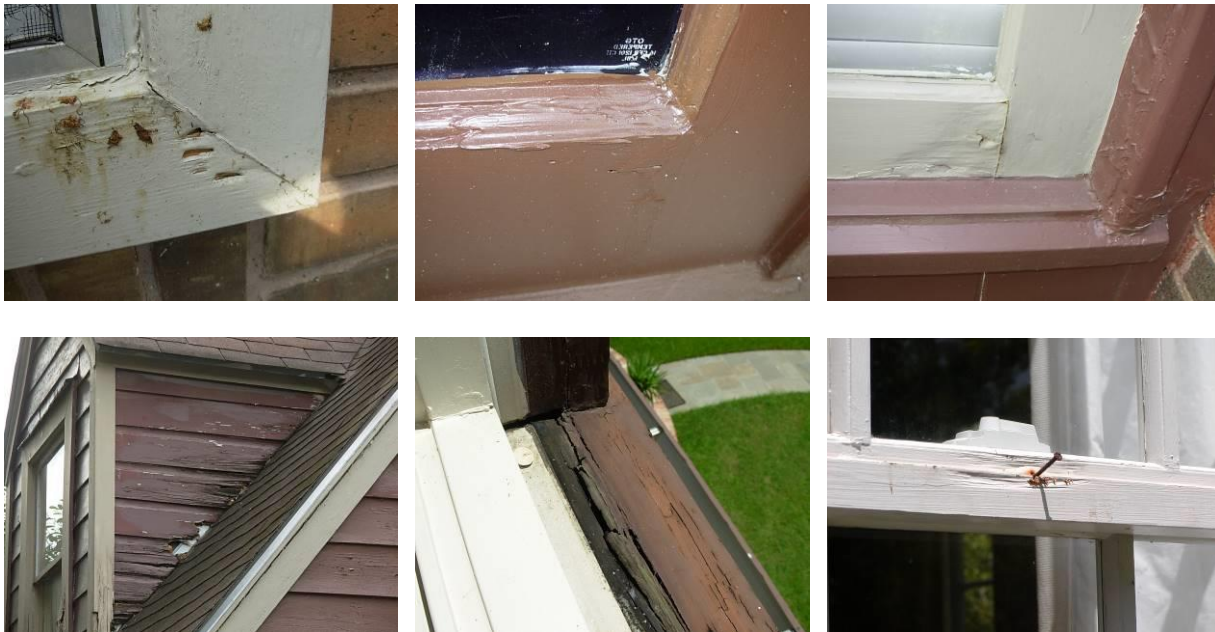
Wood rot was observed and it is recommended that the damaged wood be replaced. It is pointed out that additional damage could be present under the rotted materials, that will not be visible until the outer rotted materials are removed. Have a service company determine the entire scope of wood rot throughout the house, and provide a cost estimate to replace all rotted wood.

Obtain Cost Estimate

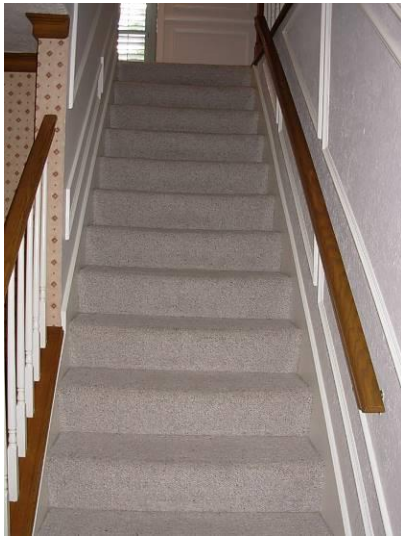
The handrails for the stairway were not constructed according to the current building code standards, which is expected given the age of the house. Therefore, the ends of the handrails do not terminate into the wall, which could allow loose clothing or a purse or bag to catch on the open end, causing tripping and/or falling down the stairs.

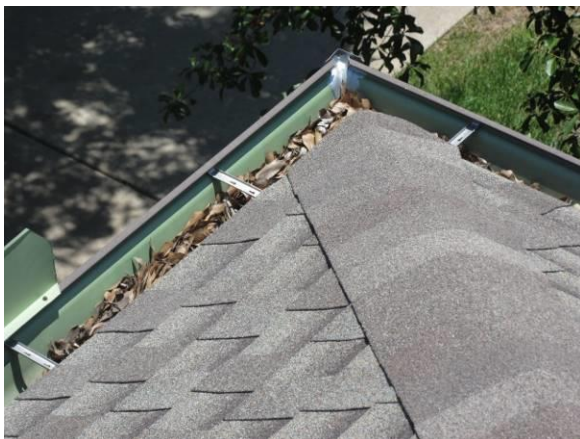
The gutters were observed to have debris in them and are in need of cleaning.

Obtain Cost Estimate

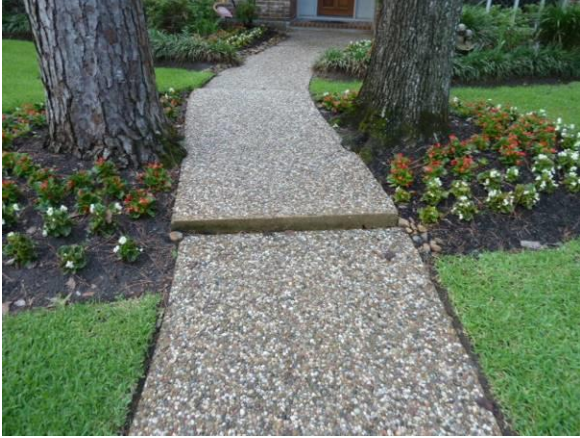
The sidewalk was cracked and uneven at the front of the house, and presents a tripping hazard.

Obtain Cost Estimate

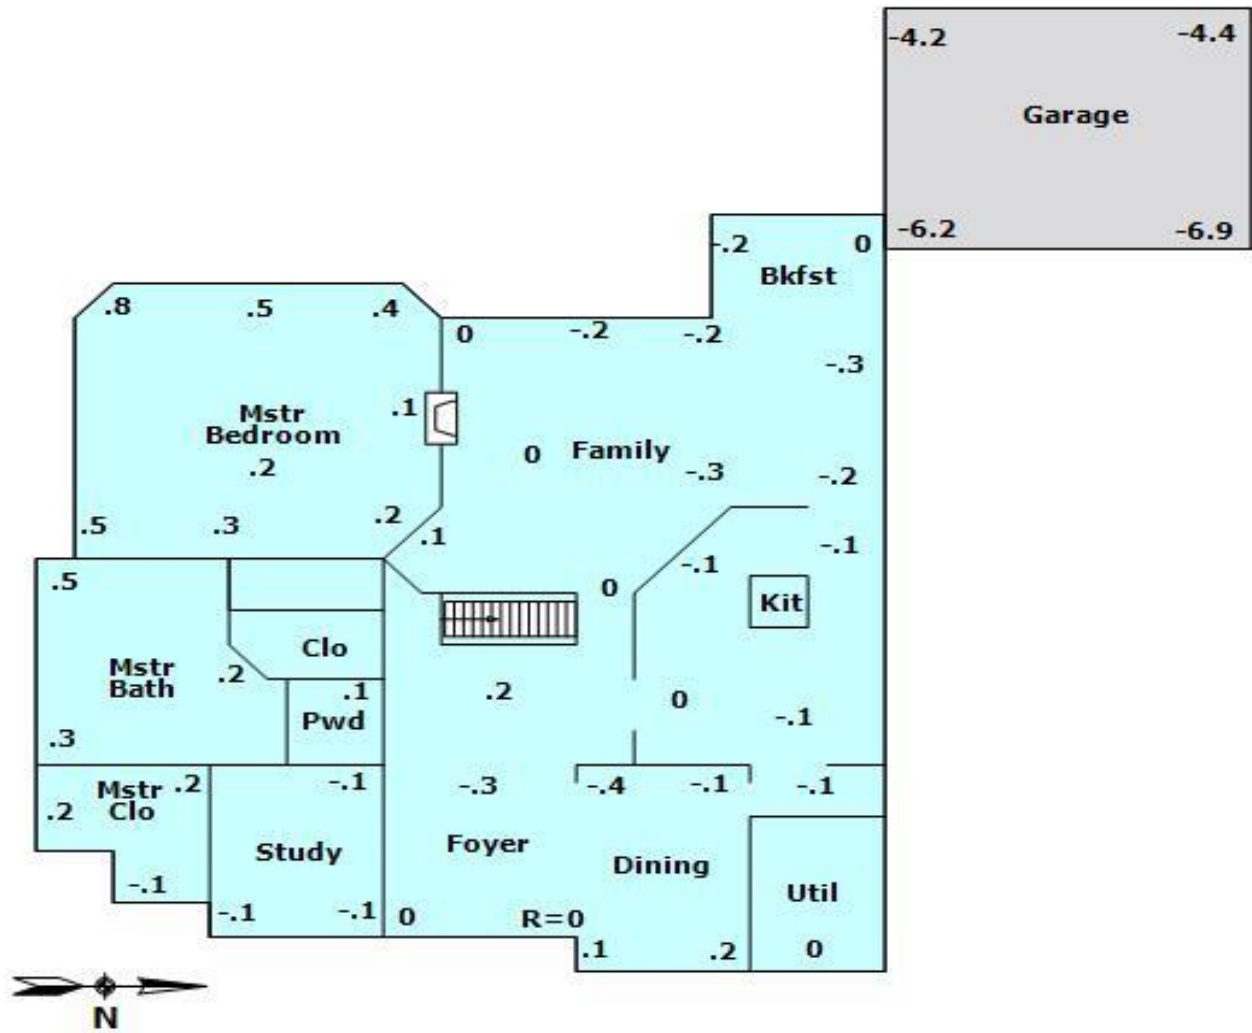
ADDRESS
Elevation Readings

Normally horizontal surfaces, such as floors, door tops, counters, window sills, etc., were observed to be acceptably level throughout the house. The floors were checked with an electronic level, and the difference in elevation between the high point and low point was 1.7 inches. The high point was located at the front corner of the house at the

dining room, and the low point was located diagonally across the house at the master bedroom. The unlevelness takes place over a horizontal distance of approximately 50-60 feet.
