Inspection Report

30047 West Barrier Reef Blvd
Lewes DE 19958

Tip Top Property Inspections, LLC

Date: 5/11/2019	Time: 03:30 PM	Report ID: 20190511-30047-West-Barrier-Reef-Blvd
Property: 30047 West Barrier Reef Blvd Lewes DE 19958	Customer: Mr. Robert Kuehnl	Real Estate Professional: Mike Kuehnl TEST Brokers

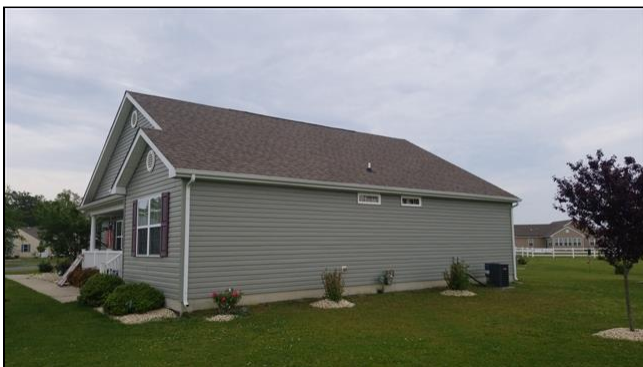
1.0 Item 1(Picture)

1.0 The Inspector inspected the roof and its components by walking the roof. The roof was covered with asphalt composition shingles.

Roof is approximately 7 years old and appears to be in good condition.

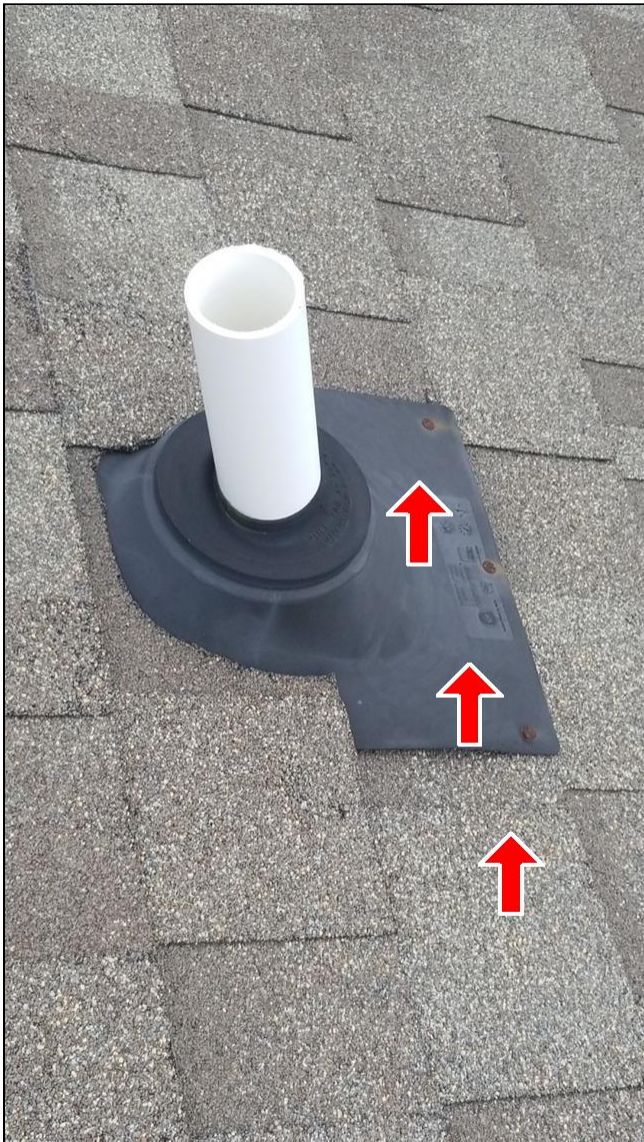
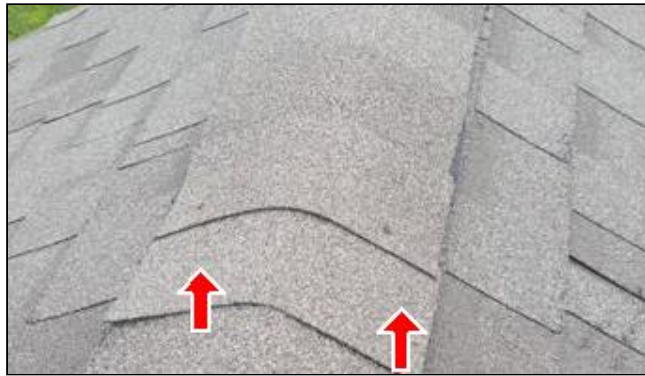
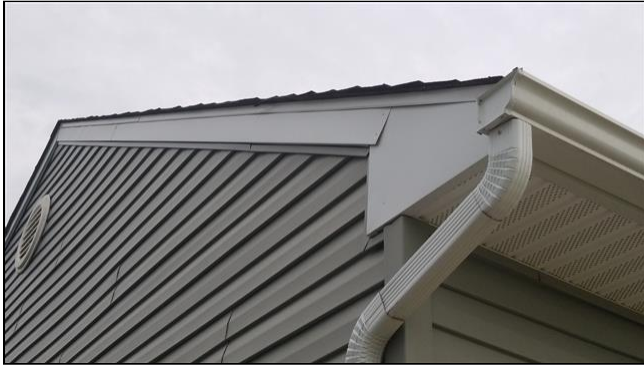
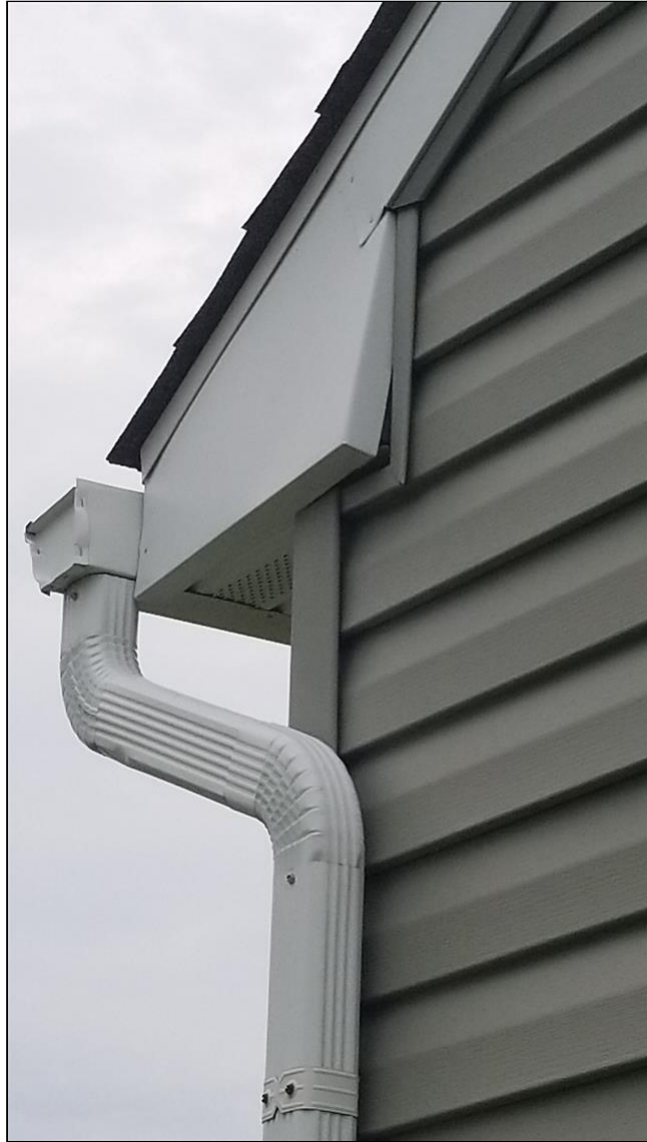
1.2 (1) Nail heads not properly covered in ridge vent and flashing resulting in corrosion. Recommend having a roofing contractor properly seal these to prevent future damage.

(2) Nails coming loose on trim panel

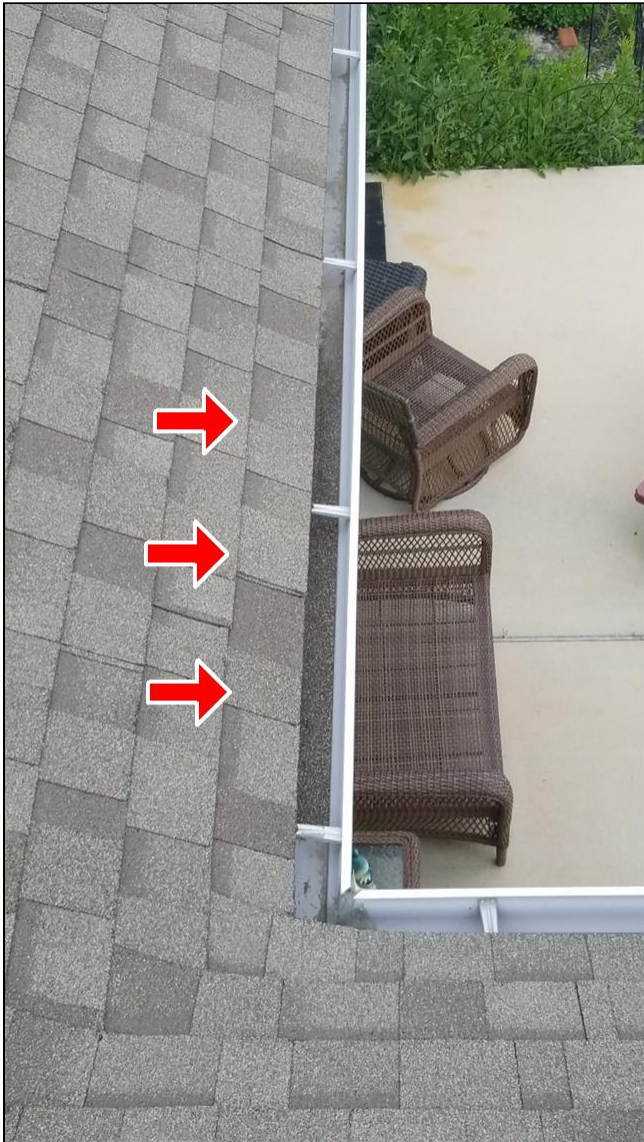
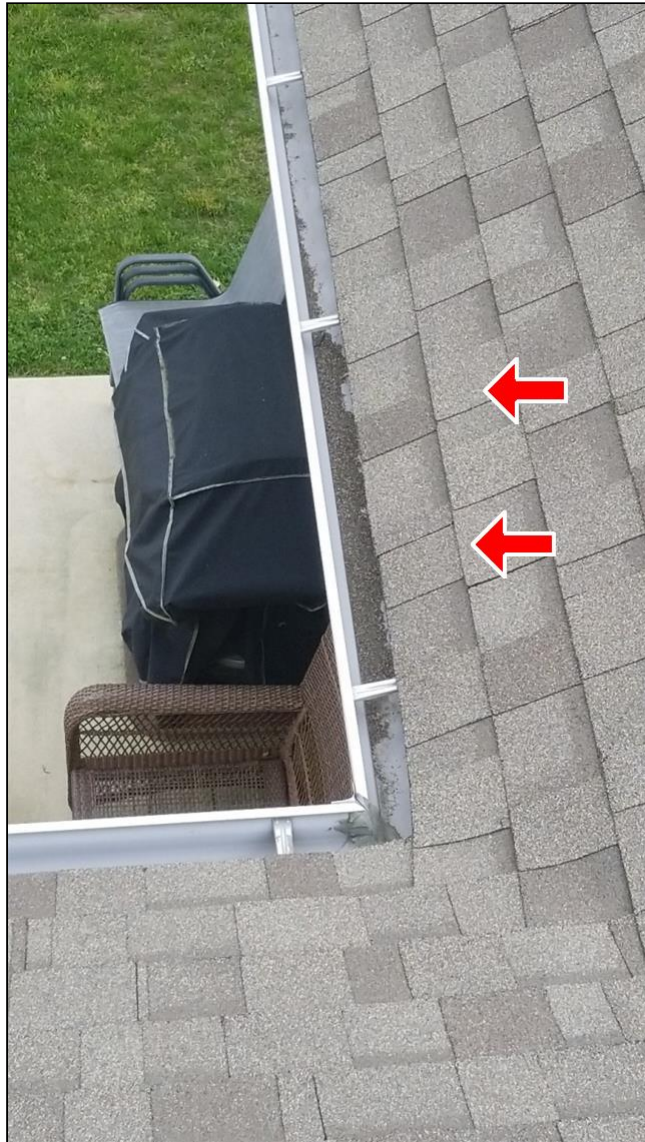
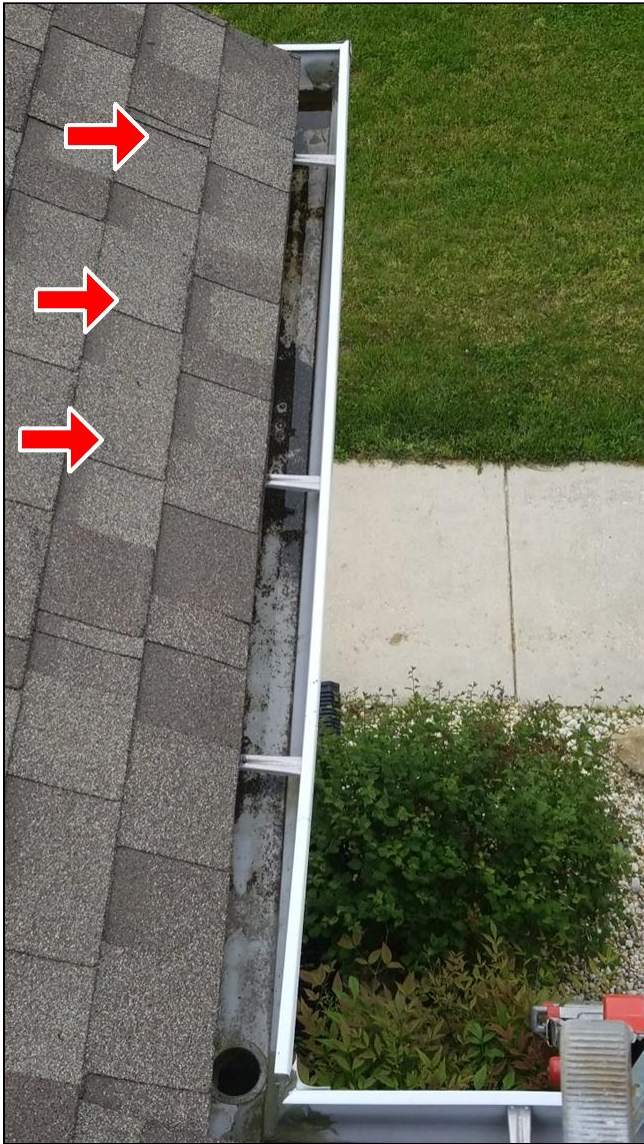
1.3 (1) Granules from the asphalt shingles were accumulated in the gutters. This condition is common as loose granules that are not embedded in the asphalt covering shingles are washed loose by runoff from rain. This is not a defective condition, but is common and expected, however the granules trap sediment, which hardens and prevents fully functional drainage of the gutters. This condition may hasten corrosion. The Inspector recommends thorough cleaning of the gutters.

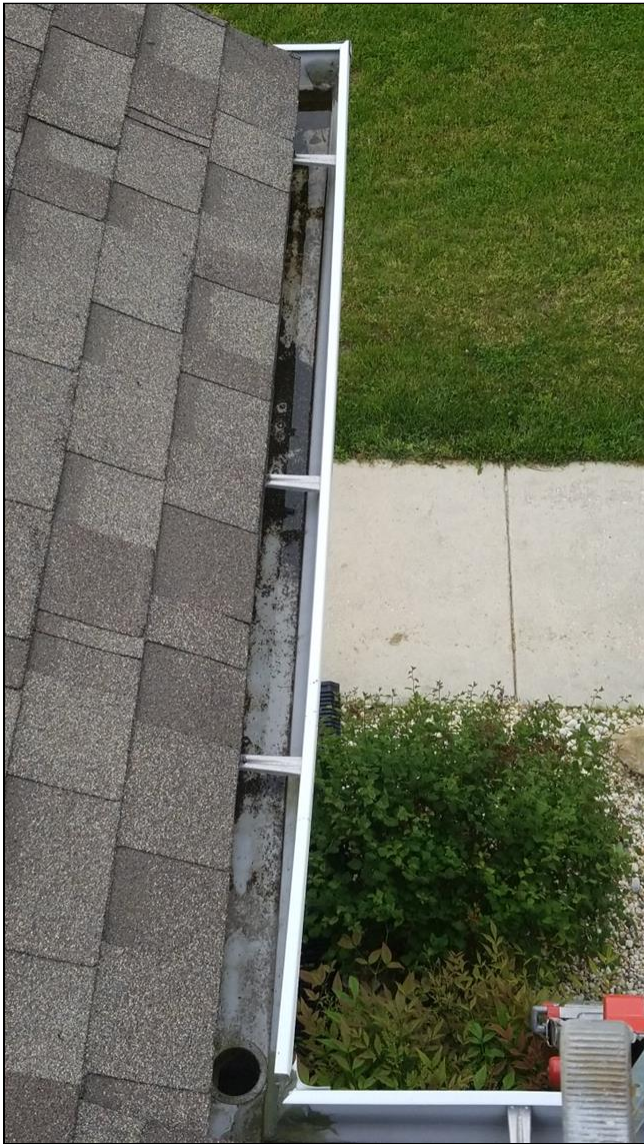
1.3 Item 4(Picture)

(2) Water laying in gutters not draining properly

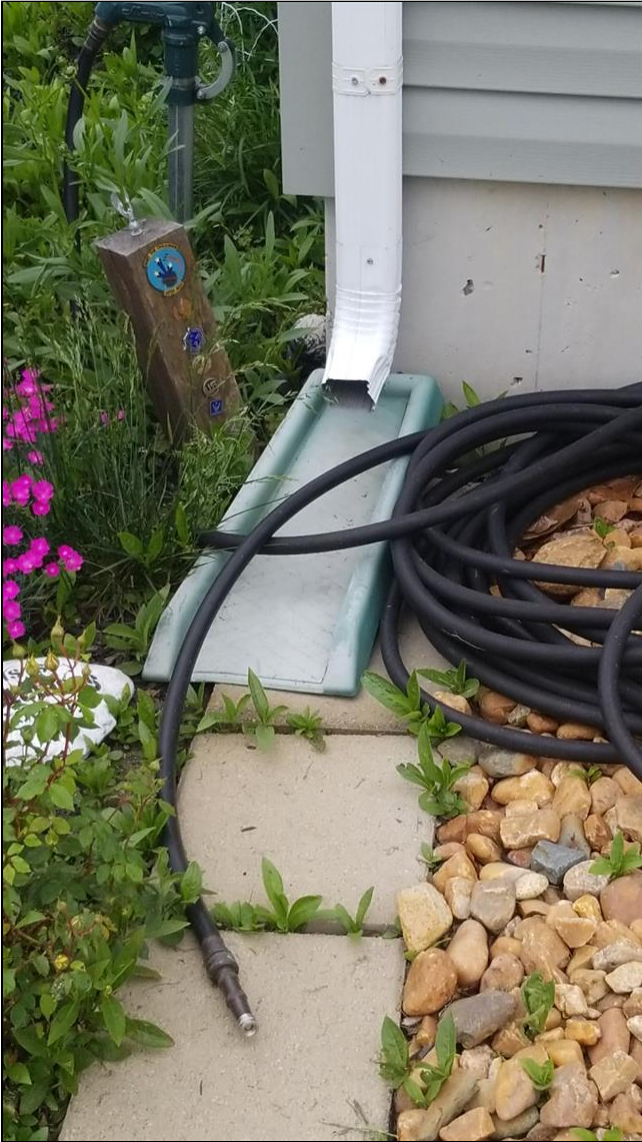
1.3 Item 5(Picture)

(3) Considering Splash blocks on downspouts to get water away from Foundation

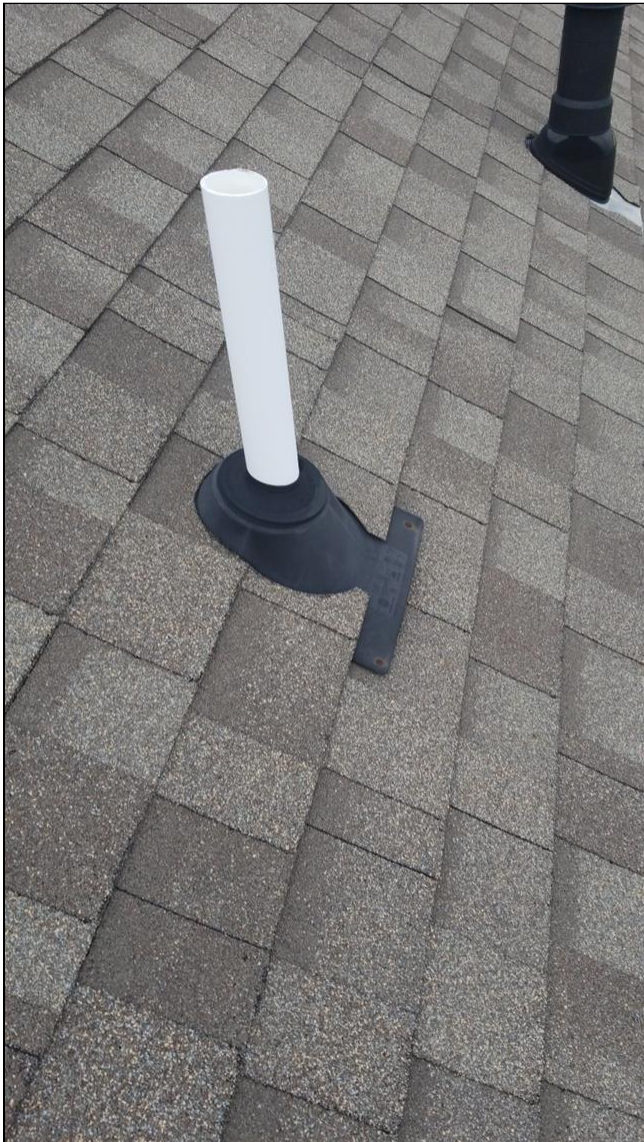
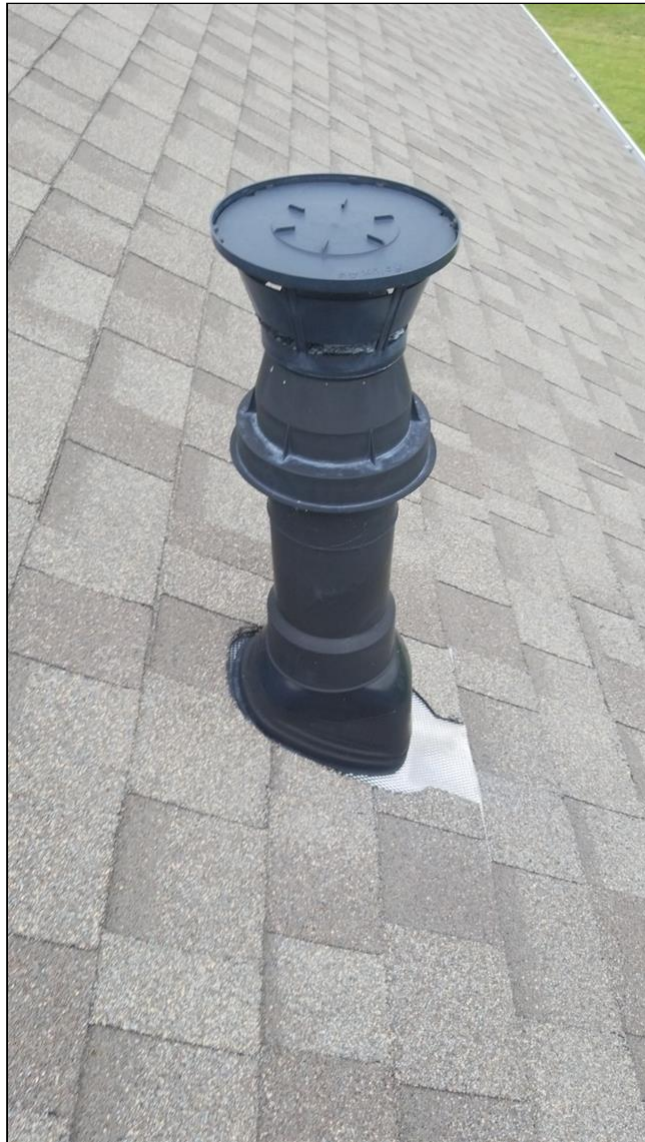
1.4 Plumbing and Combustion vents appear to be installed properly with no signs of leaks or water intrusion.

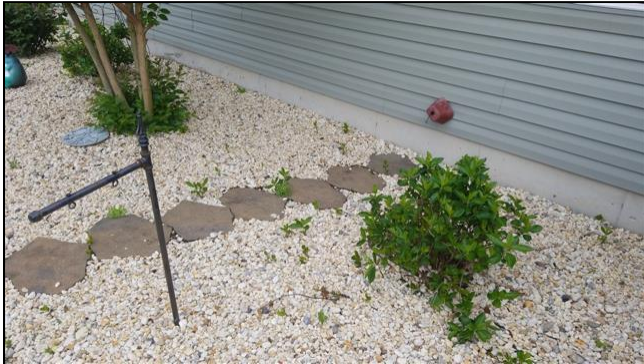
3.3 Item 1(Picture)

3.3 Neutral the negative grade in front of house near garage. The home had areas of neutral or negative drainage that will route runoff from precipitation toward the foundation. Excessively high moisture levels in soil supporting the foundation can effect its ability to support the weight of the structure above. The ground should slope away from the home a minimum of ¼-inch per foot for a distance of at least six feet from the foundation. The Inspector recommends that these area be re-grading to improve drainage near the foundation.

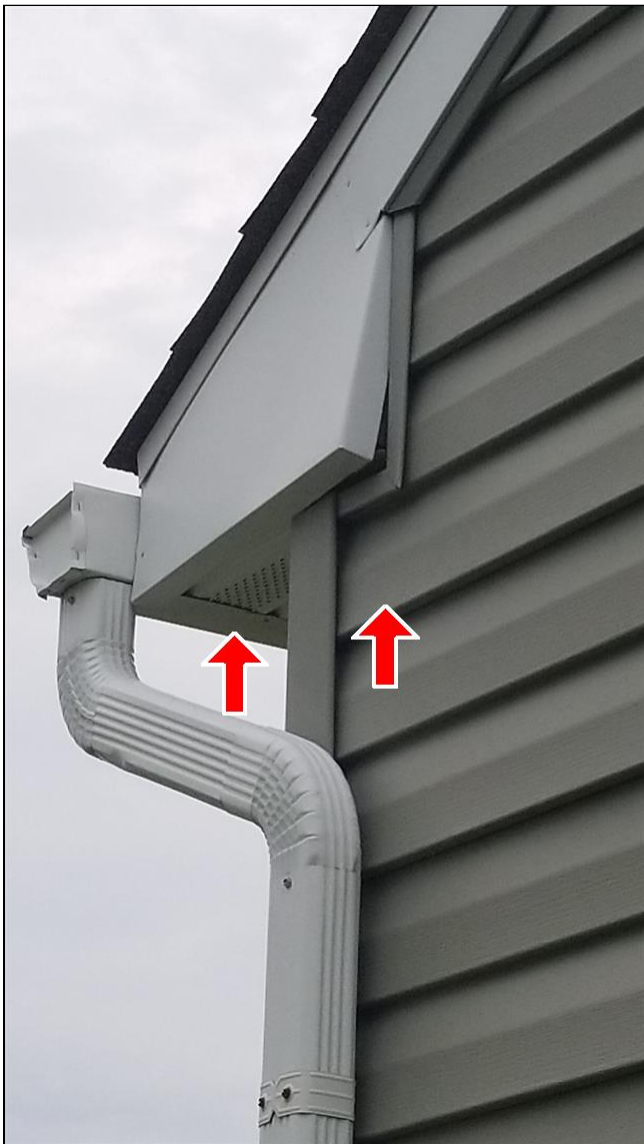
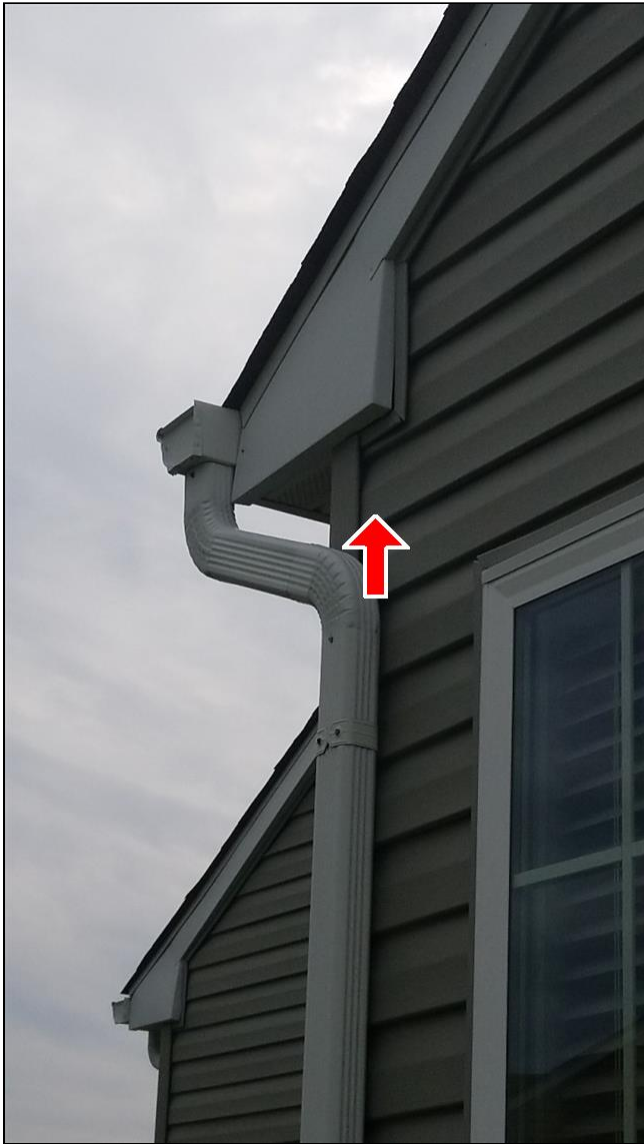
3.4 The fascia trim loose at the time of the inspection should be re-fastened by a qualified contractor.

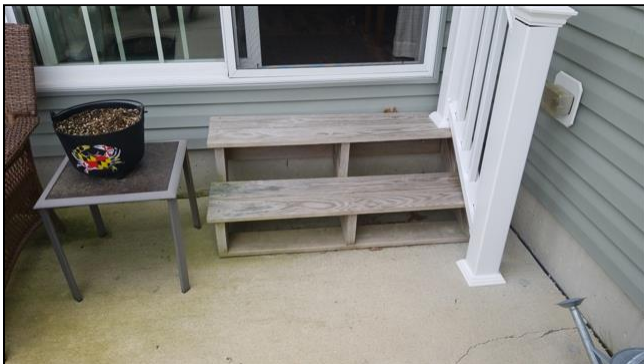
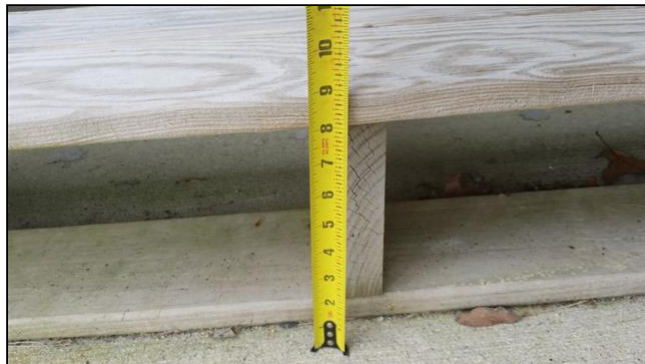
3.6 A risers are too high for exterior stairs leading into the sunroom. Risers shouldn't be more than 7 ¾ inches high. Correction and further evaluation is recommended.

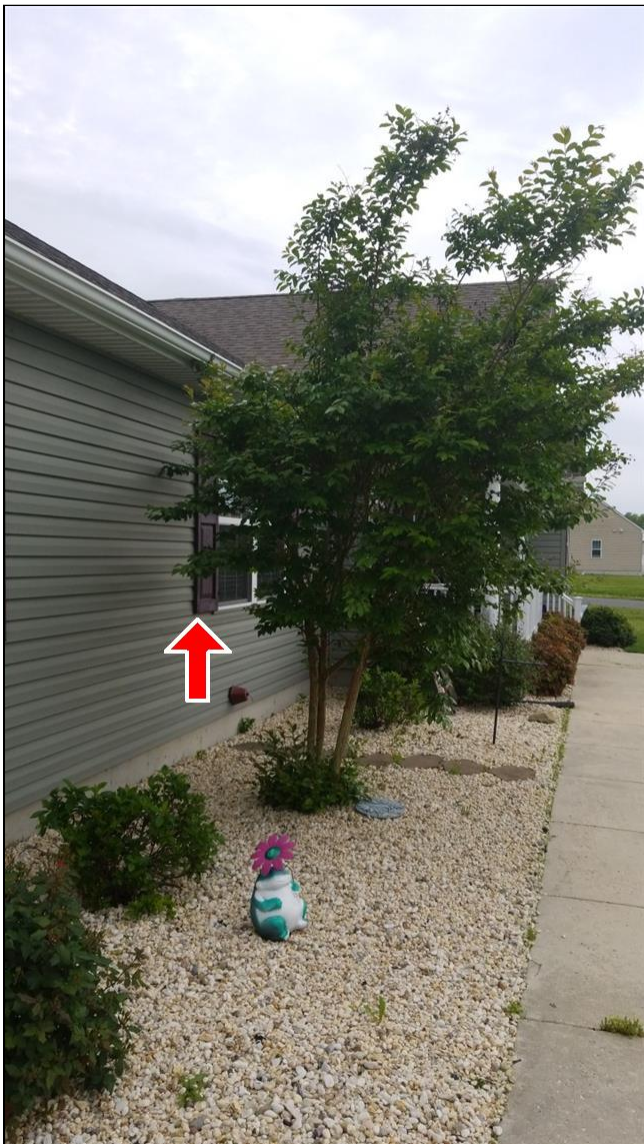
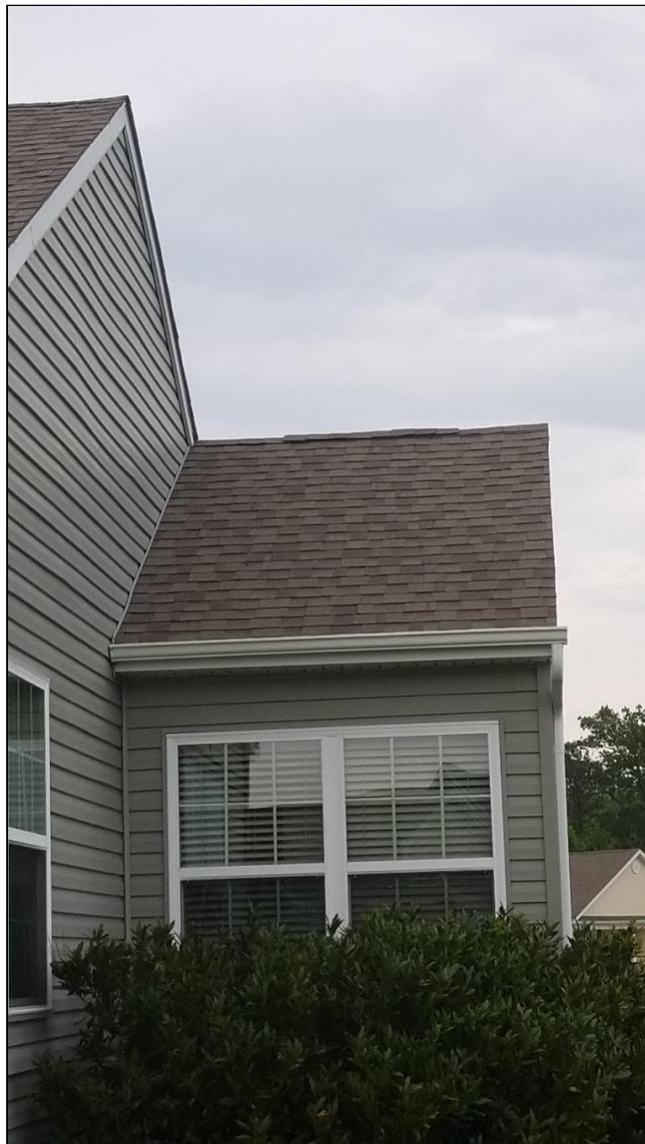
3.7 Consider trimming trees and shrubs to avoid contact with siding and/or roofing to prevent damage.

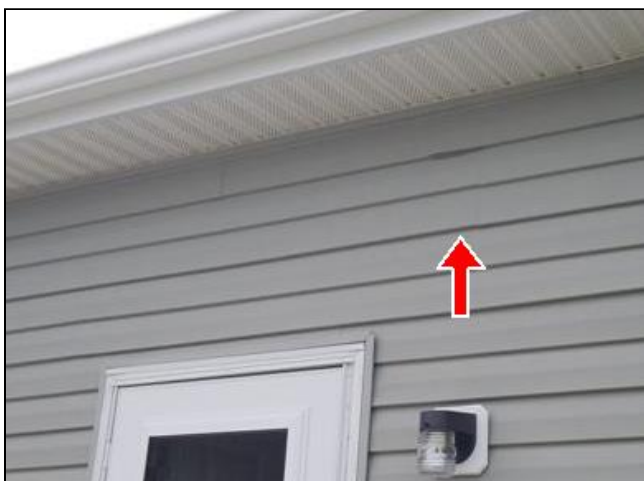
4.4 Item 1(Picture)

4.4 The vinyl siding covering exterior walls had areas of cracked or broken siding that should be replaced to prevent potential damage from moisture intrusion to the home materials, the roof structure and to prevent development of microbial growth such as mold. All work should be performed by a qualified contractor.

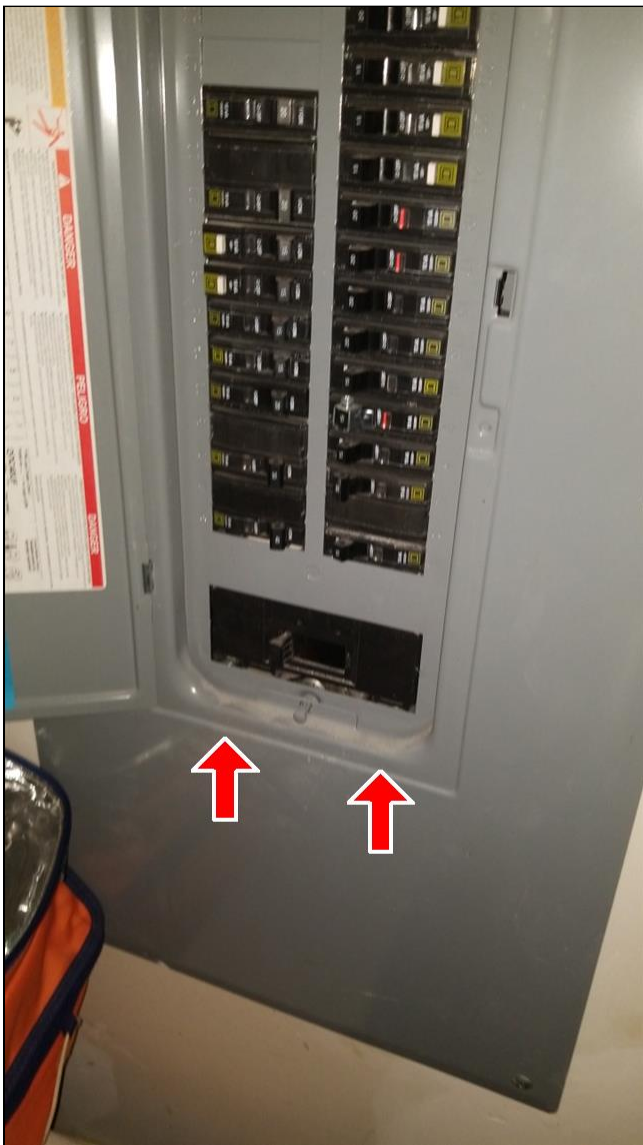
6.7 Item 1(Picture)

6.7 The inspector was unable to remove the dead front cover and electrical components inside the service panel were not inspected. The Inspector recommends that before the expiration of your Inspection Objection Deadline you have this condition corrected and the service panel contents inspected by a qualified electrical contractor.

Space between main disconnect and dead front cover which is a safety issue. Recommend a licensed electrician make necessary repairs.

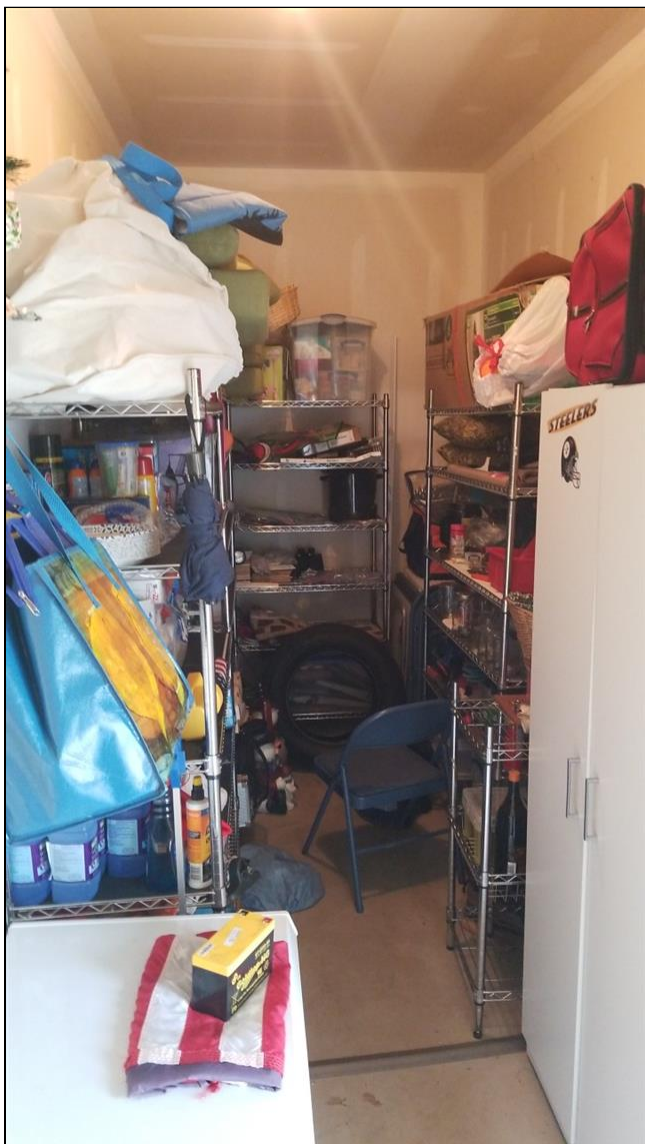
6.8 Item 1(Picture)

6.8 Unable to removed dead front cover due to limited access.

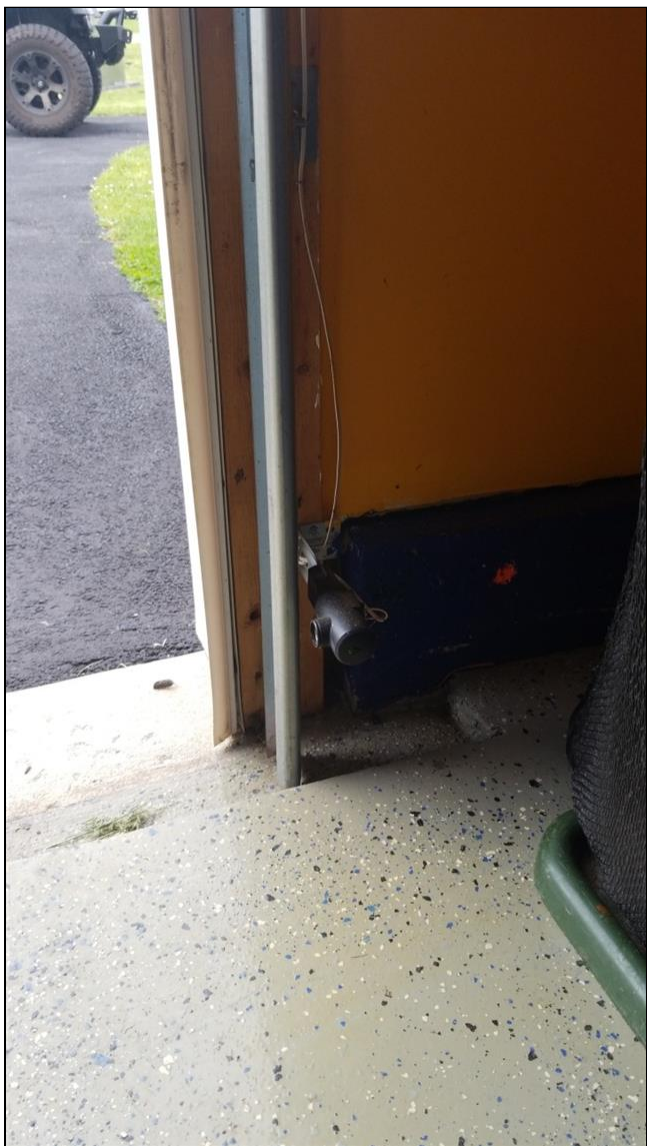
7.0 Item 1(Picture)

7.0 (1) An overhead garage door photo sensor was installed at a height greater than 6 inches above the floor. Photoelectric sensors are devices installed to prevent injury by raising the vehicle door if the sensor detects a person in a position in which they may be injured by the descending door. Installation of photo sensors in new homes has been required by generally-accepted safety standards since 1993. Safety standards designed to protect small children limit the maximum mounting height for garage door photo sensors to 6 inches. The Inspector recommends correction by a qualified garage door contractor.

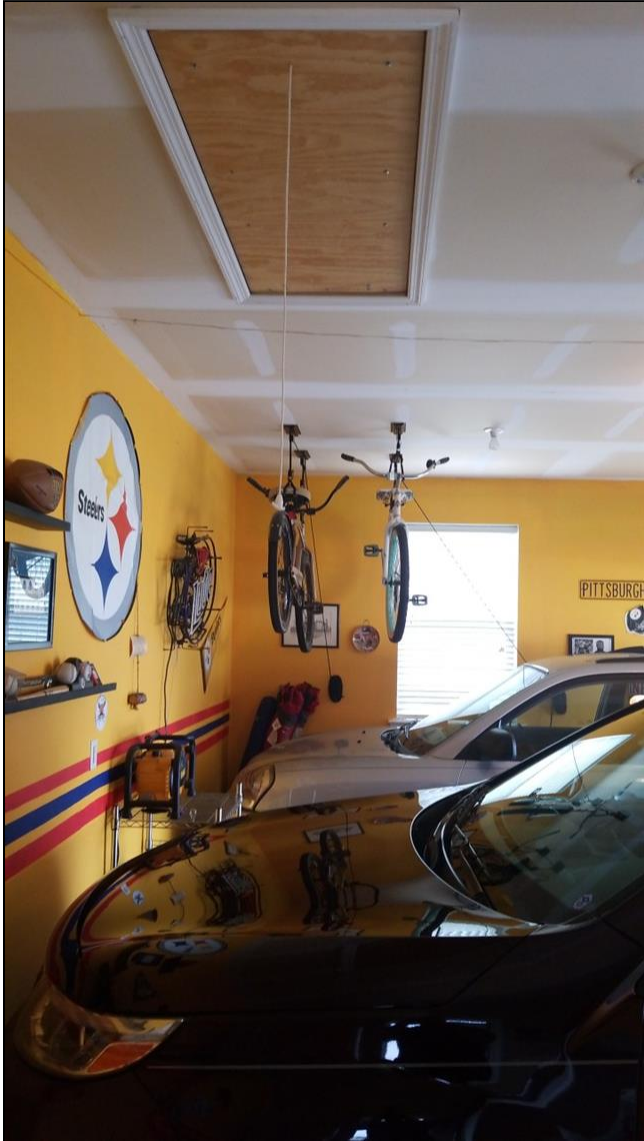
7.9 Item 1(Picture)

7.9 No access hatch was provided through which to view garage roof framing. The roof framing was not inspected and the Inspector disclaims any responsibility for confirming its condition. The Inspector

recommends having the attic area inspected by a qualified inspector after access has been provided, to help ensure that safe conditions exist.

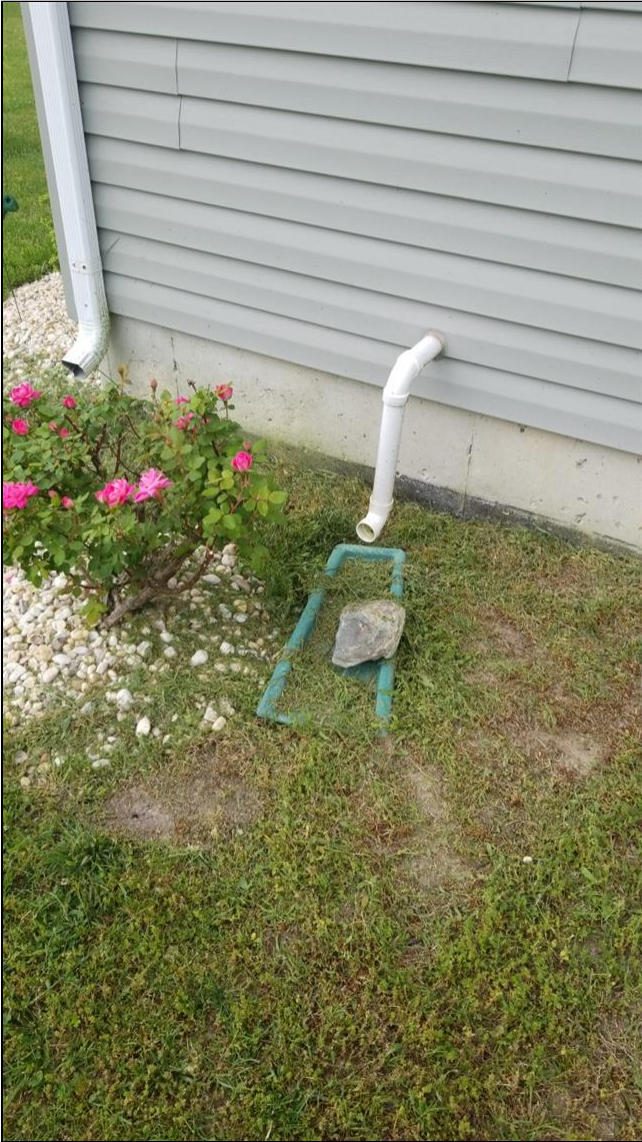
9.5 Item 1(Picture)

9.5 (1) Recommend sump-pump discharge be extended to remove water from foundation.

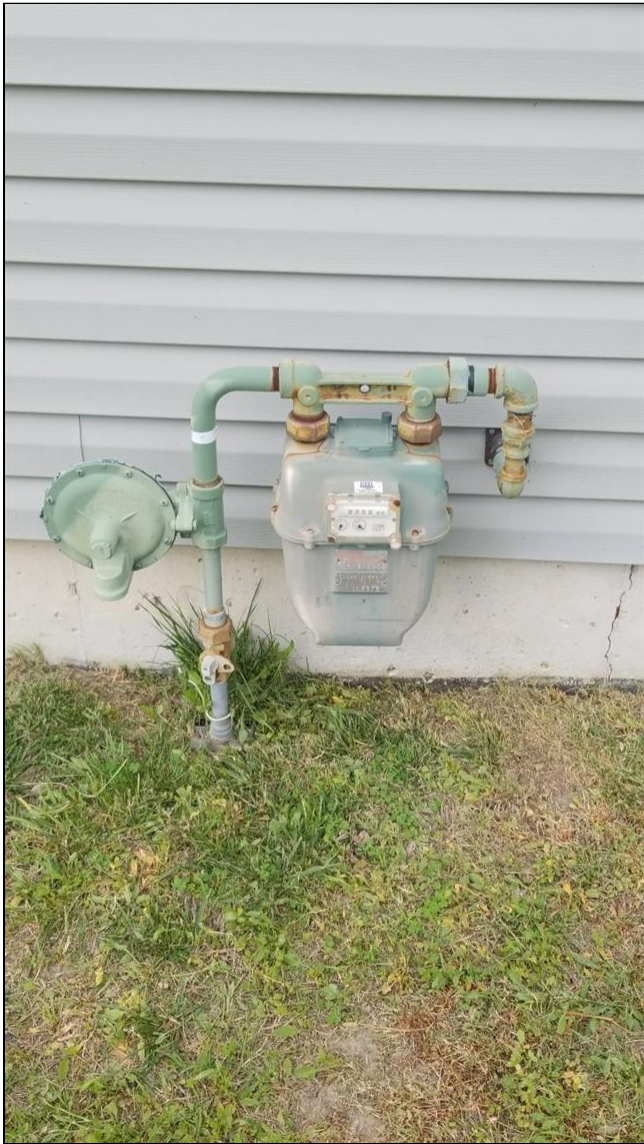
10.2 Item 1(Picture)

10.2 Consider painting gas meter and piping to reduce corrosion which can lead to leaks.

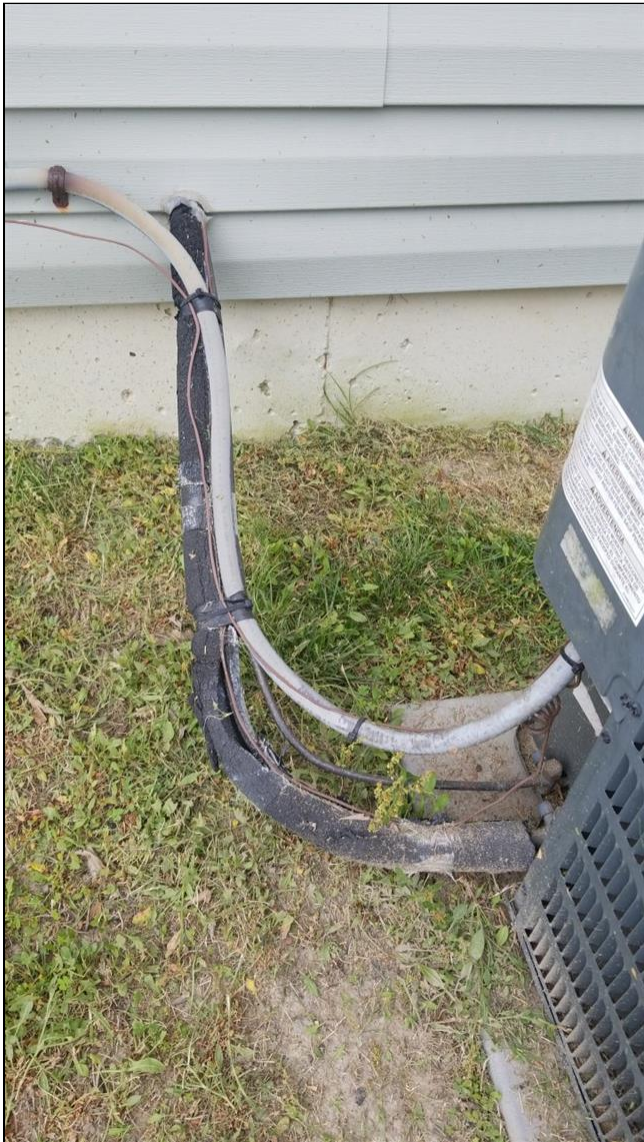
11.0 Item 3(Picture)

(2) Phone condensate line should be replaced.

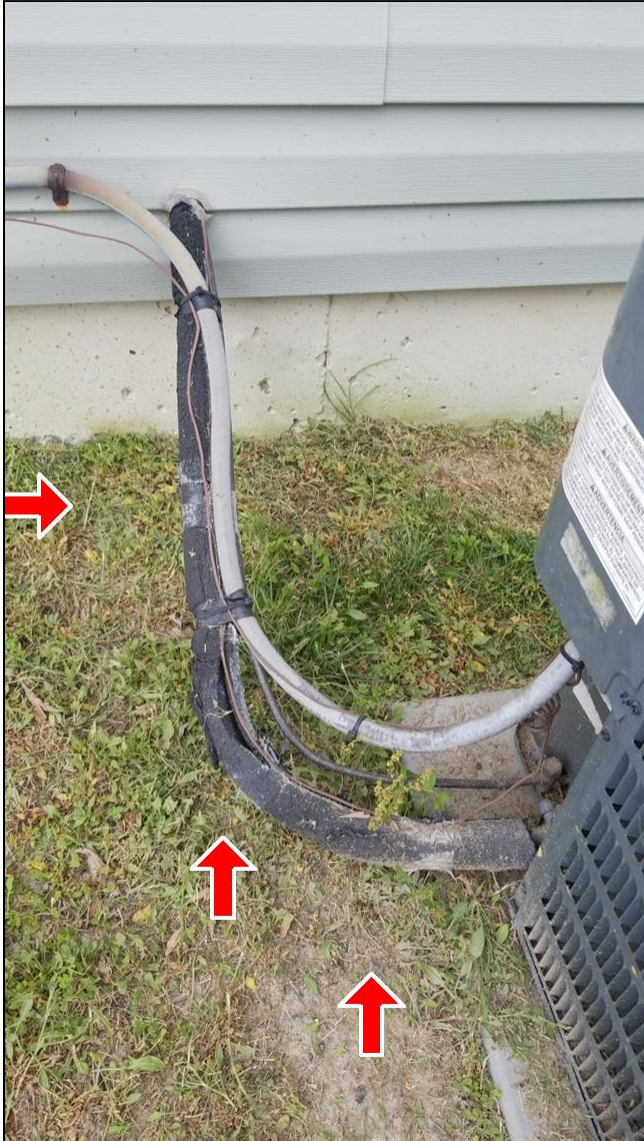
11.0 Item 4(Picture)

(3) Insulation on the air-conditioning suction (large, insulated) line was damaged or missing at areas and should be replaced by a qualified HVAC contractor.

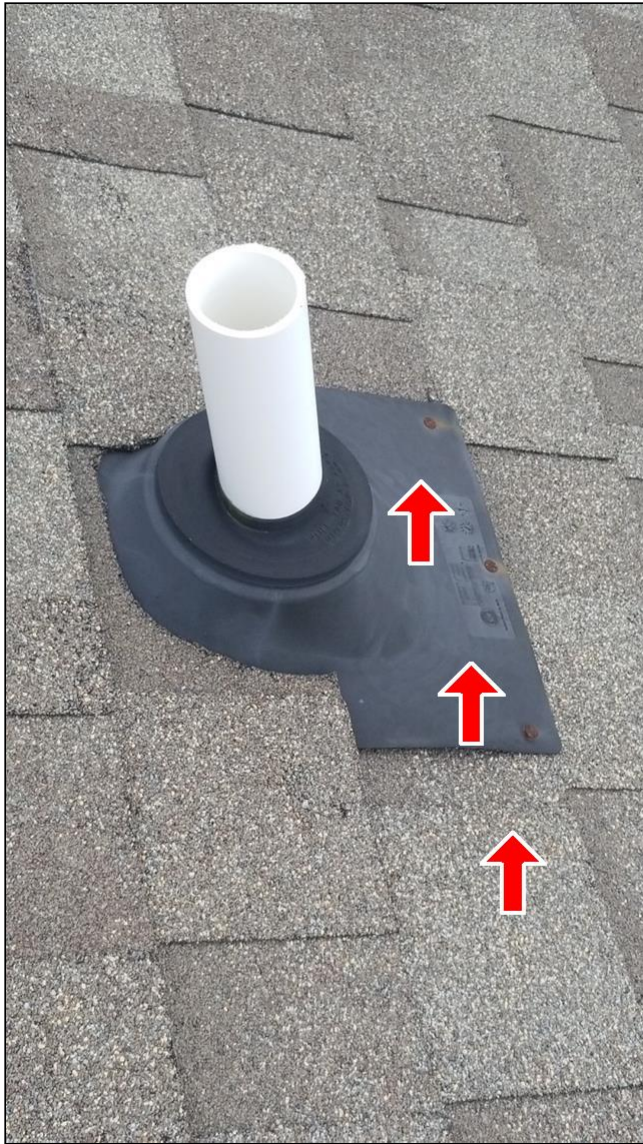
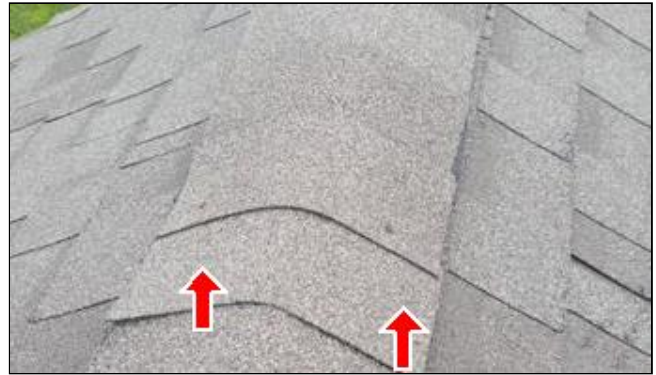
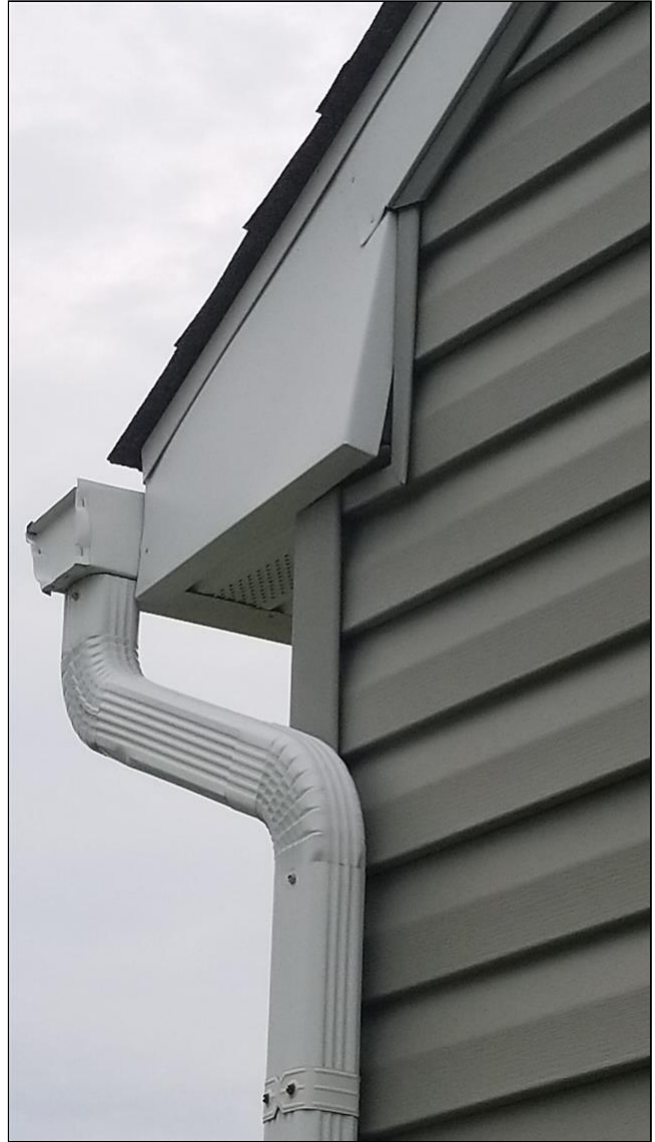
(1) Nail heads not properly covered in ridge vent and flashing resulting in corrosion. Recommend having a roofing contractor properly seal these to prevent future damage.

(2) Nails coming loose on trim panel

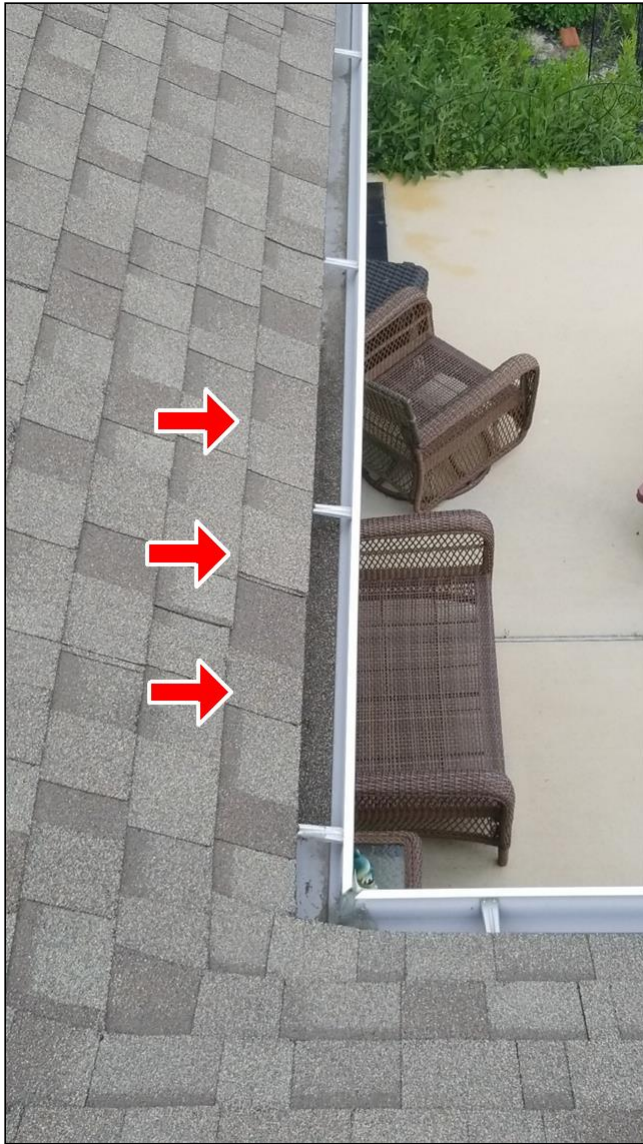
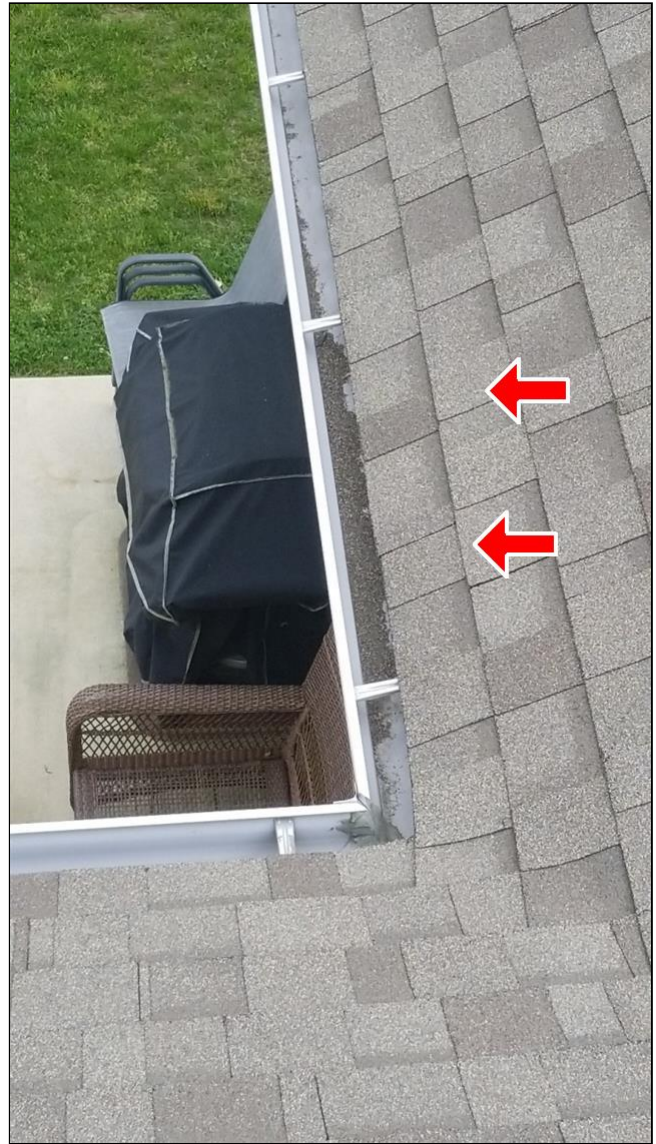
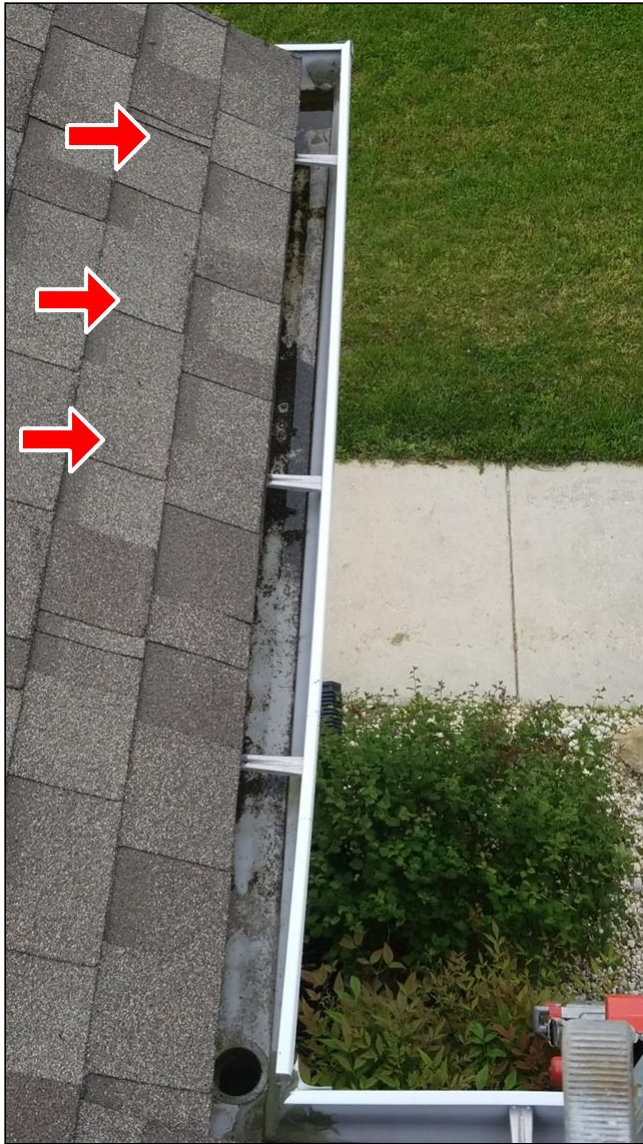
(1) Granules from the asphalt shingles were accumulated in the gutters. This condition is common as loose granules that are not embedded in the asphalt covering shingles are washed loose by runoff from rain. This is not a defective condition, but is common and expected, however the granules trap sediment, which hardens and prevents fully functional drainage of the gutters. This condition may hasten corrosion. The Inspector recommends thorough cleaning of the gutters.
