Inspection Report

30047 West Barrier Reef Blvd
Lewes DE 19958

Tip Top Property Inspections, LLC

Date: 5/11/2019	Time: 03:30 PM	Report ID: 20190511-30047-West-Barrier-Reef-Blvd
Property: 30047 West Barrier Reef Blvd Lewes DE 19958	Customer: Mr. Robert Kuehnl	Real Estate Professional: Mike Kuehnl TEST Brokers

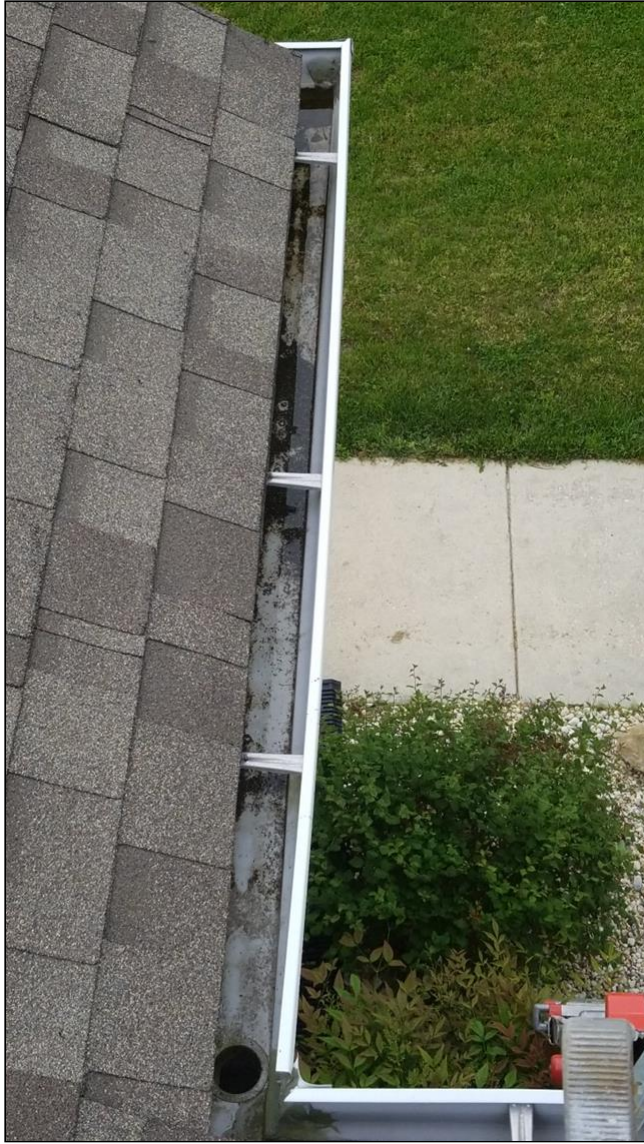
1.3 Item 4(Picture)

(2) Water laying in gutters not draining properly

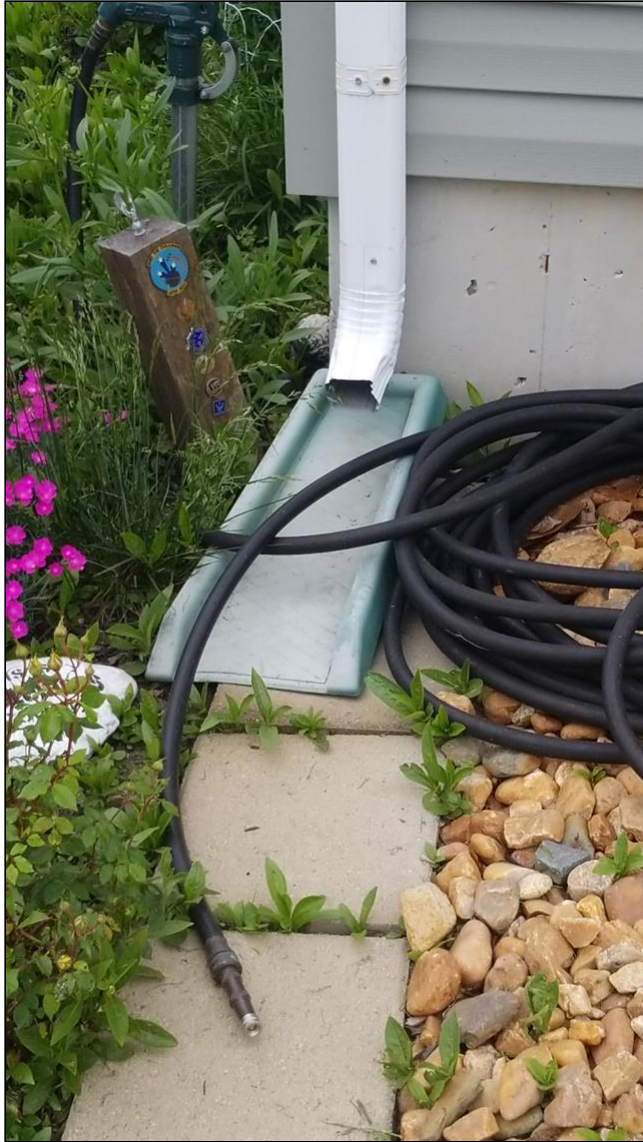
1.3 Item 5(Picture)

(3) Considering Splash blocks on downspouts to get water away from Foundation

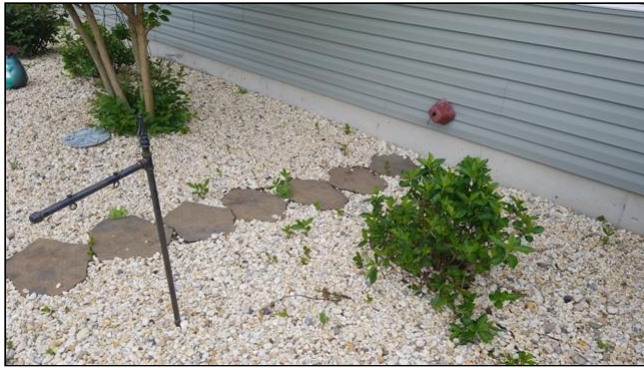
3.3 Item 1(Picture)

Neutral the negative grade in front of house near garage. The home had areas of neutral or negative drainage that will route runoff from precipitation toward the foundation. Excessively high moisture levels in soil supporting the foundation can effect its ability to support the weight of the structure above. The ground should slope away from the home a minimum of $\frac{1}{4}$ -inch per foot for a distance of at least six feet from the foundation. The Inspector recommends that these area be re-grading to improve drainage near the foundation.

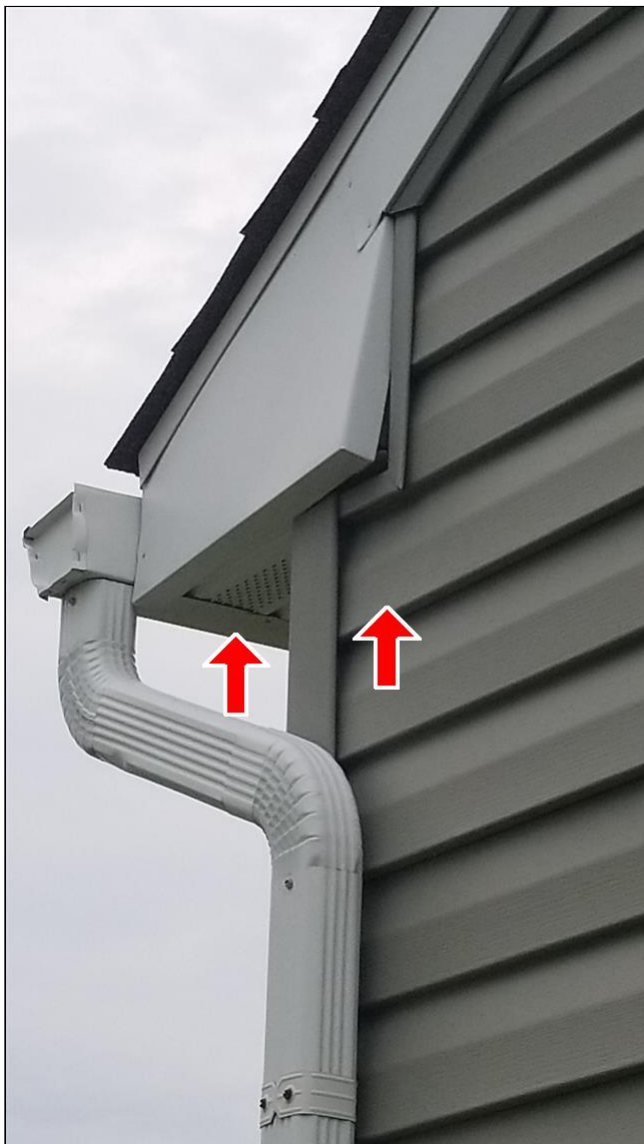
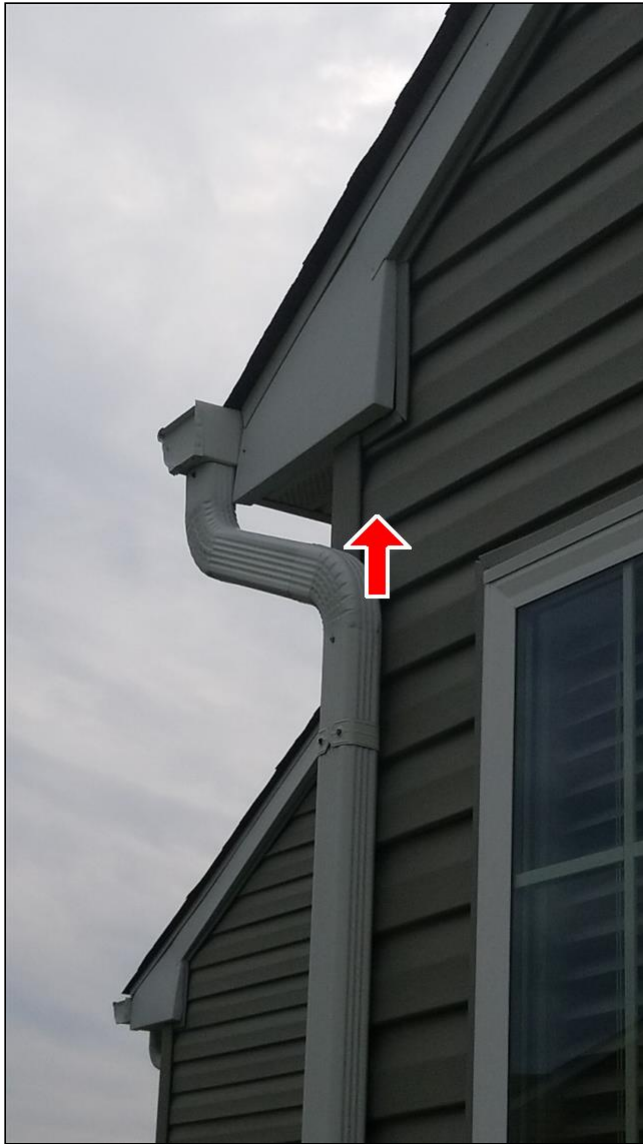
The fascia trim loose at the time of the inspection should be re-fastened by a qualified contractor.

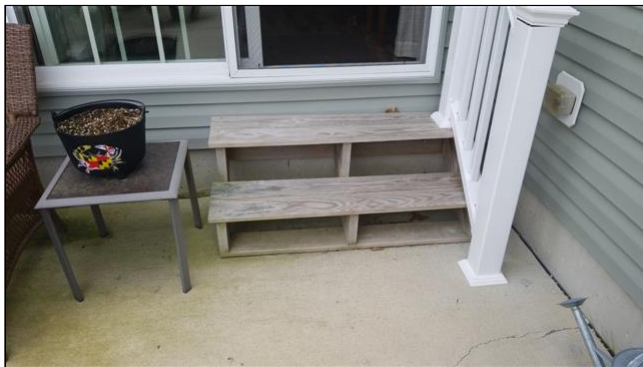
3.6 Item 1(Picture)

A risers are too high for exterior stairs leading into the sunroom. Risers shouldn't be more than 7 ¾ inches high. Correction and further evaluation is recommended.

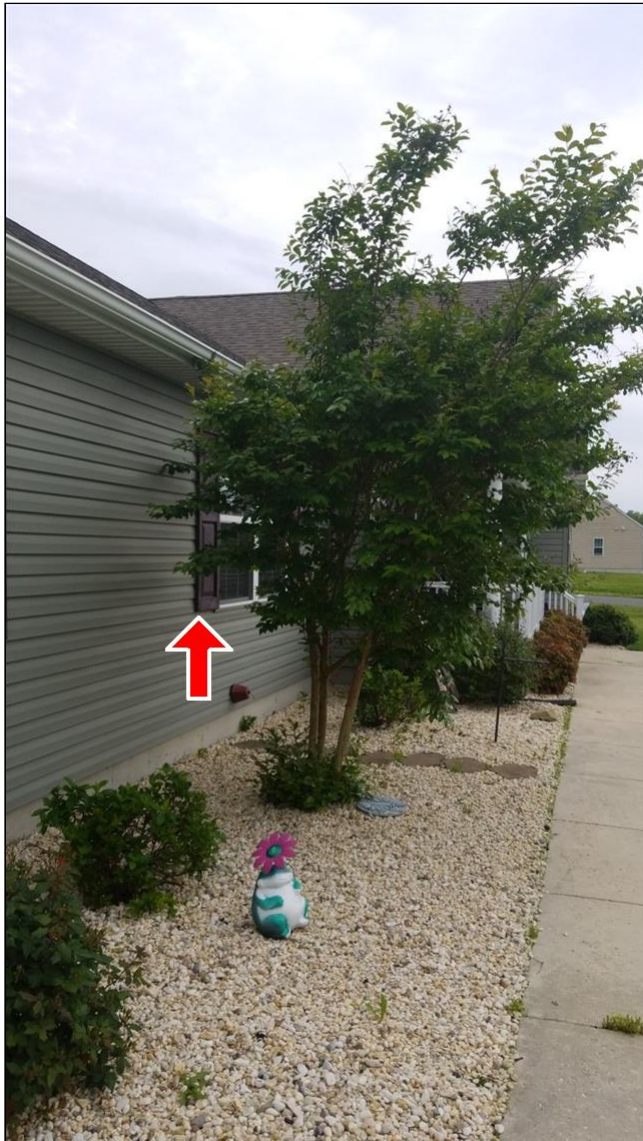
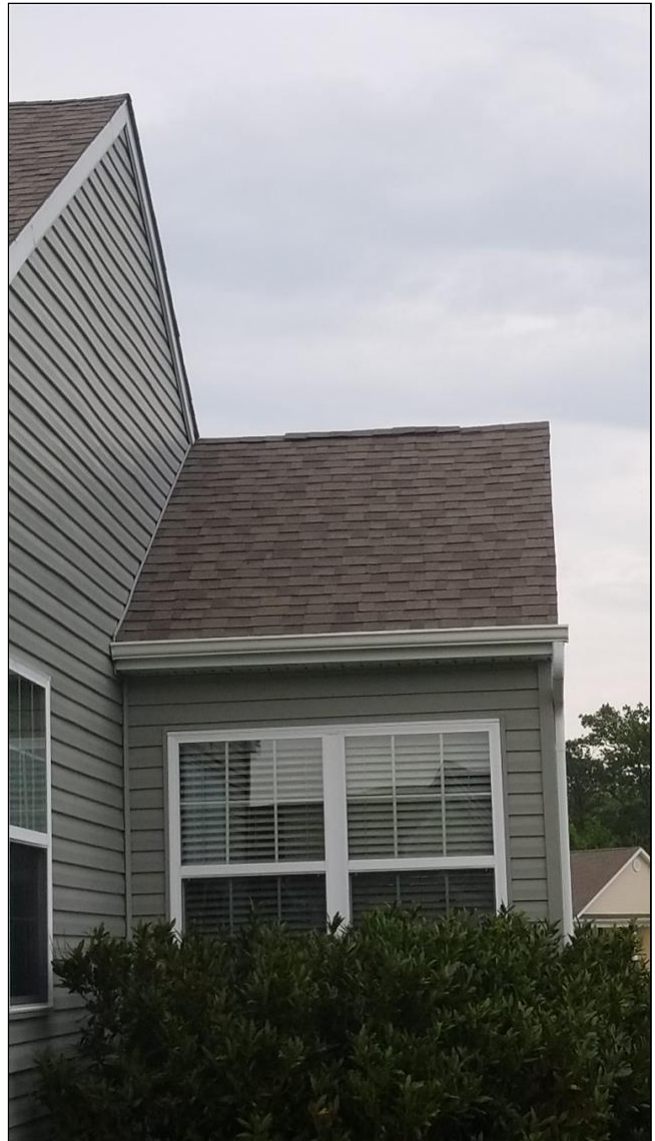
Consider trimming trees and shrubs to avoid contact with siding and/or roofing to prevent damage.

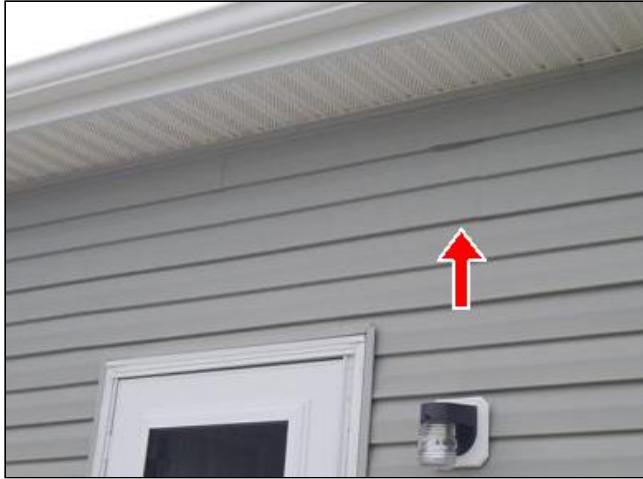
4.4 Item 1(Picture)

The vinyl siding covering exterior walls had areas of cracked or broken siding that should be replaced to prevent potential damage from moisture intrusion to the home materials, the roof structure and to prevent development of microbial growth such as mold. All work should be performed by a qualified contractor.

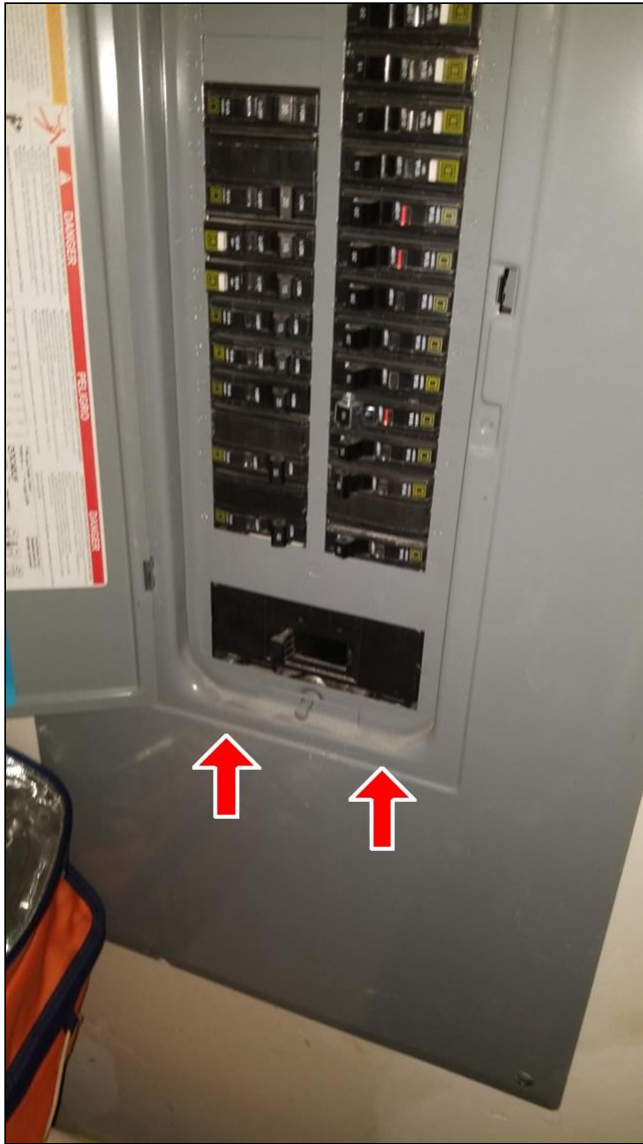
6.7 Item 1(Picture)

The inspector was unable to remove the dead front cover and electrical components inside the service panel were not inspected. The Inspector recommends that before the expiration of your Inspection Objection Deadline you have this condition corrected and the service panel contents inspected by a qualified electrical contractor.

Space between main disconnect and dead front cover which is a safety issue. Recommend a licensed electrician make necessary repairs.

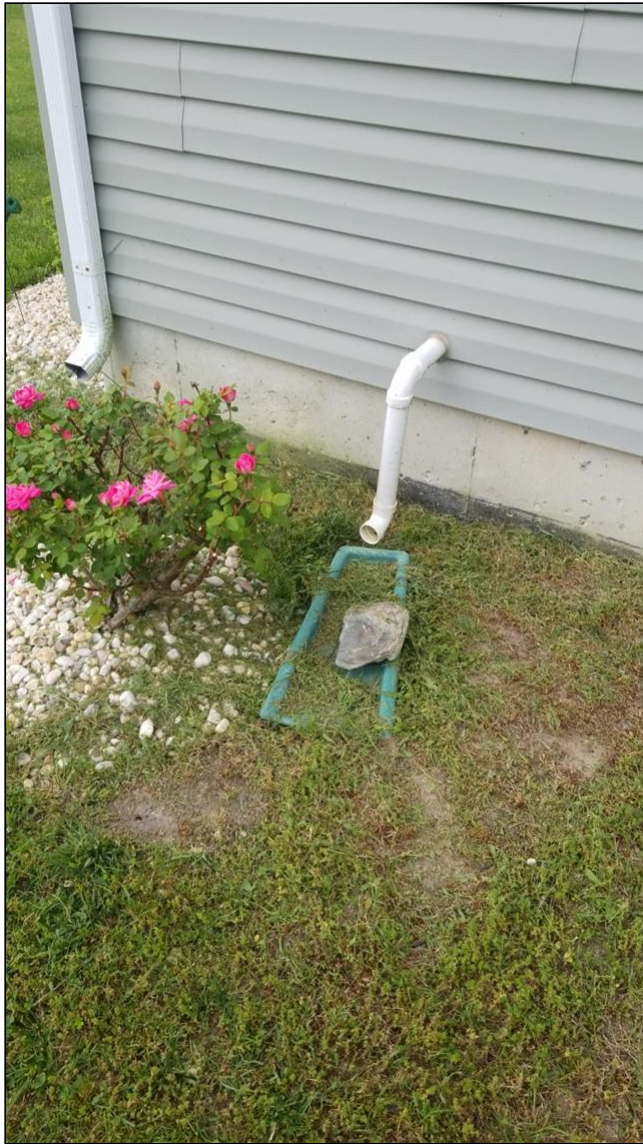
9.5 Item 1(Picture)

(1) Recommend sump-pump discharge be extended to remove water from foundation.

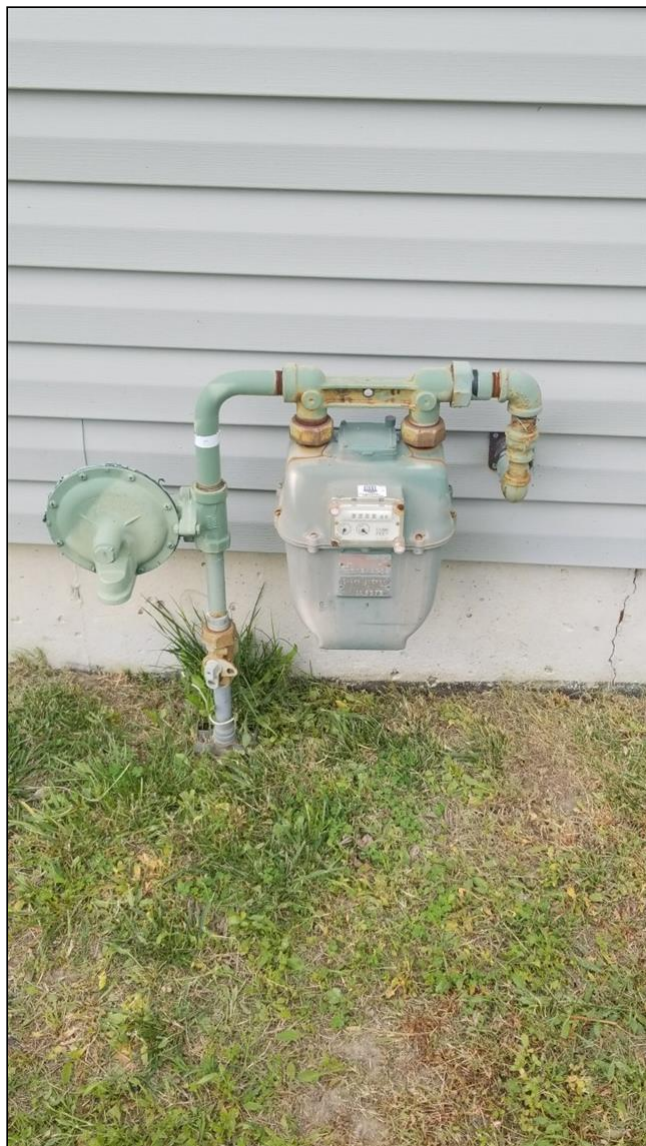
10.2 Item 1(Picture)

Consider painting gas meter and piping to reduce corrosion which can lead to leaks.

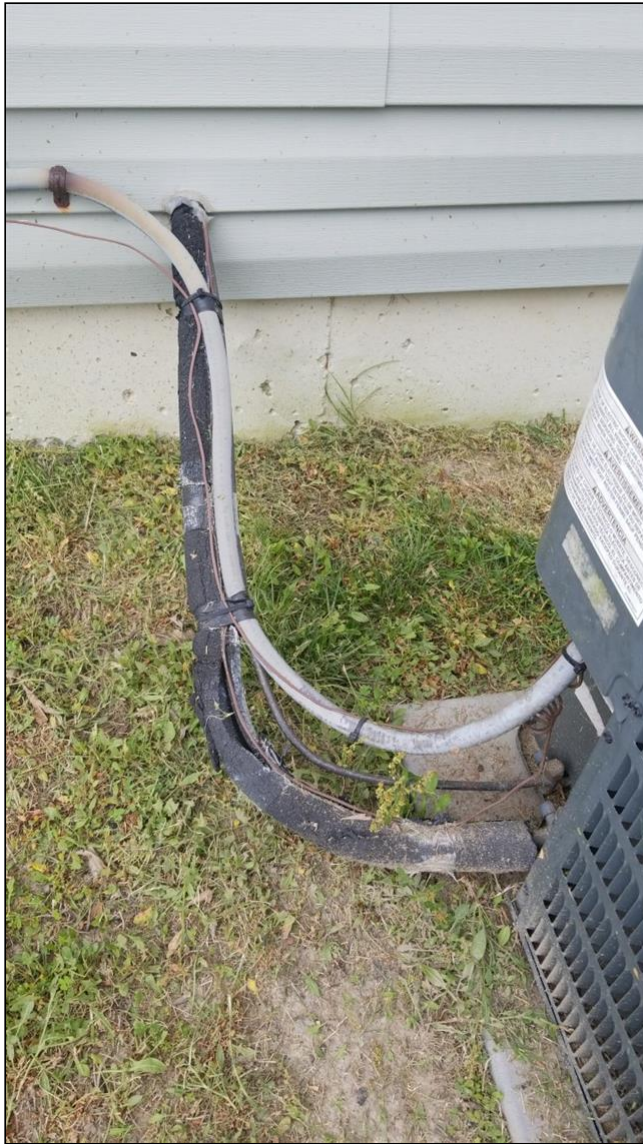
11.0 Item 3(Picture)

(2) Phone condensate line should be replaced.

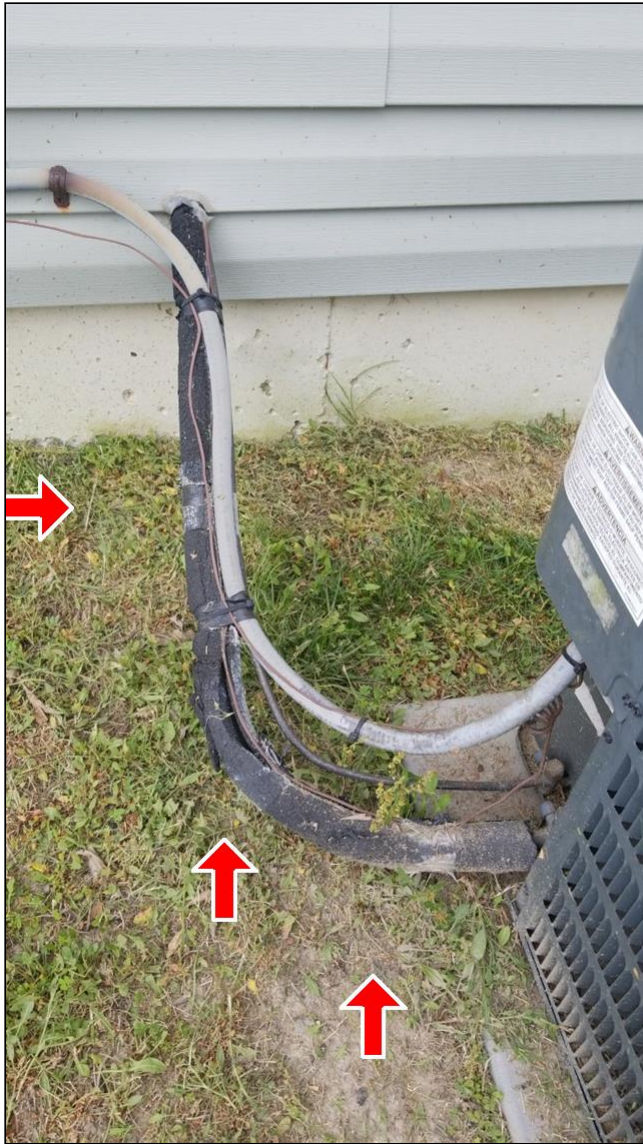
11.0 Item 4(Picture)

(3) Insulation on the air-conditioning suction (large, insulated) line was damaged or missing at areas and should be replaced by a qualified HVAC contractor.
