BELLANCA AIRCRAFT CORP.

SERVICE LETTER NO. 39 MARCH 8, 1967

SUBJECT: PILOT RUDDER PEDAL REPLACEMENT

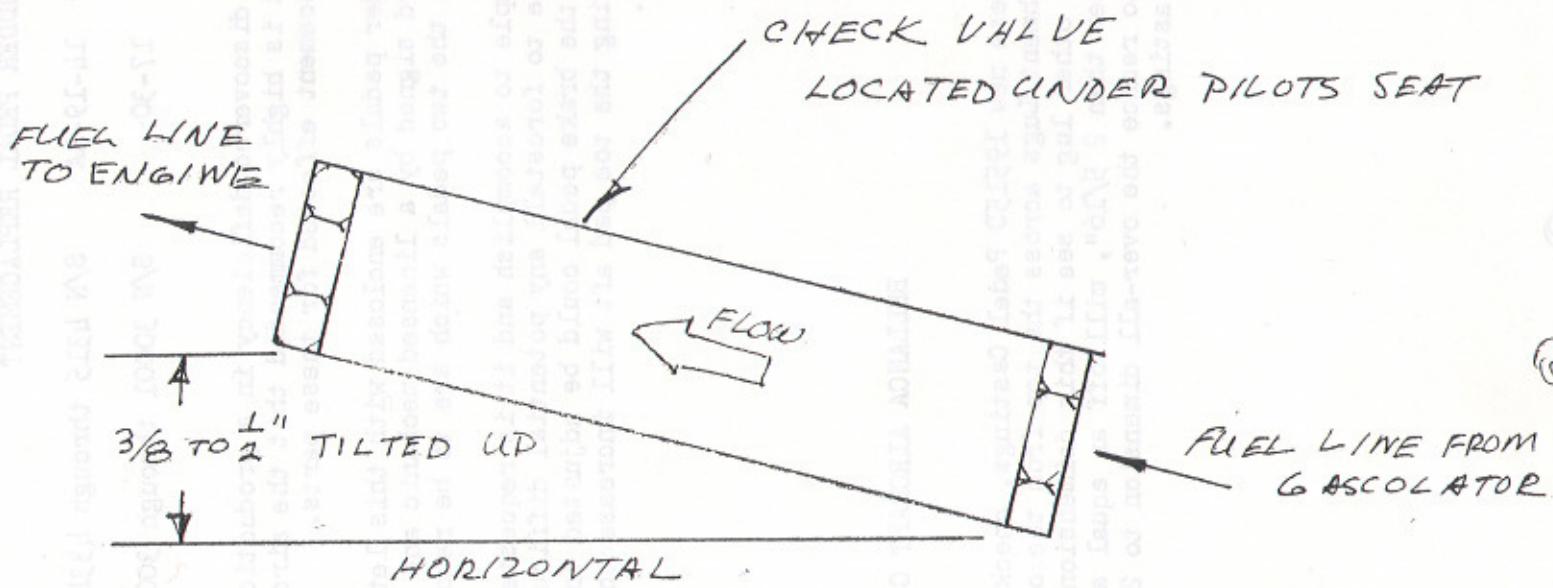
MODEL VIKING 300
S/N's APPROX 30001 THRU 30010

IN SOME OF THE VIKING 300 MODELS THIS CHECK VALVE
MAY NOT BE SLANTED ENOUGH. WHILE THE FUEL SYSTEM WILL
FUNCTION NORMALLY EVEN WITH THE VALVE HORIZONTAL, IT BECOMES
MUCH MORE SENSITIVE TO SMALL AMOUNTS OF DIRT WHICH MAY BE
PRESENT IN THE FUEL. CHECK YOUR AIRCRAFT FOR THIS CONDITION.

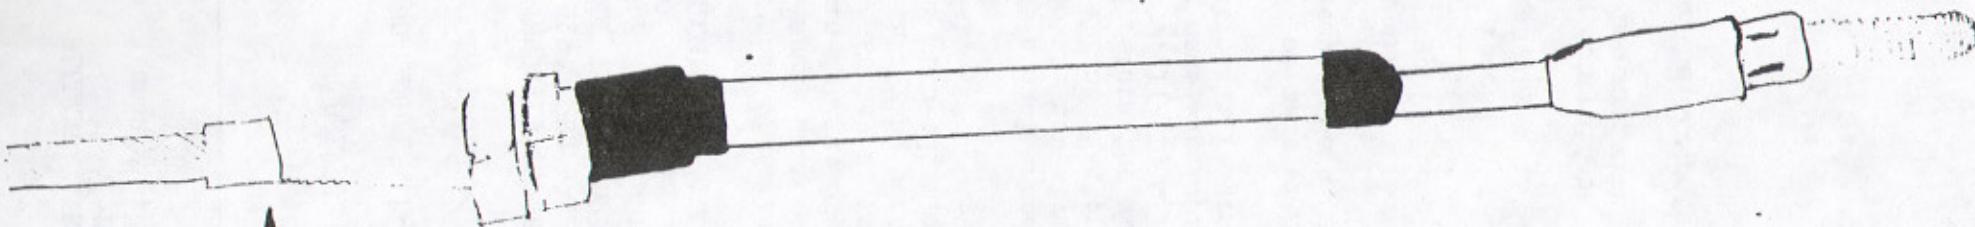
191474-0 ACCO Throttle Control
This control does not need to be changed.

Many of these aircraft were originally equipped with the ACCO Throttle Control, or have had it installed in the field. Please make sure your aircraft is equipped with an Arens Control before ordering. We cannot give credit for any ACCO Controls replaced in error.

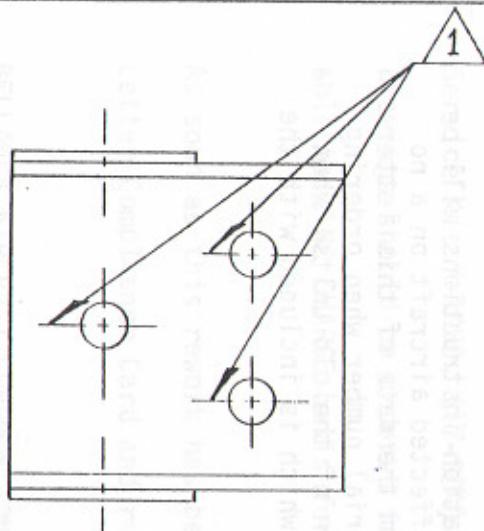
1 AREA TO BE INSPECTED FOR CRACKING.

2: VISUAL INSPECTION WITH A 10 POWER MAGNIFYING GLASS.

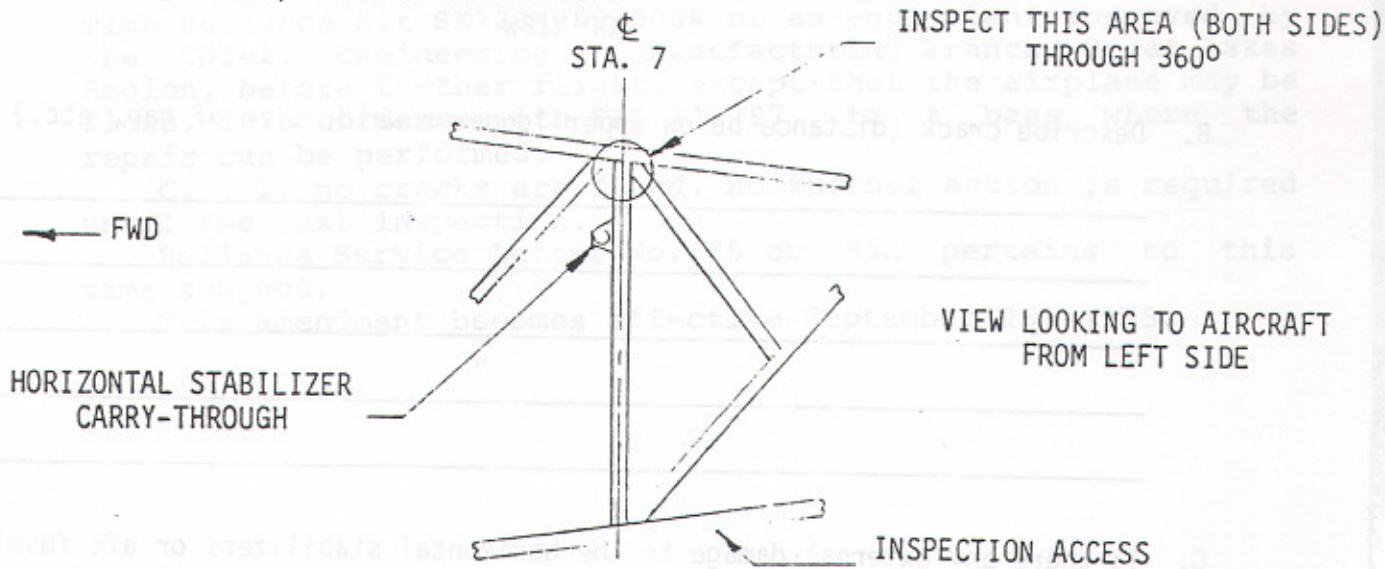
There have been a few instances where the subject vertical tube within the fuselage, which connects the horizontal stabilizer carry-through to the upper fuselage longeron, has shown signs of cracking. The cracks have appeared just below the weld on either the right, left or both sides. The following sketch identifies the potential crack area.

If your aircraft has 300 hours or more total service time, please inspect this area within the next 25 hours on your aircraft to insure that it is in a safe condition and report your findings to the Bellanca Service Department by phone or on the attached return form. Use a dye penetrant to inspect the entire area including the longerons and other adjacent truss members.

If cracks are found, repair the crack per the Bellanca Service Kit SK1234789-0004 before the aircraft is returned to service. A special flight permit pursuant to FAR 21.197 is required to allow ferrying of the aircraft to a facility where the required maintenance can be performed. If no cracks are found, return Compliance Card to Bellanca Aircraft Corporation and re-inspect the aircraft each 100 hours until Kit SK1234789-0004 is installed.

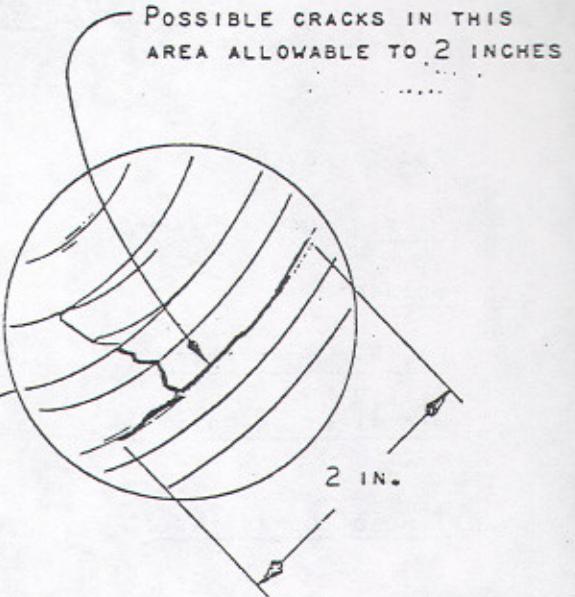
ENLARGED VIEW OF CRACKED AREA

DO NOT MISINTERPRET THE PARTING LINE OF THE CASTING IN THIS AREA TO BE A CRACK.

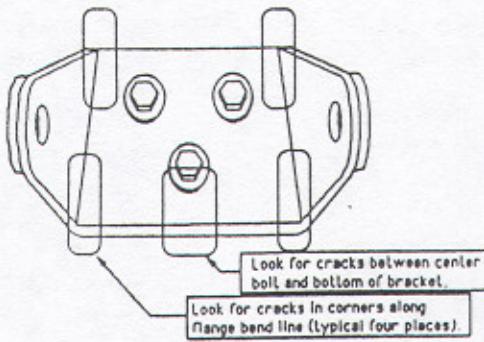
Figure 1: Critical Inspection Areas
(View Looking Up and Aft)

Determine if the brackets are bent by placing a 1 1/4 inch straight edge along the lower edge of the bracket; if there is more than a 1/16 inch gap between the straight edge and the bracket surface, it is considered bent. Visually verify that the bracket flanges are 90 +/- 3 degrees to the aft face. If a bracket is bent, replace it with new parts (PN 194650-0 right side, PN 194383-0 left side) using the alignment procedure described in Section 5: Installation New Brackets.

Place the aircraft on jacks with wheels off the ground. The NLG Drag Strut Brackets are located on the forward side of the firewall and attach the nose landing gear drag strut to the fuselage primary structure at Fuselage Station 1. Remove the bolts attaching the drag struts to the brackets. Thoroughly clean the brackets in-place. Visually inspect the brackets for cracks with a ten power magnifying glass concentrating in the areas shown in figure 1, ie: below the center bolt and along the flange radius. If cracks are found, replace the brackets with new parts (PN 194650-0 right side, PN 194383-0 left side) using the alignment procedure described in Section 5: Installation New Brackets.
