Airworthiness Directive

Amendment 39-779; AD 69-12-04

Airworthiness Directives; Bellanca Model 14-19-3A and **17-30** Airplanes
PDF Copy (If Available):

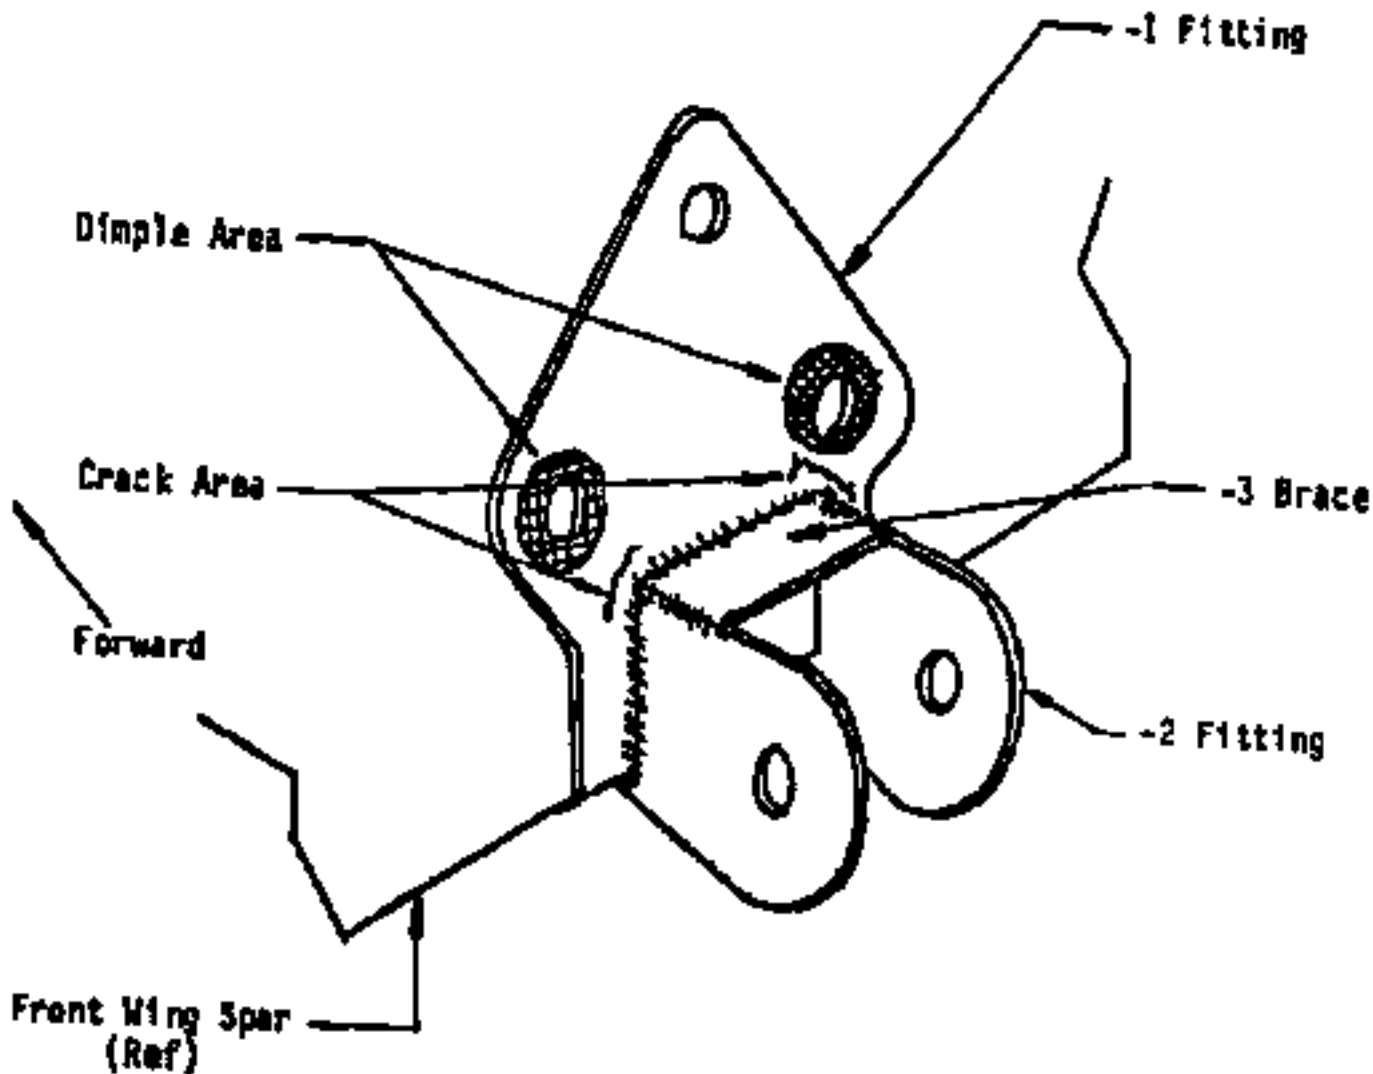
FIGURE 1

(3) Inspect for cracks adjacent to the welds which join the -1 fitting to the -2 fitting and -3 brace near the lower aft attachment bolt holes using liquid penetrant inspection techniques and a magnifying glass. If any crack is found, prior to further flight replace the assembly with a new fitting assembly, P/N 194153-30 or P/N 194153-40, as applicable.

**FRONT SPAR DRAG STRUT FITTING ASSEMBLY
BELLANCA P/N 194153-10**
