## Airworthiness Directive

Amendment 39-5454; AD **76-23-03** R1

Airworthiness Directives; Bellanca MN Models 17-30, 17-30A, 17-31, and 17-31A, Airplanes  
**PDF Copy (If Available):**

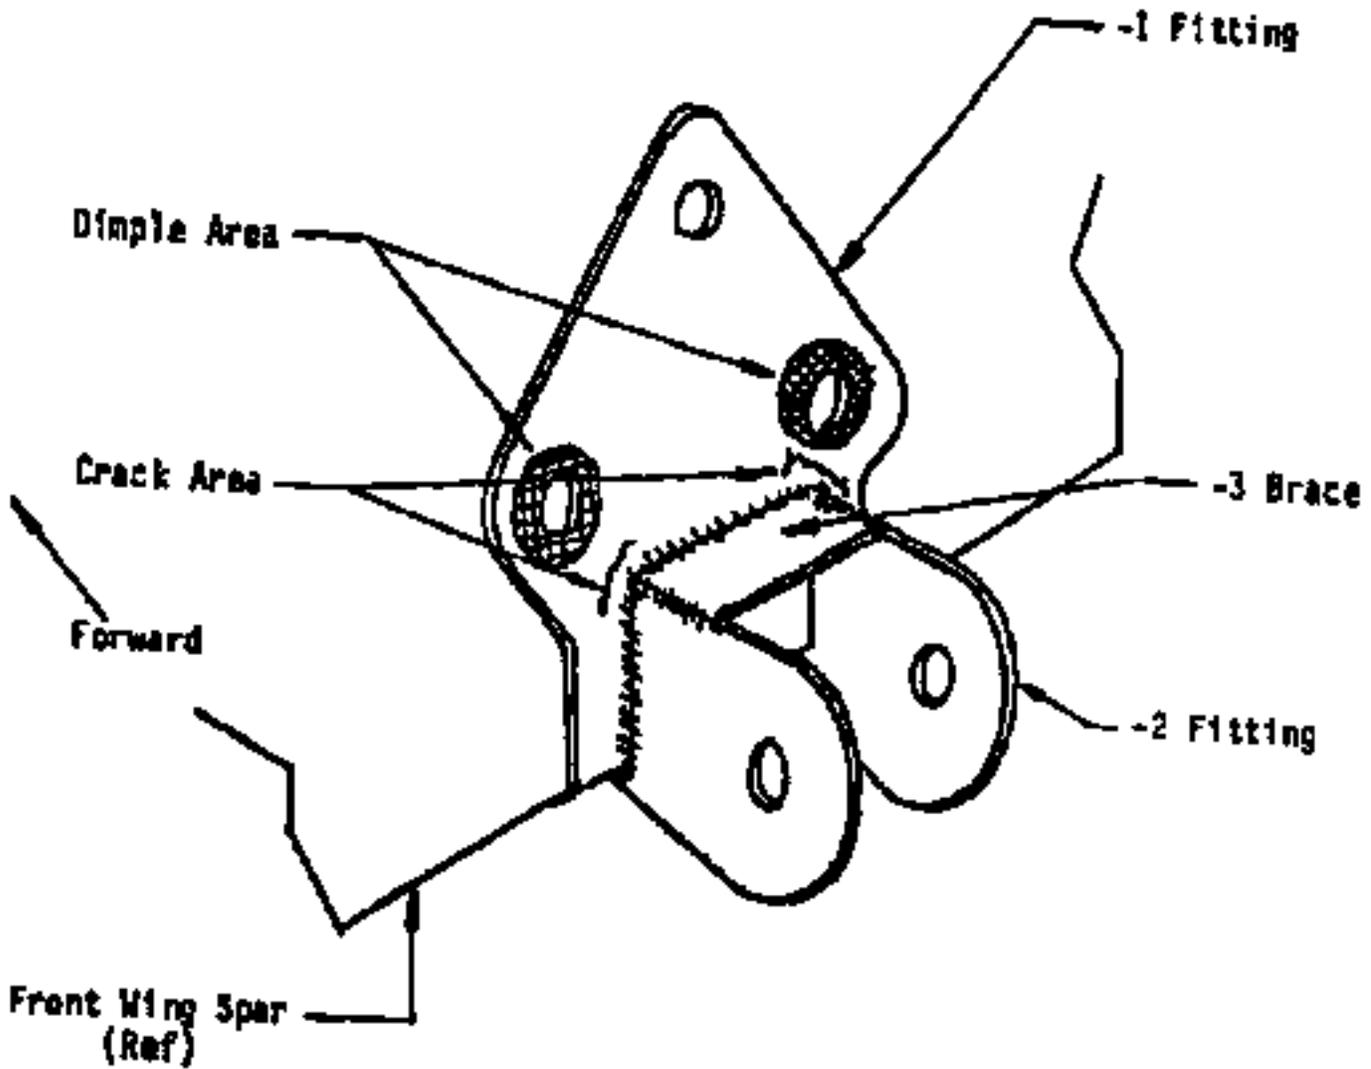
FIGURE 1

**FRONT SPAR DRAG STRUT FITTING ASSEMBLY  
BELLANCA P/N 194153-10**

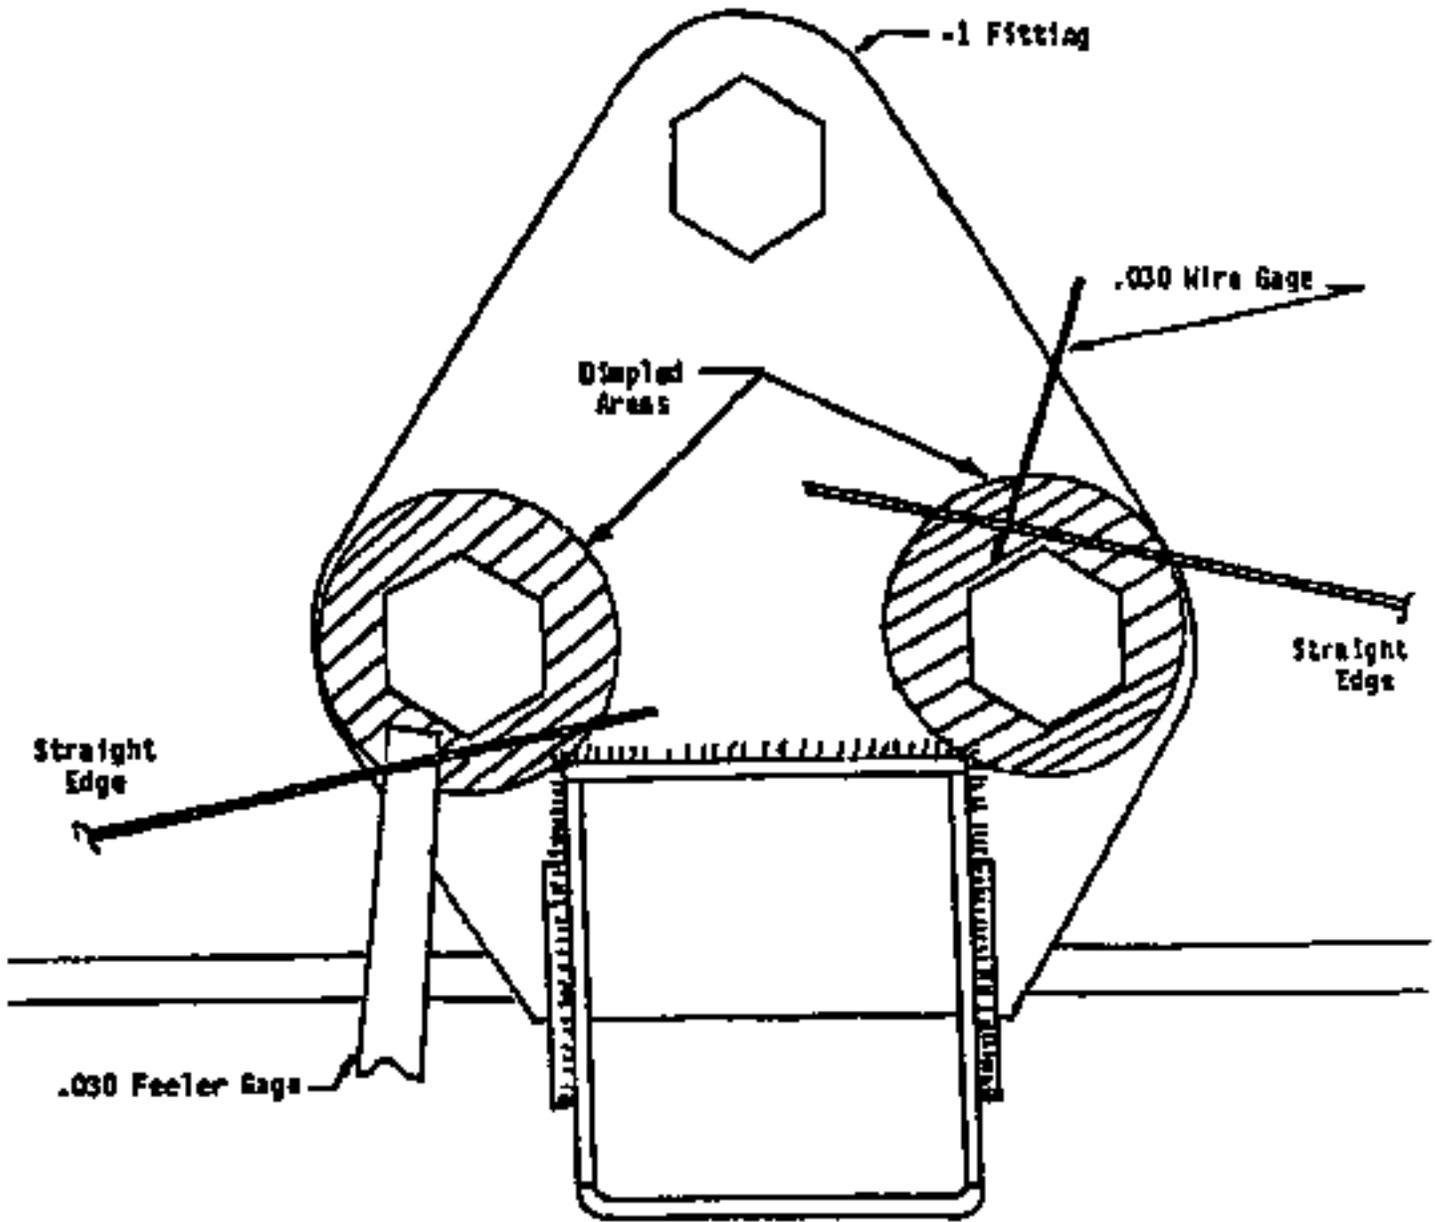
FIGURE 2

EXAMPLES OF MEASURING DEPTH OF DIMPLED AREAS

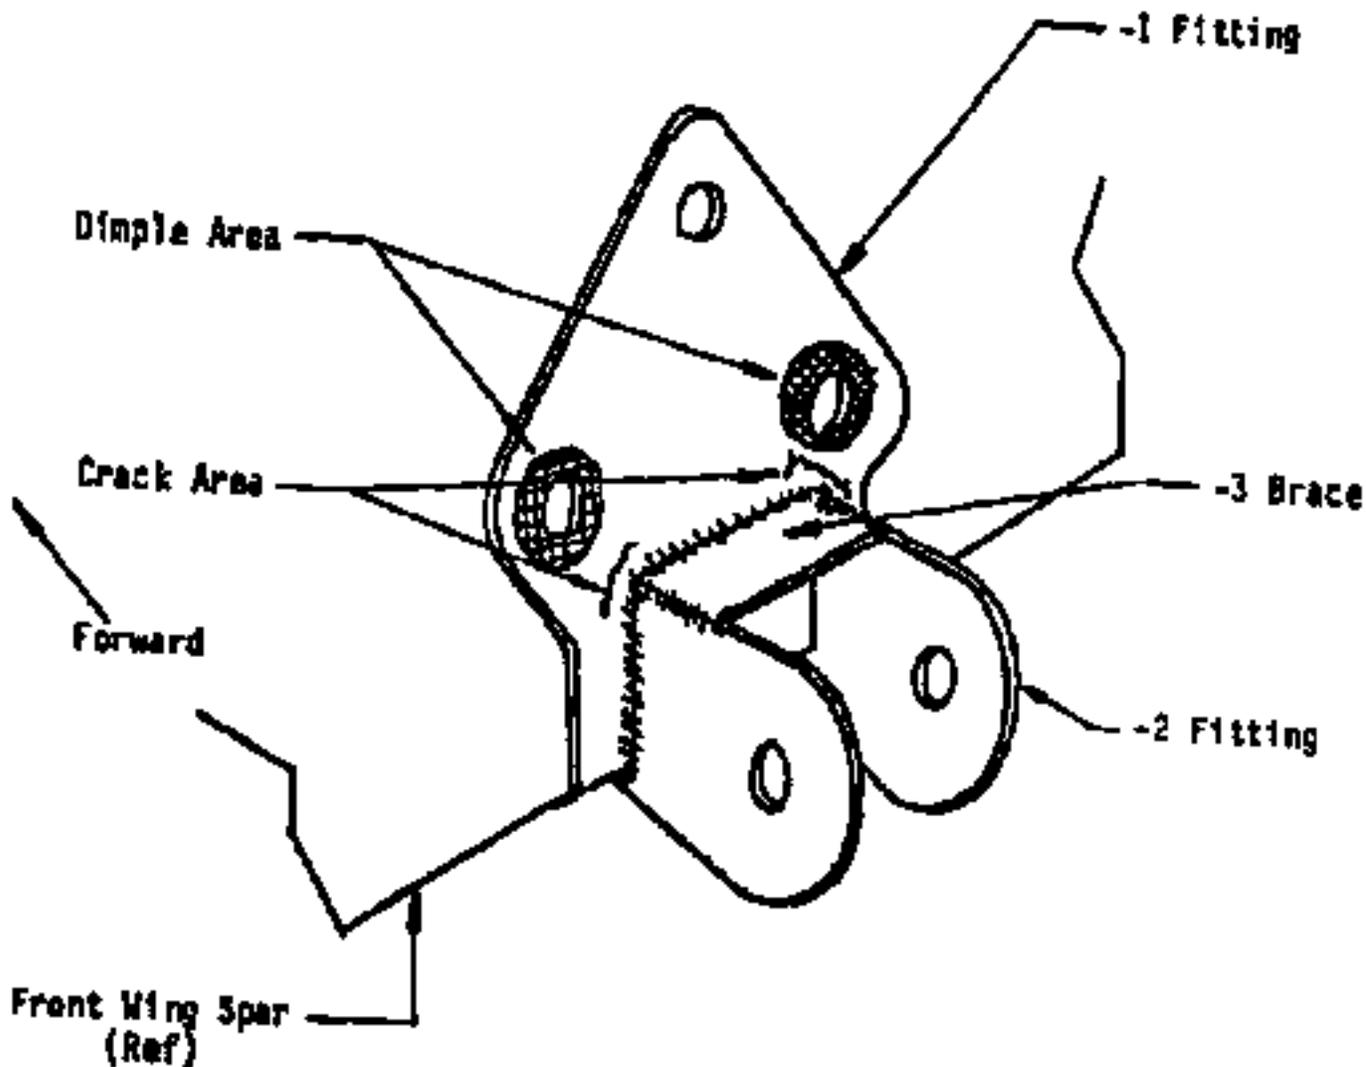
FIGURE 1

### FRONT SPAR DRAG STRUT FITTING ASSEMBLY BELLANCA P/N 194153-10

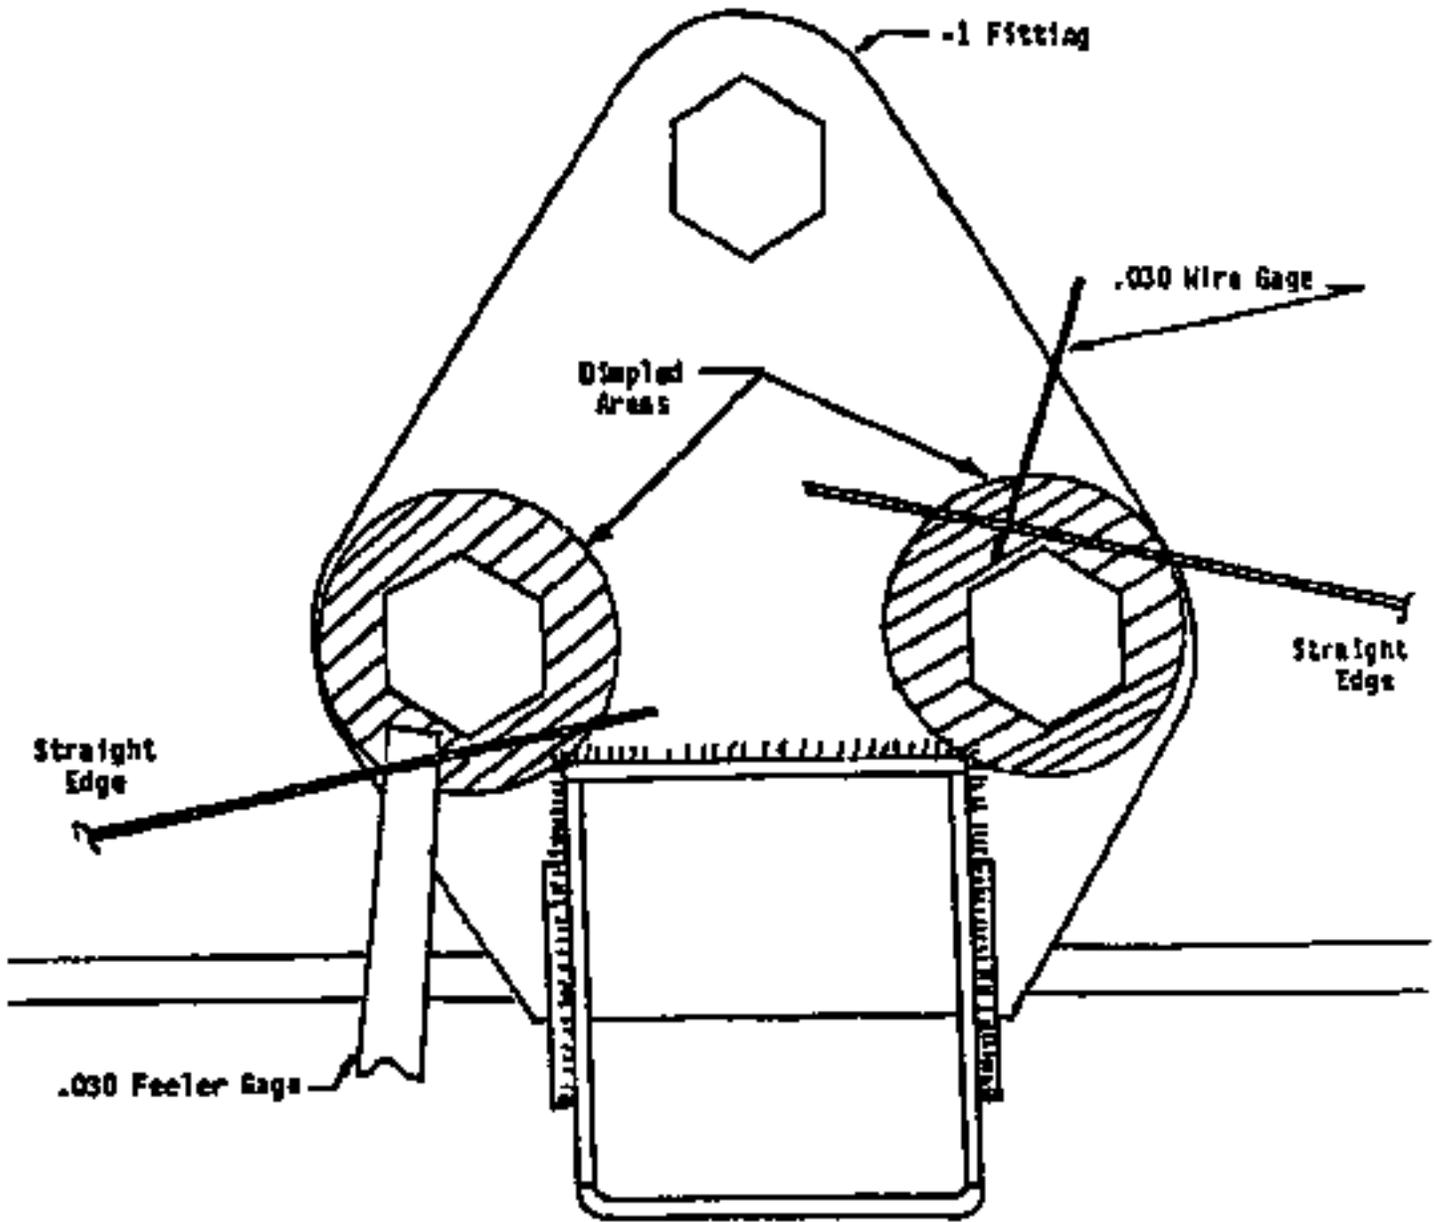
FIGURE 2

EXAMPLES OF MEASURING DEPTH OF DIMPLED AREAS
