NORTH AMERICAN - MODIFICATION OF LANDING GEAR WARNING AND INDICATING SYSTEM - P-51D, TP-51D AND F-6D

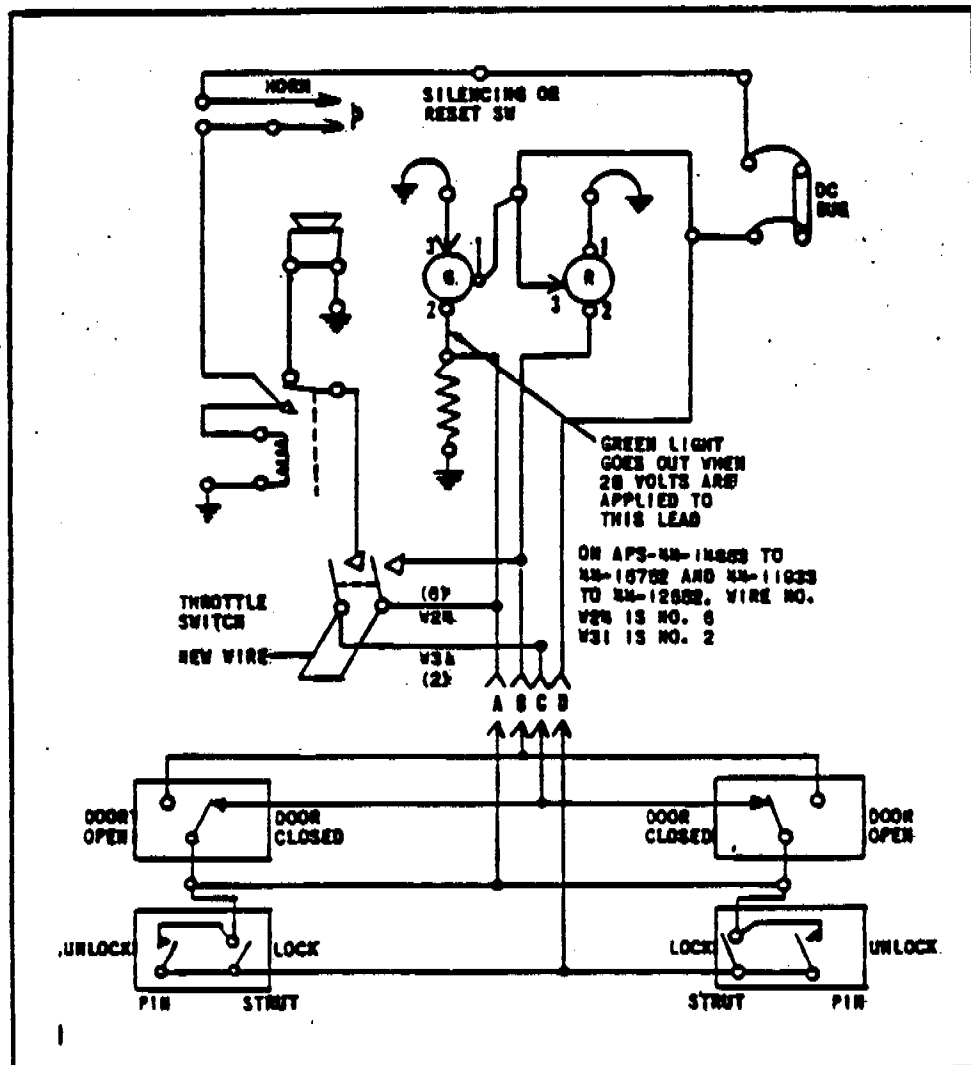
Figure 1

1. To provide for operation of the landing-gear warning horn at any time that the throttle is retarded, and the landing gear is in any position except "DOWN"

(4) Horn can be silenced by momentarily operating silencing switch. Horn silencing feature will release when throttle is advanced. Refer to figure 1 for wiring diagram.

3. Fabricate a jumper wire approximately 4 inches long of No. 18 aircraft low-tension cable. Attach a terminal lug to each end of the wire and connect the wire between wires Nos. W31 and W24 at the throttle switch. (See figure 1.) This switch may be found slightly below and forward of the throttle quadrant, on the left side of the cockpit.
