22 February 1948

## AIRCRAFT AND MAINTENANCE PARTS

NORTH AMERICAN—INSPECTION AND REWORK OF ELEVATOR AND RUDDER  
FRONT BEAMS—P-51B, P-51C, P-51D, P-51K, F-6C, F-6D, AND F-6K

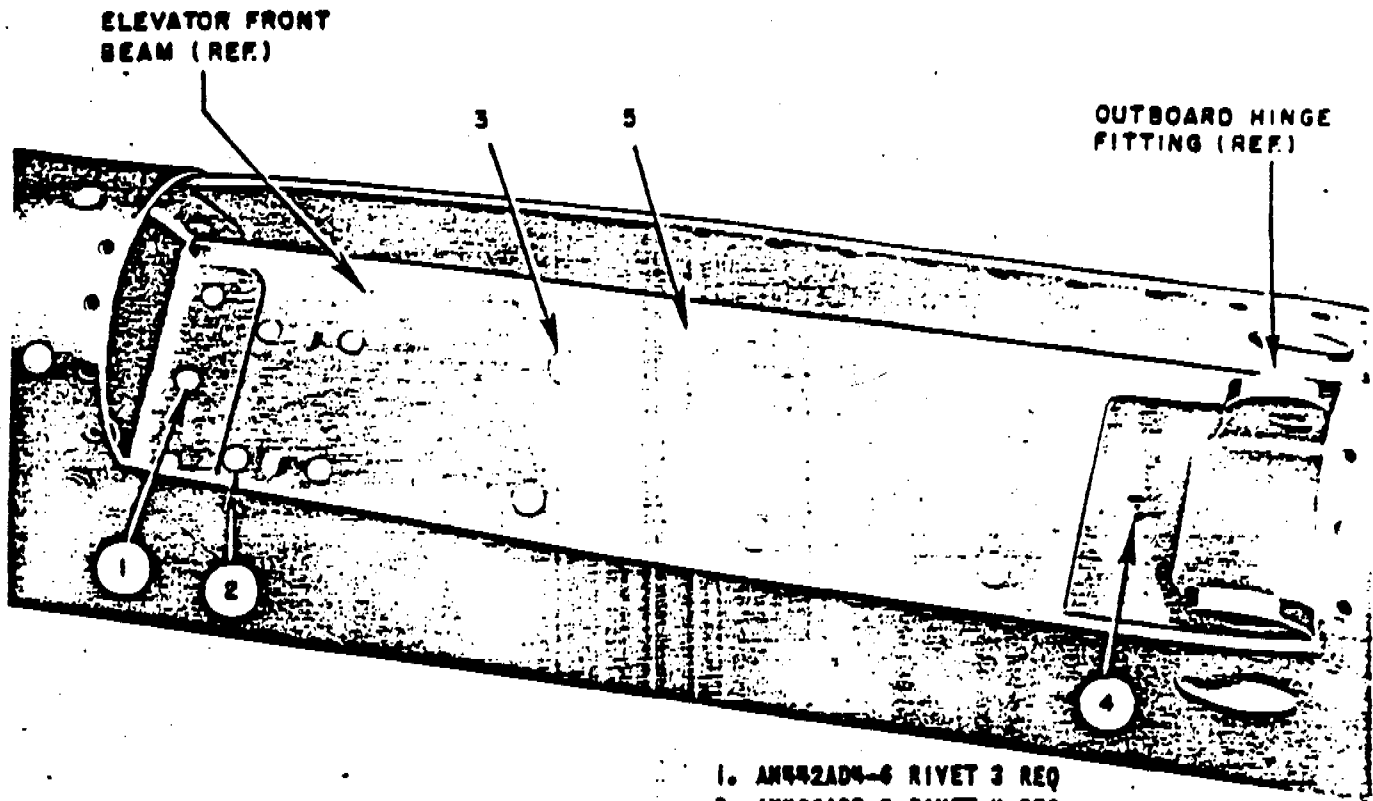
Figure 2 - Looking at Elevator Front Beam

**NOTE** If a fatigue crack is apparent in the beam, drill a No. 40 (.098-inch) hole in each end of the crack.

1. AN442AD4-6 RIVET 3 REQ
2. AN426AD3-4 RIVET 4 REQ
3. AN426AD4-4 RIVET 8 REQ
4. AN426AD3-6 RIVET 2 REQ TO SECURE NUT PLATE UNDER THIS HOLE. AN426AD3-6 RIVET 4 REQ. TO SECURE OTHER TWO NUT PLATES UNDER BRACKET.
5. REMOVE OLD DOUBLER FROM AFT SIDE OF BEAM. FABRICATE NEW .040 DOUBLER 9-9/16 IN. LONG FROM ALUM.-ALLOY SHEET. NEW DOUBLER TO BE FLANGED AS OLD DOUBLER AND WILL EXTEND TO OUTBOARD END OF BEAM.

(5) Drill out the rivets securing the nut plates to the back of the beam and doubler. Use a No. 40 (.098-inch) drill. There are five such nut plates. (See figure 2.)

(6) Drill out the rivets securing the doubler to the aft side of the beam. Use a No. 30 (.1285-inch) drill. There are 11 such rivets. (See figure 2.) Also drill out the rivets securing the doubler flanges to upper and lower surface of elevator.

(7) Remove the doubler from the aft side of the beam. Fabricate a new doubler from aluminum-alloy sheet .040 x 4-1/2 (all bend radii to be 3/32 minimum) identical to the one just removed except that it shall be 9-9/16 inches long. Flange the top and bottom just as on old doubler. Joggle each end of both flanges so that the doubler will fit on aft side of beam. The additional length of the new doubler will extend it to the outboard end of the beam.

(8) Hold the new doubler in position on the aft side of the beam and drill the 11 rivet holes through the doubler using the eleven No. 30 (.1285-inch) hole in the beam as templates.

(9) Secure the new doubler to the aft side of the beam at these holes using eight rivets, part No. AN426AD4-4, and three rivets, part No. AN442AD4-6 (See figure 2.)

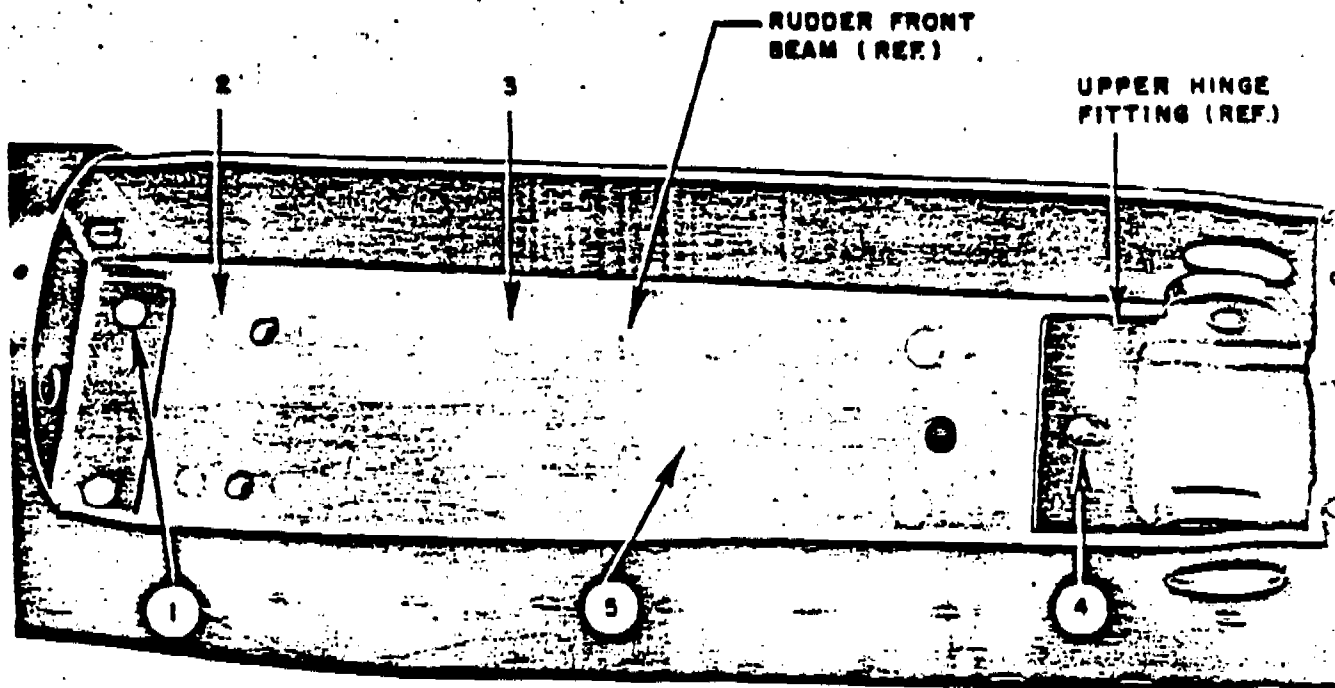
Figure 5 - Looking at Rudder Front Beam

**NOTE** If a fatigue crack is apparent in the beam, drill a No. 40 (.098-inch) hole in each end of the crack.

(5) Drill out the rivets securing the nut plate to the back of the beam and doubler. Use a No. 4 (.098-inch) drill. There are five such nut plates. (See figure 5.)

1. AN42A04-6 RIVET 2 REQ
2. AN42A03-4 RIVET 4 REQ
3. AN42A04-4 RIVET 8 REQ
4. AN42A03-6 RIVET 6 REQ TO SECURE NUT PLATES.
5. REMOVE OLD DOUBLER FROM AFT SIDE OF BEAM. FABRICATE NEW .040 DOUBLER 9-1/8 IN. LONG FROM ALUM.-ALLOY SHEET. NEW DOUBLER TO BE FLANGED AS OLD DOUBLER AND WILL EXTEND TO UPPER END OF BEAM.

(6) Drill out all rivets securing the doubler to the aft side of the beam. (See figure 5.) Use a No. 30 (.1285-inch) drill. Drill out all rivets securing the doubler and beam flanges to the left and right surfaces of the rudder.

(7) Remove the doubler from the aft side of the beam. Fabricate a new doubler from aluminum-alloy sheet .040 x 4 inches (all bend radii to be 3/32 minimum) identical to the one just removed except that it shall be 9-1/8 inches long. Flange both sides just as on the old doubler. Joggle each end of both flanges so that the doubler will fit on the aft side of the beam. The additional length of the new doubler will extend it to the upper end of the beam.

(8) Hold the new doubler in position on the aft side of the beam and drill the ten rivet holes through doubler using the ten No. 30 (.1285-inch) holes in beam as templates.

(9) Secure the new doubler to the aft side of the beam at these holes using eight rivets, part No.

AN426AD4-4, and two rivets, part No. AN442AD4-6. (See figure 5.)
