## AIRPLANES AND MAINTENANCE PARTS

**NORTH AMERICAN—REINFORCEMENT OF HORIZONTAL STABILIZER  
AND FIN—P-51B, P-51C, AND P-51D**

## AIRCRAFT AND MAINTENANCE PARTS

**NORTH AMERICAN—REINFORCEMENT OF HORIZONTAL STABILIZER  
AND FIN—P-51B, P-51C, P-51D, AND P-51K**

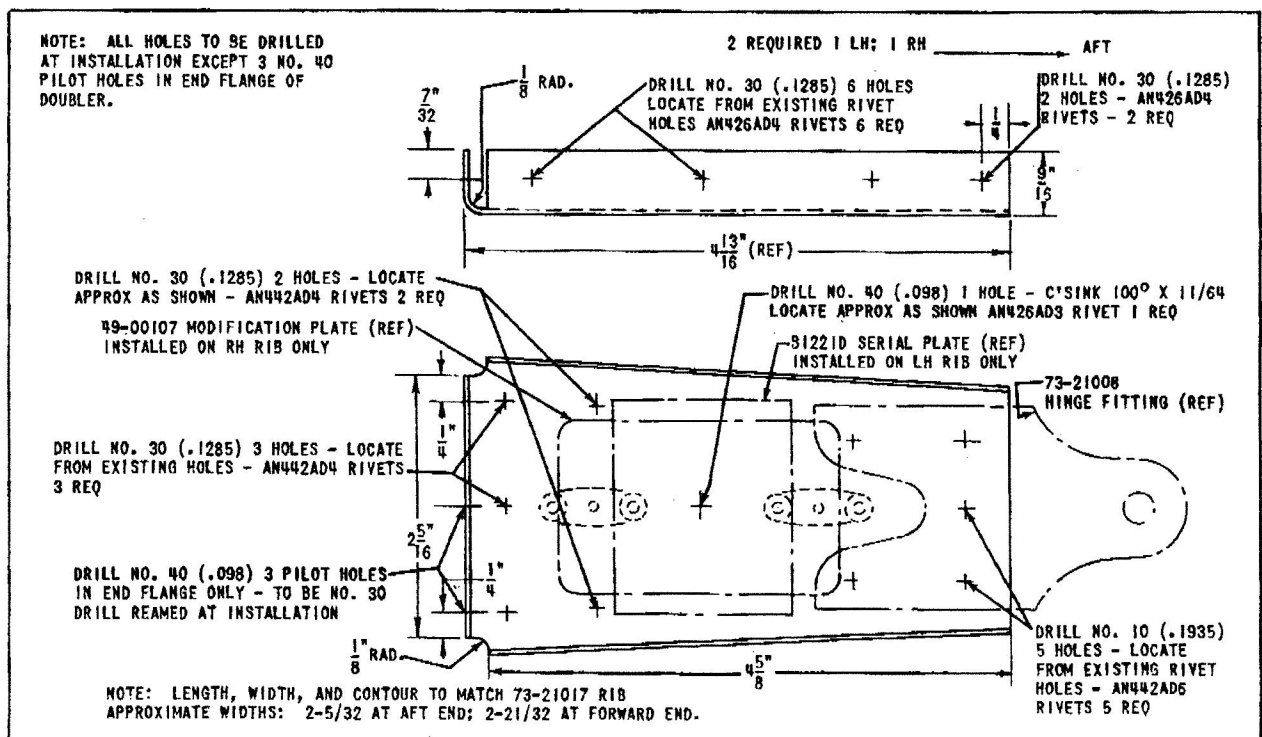
Figure 4 - Station 70 1/2 Horizontal Stabilizer Rib Reinforcing Doubler Channel

which is just above the rudder counterbalance weight cut-out. Inspect the sections of the ribs aft of the rear beam for cracks in corners at flange bend radius, for

cracks through the hinge fitting rivet holes, and for cracks across the web of the rib.

b. Manufacture three reinforcing doubler channels in accordance with figures 4 and 5.

**IMPORTANT** Manufacture from aluminum-alloy sheet, condition T, Specification No. QQ-A-362. Material to be .040 inch if inspection above reveals cracks and .032 inch if no cracks are found. The doubler installation is to be used for reinforcing strength only. Additional repair in accordance with existing instructions will be completed when cracks are present.

**NOTE** The webs should be riveted together in at least three places as indicated in figure 4. Additional rivets will be required if the rib web has been cracked; these should be located as necessary to properly reinforce the rib web.

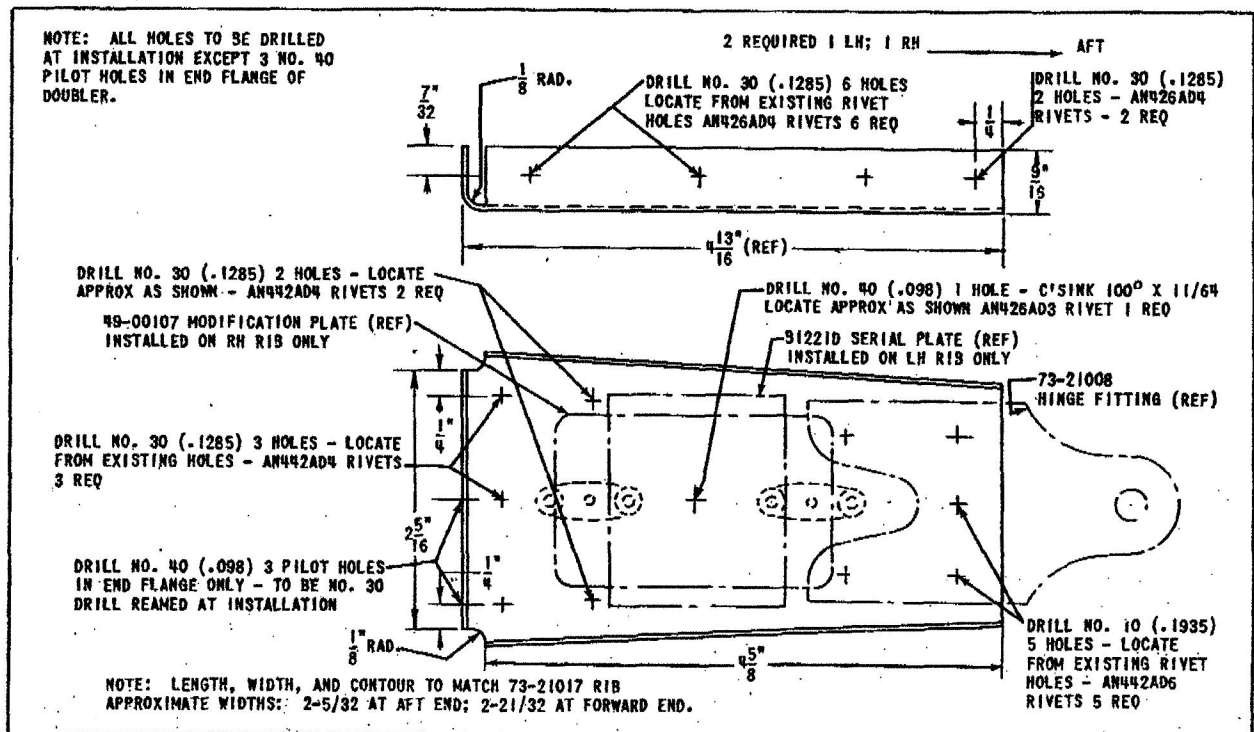
Figure 4 - Station 70 1/2 Horizontal Stabilizer Rib Reinforcing Doubler Channel

which is just above the rudder counterbalance weight cut-out. Inspect the sections of the ribs aft of the rear beam for cracks in corners at flange bend radius, for

cracks through the hinge fitting rivet holes, and for cracks across the web of the rib.

**IMPORTANT** Manufacture from aluminum-alloy sheet, condition T, Specification No. AN-A-13. Material to be .040 inch if inspection above reveals cracks and .032 inch if no cracks are found. The doubler installation is to be used for reinforcing strength only. Additional repair in accordance with existing instructions will be completed when cracks are present.

**NOTE** The webs should be riveted together in at least three places as indicated in figure 4. Additional rivets will be required if the rib web has been cracked; these should be located as necessary to properly reinforce the rib web.
