Under The Roof Home Inspection

Sample Property Inspection Report

Sample Report
Sample Report, TX 00000
Inspection prepared for: Sample Report
Date of Inspection: 0/00/0000 Time: 9:00am
Age of Home: Built 0000 Size: 0000 Total
Weather: Cloudy/Rainy

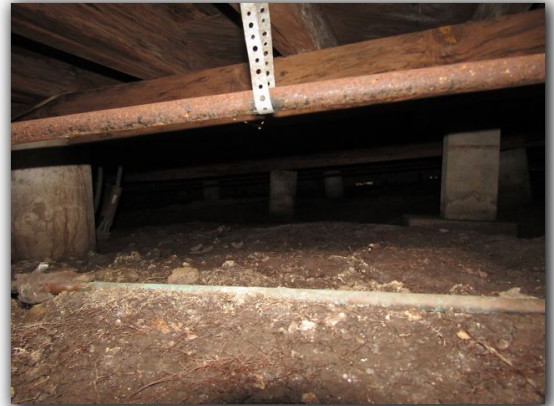
View of Crawlspace

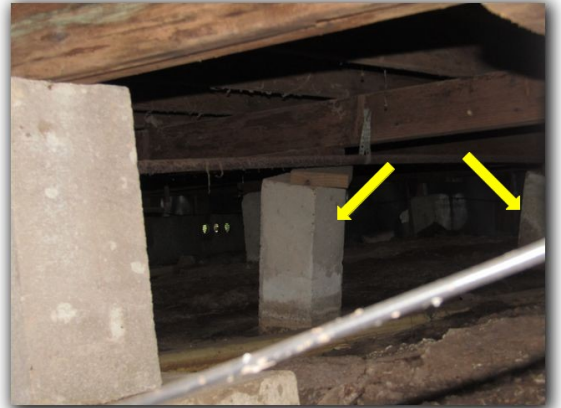
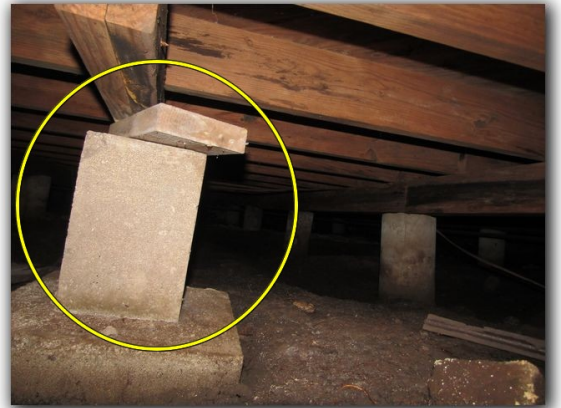
Multiple tilted piers observed in crawlspace

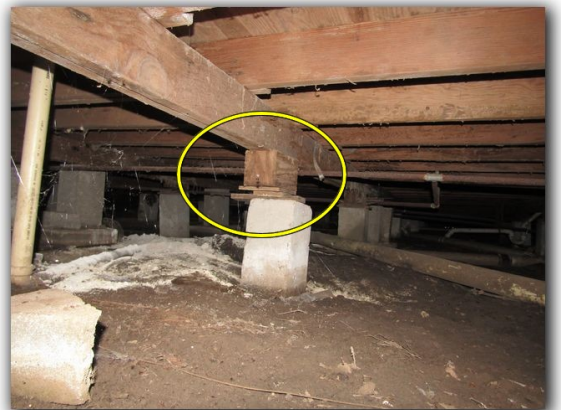
Beams not centered with piers observed in crawlspace

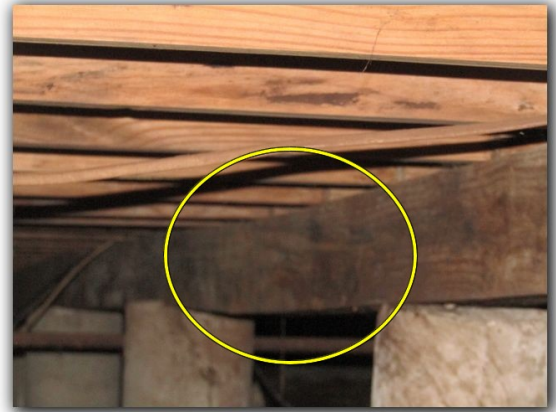
Possible damaged and warped beams observed in crawlspace

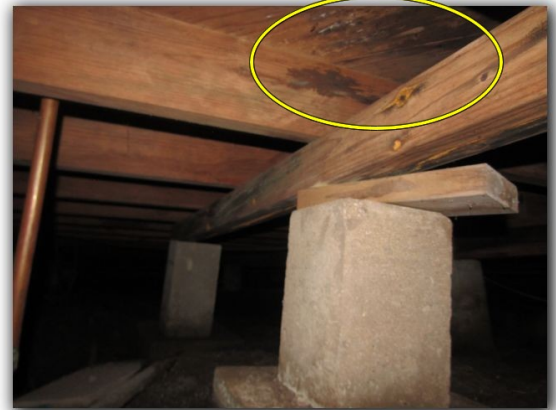
Possible damaged floor joist and signs of past leaks observed in crawlspace

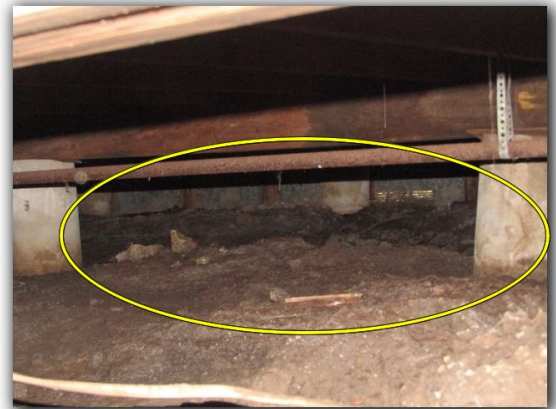
Possible poor drainage in crawlspace. Appears water may enter crawlspace and pool in multiple locations in crawlspace.

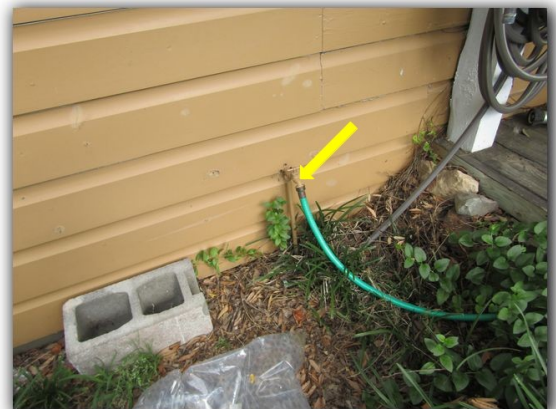
Appears grading on east side of home is flat or slopes toward home. Appears water may pool near home and enter crawlspace

Recommend splash block under exterior faucet on east side of home

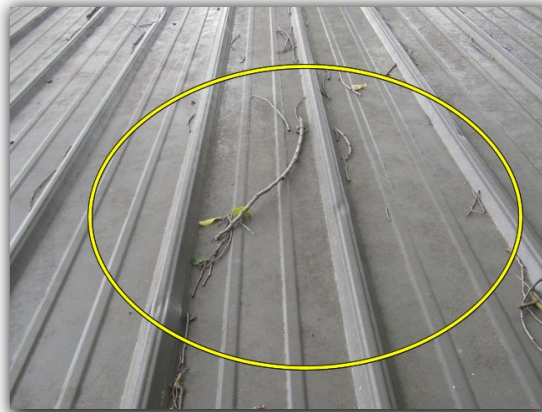
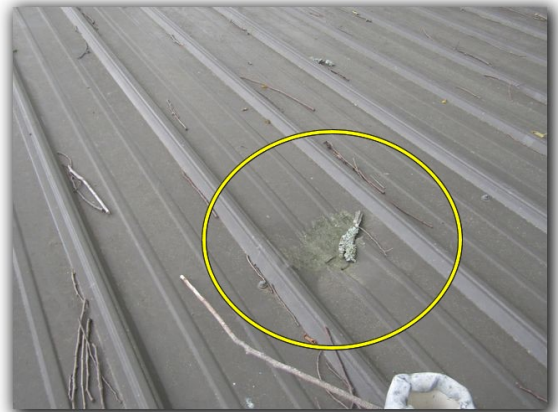
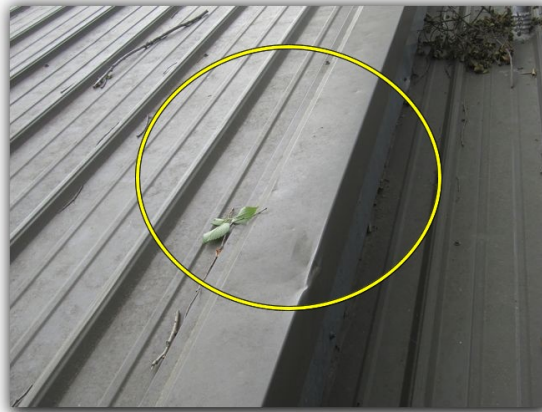
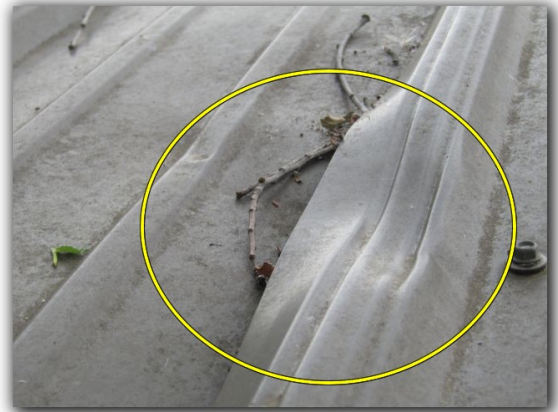
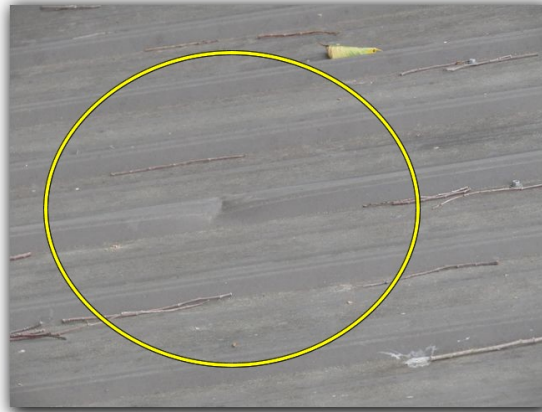
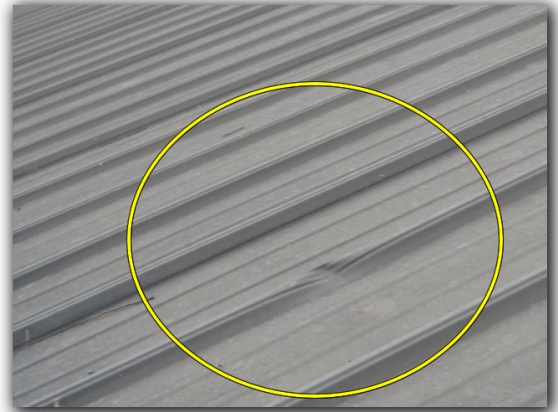
Multiple dents in roof observed

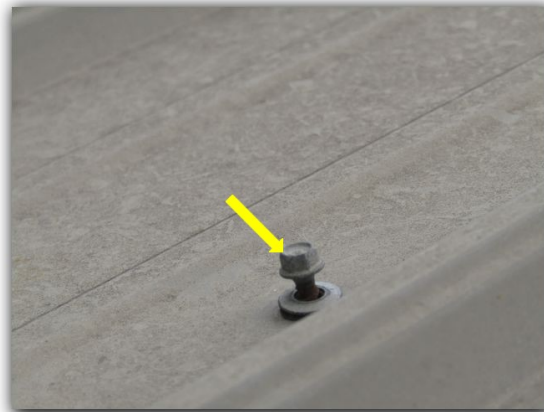
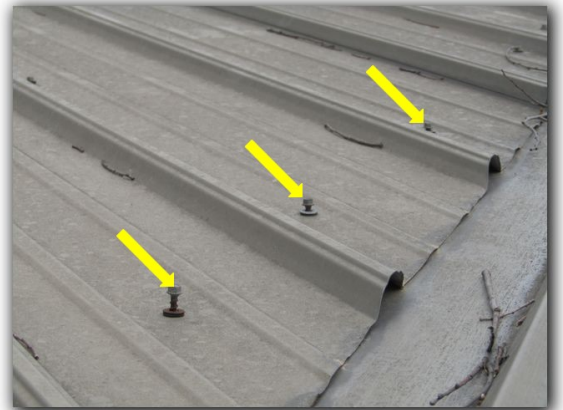
Appears multiple screws are loose on roof

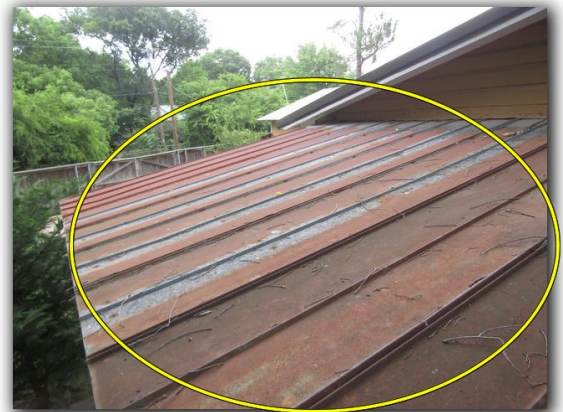
Rust observed on roofs for back and side porches

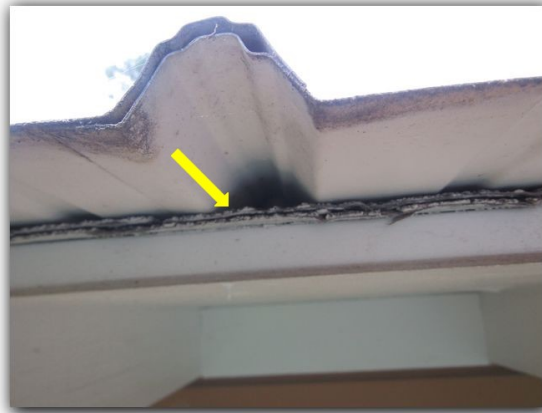
Appears metal roof is installed over asphalt shingles

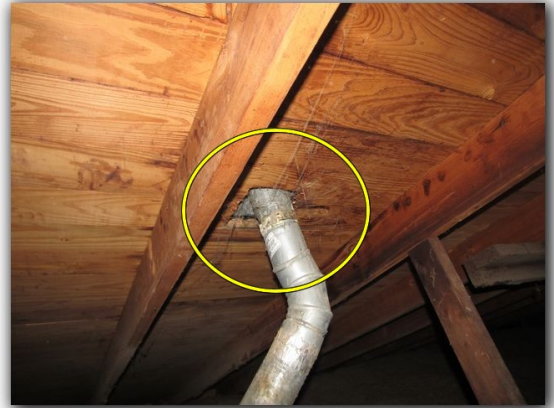
Evidence of past leaks observed in attic

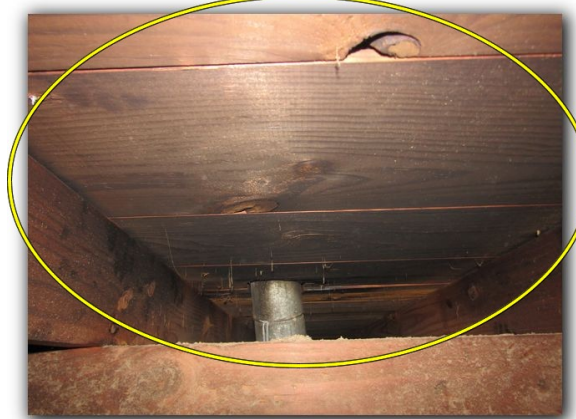
Possible soot observed in attic at furnace flue

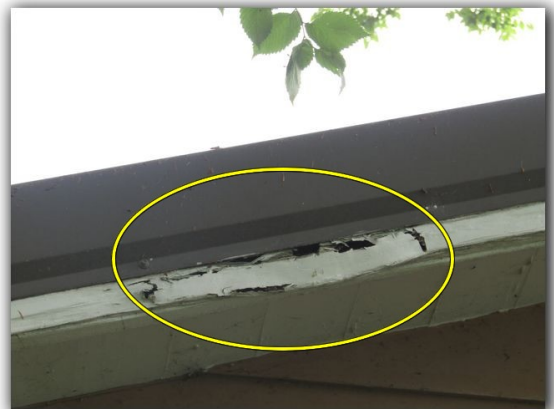
Possible damaged wood observed at eaves

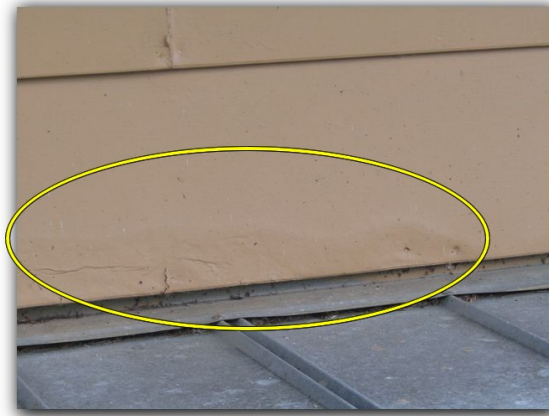
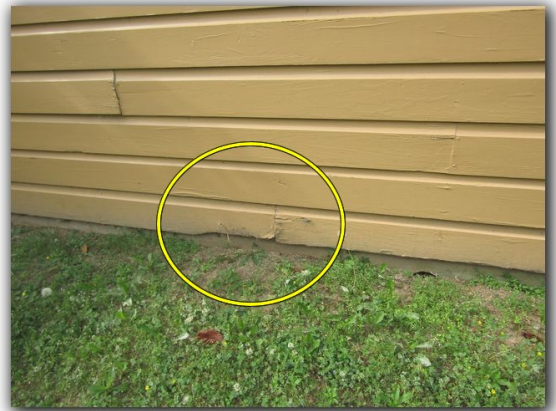
Possible damaged wood siding observed

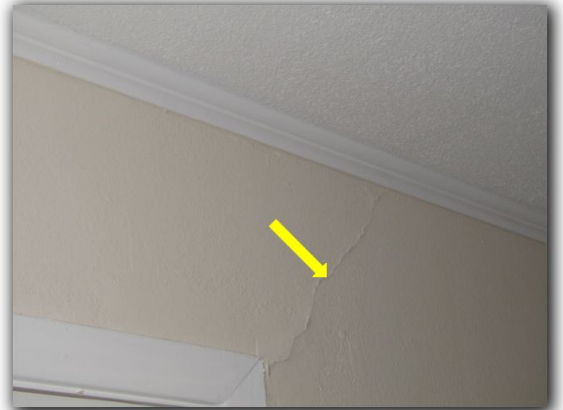
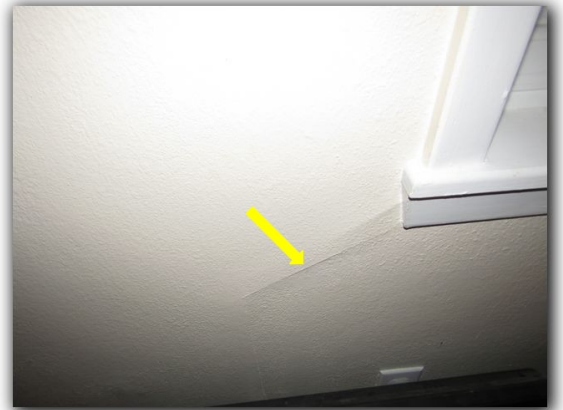
Cracks in interior walls observed

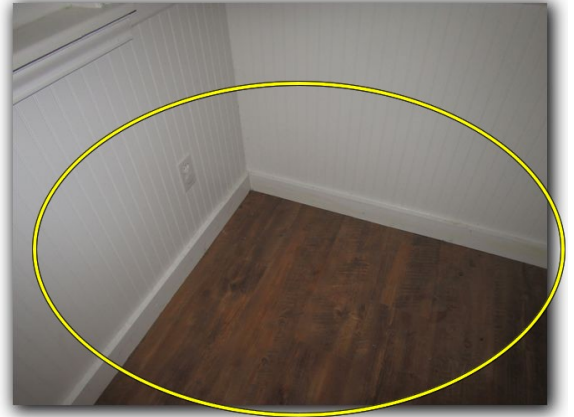
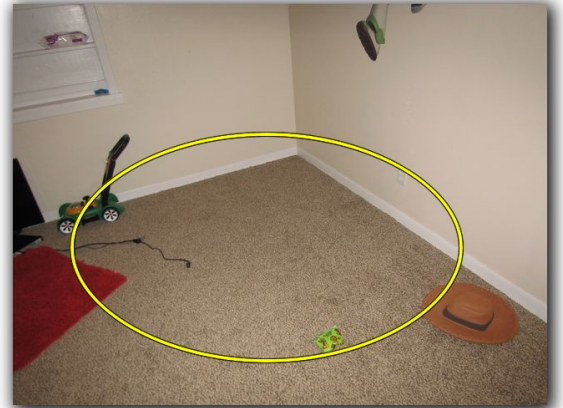
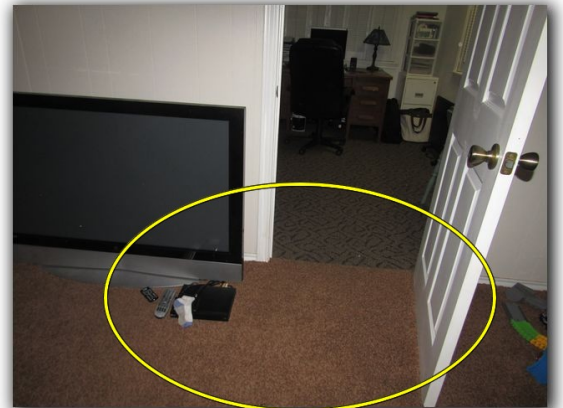
Slopes and dips observed at multiple locations in floor

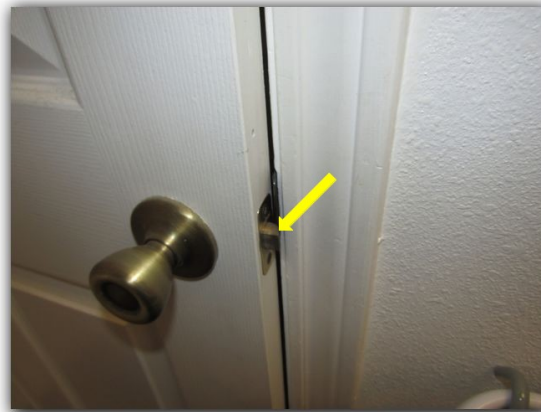
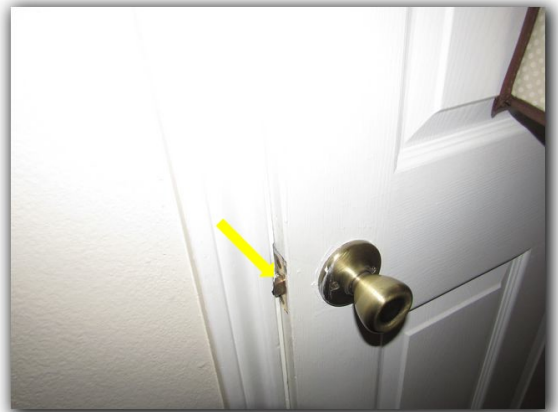
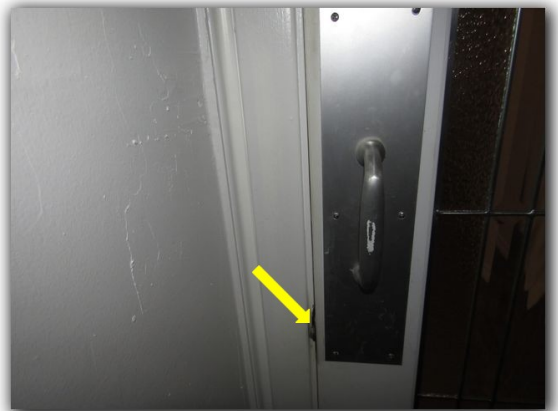
Multiple doors do not close completely or do not latch shut

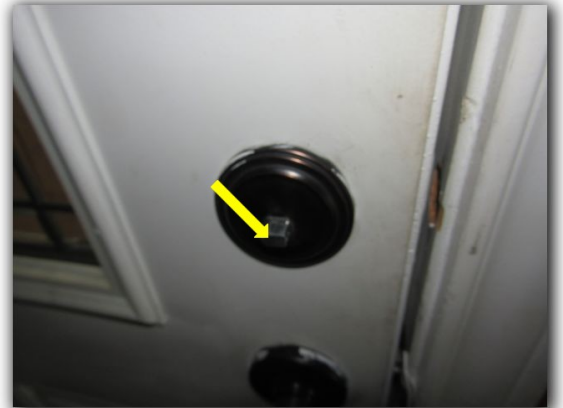
Appears entry door at carport is missing hardware

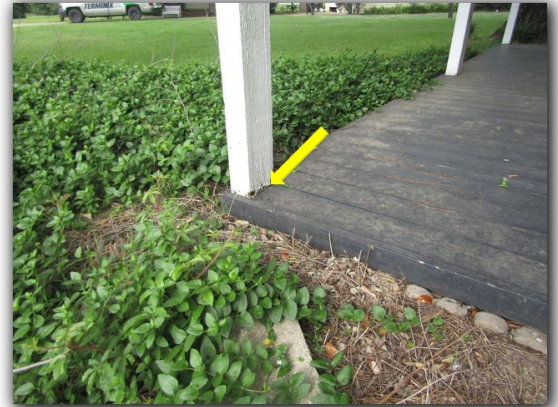
Possible damaged wood observed at side porch

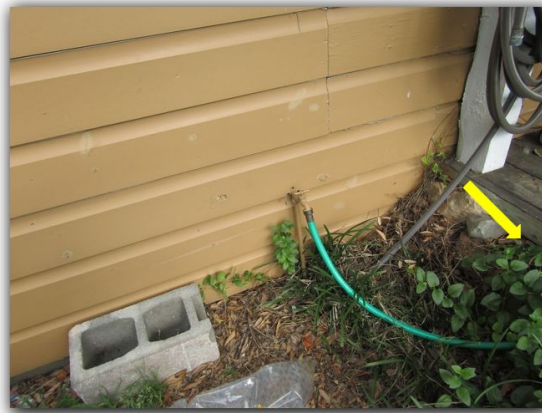
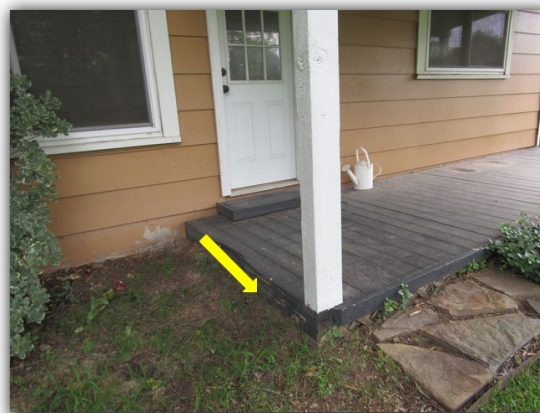
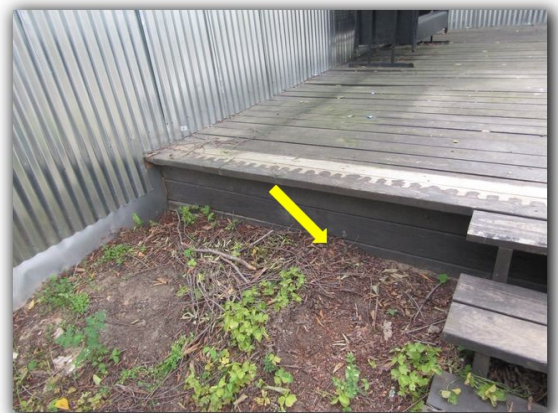
Wood to soil contact observed at back deck, front porch and side porch

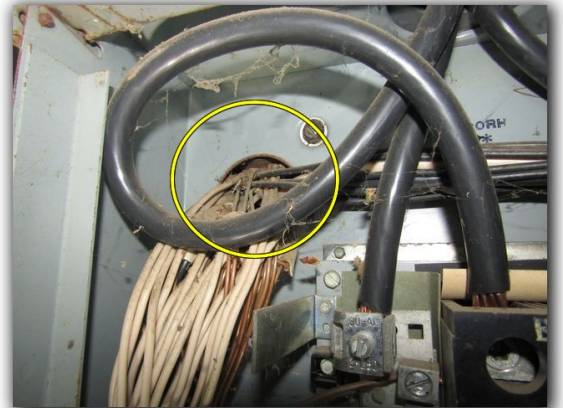
Wiring entry panel without proper bushings

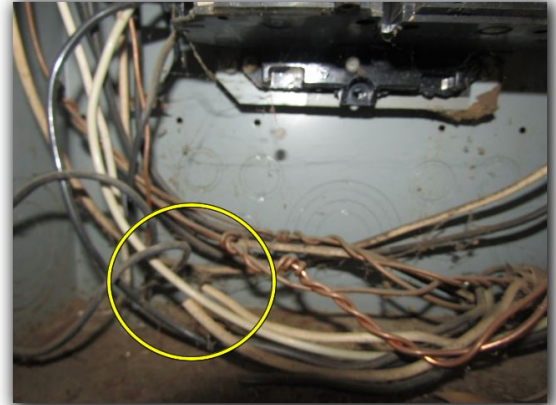
Bare wires observed at panel

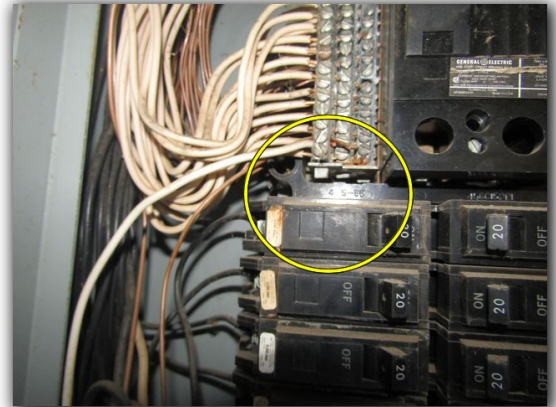
Possible rust observed at breakers and bus

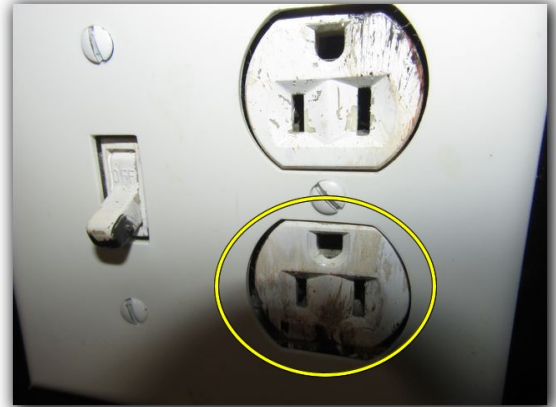
Receptacle in hall way near hallway door inoperative

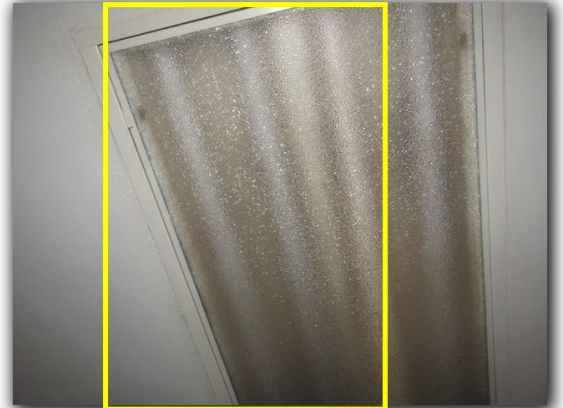
Multiple light fixtures inoperative at time of inspection

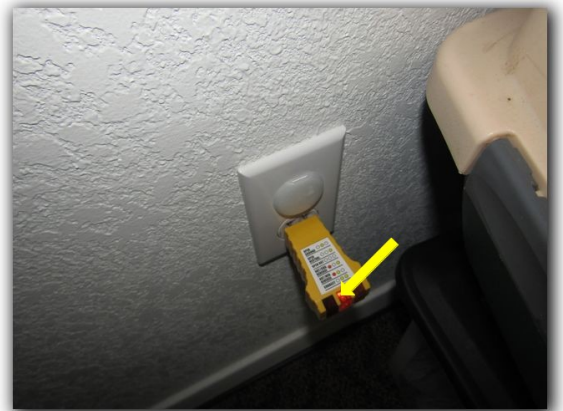
All of the two pong outlets and most of the three pong outlets are on a two wire system with no ground

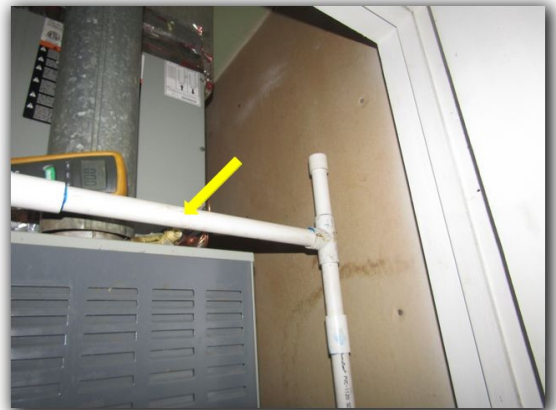
Appears A/C drain line is tilts back towards A/C unit in crawlspace and not towards termination

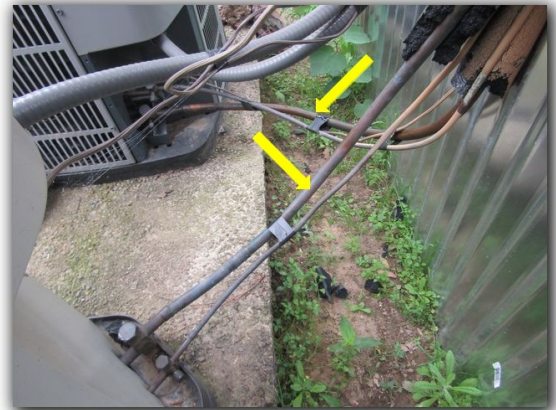
Evidence of past leak at left A/C unit

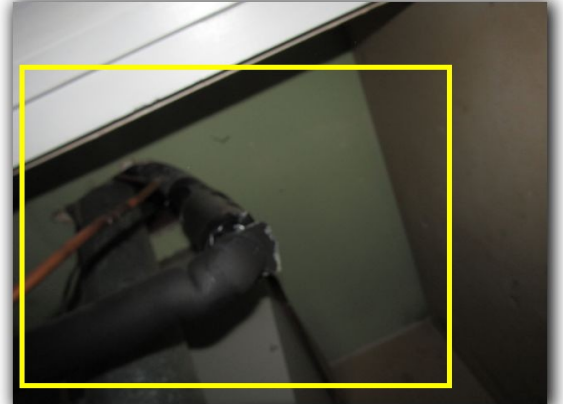
Due to gas furnaces. A/C closets should be vented

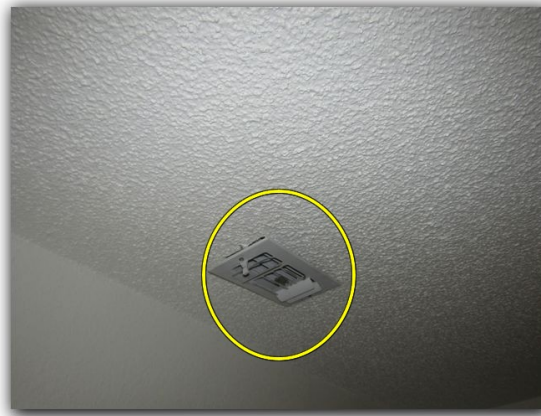
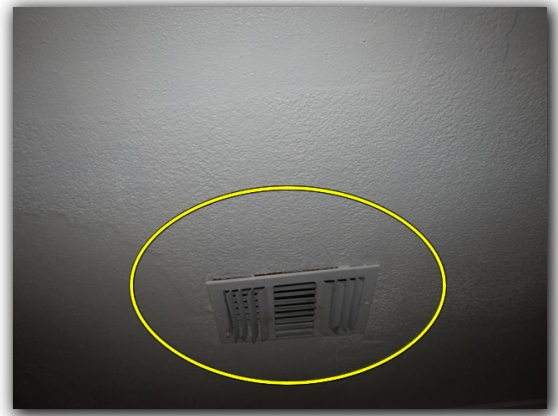
Multiple registers are not flushed against the ceiling

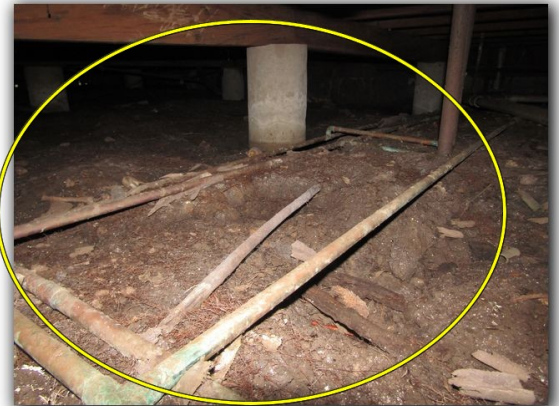
Supply lines in crawlspace should be covered with insulation

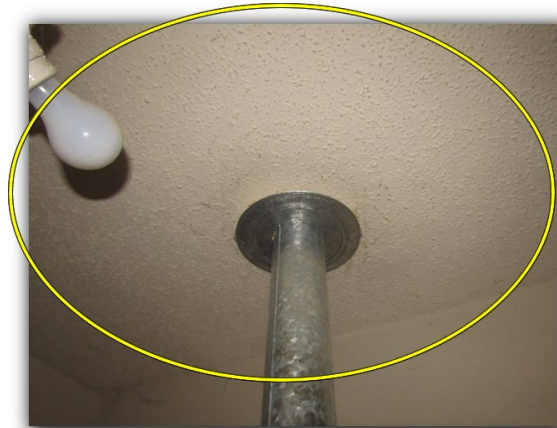
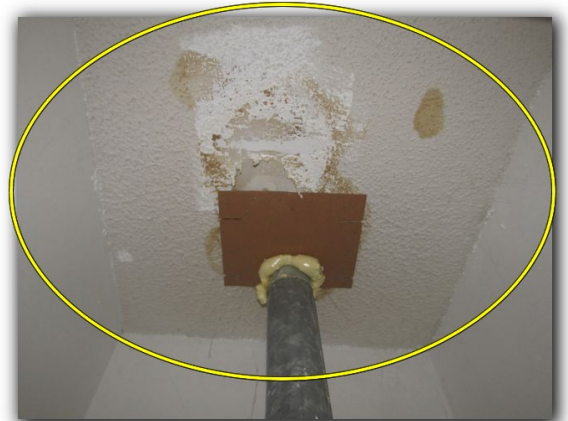
Due to gas water heaters, hall bathroom water heater closet and kitchen water heater closet should be vented.

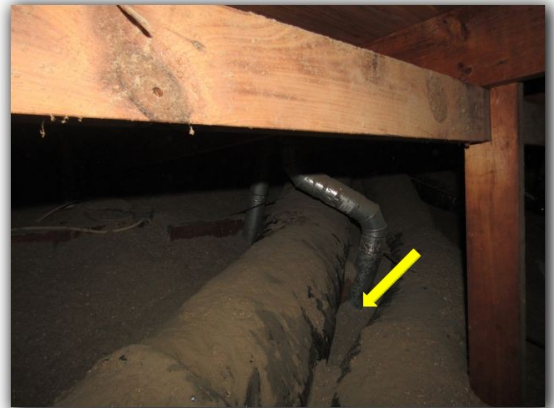
Appears flue for hall bathroom water heater contacts insulation

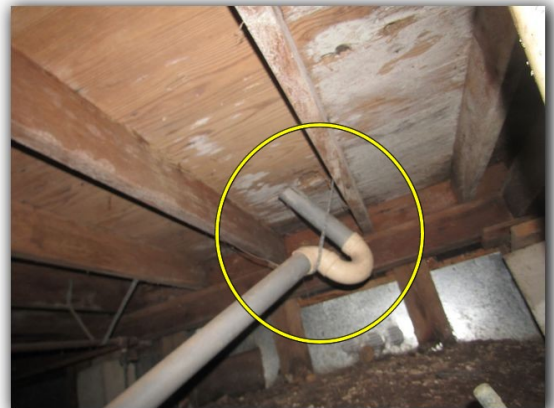
Old drain pipes observed in crawlspace

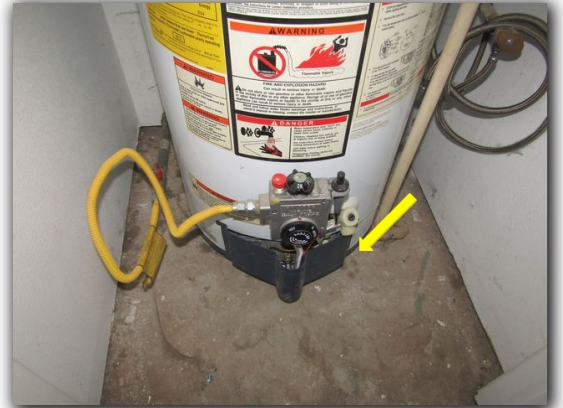
No drain pan underneath water heaters

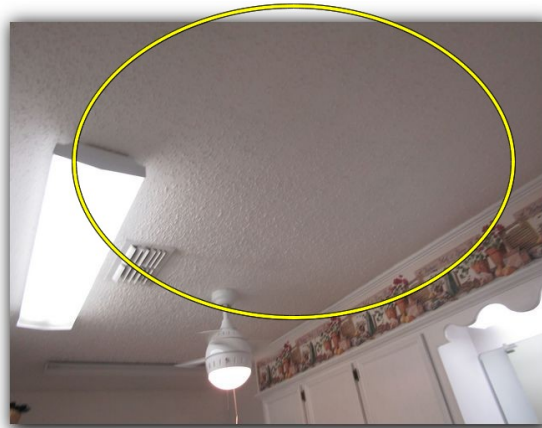
With there being no window in utility room. Recommend exhaust fan in utility room

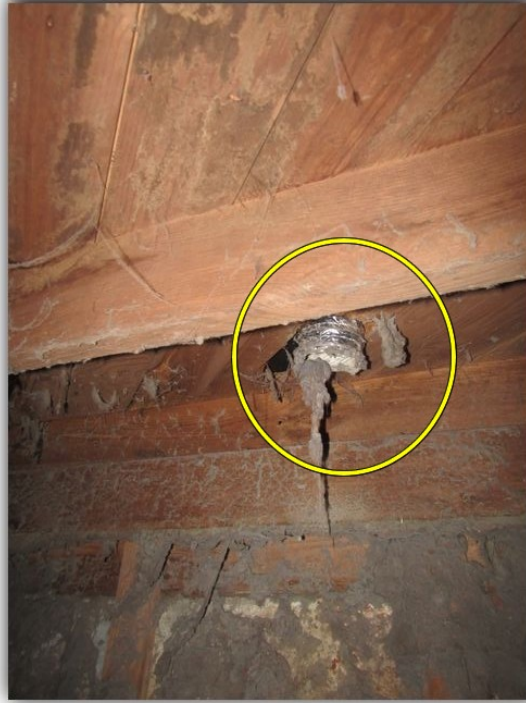
Dryer vent terminates in crawlspace
