The Energy Kite

Selected Results from the Design, Development and Testing of
Makani's Airborne Wind Turbines

Part III, Technical Artifacts

Selected Decks From RPX Lessons Learned Reviews

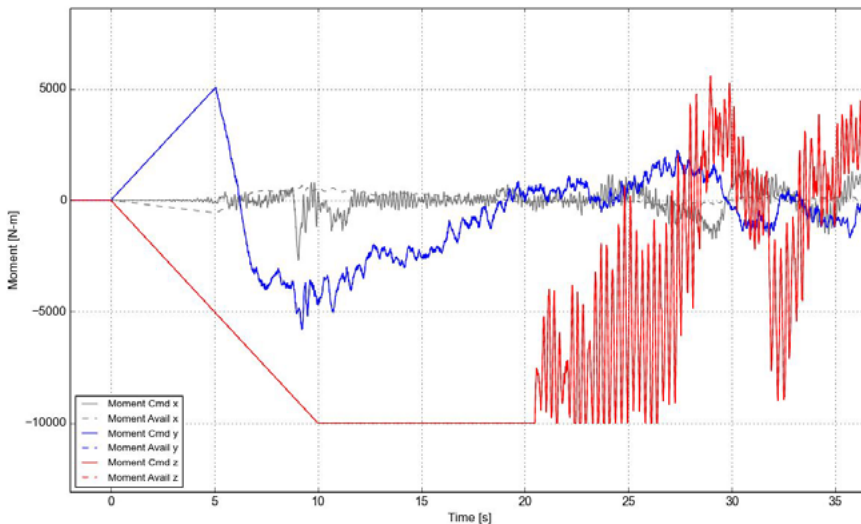
20161214-160438-rpx02_wing.h5.Controller A.Moments

In logs analyzed post-flight, a large oscillation is observed in the motor yaw command.

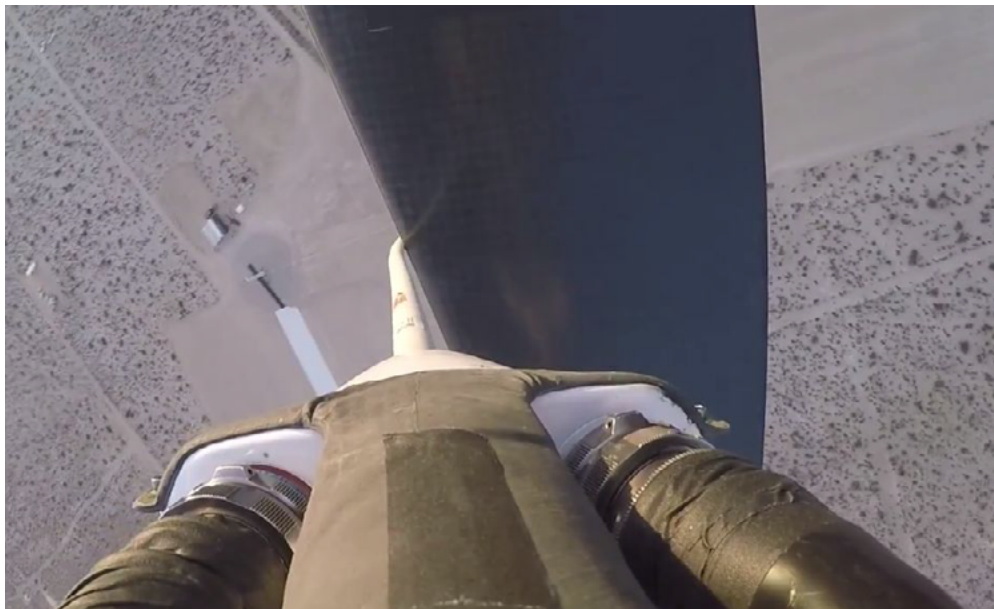
- Bridles and release seem to have worked as planned
- Release mechanism swung into wing, causing damage. Was a known risk that we had decided to fly with - working on adjustment for avoid in future flights.
- Pitch and roll range of motion: overall seem ok, except for trans-out

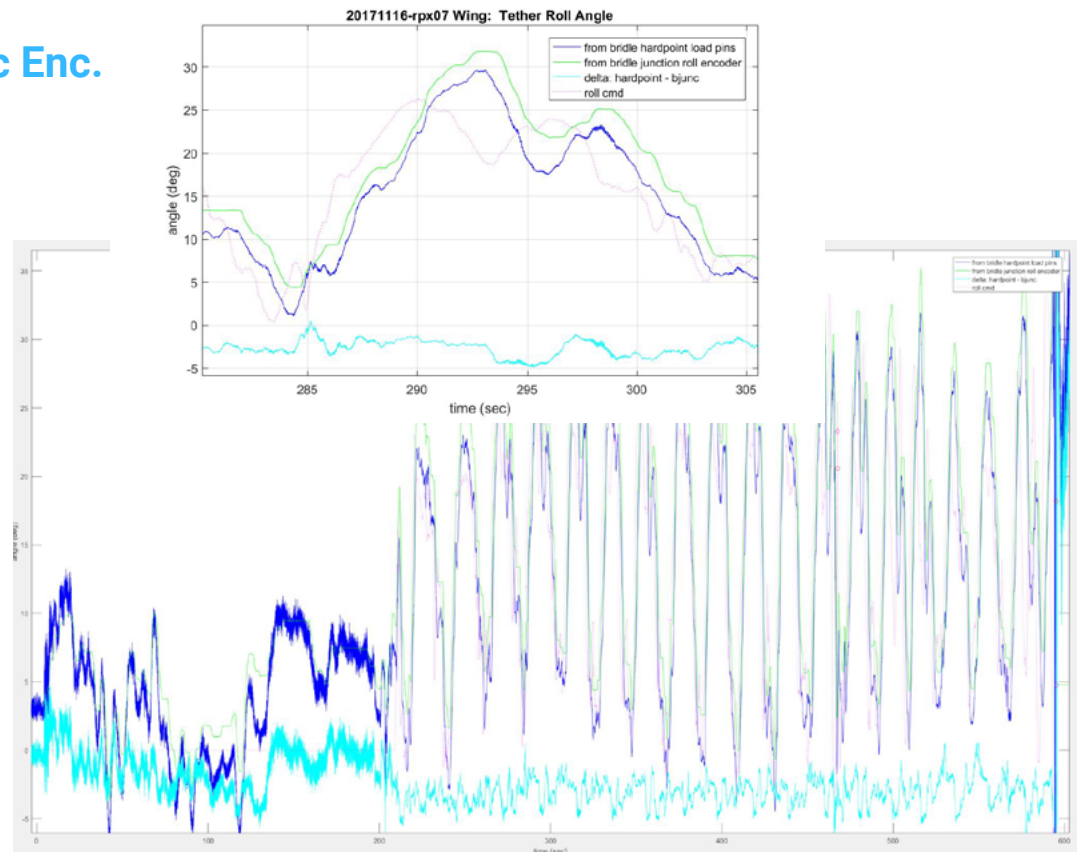
- Starboard out and midboard ailerons saturate in crosswind—may need more range in positive deflection.
- Inboard ailerons used over full range in hover, some saturation. Mostly unused in crosswind.

- Contact between bridle fairings and pylon **4 times**, Bug 69978773
 - Left marks/cracked nacelle, but seems no structural pylon damage
 - Contacted the 2nd fairing
 - Expected contact (w/o fairing) @ 17.7 deg
 - Achieved contact at just under ~19 deg as measured
 - Noticed extreme jump to ~90deg on final contact before release. Could this have future impact on controls? → file bug

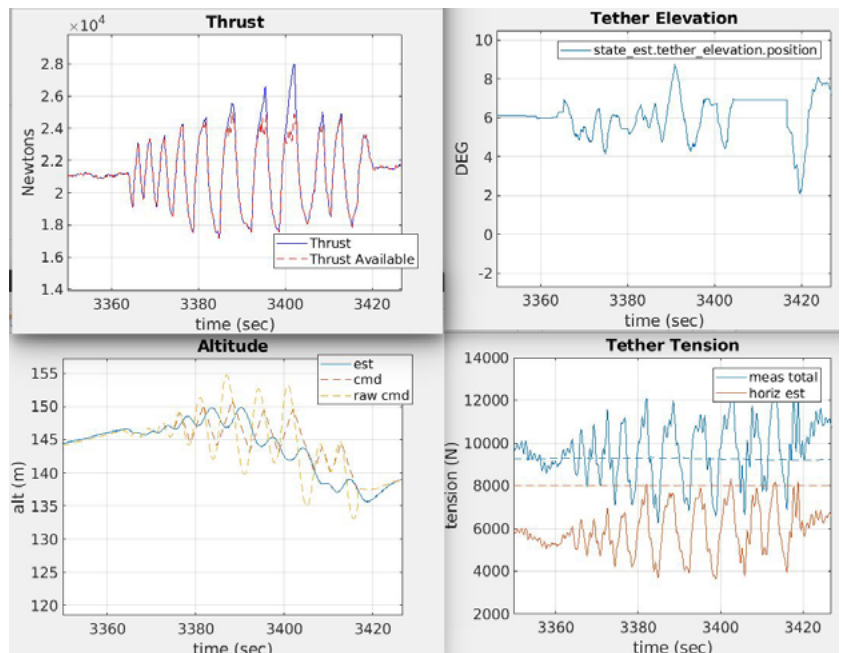
Bug In the TransOut Airspeed Command Code

- Typo Bug in ECR 406 code
- Causes faster airspeed cmd than intended
 - Therefore higher HoverTransout
- Batch sims showed good performance even with this bug in place.
- This cl [internal ref] fixes the bug.
 - 50 m lower in HoverTransOut

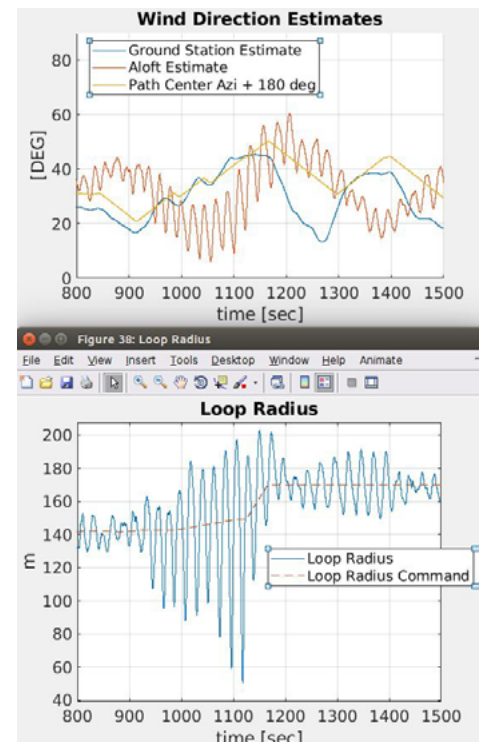
Example of Poor Flight Quality Prior to Fallback Switch

- Switched to Fallback after observing scary loops
 - Huge path tracking errors
 - Kite was "cutting the corner" near 12 o'clock
- Hypothesis: This has to do with
 - Shear + Veer + Path Being Not Downwind
 - Have not shown this to be true, however
 - MUST have to do with wind conditions (the control laws are deterministic!!!)
- C-sim does NOT show this behavior when using wind replay (does not include veer)
 - Still working on reproducing it manually.

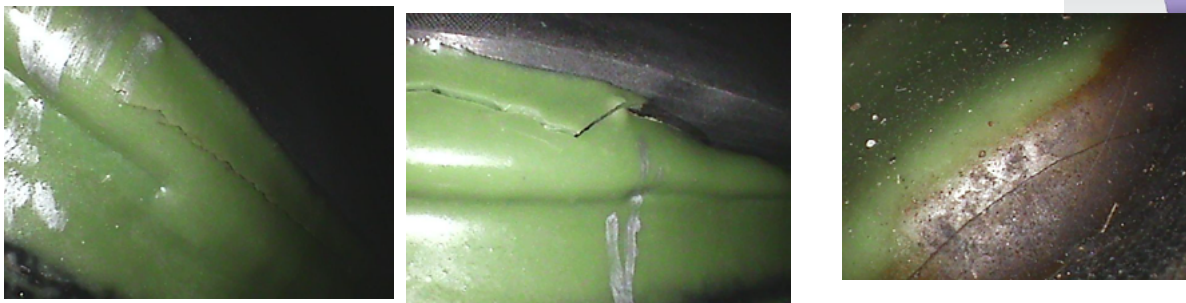
Pylon 2 - Aft Hardpoint Bond, Lower Nacelle

- Bug 132559403
- RH skin <-> hardpoint spar bond repaired after jazz hands - this crack did not grow
- Possible new cracks on LH skin <-> hardpoint spar bond (still collecting info)

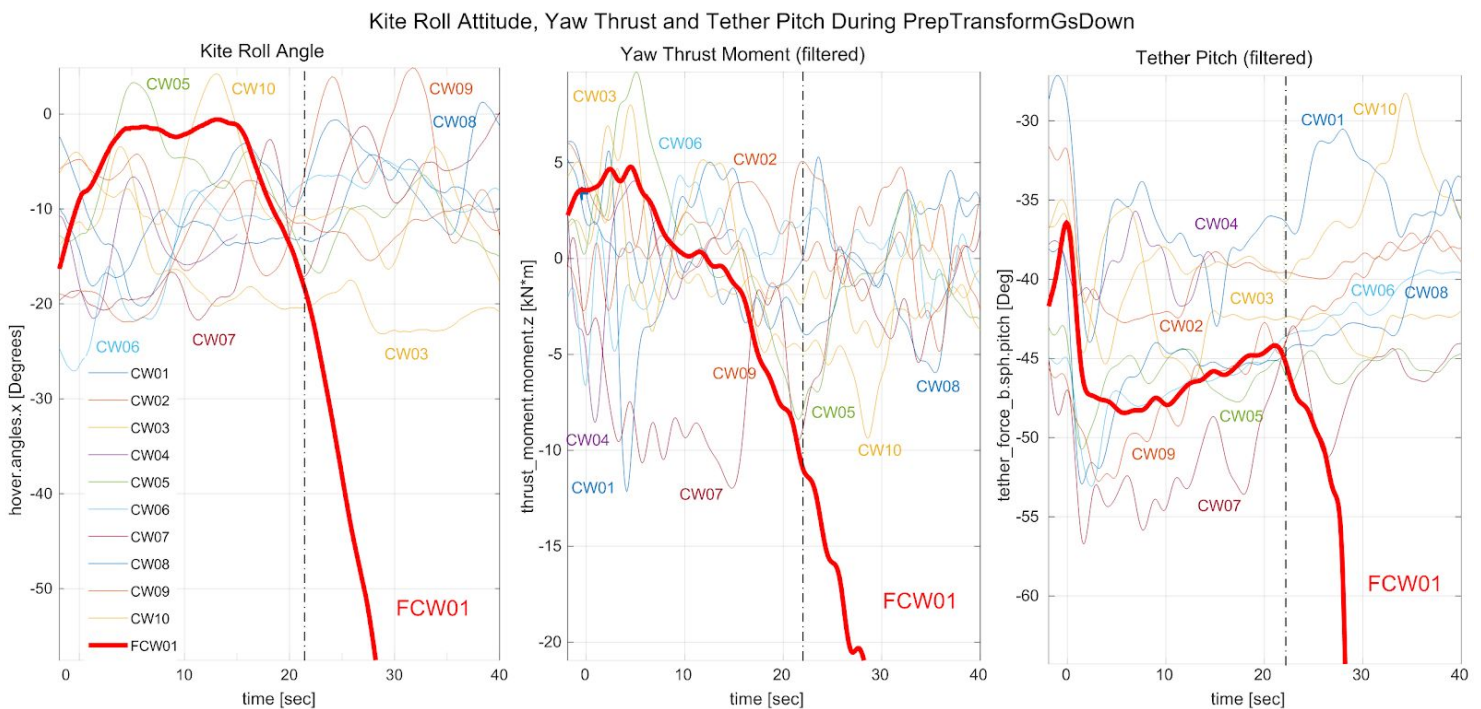
Fig. 3: Kite attitude and tether pitch during PrepTransformGsDown.

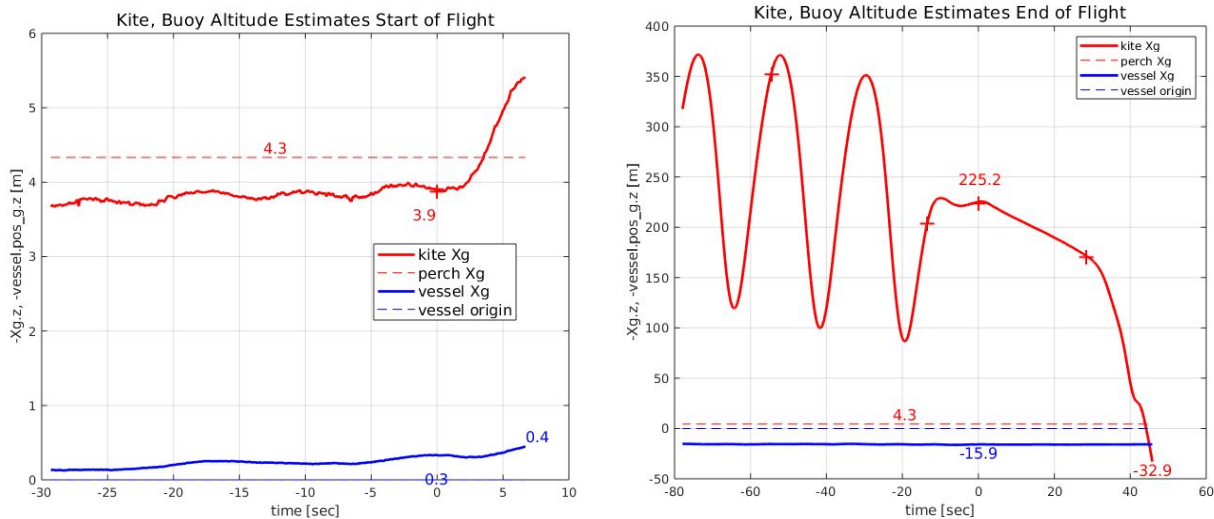
Fig. 17: The GPS measurements introduce errors in the kite altitude estimate.

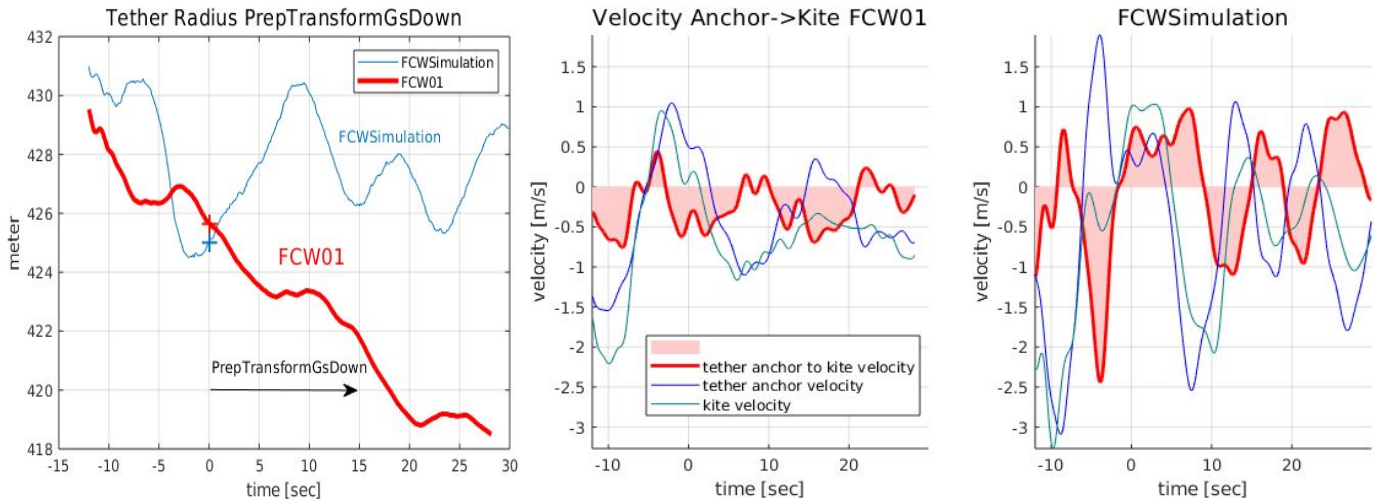
Fig. 21: Components of kite and buoy motion. In the C-sim, there is no net difference in the kite to buoy distance, in the actual flight about 7m accumulates.

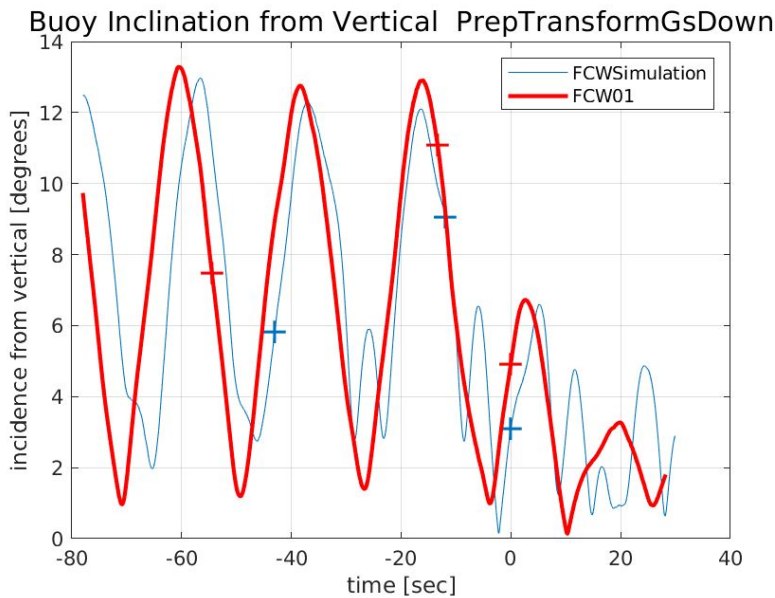
Fig. 22: The inclination from vertical shows an extra component in the C-Sim.

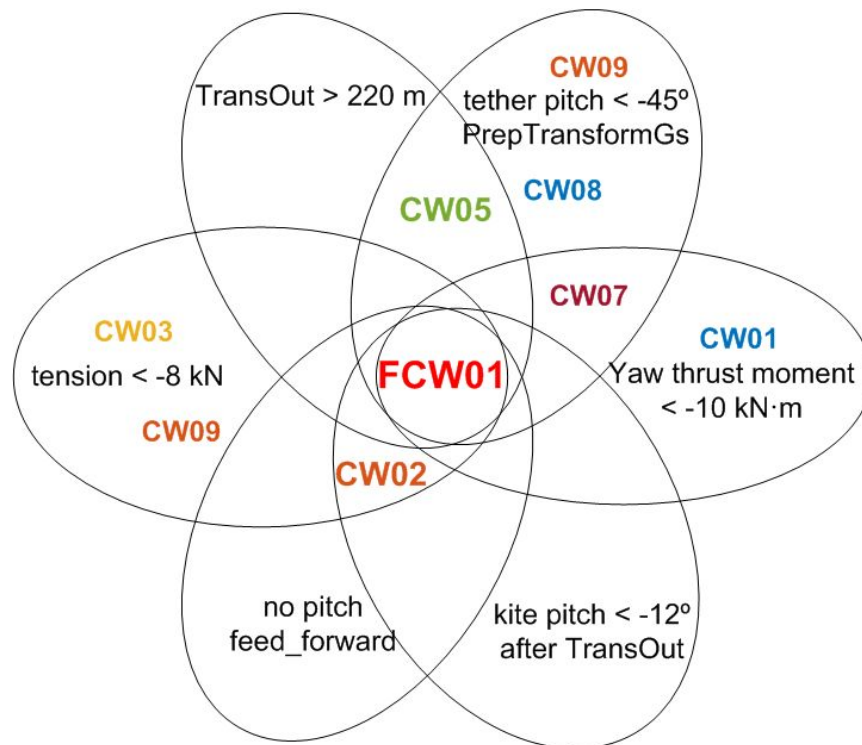
Fig. 23: Contributing causes to the loss of kite in FCW-01.
