101MI007 **CENTERFORCE TECH. LINE (928) 771-8422**

**FOR ALL GENERAL MOTORS APPLICATIONS UTILIZING STAMPED STEEL THROW OUT BEARING ARMS (FORKS).**

## CHEVROLET, PONTIAC, OLDSMOBILE & BUICK V-8 ENGINES WITH MECHANICAL CLUTCH LINKAGE

## ***GENERAL BELLHOUSING ALIGNMENT INSTRUCTIONS***

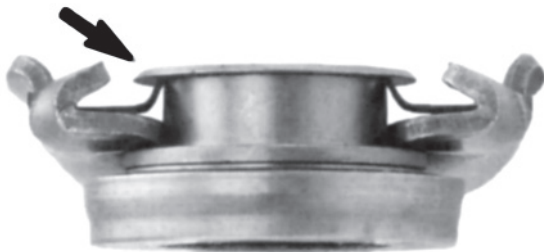
## CORRECT

THE FORK SPRING CLIPS MUST BE INSTALLED BETWEEN THE THROWOUT BEARING COLLAR FLANGES. IF THE CLIPS ARE INSTALLED ABOVE THE TOP FLANGE AS SHOWN BELOW, PROPER ADJUSTMENT CANNOT BE MADE.

WE RECOMMEND THAT OUR THROW OUT BEARING PART NUMBER N1716 BE USED WHICH IS A SELF ALIGNING TYPE BEARING

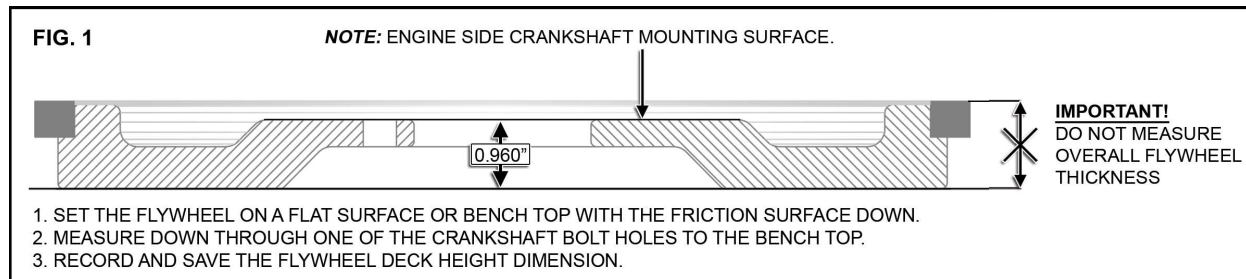
To help achieve proper mechanical clutch linkage geometry, you will need to measure your flywheel deck height (distance from the flywheel crankshaft flange surface to the clutch friction surface) as shown in FIG. 1. Aftermarket flywheel variances and/or flywheel resurfacing may have reduced your flywheel deck height from the Original Equipment (O.E.) flywheel measurement of 0.960".

FIG 2 shows the O.E. clutch fork pivot ball height of 4.750" as measured from the engine block side of the Bellhousing plate (block saver) to the flat of the clutch fork pivot ball. If your flywheel deck height measures between 0.910" and 0.960", be sure your clutch fork pivot ball height is 4.750". If your flywheel deck height is less than 0.910" you will need to adjust the clutch fork pivot ball height to accommodate the thinner flywheel as follows:

Enter your flywheel Deck Height measurement here: \_\_\_\_\_ and SUBTRACT from 0.960" (O.E. standard flywheel deck height) = "Pivot ball adjustment distance".

Then: SUBTRACT "Pivot ball adjustment distance" from 4.750" (O.E. standard pivot ball height) to find the correct clutch fork pivot ball height.

Use an aftermarket adjustable pivot ball to move the clutch fork pivot ball 0.110" CLOSER to the engine:

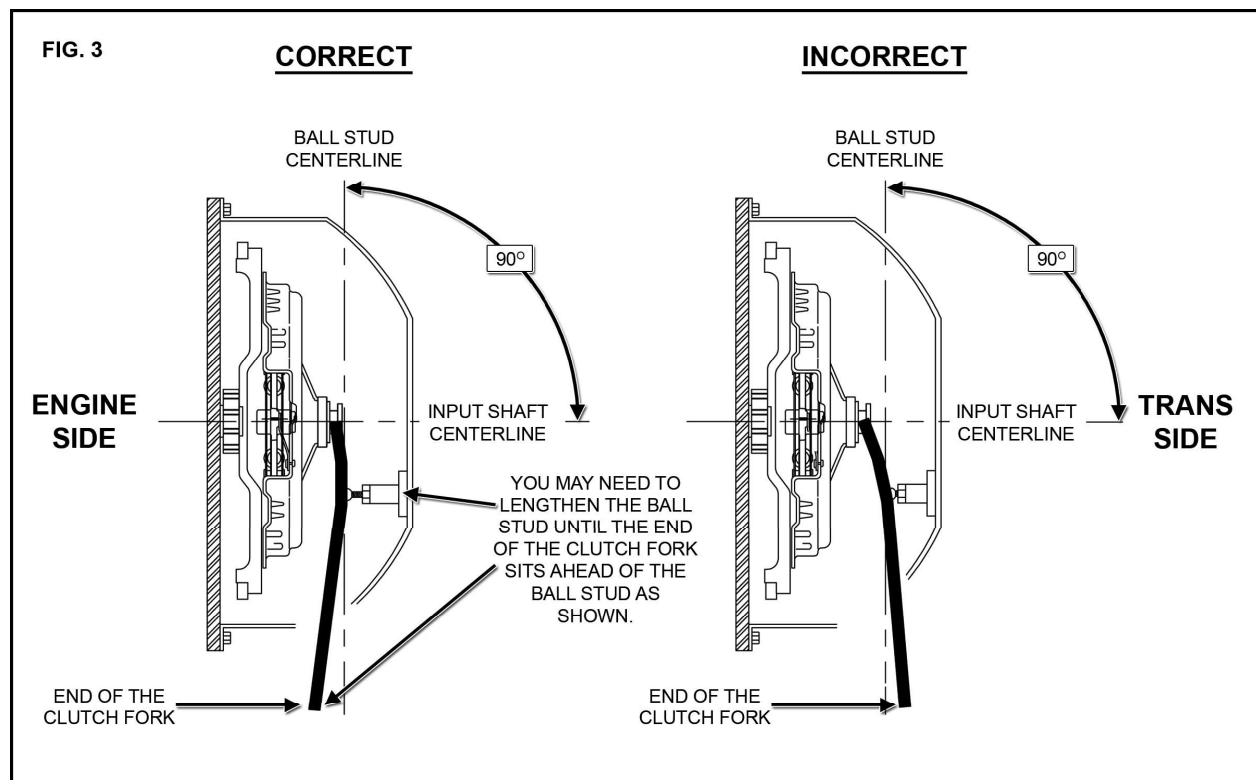
## MECHANICAL CLUTCH LINKAGE GEOMETRY FINAL CHECK

Once the clutch assembly, release bearing, clutch fork and Bellhousing are bolted in place you can visually ensure the clutch fork ball stud is adjusted properly. Do not connect the remainder of the clutch linkage at this point. Move the clutch fork by hand until the release bearing contacts the clutch fingers. The outer end of the clutch fork should point towards the engine, ahead of the ball stud centerline as shown in FIG 3. If the outer end of the clutch fork is behind the ball stud centerline (pointing towards the transmission), your clutch linkage geometry is incorrect. Please re-visit the clutch fork pivot ball adjustment instructions or call the Centerforce Tech line at (928) 771-8422 for further assistance. Once the geometry is correct, connect the remainder of the clutch linkage and then adjust to where the clutch engagement point is approximately half-way up the pedal travel. Small adjustments can be made to suit individual driving preferences. Lastly, fully retract the release bearing away from the clutch fingers and visually check to ensure that you have at least 1/4" clutch wear allowance gap between the release bearing and the clutch fingers. Throughout the service life of your clutch, be sure to periodically check the wear allowance gap and adjust as needed. Caution! If the clutch engagement point is at or near the top of your clutch pedal travel – your clutch may be pre-loaded (release bearing too close or touching the clutch fingers). Continued operation with the clutch in a pre-loaded condition will void the warranty and cause poor performance as well as significant damage.
