# IMPORTANT

## Installation Notes for DF700000, DF559000, CFT260000, and CF260000

## FORD FLYWHEELS

## FORD CARS AND TRUCKS

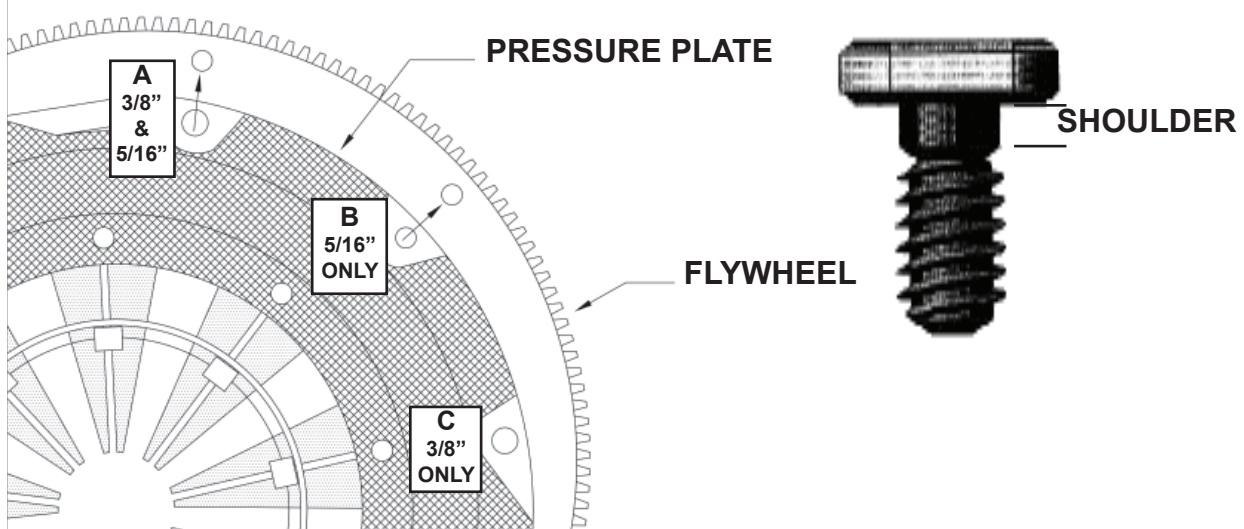
To avoid confusion on which holes to use when bolting the pressure plate to the flywheel. When installing a Centerforce pressure plate, the pressure plate has 9 bolt holes; only 6 of them will be used.

The picture below will help you in identifying which set of holes to use:

**NOTE:** 6 bolts are required to properly locate and fasten the pressure plate to the flywheel. Original equipment flywheels use (6) 5/16" shouldered bolts; bolt hole A & B (see above) to locate and retain the pressure plate. Some aftermarket flywheels may have a pattern aligning to the bolt holes A & C. The pressure plate may be bolted to such flywheels with shouldered 3/8" bolts in holes A & C.

**You must use shoulder type bolts** to mount the pressure plate to the flywheel. This will keep the clutch aligned properly on the flywheel and increase the shear strength. **Please do not use the improper bolts as you will be endangering your safety as well as affecting the balance of the assembly.**

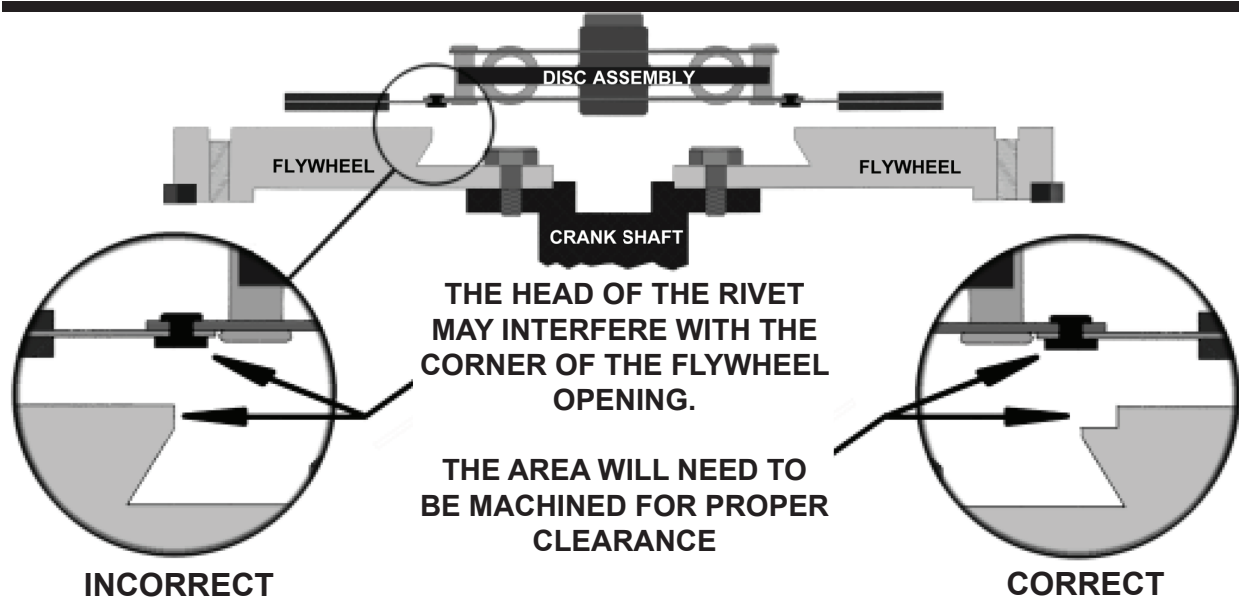
POSSIBLE INTERFERENCE MAY OCCUR BETWEEN THE CLUTCH DISC HUB TO MARCEL RIVETS DUE TO THE CENTER OPENING OF THE FLYWHEEL BEING INADEQUATE. THE RIVETS MAY RUB ON THE FACE OF THE FLYWHEEL. CAUSING THE ASSEMBLY TO RELEASE IMPROPERLY, MAKE NOISE DURING ENGAGEMENT, POSSIBLE FLYWHEEL AND DISC DAMAGE, AND/OR PREMATURE CLUTCH DISC FAILURE.

TO CORRECT THIS INTERFERENCE PROBLEM, A RELIEF MUST BE MACHINED INTO THE FLYWHEEL BY A QUALIFIED MACHINE SHOP. THE RELIEF SHOULD BE APPROXIMATELY .100" DEEP WITH SUFFICIENT DIAMETER TO CLEAR THE RIVET HEADS.
