## Installation Notes for DF700000, DF559000, CFT260000, and CF260000

## FORD FLYWHEELS

## ***GENERAL BELLHOUSING ALIGNMENT INSTRUCTIONS***

## EARLY FORDS USING THE PART NUMBERS:

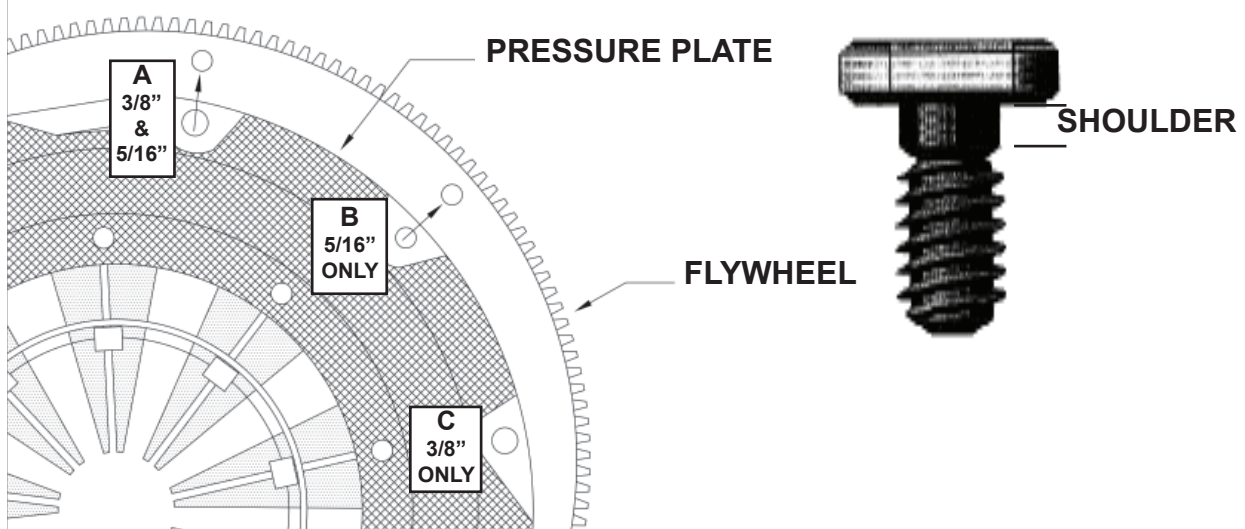
To avoid confusion on which holes to use when bolting the pressure plate to the flywheel. When installing a Centerforce pressure plate, the pressure plate has 9 bolt holes; only 6 of them will be used.

**NOTE:** 6 bolts are required to properly locate and fasten the pressure plate to the flywheel. Original equipment flywheels use (6) 5/16" shouldered bolts; bolt hole A & B (see above) to locate and retain the pressure plate. Some aftermarket flywheels may have a pattern aligning to the bolt holes A & C. The pressure plate may be bolted to such flywheels with shouldered 3/8" bolts in holes A & C.

**You must use shoulder type bolts** to mount the pressure plate to the flywheel. This will keep the clutch aligned properly on the flywheel and increase the shear strength. **Please do not use the improper bolts as you will be endangering your safety as well as affecting the balance of the assembly.**

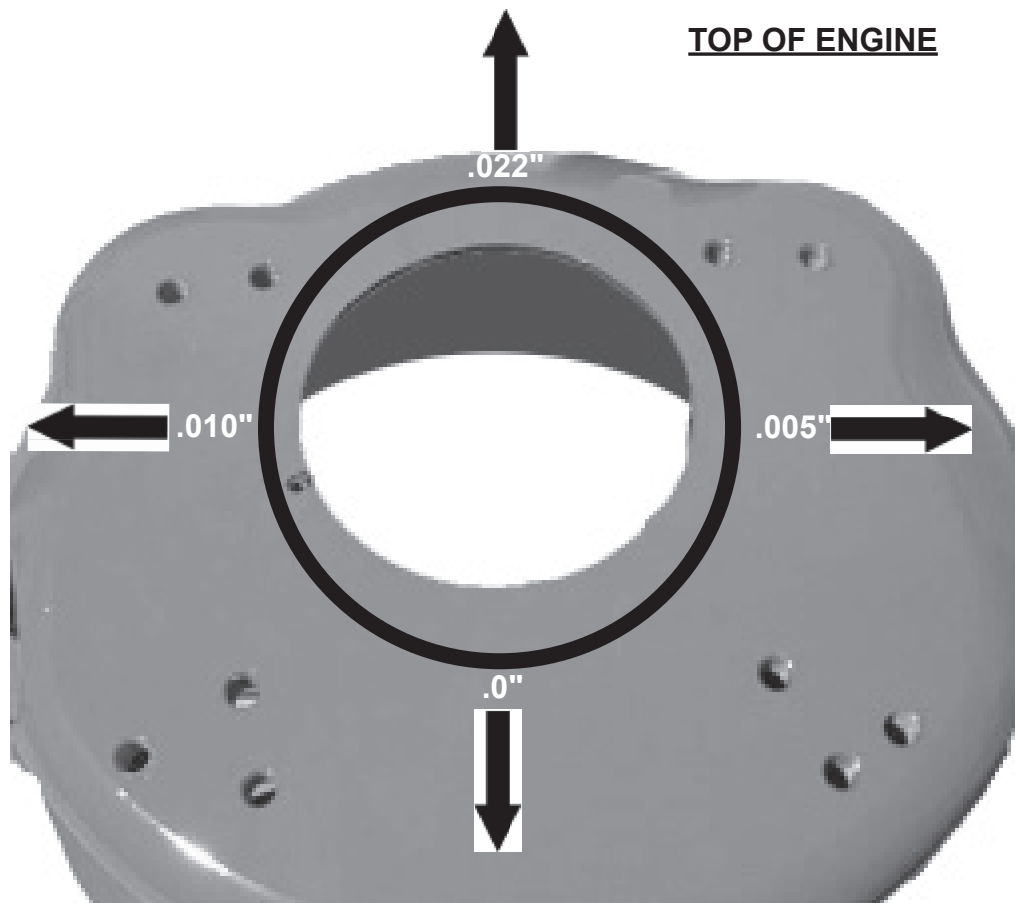
THE BELLHOUSING WAS OFFSET TOWARD TOP OF ENGINE AND SLIGHTLY TO THE LEFT (AS VIEWED FROM BEHIND). TO ALIGN THE BELLHOUSING, INSTALL TWO .014" OFFSET DOWEL PINS WITH THE MAXIMUM OFFSET POSITIONED ROUGHLY AT THE 5 O'CLOCK POSITION.

TO CORRECT OFF-CENTER CONDITION, SELECT THE OFFSET DOWEL PIN PAIR THAT IS CLOSEST TO ONE-HALF OF THE INDICATOR READING (I.E., IF READING IS .016", 1/2R=.008" USE .007" DOWELS. IF READING IS .024", 1/2R=.012" USE .014 DOWELS).
