MORRO BAY WATERSHED STEELHEAD RESTORATION PLANNING PROJECT

STREAM INVENTORY REPORT

CHORRO CREEK, 2001

Prepared to:
Coastal San Luis Resource Conservation District

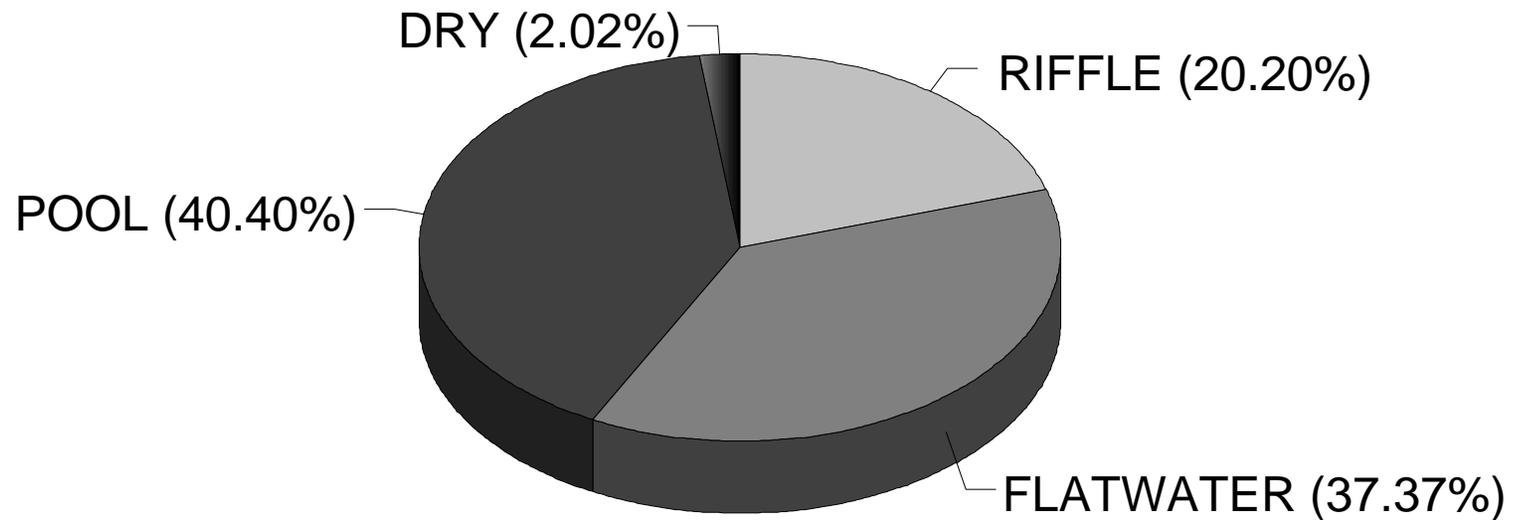
GRAPH 1

Table 1 summarizes the Level II riffle, flatwater, and pool habitat types. Based on frequency of occurrence there were 20% riffle units, 37% flatwater units, and 40% pool units (Graph 1). Based on total length of Level II habitat types there were 14% riffles, 43% flatwater units, and 33% pools (Graph 2).

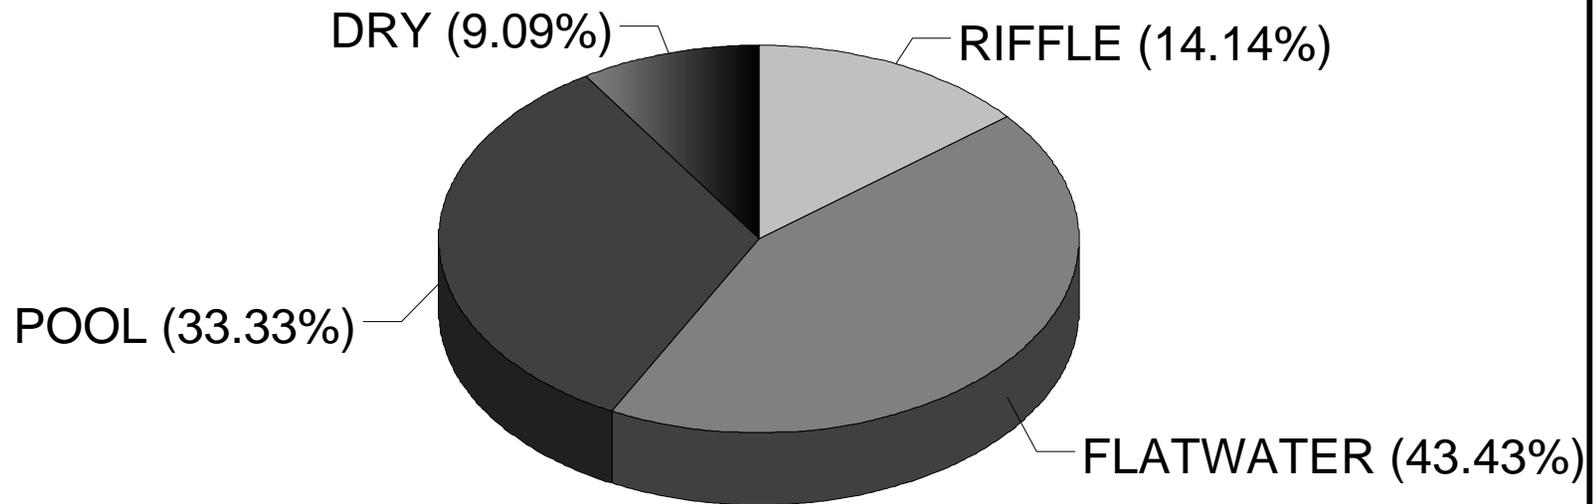
GRAPH 2

Flatwater habitat types comprised 43% of the total length of this survey, riffles 14%, and pools 33%. The pools are relatively deep, with 129 of the 241 pools (54%) pools having a maximum depth greater than 2 feet. In general, pool enhancement projects are considered when primary pools comprise less than 40% of the length of total stream habitat. In first and second order streams, a primary pool is defined to have a maximum depth of at least two feet, occupy at least half the width of the low flow channel, and be as long as the low flow channel width. Installing structures that will increase or deepen pool habitat is recommended in the B4 channel type.

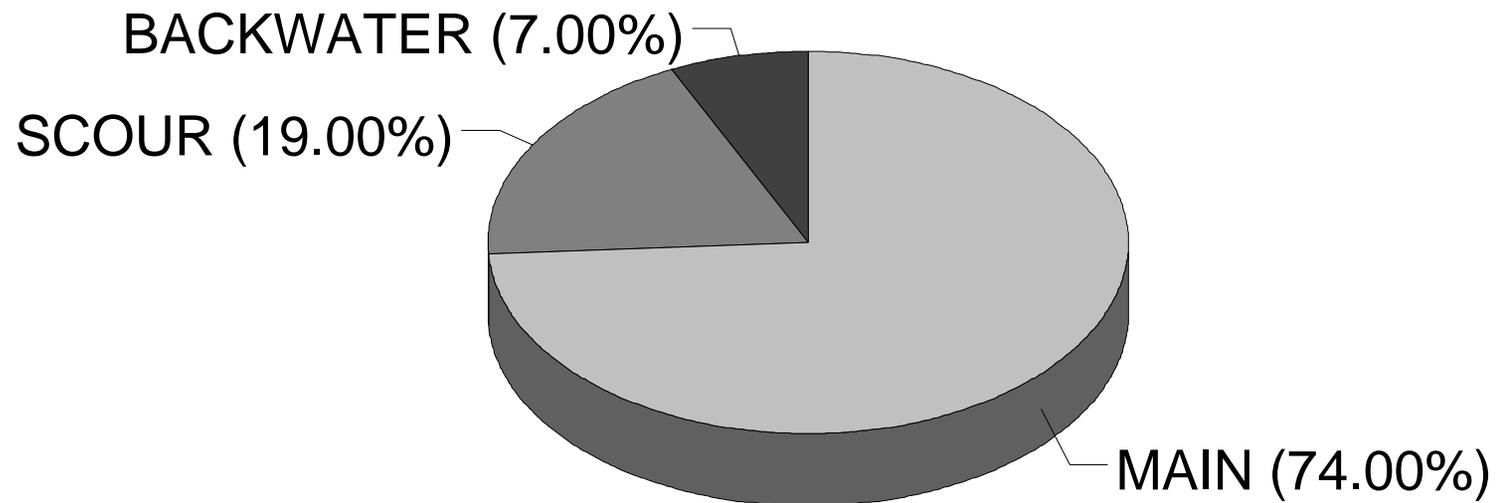
GRAPH 4

A total of 241 pools were identified (Table 3). Main-channel pools were most frequently encountered at 74% and comprised 82% of the total length of all pools (Graph 4).

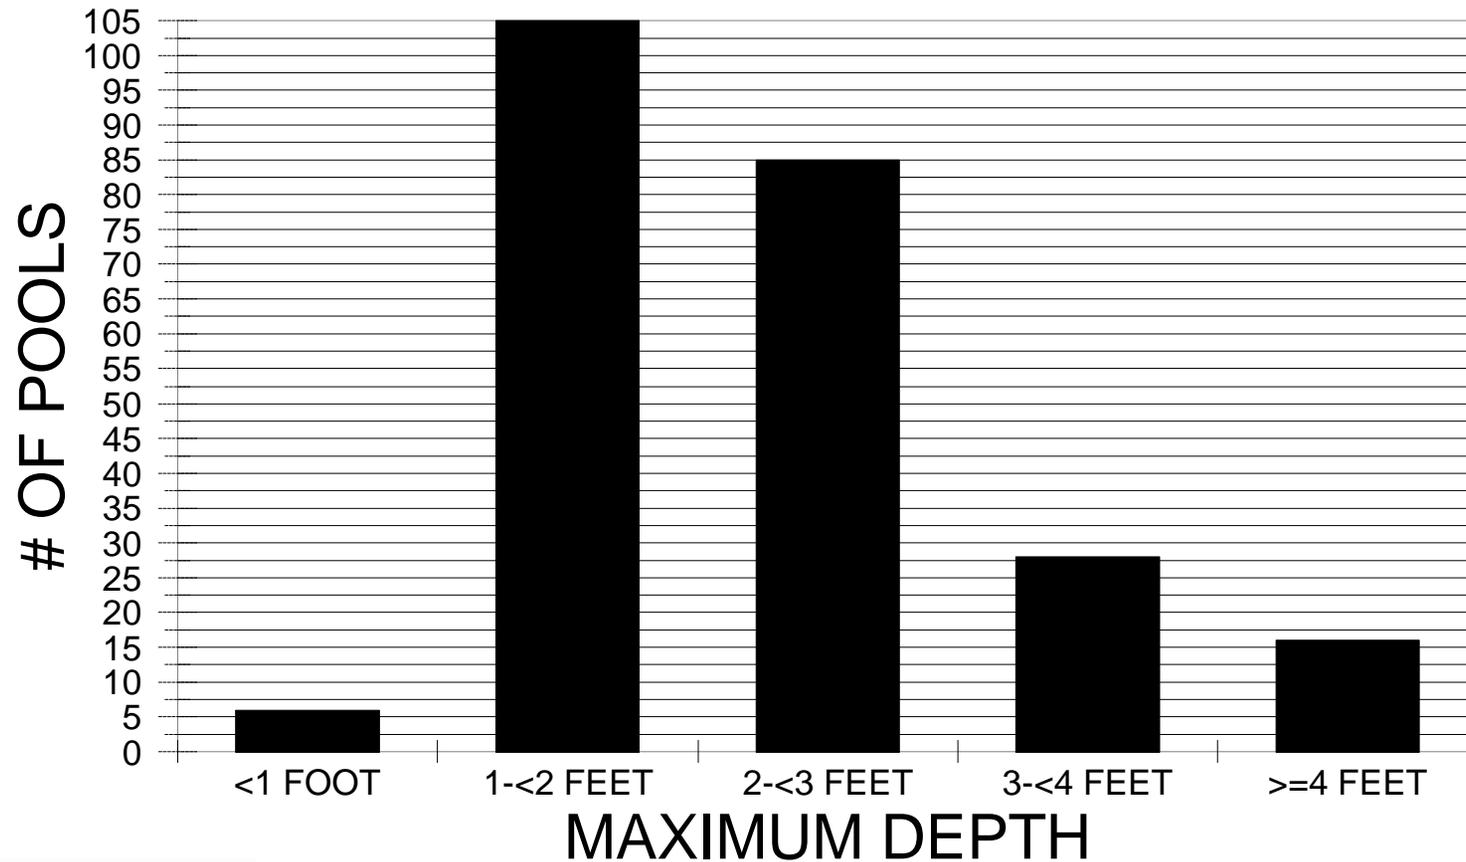
GRAPH 5

Table 4 is a summary of maximum pool depths by pool habitat types. Pool quality for salmonids increases with depth. One hundred and twenty-nine of the 241 pools (54%) had a depth of two feet or greater (Graph 5).

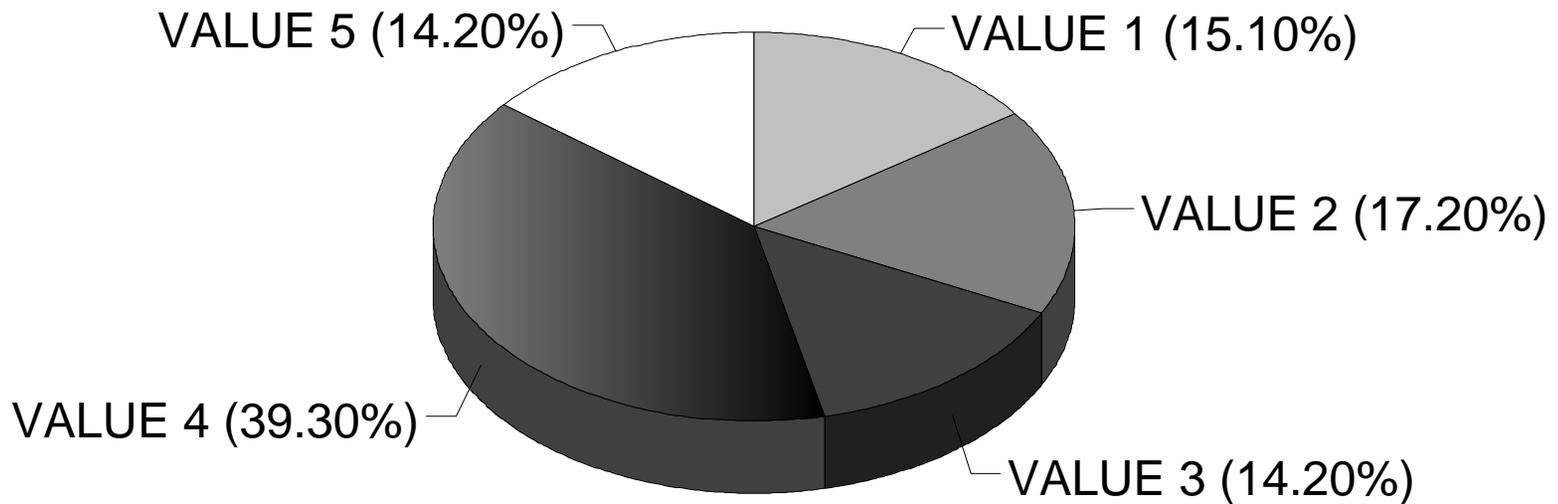
GRAPH 6

The depth of cobble embeddedness was estimated at pool tail-outs. Of the 239 pool tail-outs measured, 36 had a value of 1 (15%); 41 had a value of 2 (17%); 35 had a value of 3 (14%); 94 had a value of 4 (39%) and 33 had a value of 5 (14%) (Graph 6). On this scale, a value of 1 indicates the highest quality of spawning substrate and a value of 5 indicates the tail-out is not suitable for spawning. In Chorro Creek, five of the 241 pool tail-outs which were valued at 5 had silt/clay/sand or gravel too small to be suitable for spawning as the substrate. The other 28 tail-outs, valued at 5, were unsuitable for spawning due to the tail-outs being comprised of large cobble, boulder, bedrock or wood.

Thirty-six of the 239 pool tail-outs measured had an embeddedness rating of 1. Forty-one of the pool tail-outs had embeddedness rating of 2, and 129 pool tail-outs had ratings of 3 or 4. Thirty-three of the pool tail-outs had a rating of 5 or were considered unsuitable for spawning. Five of the 239 were unsuitable for spawning due to the dominant substrate being silt/sand/clay or gravel. Cobble embeddedness measured to be 25% or less, a rating of 1, is considered to indicate good quality spawning substrate for salmon and steelhead. In Chorro Creek, sediment sources should be mapped and rated according to their potential sediment yields, and control measures should be taken. An effort to map sediment sources is currently underway by the Morro Bay National Estuary Program.

- 4) Inventory and map sources of stream bank erosion and prioritize them according to present and potential sediment yield. Identified sites should then be treated to reduce the amount of fine sediments entering the stream.

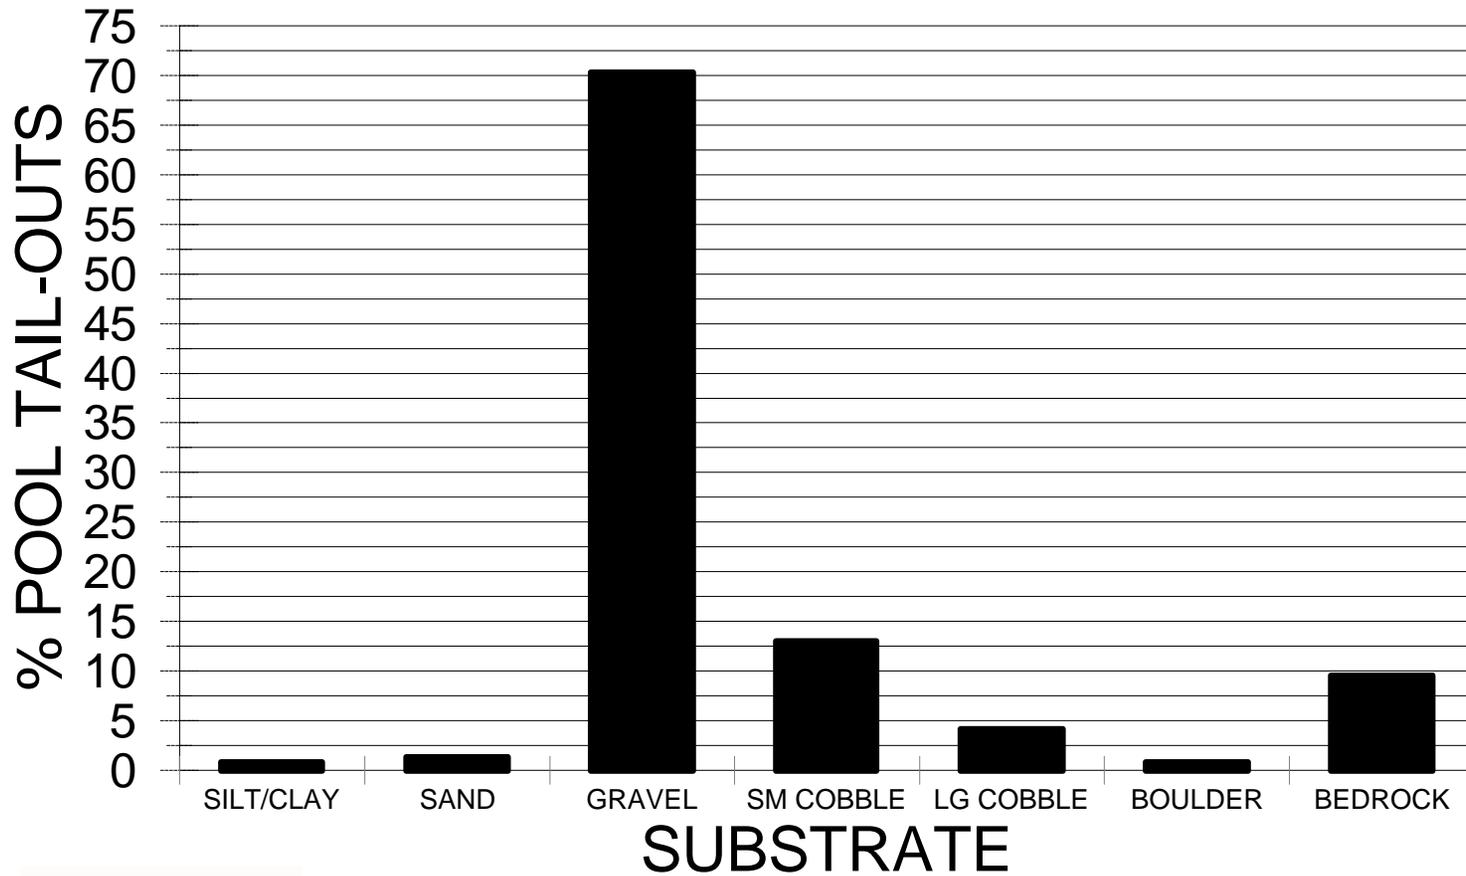
GRAPH 8

Table 6 summarizes the dominant substrate by habitat type. Graph 8 shows the dominant substrate observed in pool tail-outs. Gravel was the dominant substrate observed in 70% of the pool tail outs; small cobble was the next most frequently observed substrate type at 13%.

One hundred and ninety-nine of the 239 pool tail outs measured had gravel or small cobble as the dominant substrate. This is generally considered good for spawning salmonids.

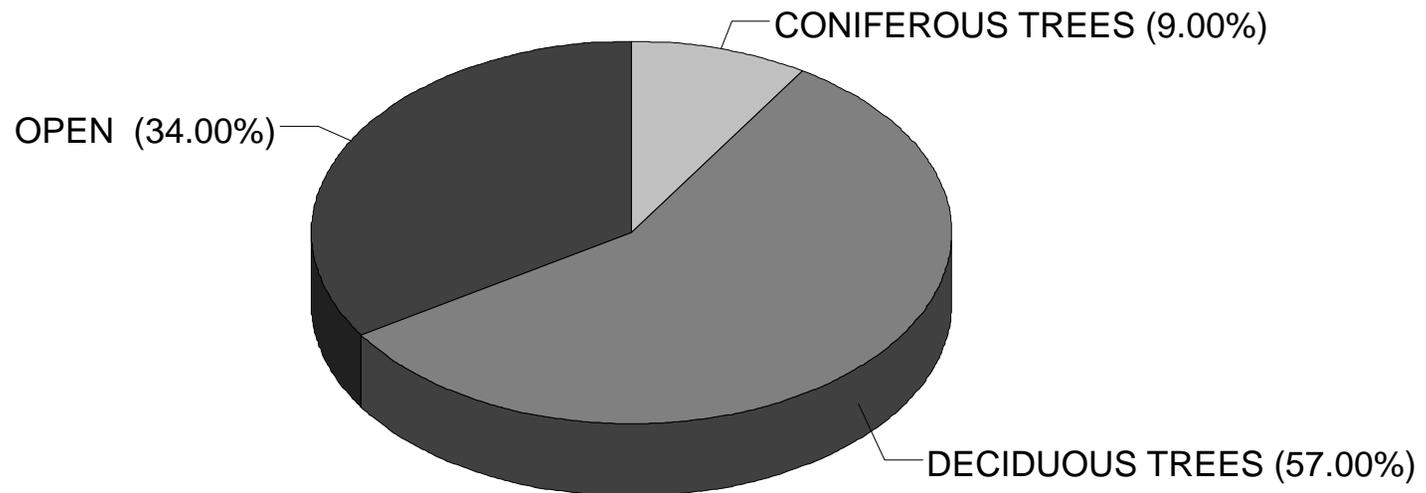
GRAPH 9

The mean percent canopy density for the surveyed length of Chorro Creek was 66%. The mean percentages of deciduous and coniferous trees were 87% and 13%, respectively. Graph 9 describes the canopy in Chorro Creek.

The mean percent canopy density for the stream was 66%. This is a relatively low percentage of canopy. In general, revegetation projects are considered when canopy density is less than 80%. Each reach in Chorro Creek had less than 80% mean percent canopy density (Table 8). A planting project has already been implemented in Reach 2 at the Chorro Flats section, which should eventually increase canopy cover in this area. Reaches 6 and 7 have the lowest relative canopy levels, and also visually appear to have the longest stretches of little to no canopy. Therefore, these areas should be given high priority for revegetation projects.
