PSEUDO TEETH- A CONE BEAM COMPUTED TOMOGRAPHY ARTEFACT**Sahana K.¹, Vijayendranath Nayak*¹, Raghavendra Kini², Prasanna Kumar Rao³, Gowri P. Bhandarkar⁴,
Roopashri Rajesh Kashyap⁴**¹Postgraduate Student, Department of Oral Medicine and Radiology, AJ Institute of Dental Sciences, Kuntikana, Mangaluru, Karnataka, India.²Professor and Head, Department of Oral Medicine and Radiology, AJ Institute of Dental Sciences, Kuntikana, Mangaluru, Karnataka, India.³Professor Department of Oral Medicine and Radiology, AJ Institute of Dental Sciences, Kuntikana, Mangaluru, Karnataka, India.⁴Reader, Department of Oral Medicine and Radiology, AJ Institute of Dental Sciences, Kuntikana, Mangaluru, Karnataka, India.***Corresponding Author: Dr. Vijayendranath Nayak**

PSEUDO TEETH- A CONE BEAM COMPUTED TOMOGRAPHY ARTEFACT

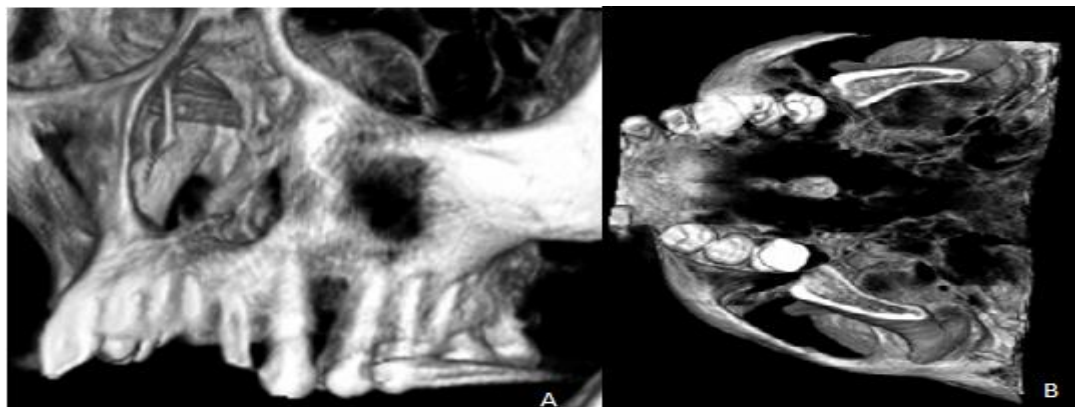
**FIGURE 1**

A 22 years old female patient has visited the outpatient department with the requisition for CBCT (cone beam computed tomography) of maxillary arch. CBCT on 3D reconstruction, revealed a structure resembling the tooth, lying horizontally adjacent to buccal aspect of left maxillary second premolar crown extending till coronal aspect of maxillary left third molar thus giving a illusion of hanging tooth.(FIGURE 1A).

However on axial section, tooth was not evident, suggesting that it could be a CBCT artefact. (FIGURE

1B) The artefact was probably due to the beam hardening effect by the metallic restoration on the maxillary first molar. CBCT is mainly designed for imaging the orofacial area, which is suitable for diagnosing any pathology. As they say, "Every good thing has a dark side" CBCT is not a exception. The dark side of CBCT is contributed by the artefact. Artefact may simulate pathology often leading to a misdiagnosis.^[1] though various forms of artefacts are encountered in CBCT; the most highlighted is beam hardening artefact which was observed in the above case. As the beam passes through object like metal serves as a filter within the object and lower energy waves are emitted resulting in dark streaks.^[2,3,4,5]

FIGURE 1A-Showing tooth like structure, lying horizontally adjacent to buccal aspect of left maxillary second premolar.

FIGURE 1B-Showing tooth like structure, lying horizontally adjacent to buccal aspect of left maxillary second premolar.
