2025 Shoreland and Shallows Habitat Monitoring Survey

Lake Ripley, Jefferson County, Wisconsin

By: Lianna Spencer, Lake Manager, Lake Ripley Management District

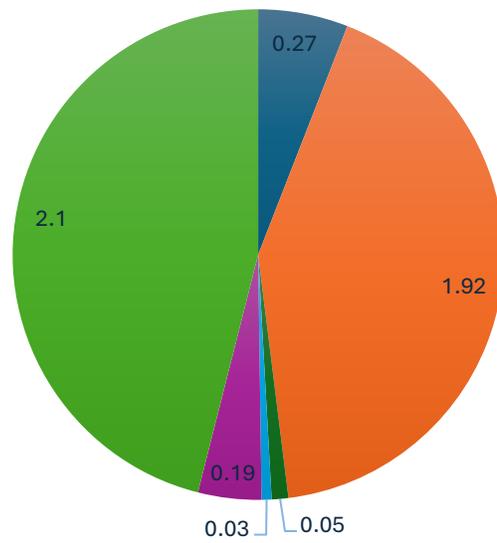
Substrate Type on Lake Ripley

Each time the substrate changed a GPS waypoint was taken and the predominant substrate class observed was recorded. There were fourteen times the substrate changed while making the second loop around Lake Ripley. The most dominant substrate recorded was sand with 2.1 miles of shoreline, followed by organic matter with 1.92 miles of shoreline. The other substrate classes were all observed, but were less prevalent than sand and organic matter.

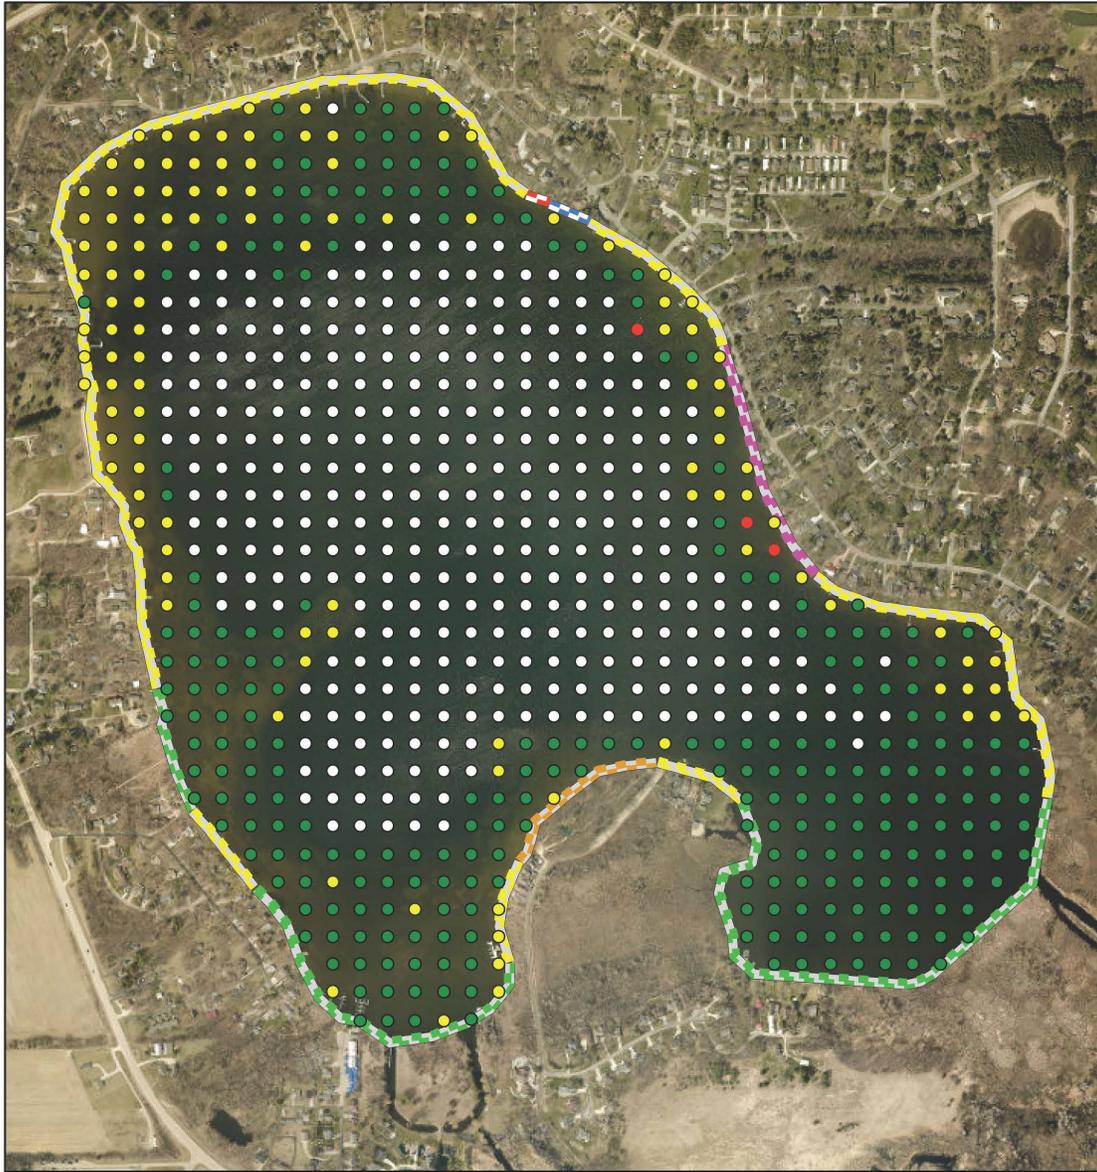
Lake Ripley Nearshore Substrate and Lake Sediment Type

Nearshore substrate type shown on this map of Lake Ripley.

The nearshore habitat has never been recorded before, making the 2025 data the baseline data set. Sand is currently the majority, leading only by 0.18 miles. Protecting and preserving aquatic plant beds will help

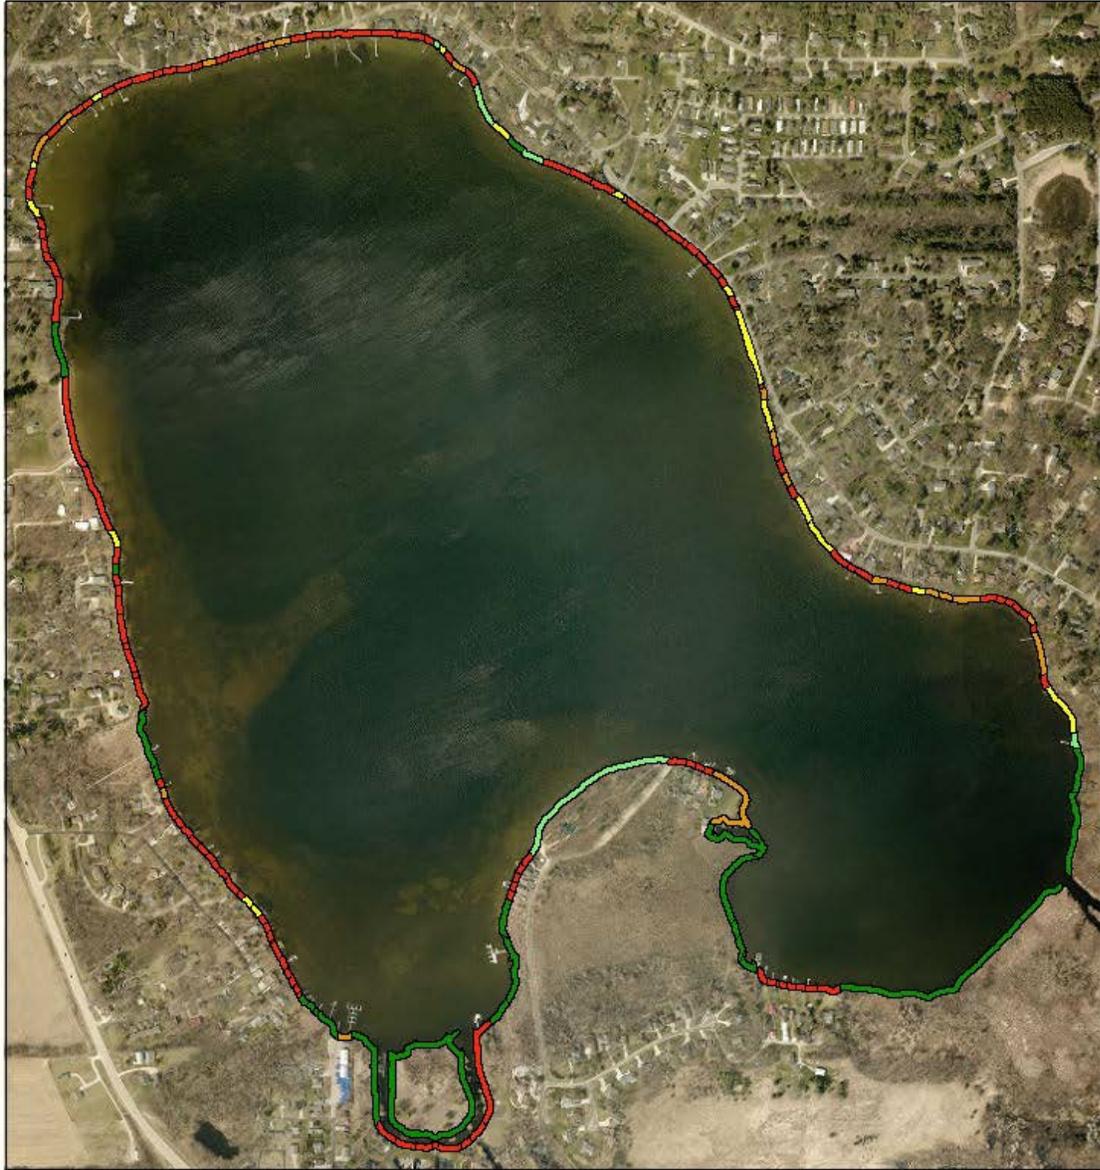
Herbaceous & Shrub Cover within 35 Feet of Lake Ripley

A whopping 22.8% of parcels had no shrub or herbaceous cover. In 2020, that number was lower at 14.3%. Within five years' time, an additional 8.5% of Lake Ripley's shoreline was converted to have fewer natural conditions. If this trend continues, Lake Ripley's water quality could suffer from runoff pollution.

The amount of shoreland vegetation along the lake should be increased in order to achieve more water quality protections and to increase habitat for fish and other

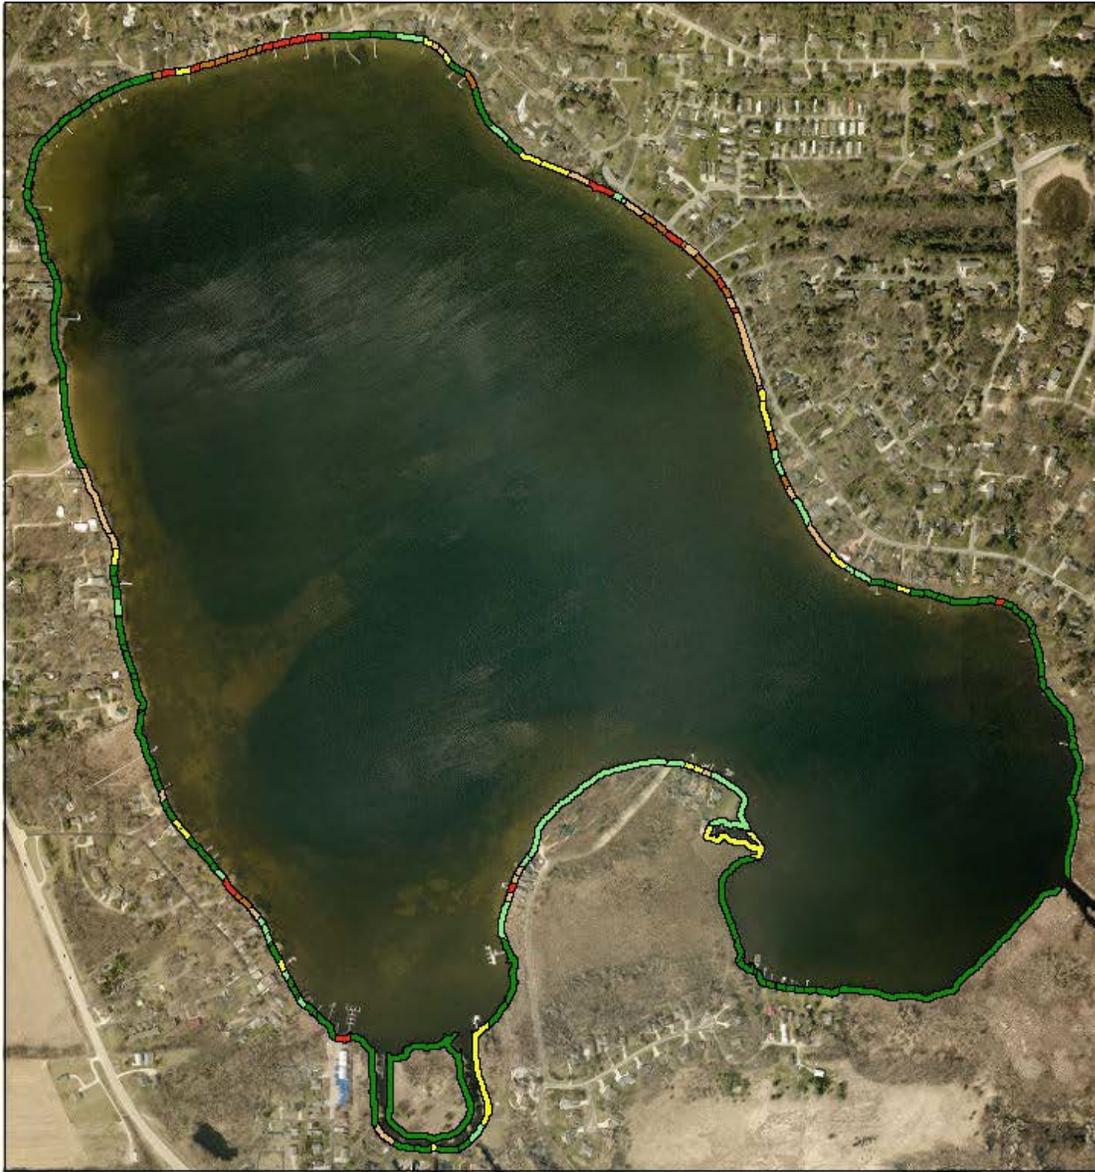
Impervious Surfaces Cover within 35 Feet of Lake Ripley

Of the 184 parcels sampled, 12.5% of the parcels had impervious surface $\geq 55\%$, a 3.9% increase from the 2020 survey. Increasing impervious surfaces around the lake will contribute to excessive aquatic plant growth and increased algae blooms. Fish populations decline as impervious surface coverage increases (Markham and Dunzik, 2012).

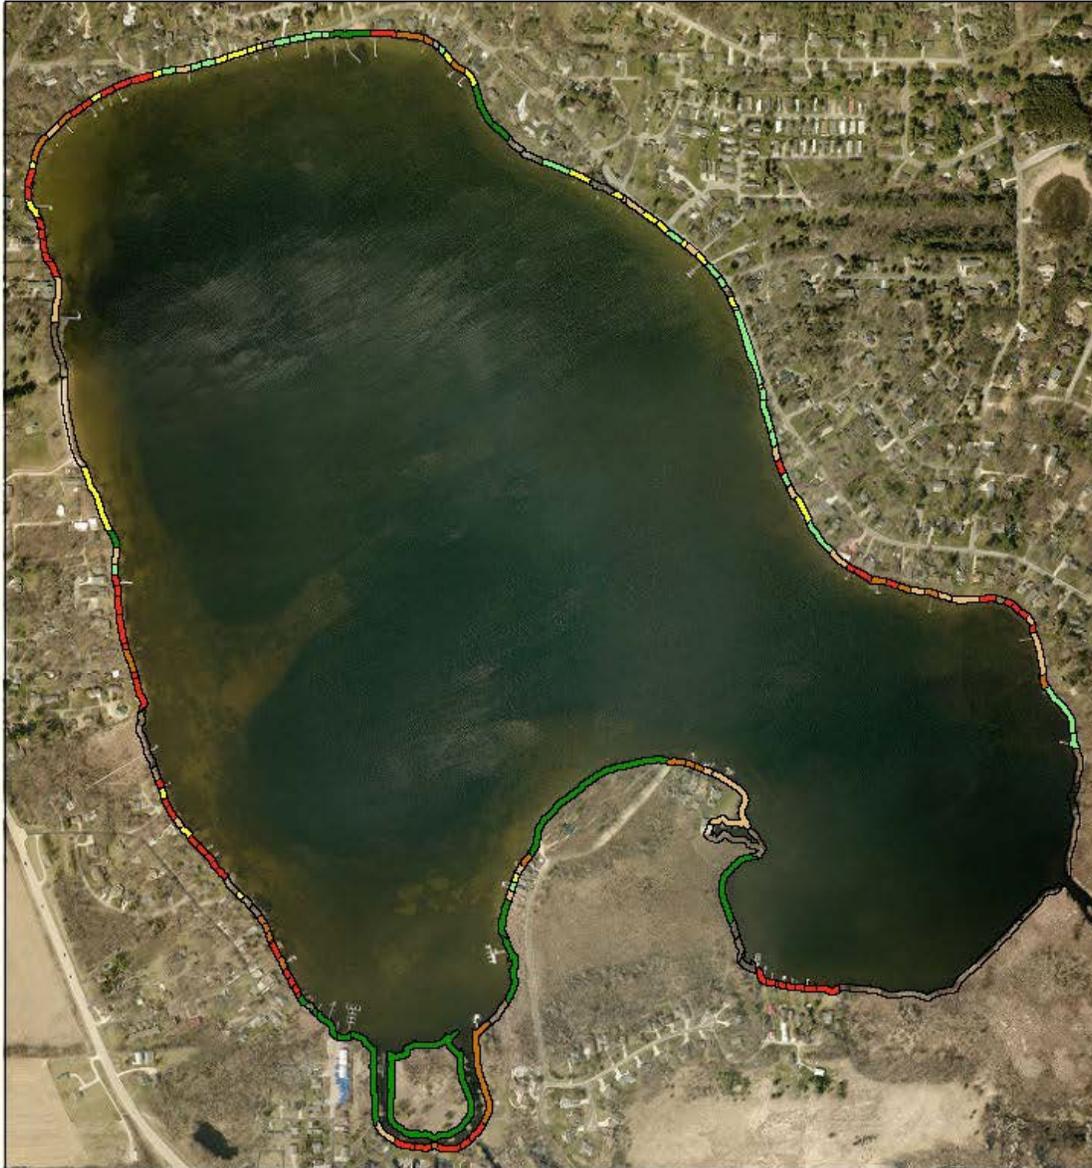
Manicured Lawn within 35 Feet of Lake Ripley

The amount of parcels with 0% lawn cover decreased by two parcels in 2025. There were noteworthy changes that were seen in the 30-50%, 55-75% and 80-100% manicured lawn categories. The 30-50% category increased by 7% since 2020, the 55-75% category decreased by 9%, and the 80-100% category increased by 7%. Overall, the average manicured lawn increased by 3.8% since 2020.

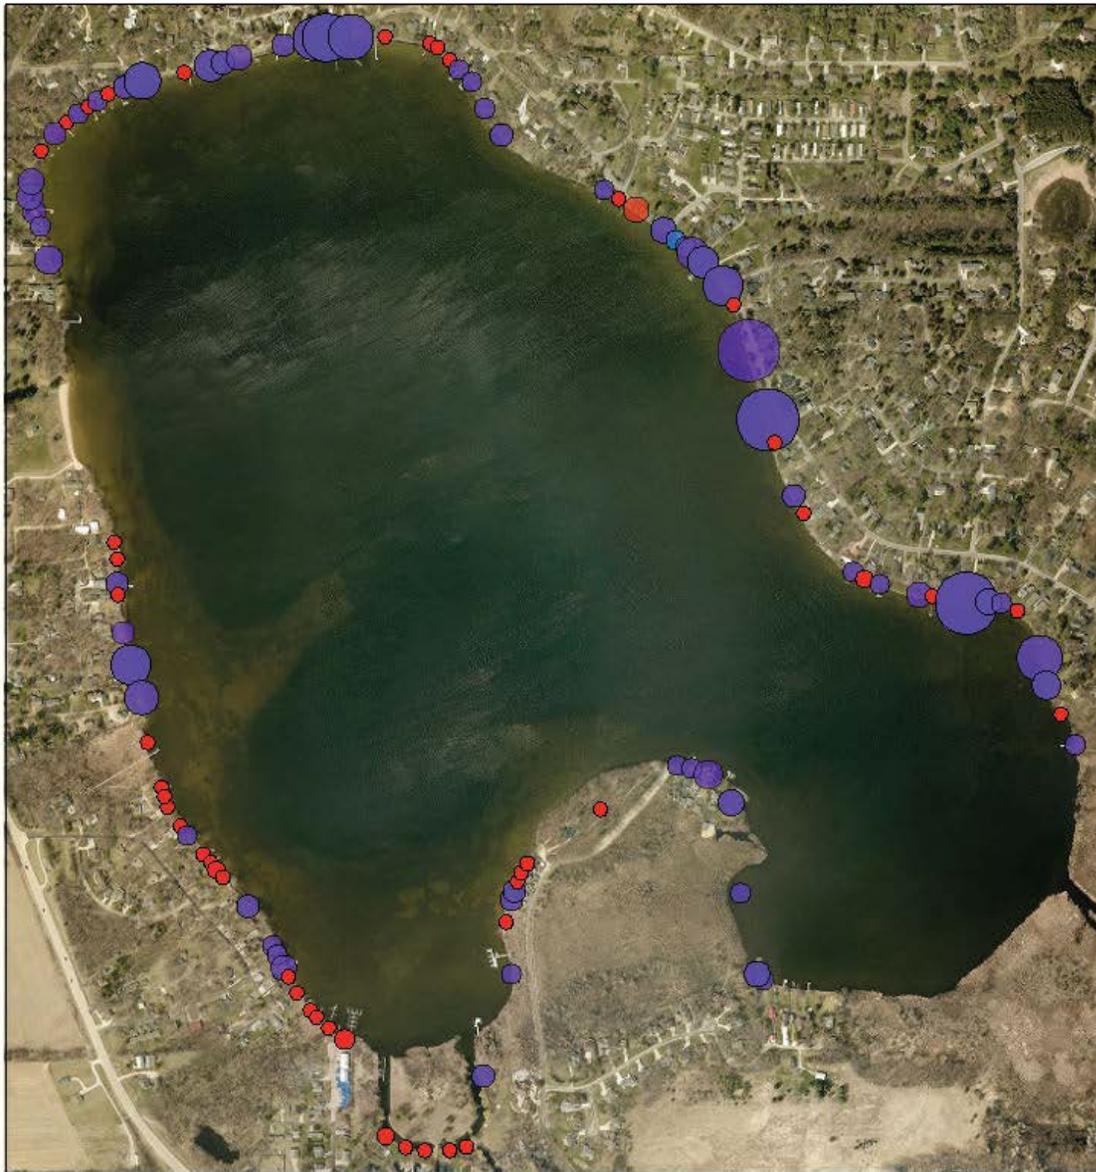
Human Structures around Lake Ripley

In 2025, 186 piers were counted on Lake Ripley over 154 parcels. That is seven more piers than the 2020 data. Eleven parcels had two piers, and four parcels had three piers. One parcel had a whopping 14 piers! This was one of the many homeowners’ associations found on the lake.
