POWDER COATING QUALITY: WHAT TO ASK AND LOOK FOR AND SOME BASIC TESTS?

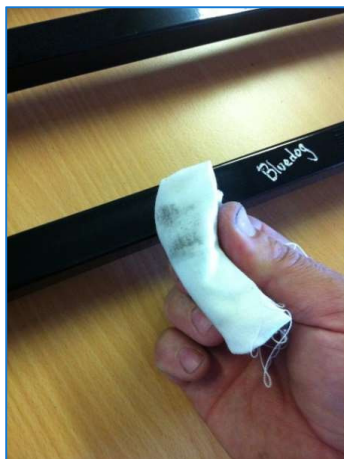
This image shows the white rag after a light rub laterally across the face of the tube of product powder coated by Bluedog (15 cycles). This result indicates the coating passes the MEK solvent rub test per AS4506.

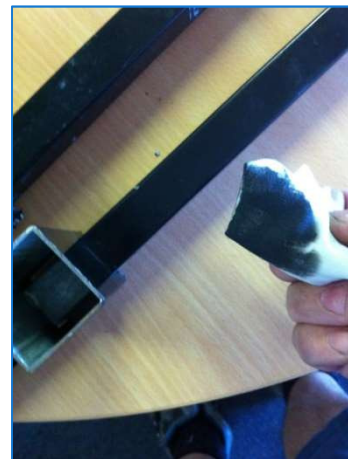
This image shows the white rag after a light rub laterally across the surface of the tube (10 cycles). The presence of extensive coating on the rag indicates a failure of the coating to pass the MEK solvent rub test per AS4506.

This indicates poor quality powder, poor metal pretreatment and under cure of the powder. Under cure means the mechanical and corrosion protection qualities of the coating are compromised. Image of 'new' fence.

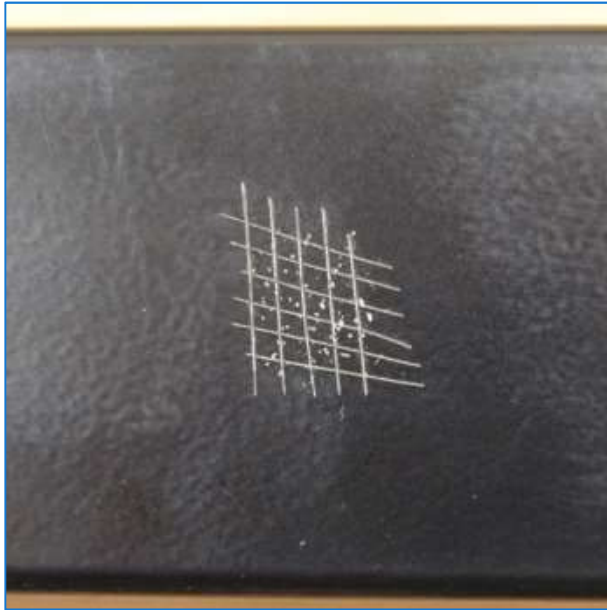
This image shows the cross hatch test of product powder coated by Bluedog. A tool/ blade creates a cross hatch on the powder surface. The powder sections should adhere when flicked with the edge of the blade. The lack of delamination of the square hatches indicates the coating passes the cross hatch test under AS4506.

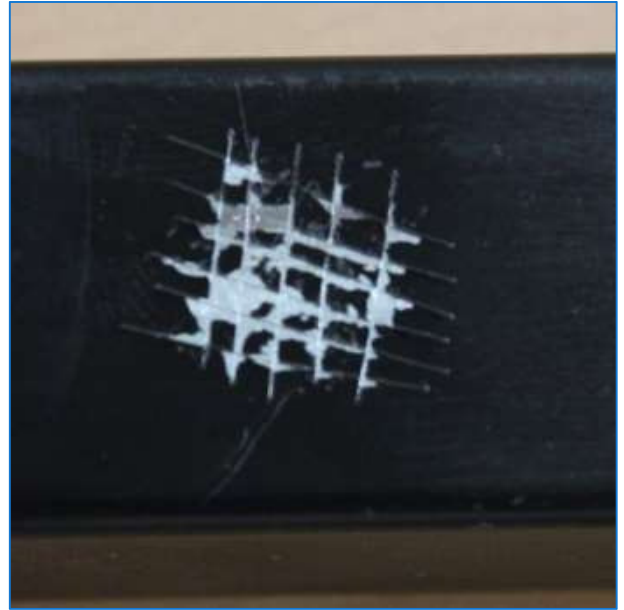
This image shows the cross hatch test of product powder coated in the market. The delamination of the square hatches indicates the coating fails to meet the cross hatch test under AS4506. Image of 'new' fence.

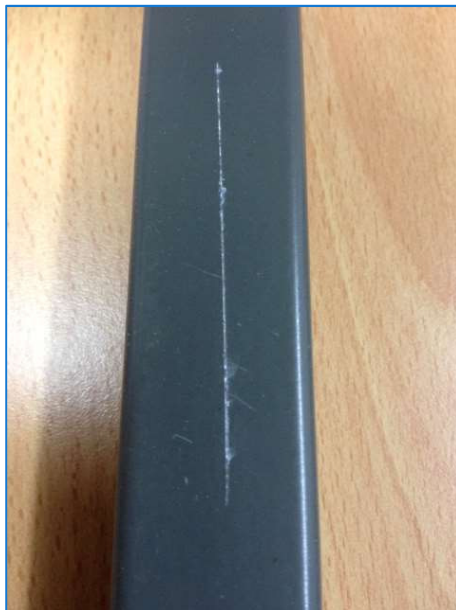
This image shows a Bluedog sample tube after Neutral Salt Spray (NSS) adhesion test at 1000 hours. There is less than 2mm of under cut (delamination) off the scribe indicates the coating passes the NSS test under AS4506.

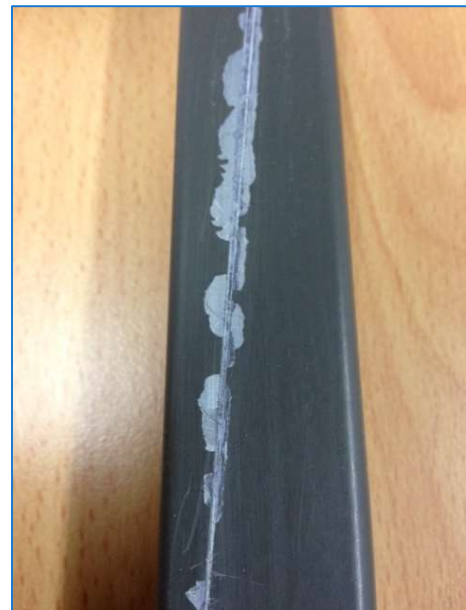
This image shows a sample tube after Neutral Salt Spray (NSS) adhesion test at 1000 hours. There is significant under cut (delamination) off the scribe indicates the coating fails the NSS test under AS4506 at 1000 hours.

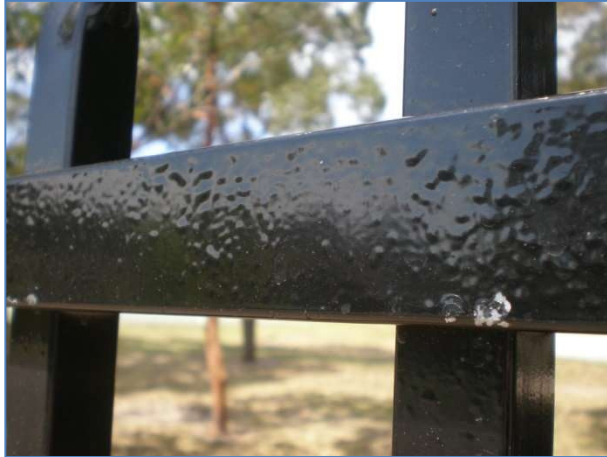
An example of the powder application being too 'heavy'. This powder film will be under cured and as a result the proper mechanical properties of the film will not have been achieved. The film will be 'soft' and will readily delaminate.

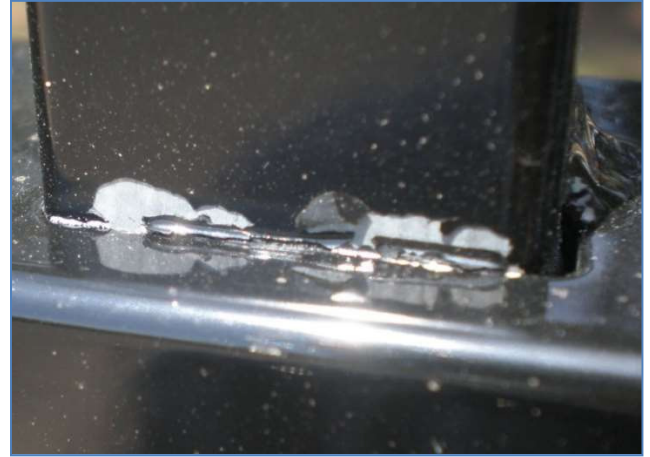
An example of the powder film delaminating as a result of poor metal pretreatment and under cure. This image was taken less than 1 month after installation of the fence.

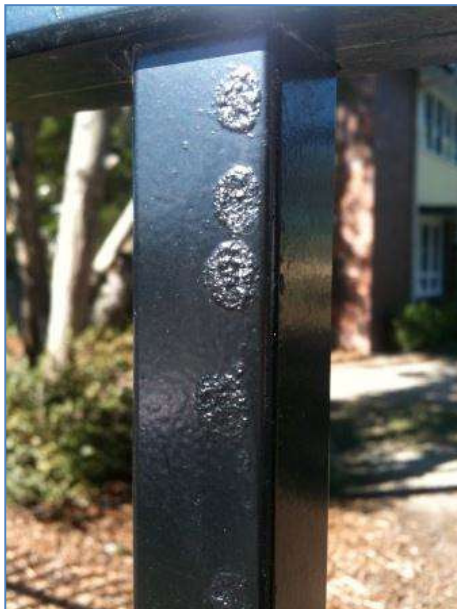
An example of blistering of the powder coating or the 'orange peel' effect a result of poor quality metal surface preparation on an imported panel. This image was taken less than 18 months after installation of the fence.

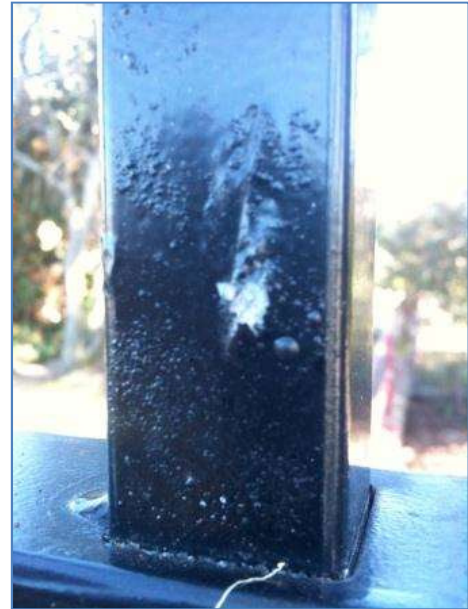
An example of delamination (failure) of the powder film. This is likely a result of contaminants or oxidation (white rust) on the surface of the steel before coating. This image was taken less than 18 months after installation of the fence.

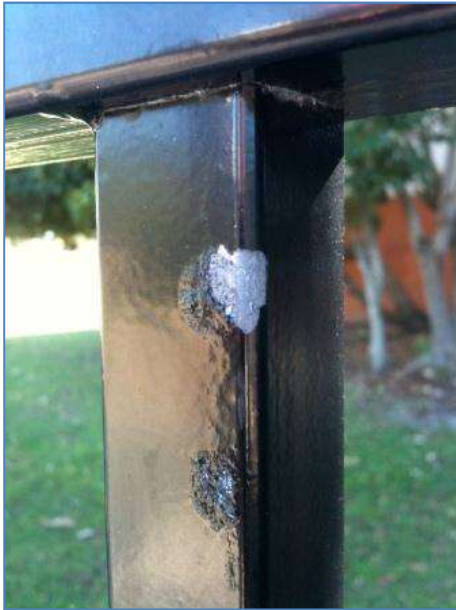
An example of delamination of the powder film. This image was taken less than 18 months after installation of the fence.

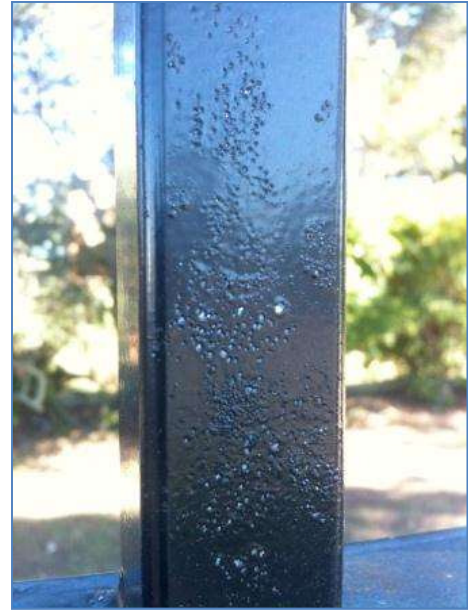
An example of 'pin holing' most likely a result of low quality powders and/ or poor pretreatment and cleaning of the steel surface before coating. This image was taken less than 18 months after installation of the fence.

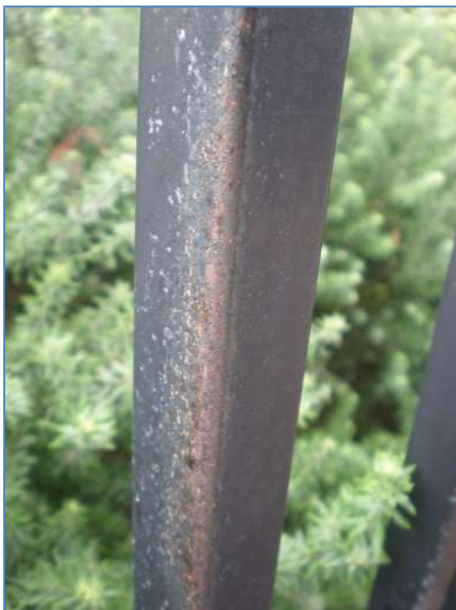
An example of the result of using low quality powder and insufficient coating thickness. The coating has severely faded. The coating has offered little barrier corrosion protection of the steel resulting in aggressive corrosion. This image was taken less than 24 months after installation of the fence.

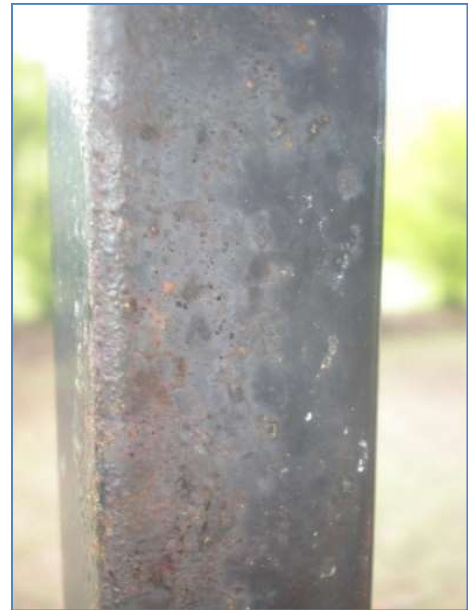
A close up of image (left) showing failure of the powder coating at 24 months. The film has severely faded and lost its barrier corrosion protection qualities.
