RCWD BOARD OF MANAGERS WORKSHOP

MEMO

Date: January 8, 2015

Subject: Washington County Judicial Ditches 5, 6,
and 7 (WJD 5, 6, & 7) Historical Review

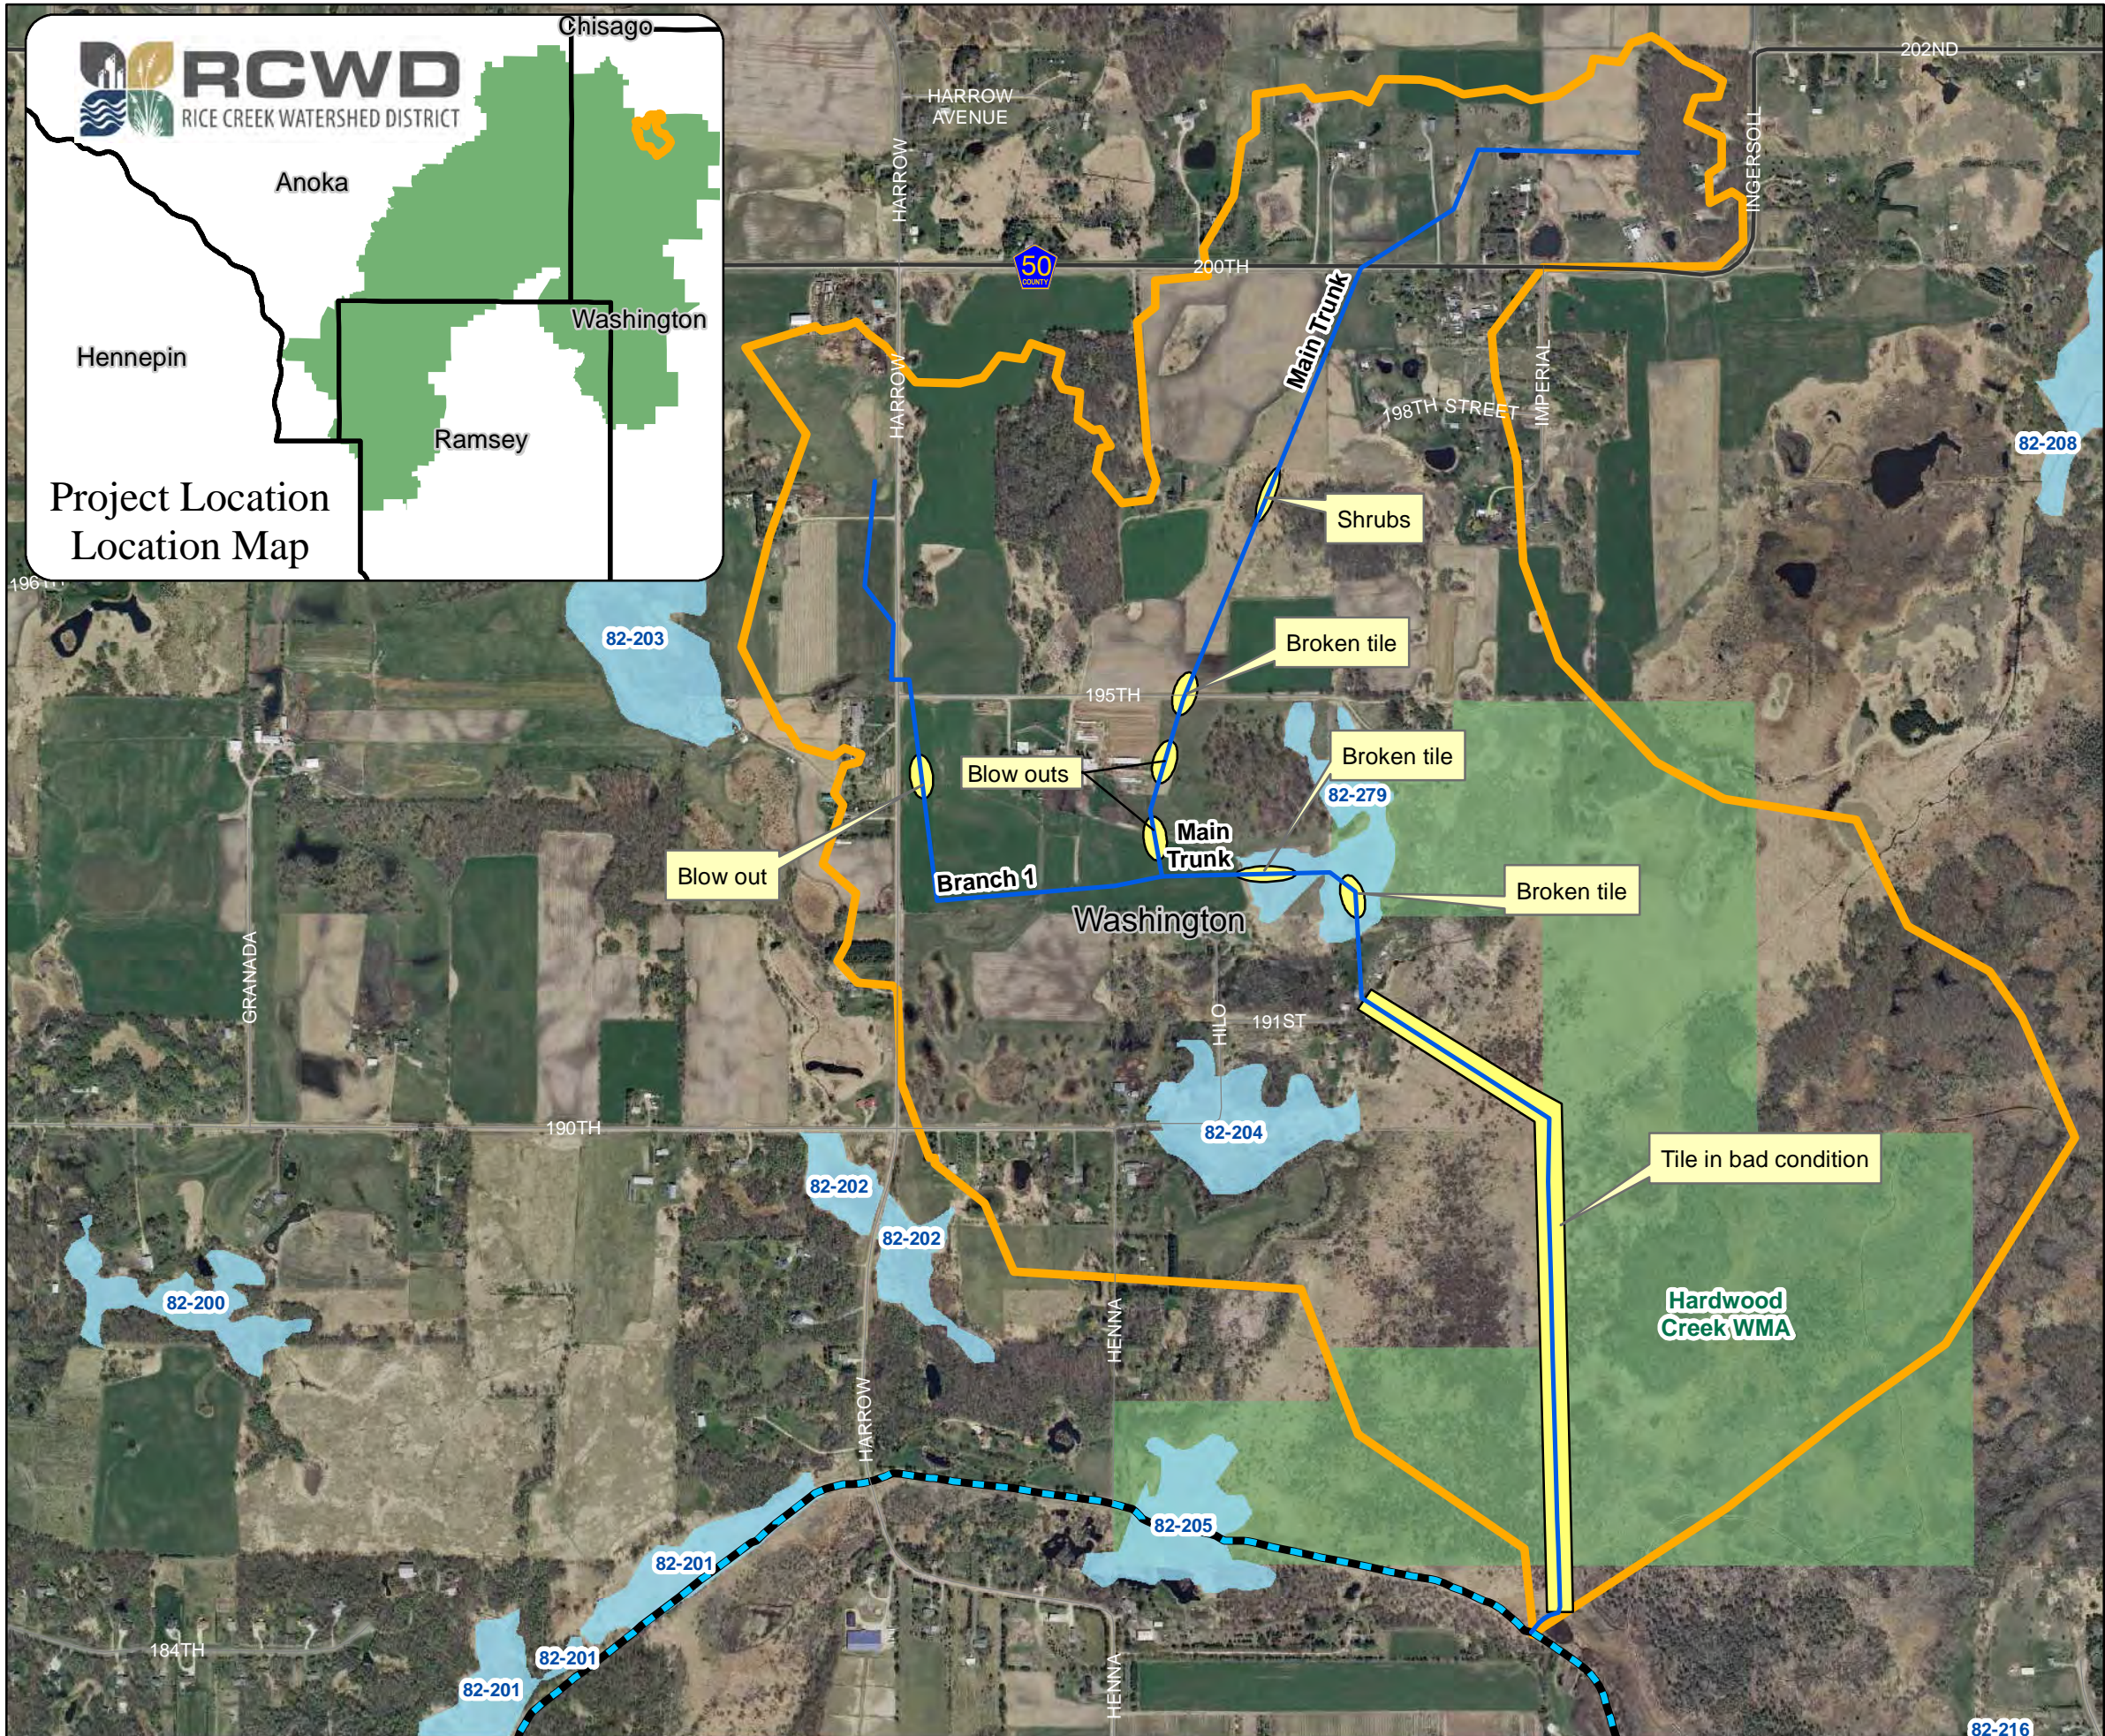
Figure 7: Problem Areas - Washington County Judicial Ditch 5					
Scale: AS SHOWN	Drawn by: SMW	Checked by:	Project No.: 5555-233	Date: 10/10/2014	Sheet: 1 of 1
			Maple Grove P: 763.493.4522 F: 763.493.5572

Tile blowouts, or ruptures, are the primary known problems within the drainage system which need to be addressed. Because of the large contributing drainage area and flat tile grades, the original clay tile system has experienced blowouts at various locations throughout the tile system.

Problem areas on the WJD 5 public drainage system consist primarily of blow outs on both the Main Trunk and Branch 1, as well as tiles that are broken, in poor condition, or plugged with roots on the Main Trunk. These problem areas are shown in **Figure 7**.

Many tile blowouts have been repaired under the RCWD's maintenance program. Although these repairs provide temporary relief from some drainage problems in the system, they do not address the underlying causes of the blowout failures, including the age and condition of the overall system and the lack of capacity in the system to accommodate the runoff volumes generated by the contributing drainage area.

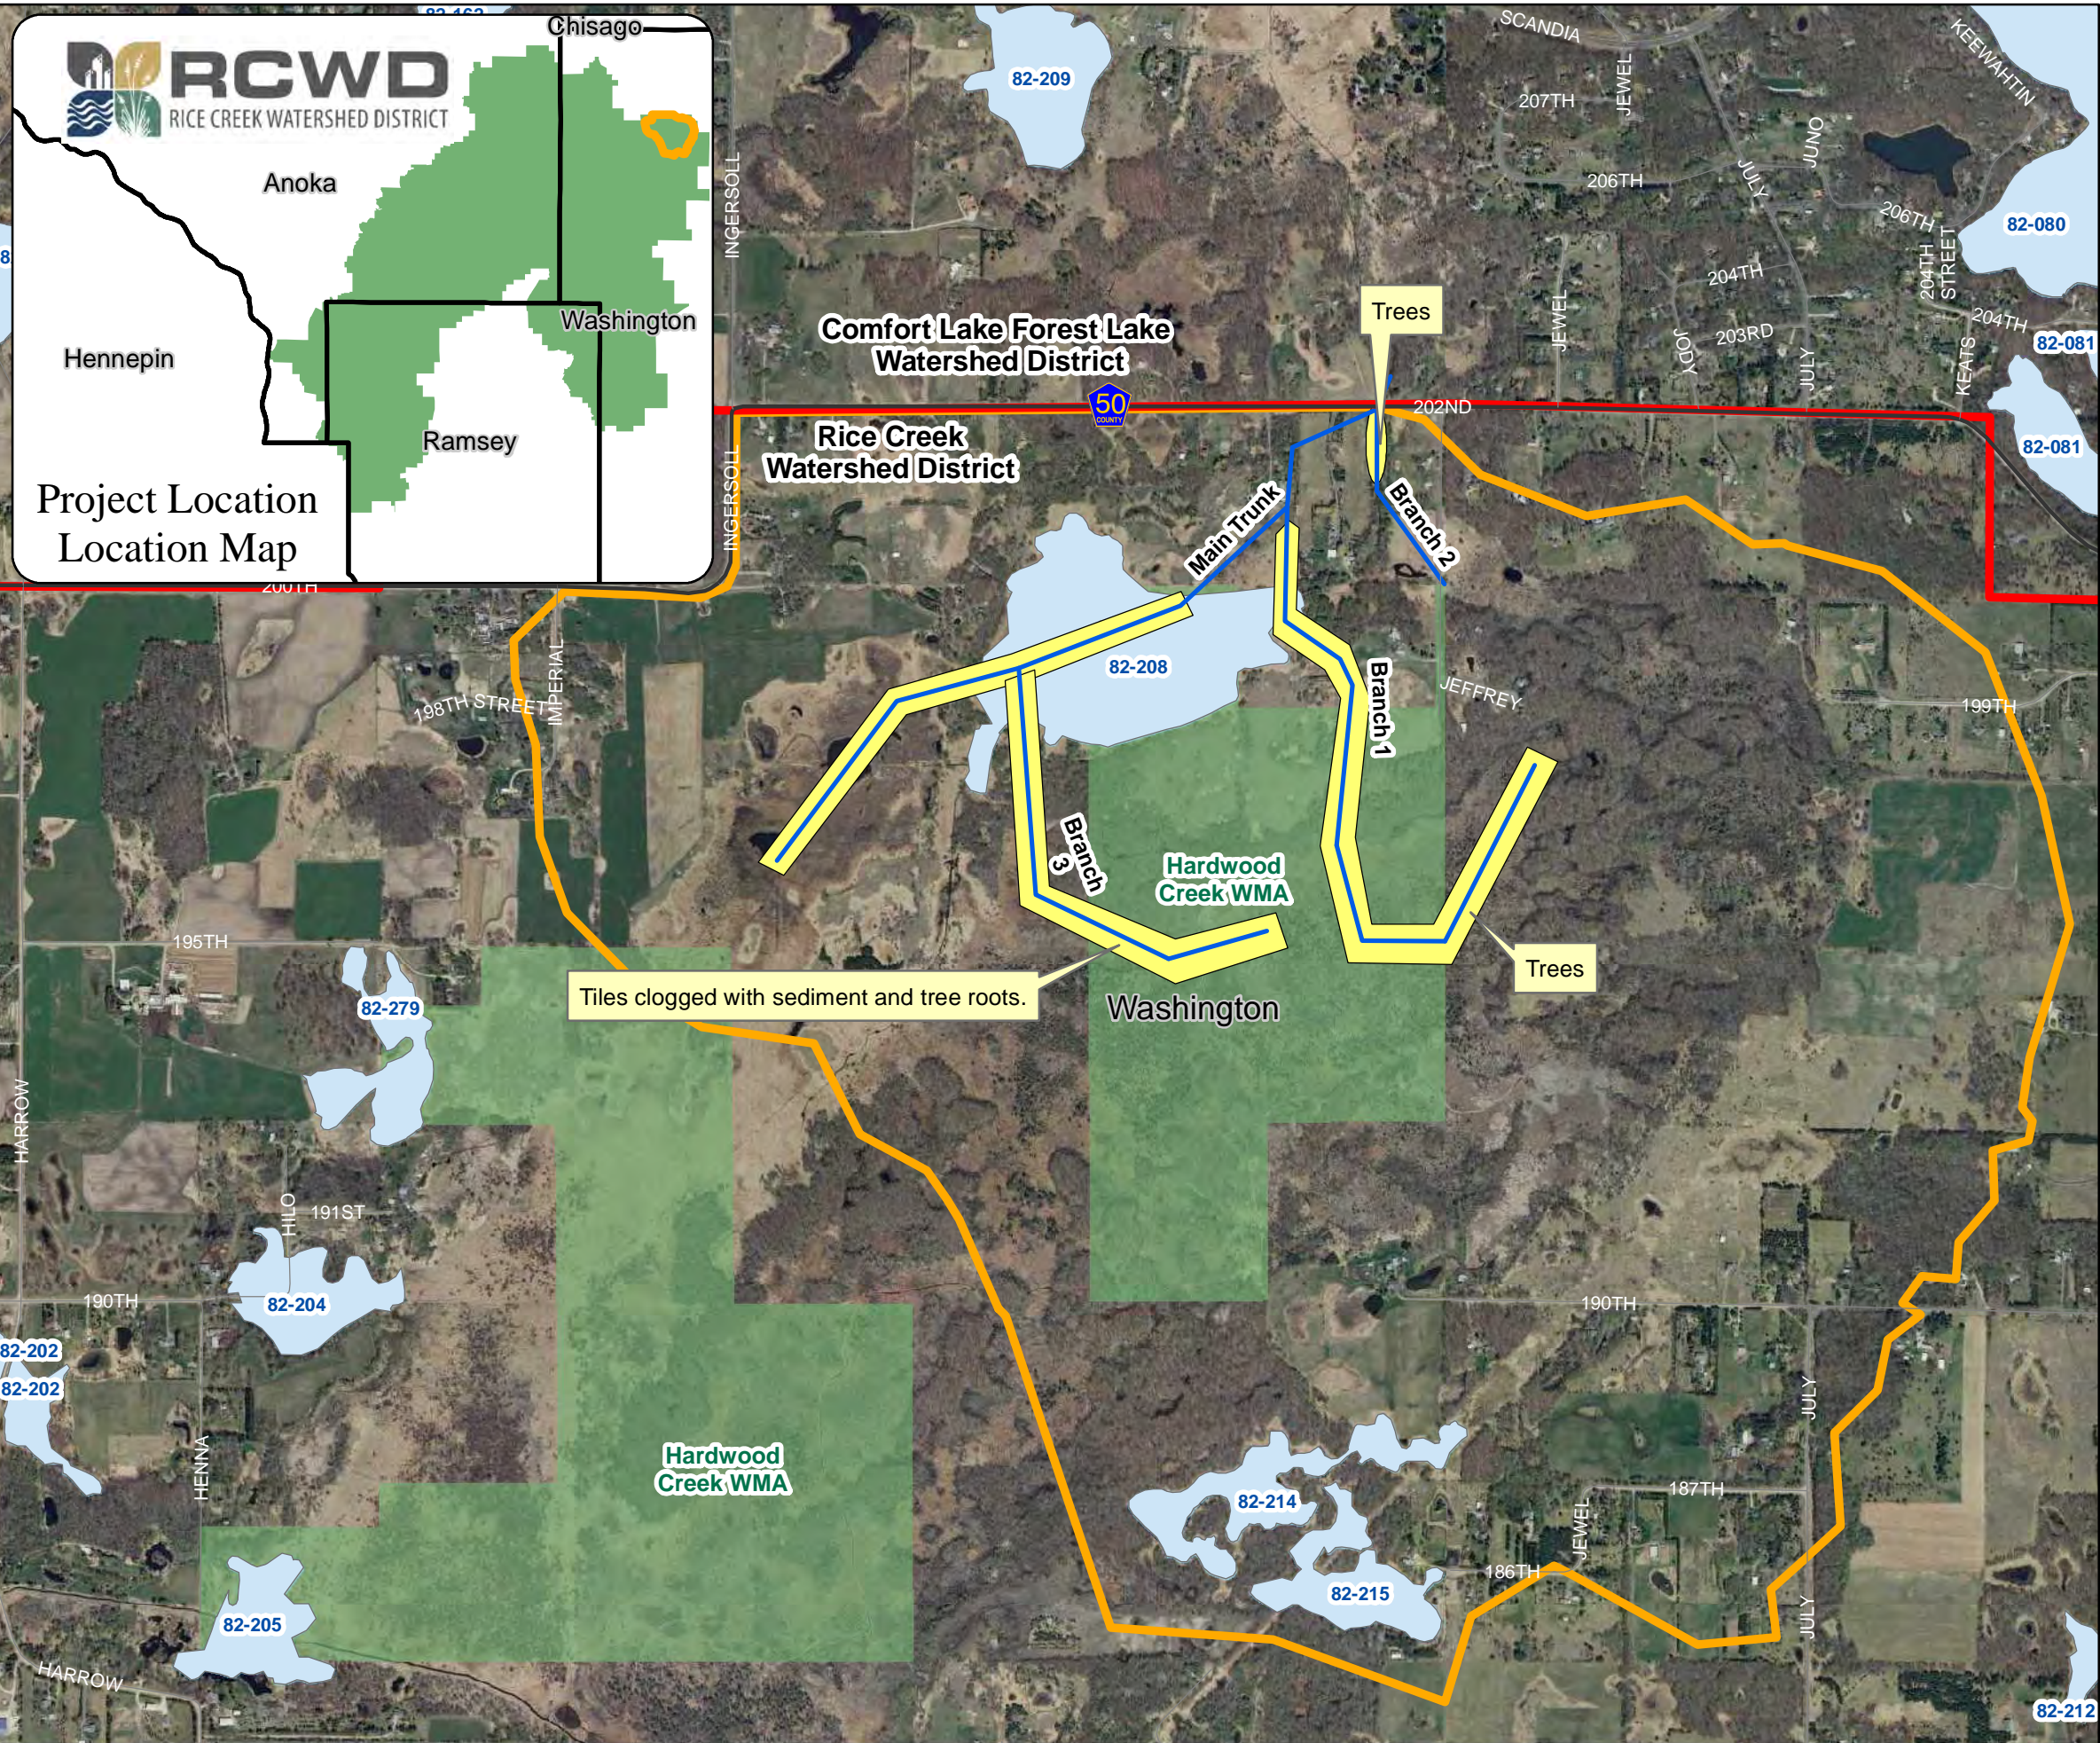
Rice Creek Watershed District Problem Areas Washington County Judicial Ditch 6

The WJD 6 public drainage system is in general disrepair, with many tiles clogged with sediment and tree roots. Much of the system is located in deep marshes and in forested areas which have accelerated the deterioration of the system. Several open channels have been excavated parallel to or crossing the historic alignment, presumably damaging portions of the tile system (if the tiles were intact at the time of the excavation). Very few remnants of the historic tile system are visible at the surface, even at locations where the excavated channels cross the tile system. Some of the problem areas are shown in **Figure 10**.

Due to the fact that WJD 6 drains to the north out of the RCWD boundary, we recommend that the District enter into discussions with the Comfort Lake Forest Lake Watershed District (CLFLWD) regarding the transfer of the authority of the public drainage system to them. We also recommend that the RCWD collaborate with the Board of Water and Soil Resources (BWSR) and the CLFLWD to modify the district boundaries to more closely reflect the contributing drainage area for both districts. The modification of the district boundaries and transfer of the drainage system authority will likely need occur concurrently.

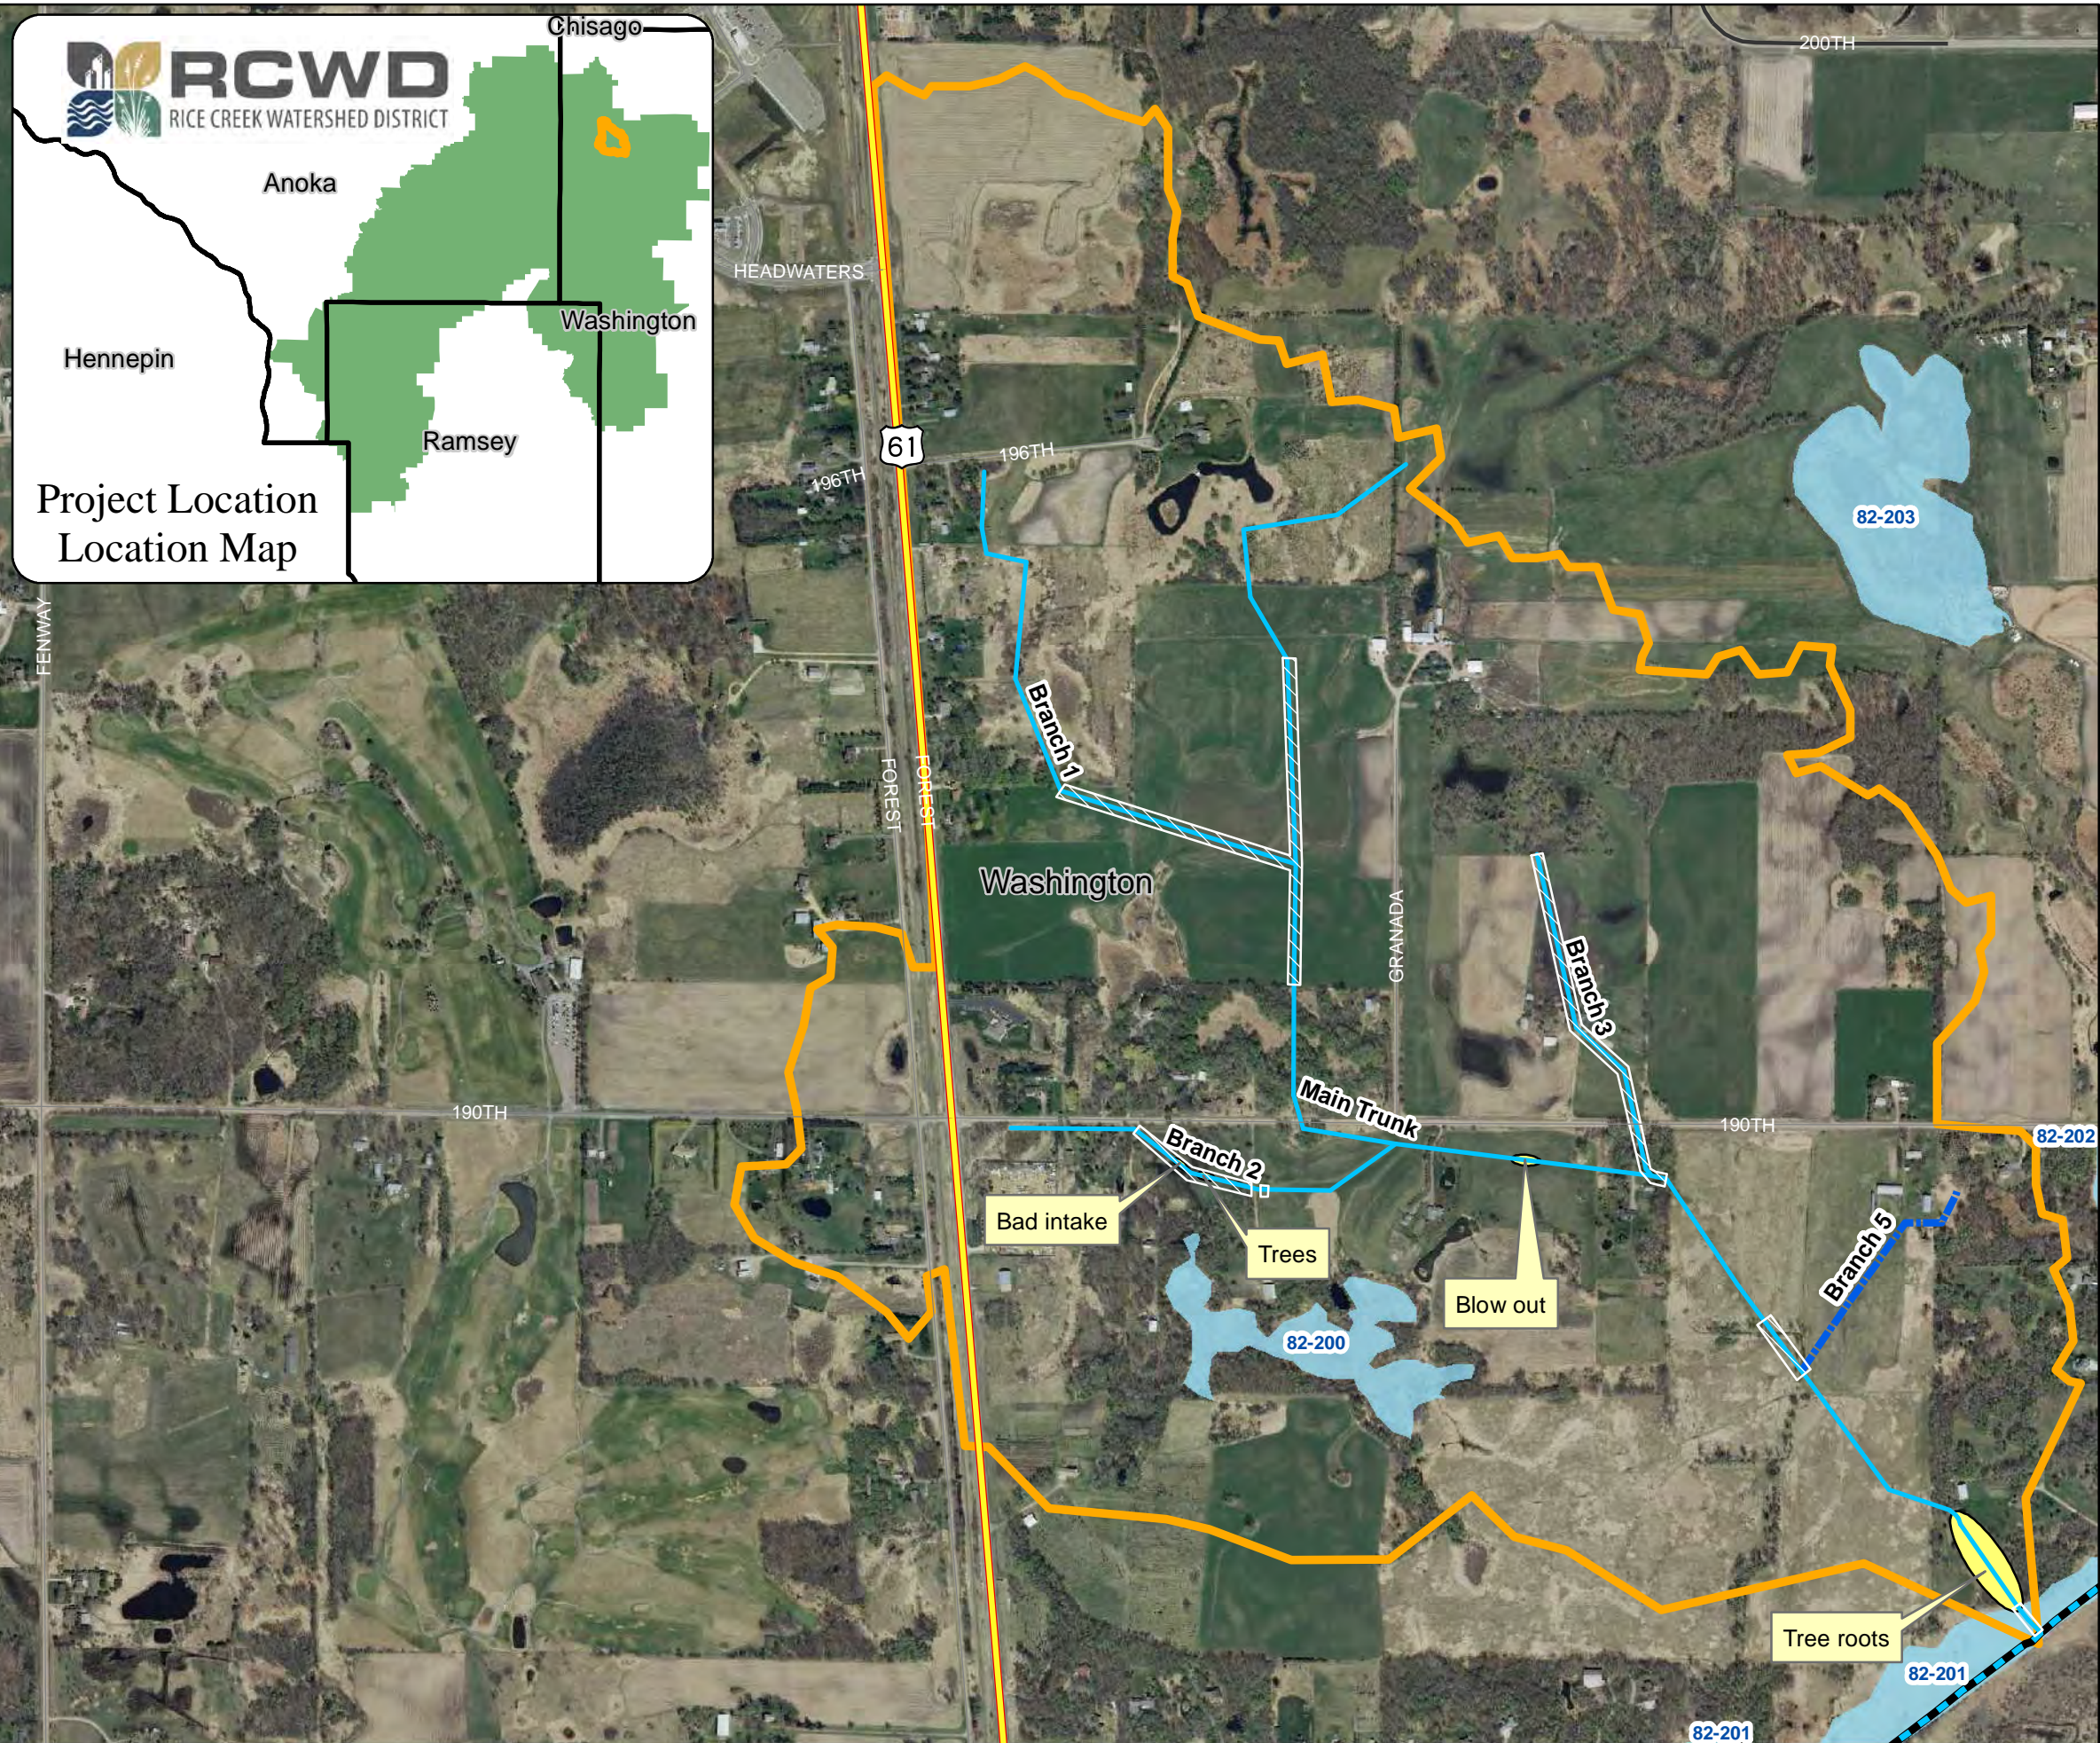
Rice Creek Watershed District Problem Areas and Completed Maintenance Washington County Judicial Ditch 7

In 2009, RCWD completed minor maintenance of Branch 3 under permit 09-067. This project repaired an intake at the upstream extent of the branch, replaced the crushed tile, and repaired the connection of Branch 3 to the Main Trunk. In 2009, RCWD staff reconstructed a headwall at the outlet of the Main Trunk.

Tile blowouts, or ruptures, are the primary known problems within the drainage system which need to be addressed. Because of the large contributing drainage area and flat tile grades, the original clay tile system has experienced blowouts at various locations throughout the system. Many of these blowouts have been repaired in recent years as indicated in **Figure 13**. Current problem areas on the WJD 7 public drainage system consist of a bad intake and trees on Branch 2 and a blow out and trees on the Main Trunk.
