At the Repair Bench – NanoVNA Touch Screen – June 2023

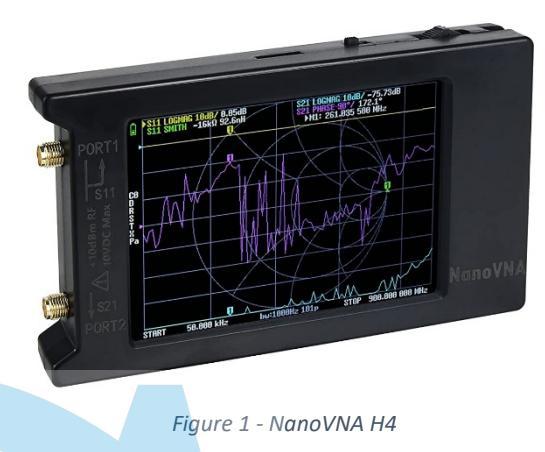
One recent Saturday afternoon, one of our fellow club members had cause to use the club's NanoVNA for some new equipment testing. Unfortunately, when he tried to operate the unit, the touch-screen feature was not working, and in fact, it seemed that the menu system was completely inoperative. I decided to bring it home with me to make the required repairs.

The club's NanoVNA is the H4 (Figure 1) variant which, at the time, was loaded with the DiSlord version 1.1.01 firmware dated 30 December 2021. While the firmware was most likely not the cause of the problem, as the unit had been working fine for a long while, I did notice that

In testing the NanoVNA quite thoroughly, I found that occasionally, I could get the menu system to operate via the multi-function control (MFC) wheel on the unit's top edge, after which the touch screen would occasionally operate until the next power-off. However, it was not consistent enough to say that this would be a usable work-around, so I kept on digging for an answer.

The clock speed of the NanoVNA is controlled by a firmware value called *Threshold*, which is set to 300.000100MHz by default. The *Threshold* setting is found under *Config* > *Expert Settings*. I decided to set it down to 290MHz. *Voilá*! The touch screen now behaved

I next went about performing a firmware upgrade on the NanoVNA. This is a simple operation that is done using the STMicroelectronics DfuSe software. I had the software (Figure 3) installed on my PC already, so all that I needed to do was to download the newest DiSlord firmware file in the commonly-used .dfu firmware format. That filename is NanoVNA.H4.v1.2.20.dfu which indicates that the firmware is version 1.2.20, dated 12 March 2023. The various firmware files can be downloaded from https://github.com/DiSlord/NanoVNA-D/releases under the Assets listing.

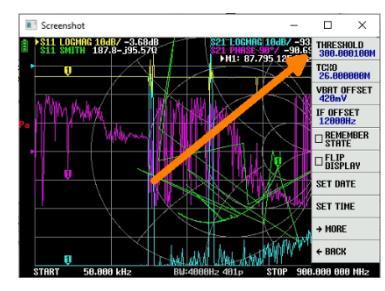
Figure 2 - Threshold setting

NanoVNA stability. This seemed to fit, so I looked some more into that concept – stability and how to control it. What I found was that the default settings for the DiSlord firmware versions are set to slightly overclock the NanoVNA. I decided to slow it down a little bit and see what happens.

OK – so slowing the clock speed solved the initial touch screen response issue in the old firmware. Of that there is no doubt. As a result, I feel comfortable suggesting that as a solution for anyone who may encounter a similar issue with the touch screen on a NanoVNA H4 and needs an immediate fix.
