**PRELIMINARY GEOTECHNICAL INVESTIGATION
PROPOSED MALLARD POINTE RESIDENTIAL DEVELOPMENT
MALLARD ROAD
BELVEDERE, CALIFORNIA**

January 18, 2022

Job No. 3068.001

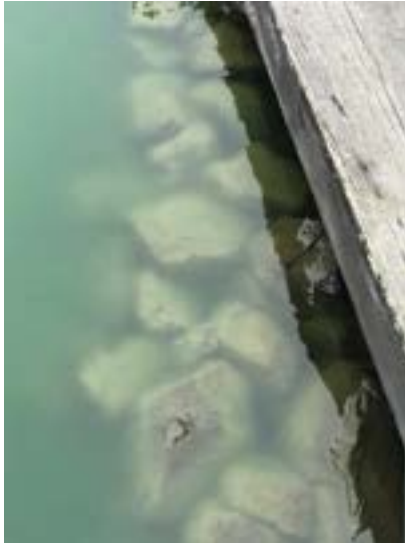
1-3 Mallard Drive

We performed a site reconnaissance on August 27, 2020 to observe and evaluate the existing bulkhead conditions along the Belvedere Lagoon frontage of the subject properties. The initial intent of the inspection was to evaluate a global repair plan for the old, 2 to 3 feet high, wooden bulkheads using a new retaining structure on the water side of the bulkheads. Upon inspection, it became apparent that landscape improvements and site conditions in the rear yards were variable, and a majority of the old wood bulkheads had either been partially buried and supported by rip-rap, or in some cases, wooden bulkheads were removed and replaced entirely with rip rap. Examples of existing conditions are shown below.

It was also noted during our site inspection that generally adverse surface drainage conditions exists in most yards and posts that support decks in the lagoon are in poor condition.
